CITY OF BOULDER
Facilities and Asset Management

Atrium Building and Band Shell

Structural Flood Assessment

April 22, 2013

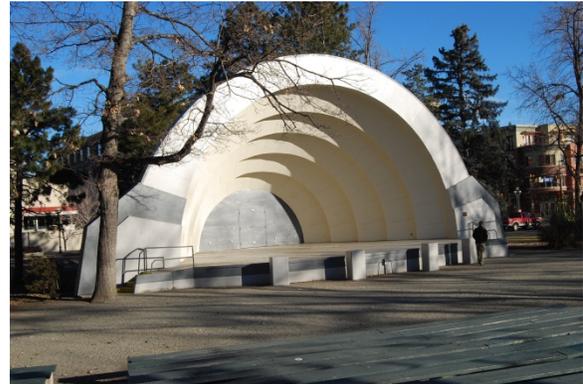
Originally constructed in 1938, no drawings are available for the Bandshell. Based on visual observations and descriptions by city staff, the structure consists of a wood framed platform over crawl space. The superstructure is clad with plywood paneling - however, the underlying support members are unclear. Perimeter concrete stem walls bear on

footings which have been assumed to bear 2'-0" below the adjacent grade. The top of the platform varies from 2'-6" to 3'-0" above the gravel surface along the south side.

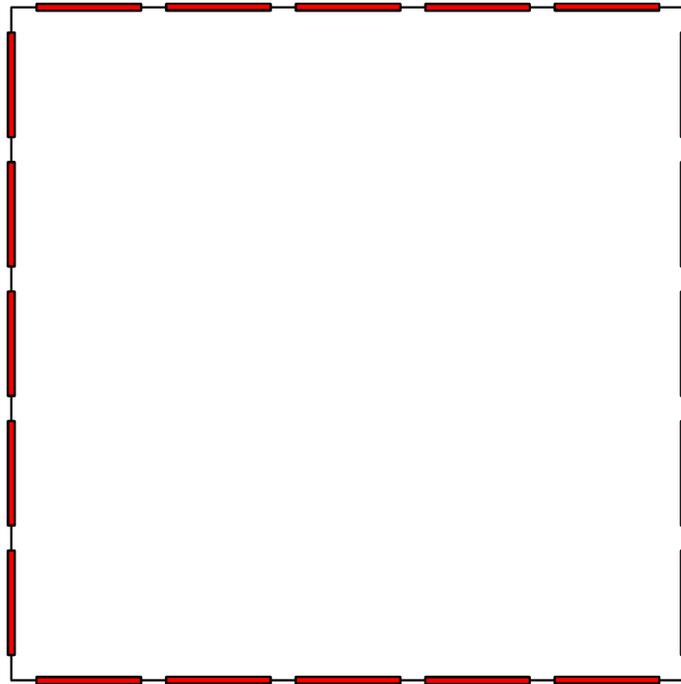
ATRIUM BUILDING IMPROVEMENTS

As indicated in table 7.1, the flood protection elevation is 5'-0" above the first floor elevation of the Atrium building. The storefront between the vertical brick bands would need to be replaced with 8" concrete infill walls to the flood protection elevation. The existing first floor is a concrete slab-on-grade, and would not be effective at resisting 312 psf buoyant forces. A dewatering system would need to be installed to continuously pump flood water to a level below the floor elevation. Additionally, passive flood gates would need to be installed at all of the entrances.

STOREFRONT INFILL/DOOR FLOODPROOFING

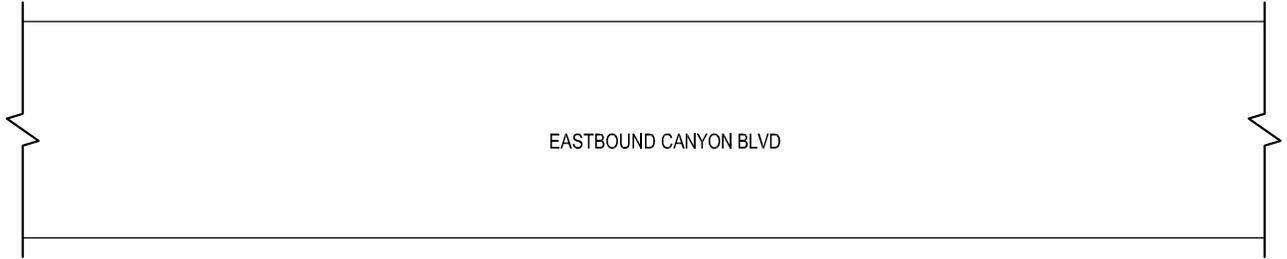
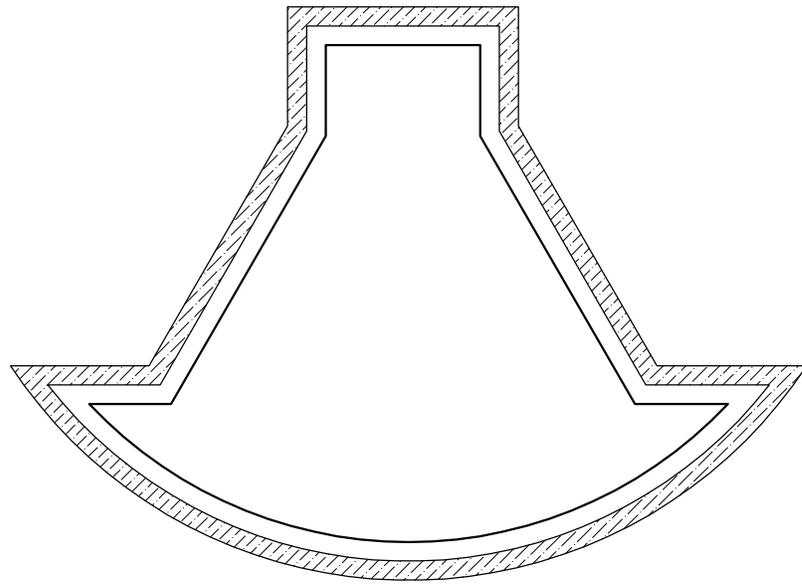
BANDSHELL IMPROVEMENTS

As indicated in Table 7.1, during a 100-year flood event, scouring would cause the existing footings to be undermined by 1.12 feet, thereby compromising the supporting foundations of the superstructure. One method to protect the foundation from scour is to provide riprap protection extending below the bottom of footing approximately 2'-0".
