SITE REVIEW DOCUMENTS FOR:  
**BOULDER CREEK COMMONS**  
 5399 KEWANEE DRIVE AND 5697 S. BOULDER ROAD  
 LOCATED IN THE SW¼ OF SECTION 3 AND THE SE¼ OF SECTION 4,  
 T15, R70W, 6TH P.M., COUNTY OF BOULDER, STATE OF COLORADO

EXISTING TREE SURVEY  
 PROJECT NO. B1006

**L6**  
 SHEET: 16 OF 36

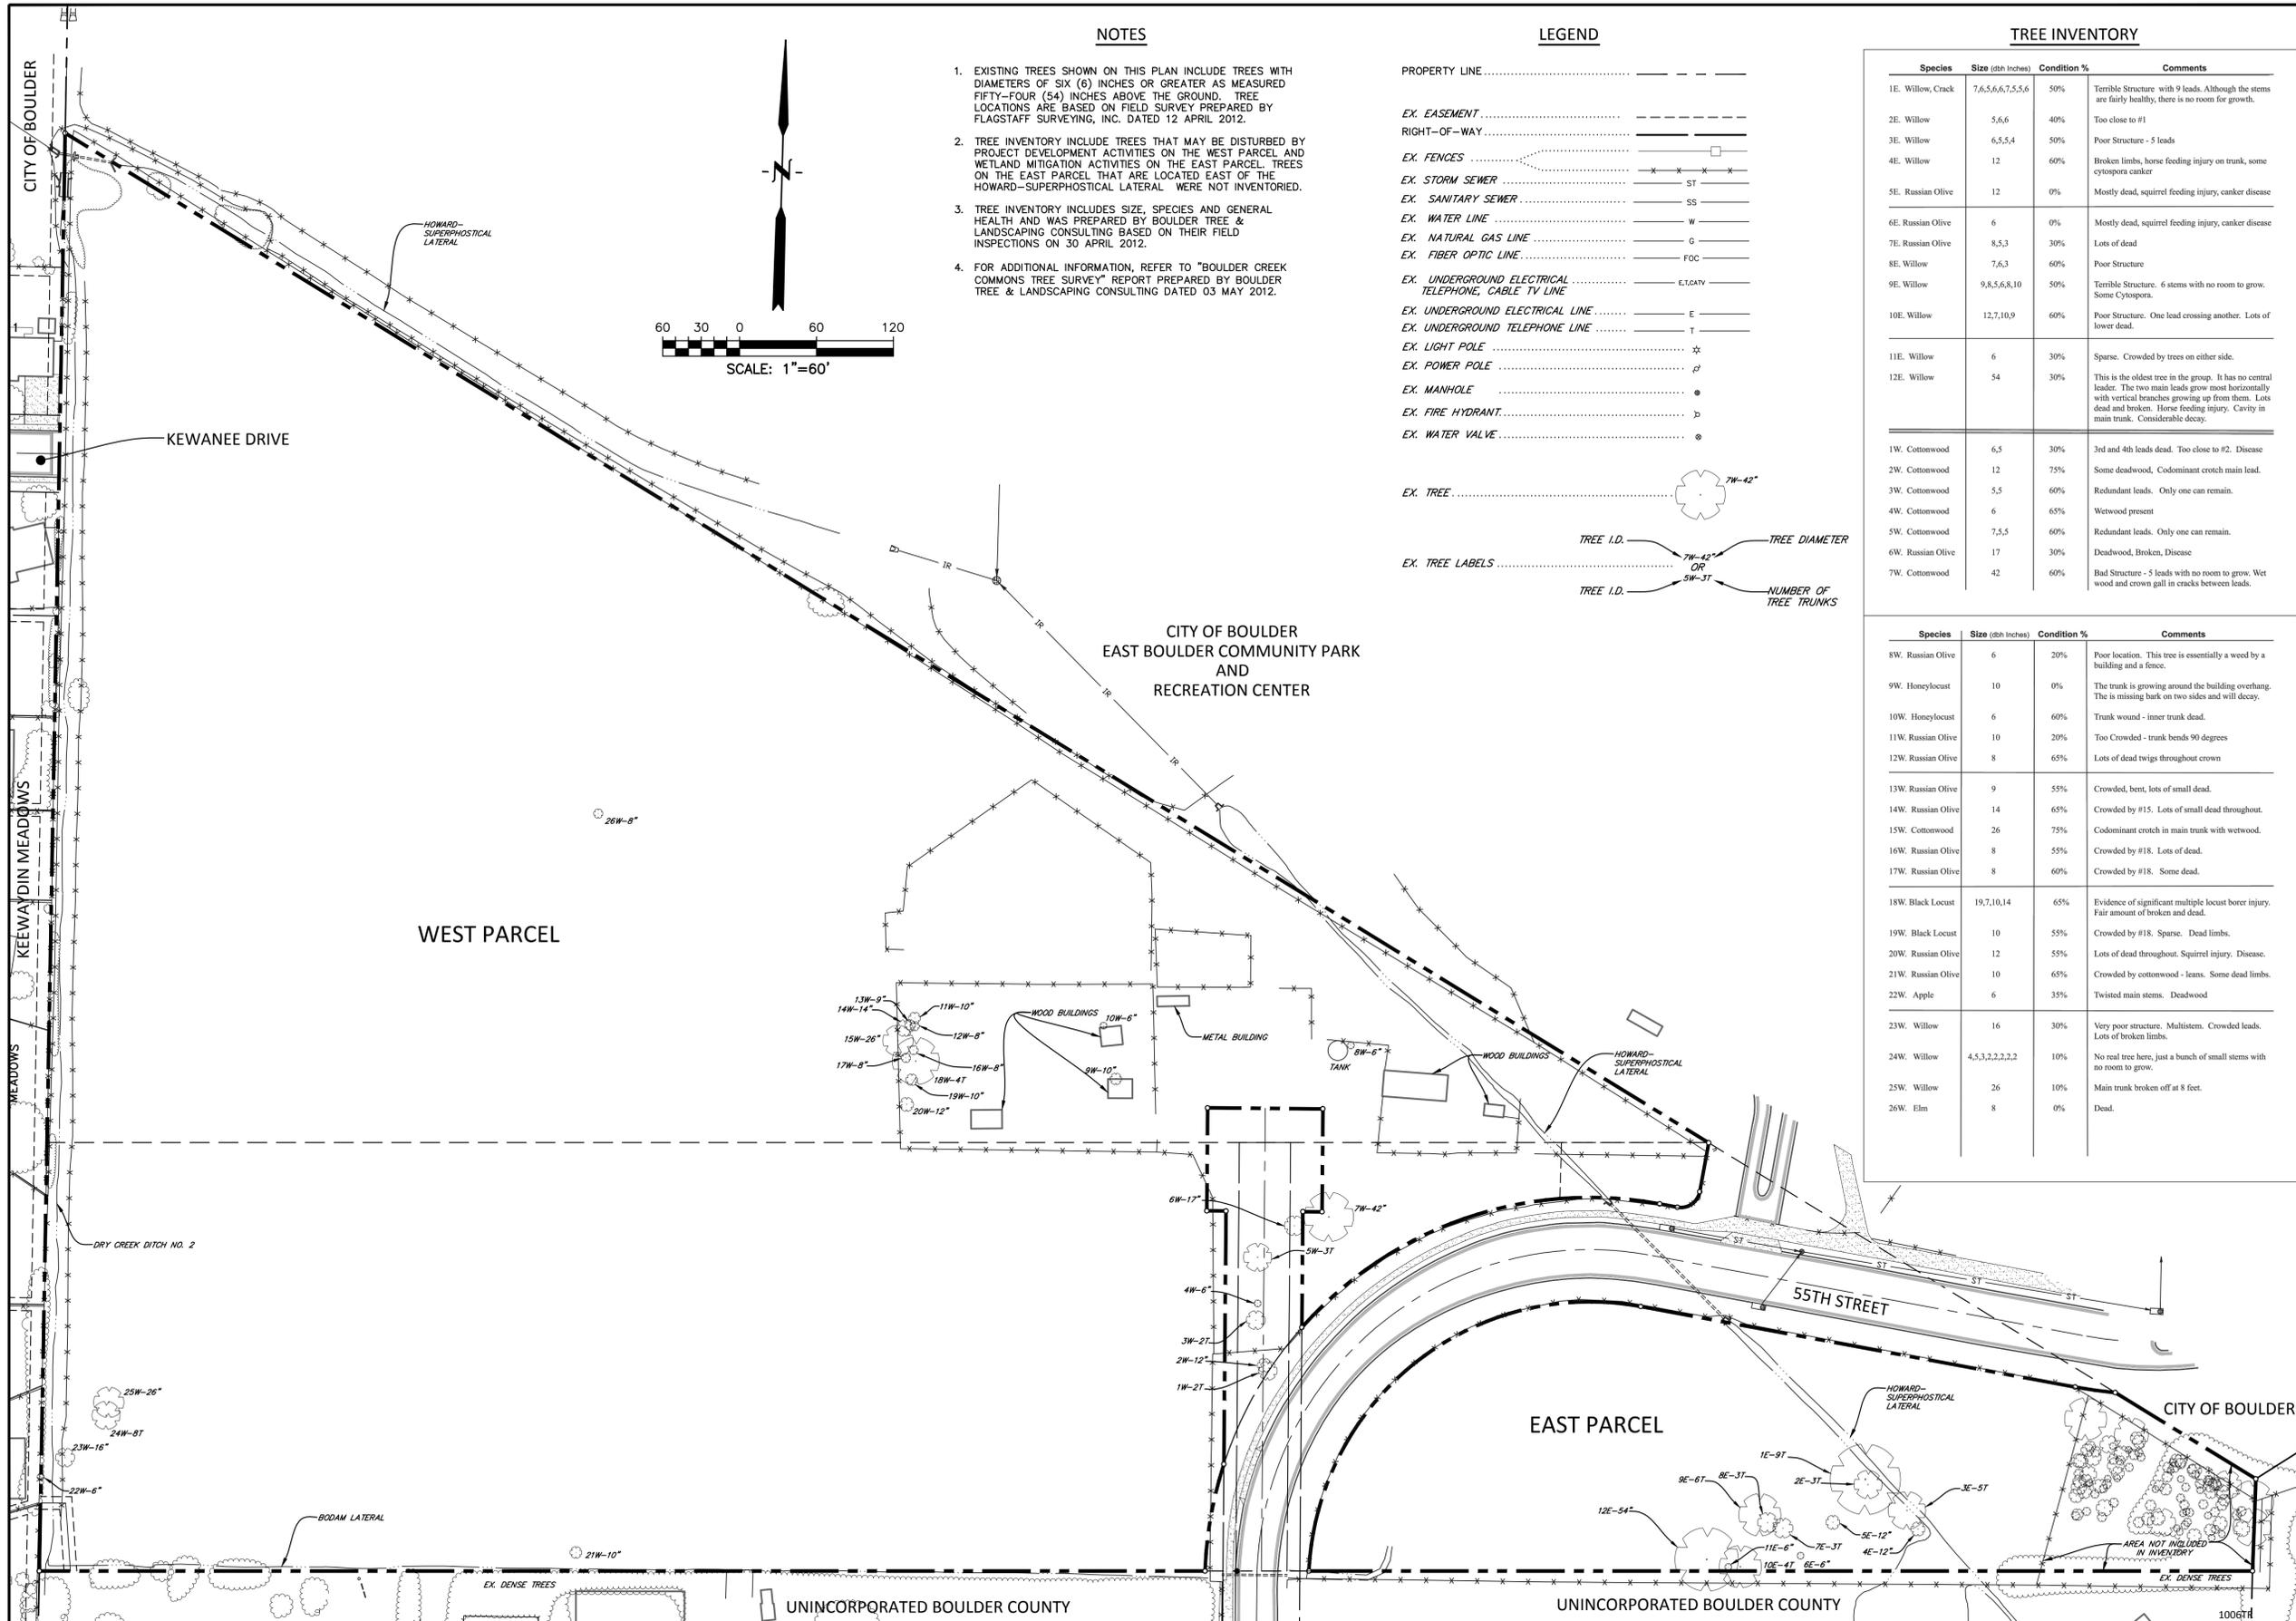
Species	Size (dbh inches)	Condition %	Comments
1E. Willow, Crack	7,6,5,6,6,7,5,5,6	50%	Terrible Structure with 9 leads. Although the stems are fairly healthy, there is no room for growth.
2E. Willow	5,6,6	40%	Too close to #1
3E. Willow	6,5,5,4	50%	Poor Structure - 5 leads
4E. Willow	12	60%	Broken limbs, horse feeding injury on trunk, some cytospora canker
5E. Russian Olive	12	0%	Mostly dead, squirrel feeding injury, canker disease
6E. Russian Olive	6	0%	Mostly dead, squirrel feeding injury, canker disease
7E. Russian Olive	8,5,3	30%	Lots of dead
8E. Willow	7,6,3	60%	Poor Structure
9E. Willow	9,8,5,6,8,10	50%	Terrible Structure. 6 stems with no room to grow. Some Cytospora.
10E. Willow	12,7,10,9	60%	Poor Structure. One lead crossing another. Lots of lower dead.
11E. Willow	6	30%	Sparse. Crowded by trees on either side.
12E. Willow	54	30%	This is the oldest tree in the group. It has no central leader. The two main leads grow most horizontally with vertical branches growing up from them. Lots dead and broken. Horse feeding injury. Cavity in main trunk. Considerable decay.

1W. Cottonwood	6,5	30%	3rd and 4th leads dead. Too close to #2. Disease
2W. Cottonwood	12	75%	Some deadwood. Codominant crotch main lead.
3W. Cottonwood	5,5	60%	Redundant leads. Only one can remain.
4W. Cottonwood	6	65%	Wetwood present
5W. Cottonwood	7,5,5	60%	Redundant leads. Only one can remain.
6W. Russian Olive	17	30%	Deadwood, Broken, Disease
7W. Cottonwood	42	60%	Bad Structure - 5 leads with no room to grow. Wet wood and crown gall in cracks between leads.
8W. Russian Olive	6	20%	Poor location. This tree is essentially a weed by a building and a fence.
9W. Honeylocust	10	0%	The trunk is growing around the building overhanging. The is missing bark on two sides and will decay.
10W. Honeylocust	6	60%	Trunk wound - inner trunk dead.
11W. Russian Olive	10	20%	Too Crowded - trunk bends 90 degrees
12W. Russian Olive	8	65%	Lots of dead twigs throughout crown
13W. Russian Olive	9	55%	Crowded, bent, lots of small dead.

14W. Russian Olive	14	65%	Crowded by #15. Lots of small dead throughout.
15W. Cottonwood	26	75%	Codominant crotch in main trunk with wetwood.
16W. Russian Olive	8	55%	Crowded by #18. Lots of dead.
17W. Russian Olive	8	60%	Crowded by #18. Some dead.
18W. Black Locust	19,7,10,14	65%	Evidence of significant multiple locust borer injury. Fair amount of broken and dead.
19W. Black Locust	10	55%	Crowded by #18. Sparse. Dead limbs.
20W. Russian Olive	12	55%	Lots of dead throughout. Squirrel injury, Disease.
21W. Russian Olive	10	65%	Crowded by cottonwood - leans. Some dead limbs.
22W. Apple	6	35%	Twisted main stems. Deadwood
23W. Willow	16	30%	Very poor structure. Multistem. Crowded leads. Lots of broken limbs.
24W. Willow	4,5,3,2,2,2,2	10%	No real tree here, just a bunch of small stems with no room to grow.
25W. Willow	26	10%	Main trunk broken off at 8 feet.
26W. Elm	8	0%	Dead.
