**PHASE I ENVIRONMENTAL  
SITE ASSESSMENT**

Valmont Butte Property  
3000 North 63<sup>rd</sup> Street  
Boulder, Colorado

Alisto Project No. 50-071

September 18, 2000

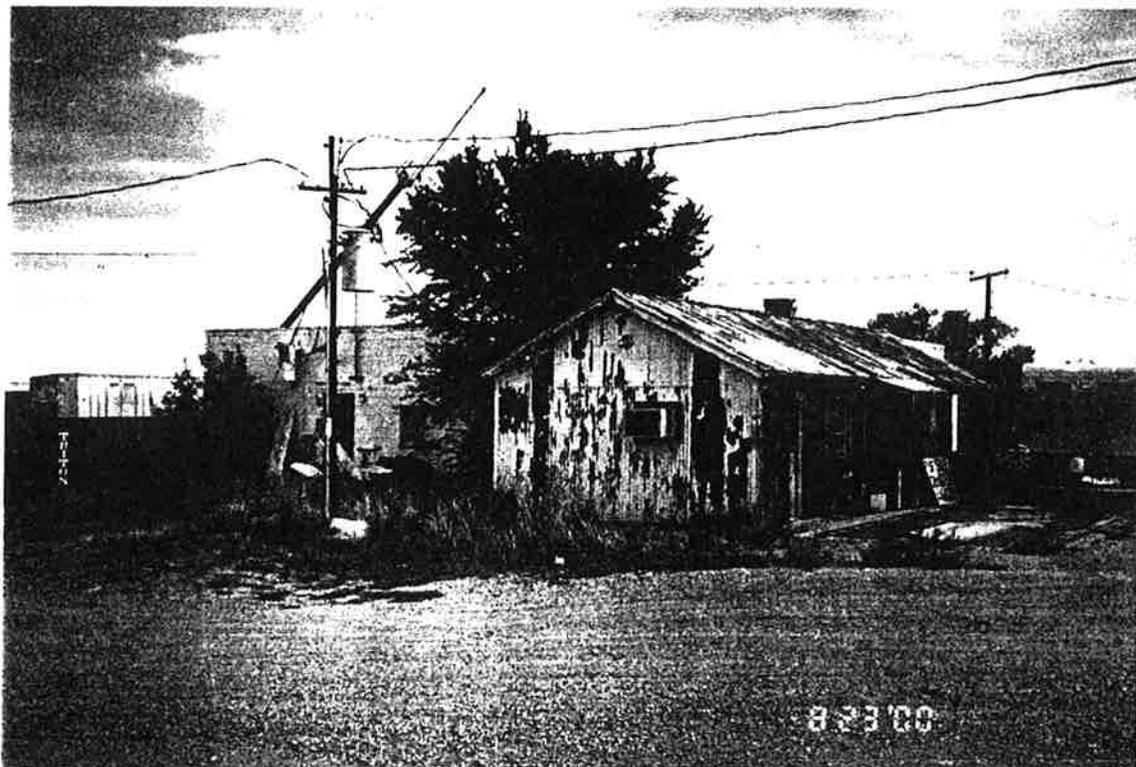
A pole-mounted transformer was observed in the yard north of the office building. There was no label on the equipment identifying ownership or PCB content. It was observed to be in good condition with no evidence of leakage. The property owner typically owns on-site transformers

Photo #3: View southeast of the "office building". Note the pole-mounted transformer to the left.

The local utility company should be contacted for information as to the ownership of the transformer on-site and the presence of polychlorinated biphenyls (PCBs) in the oil. If no information is available or can be obtained, the City should consider testing the transformer oil for PCBs, which if detected should be removed and replaced with non-PCB oil. Recommendations related to the ACMs present at the property are presented in a separate report.

- The owner of one unlabeled transformer identified at the site is not known. The transformer appeared to be in good condition, but its ownership should be determined.

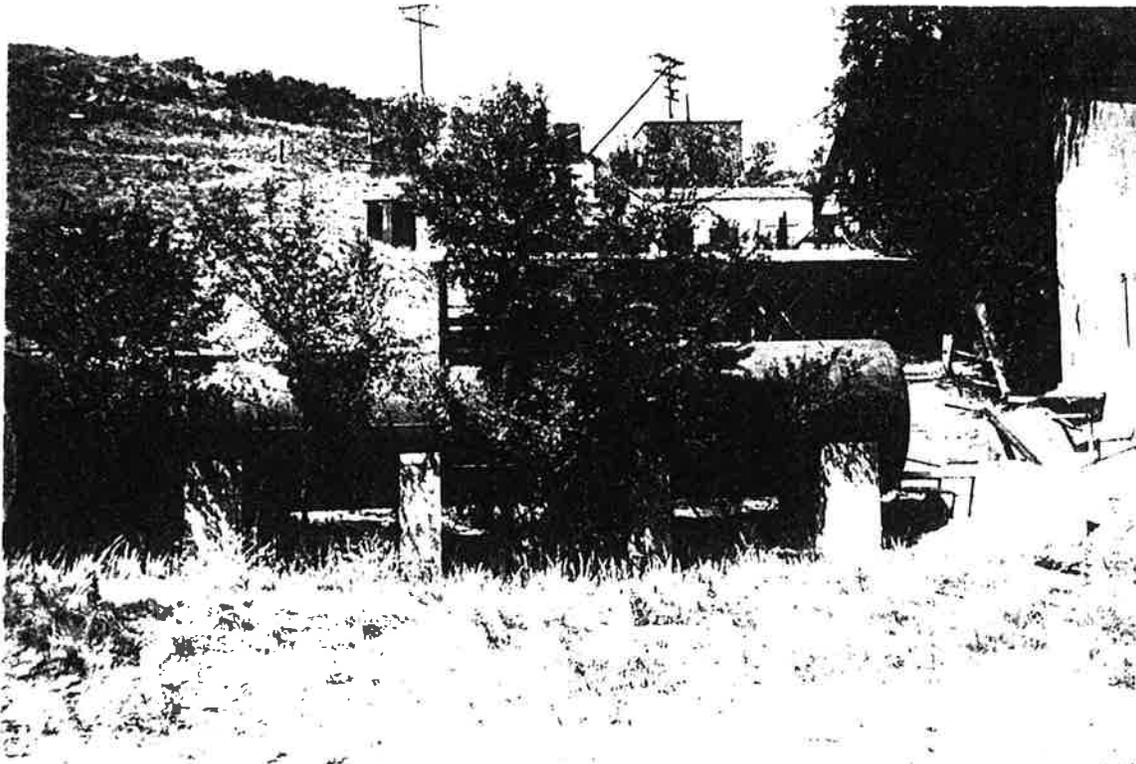
Photo #5: View north of the Actinol tank (partially full) near the southwest corner of the mill building.

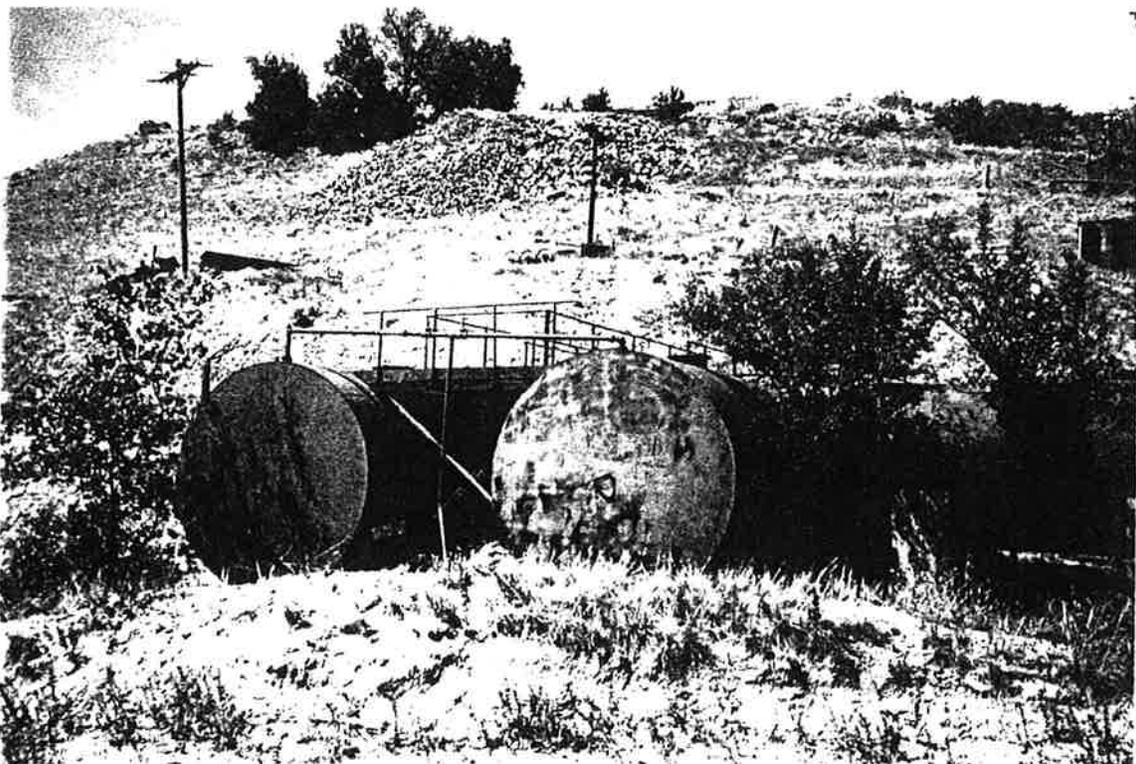
2. No information is available as to the content of the abandoned drums, reportedly used by the former Hendricks operation.
3. Releases from leaking pipes associated with the two diesel ASTs, if any could potentially impact the subsurface soil in the vicinity.

Photo #6: View northwest of the two large empty diesel ASTs near the southwest corner of the mill building.

At the time the buildings are demolished, the piping associated with the diesel ASTs for the mill operations should be excavated and removed. If there is evidence of leakage from the piping, additional excavation or exploratory borings should be performed along with confirmation soil sampling and analysis to determine the nature and extent of impact, if any.

The piping associated with the diesel ASTs for the mill building would need to be excavated and removed from the site. If there is evidence of leak or release in the soil from the piping, additional excavation or exploratory borings should be completed to determine the extent of the impacts.

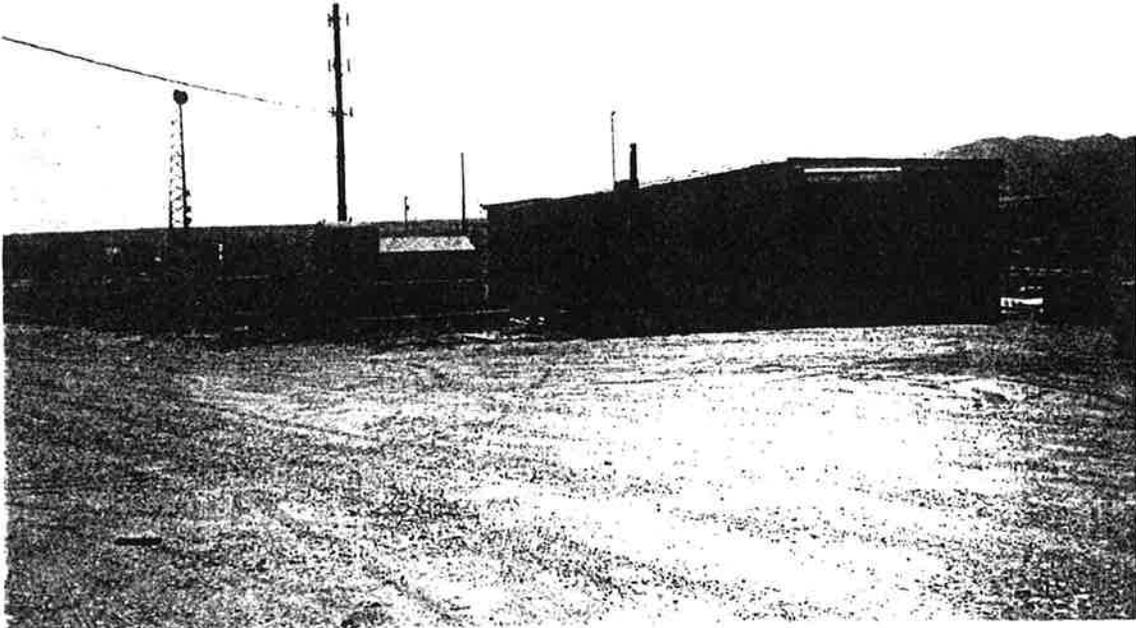
One empty gasoline farm tank has been empty since Valmont Butte acquired the property. There was no evidence of USTs observed on the site during inspection.

**Photo #7:** View south from the driveway of the cinder block storage building. An unused gasoline AST is on the east side.

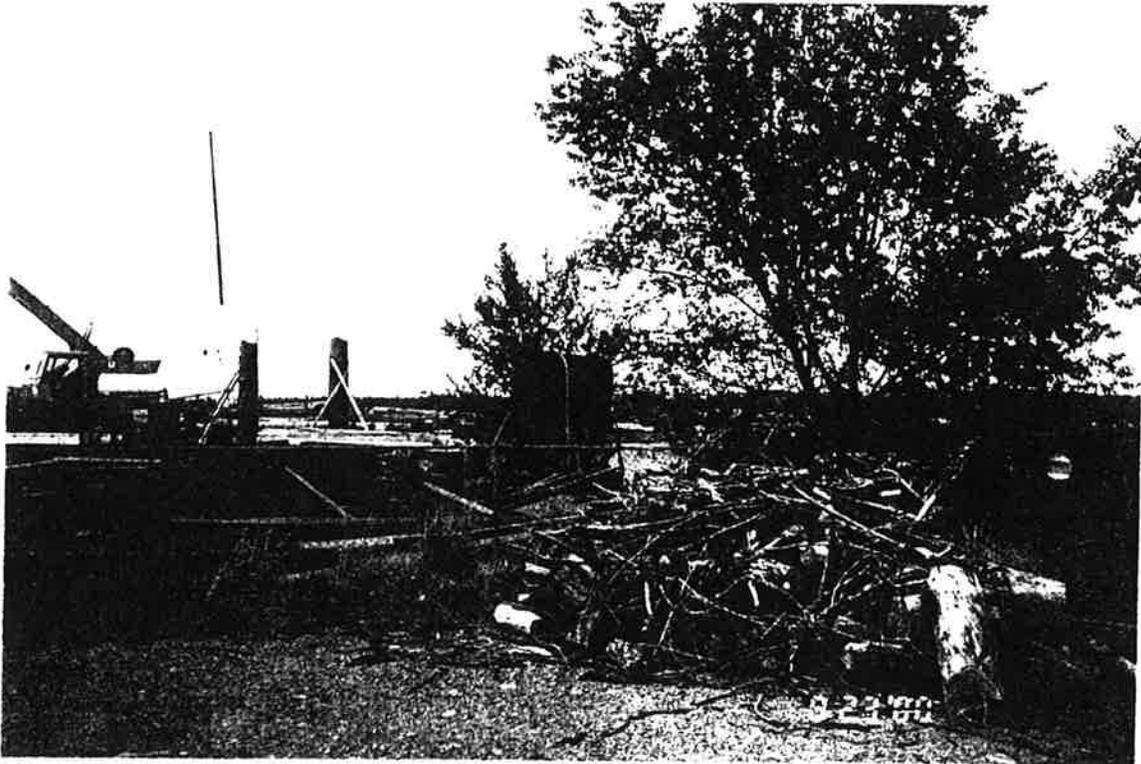
Timmerhaus operates one small diesel AST at the site for its equipment fueling. There was no evidence of staining of the soils around the AST.

**Photo #8:** View northeast of part of the Timmerhaus storage yard. The AST (center) contains diesel fuel for their on-site equipment.

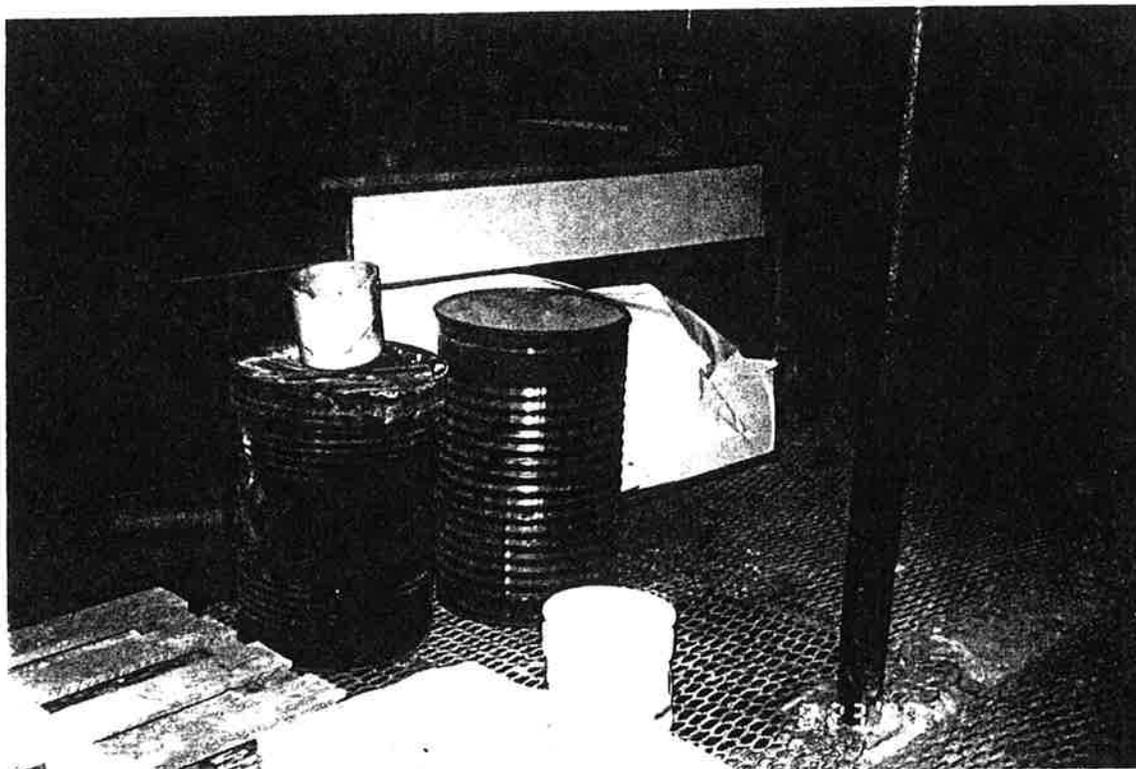
Photo #9: Two drums of unknown contents inside the mill building's east door.

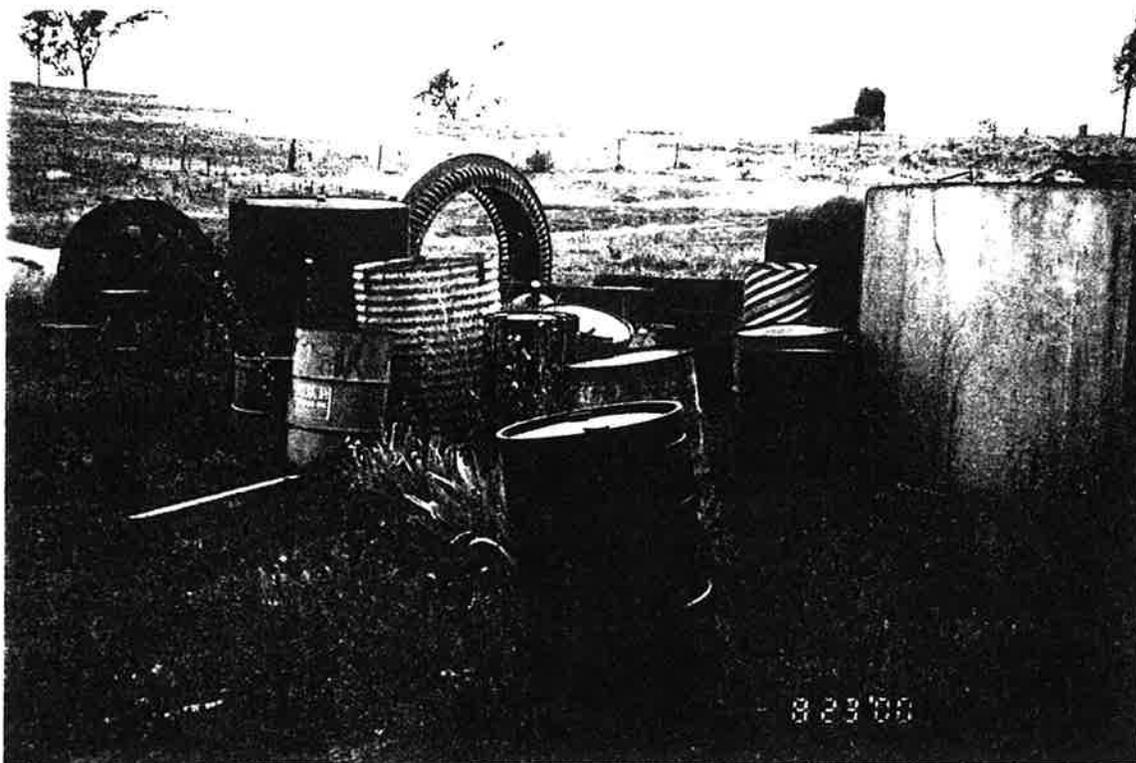
In addition, there were several drums with unknown contents present in an area of abandoned equipment west of the former tailings pond. One of the drums contains liquid, but there was no evidence of leakage. According to Mr. Smith, the former plant operator, Mr. Tom Hendricks, owns the drums, which will be removed from the site.

Photo #10: Several drums of unknowns in an old equipment area east of the main yard and just west of the old tailings pond. View south.

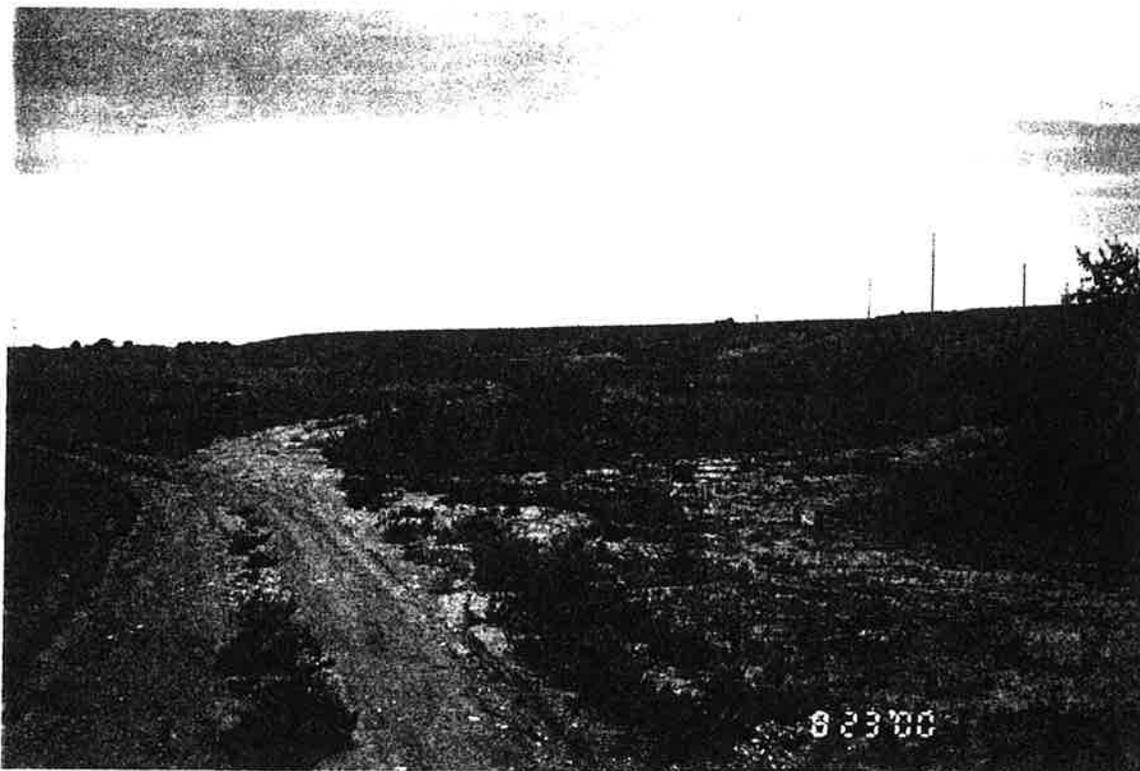
No pits or lagoons were observed on the site. A large, dry, tailings pond is present on the central portion of the site, which received ore tailings from the 1930s or 1940s through the mid 1980s. Some of the tailings waste contained low-level radioactive material as previously discussed. Since its closure, several feet of clean fill has been placed over the tailings.

Photo #11: View southeast of the former tailings pond from the west end.

Since process wastes or tailings are reportedly contained in the pond, are covered with clean fill, and groundwater has not been encountered in the area, it is apparent that there is no exposure pathway to impact public health or the environment. On that basis, and since the State has placed drilling restrictions on the tailings pond area, no additional investigation is recommended at this time. At such time as the soils within the tailings pond will be disturbed, it should first be sampled and analyzed for the presence of hazardous constituents and managed accordingly.
