Trail Condition Monitoring

Boulder Open Space and Mountain Parks

North Trail Study Area

North Trail Study Area Trail Condition Monitoring Report

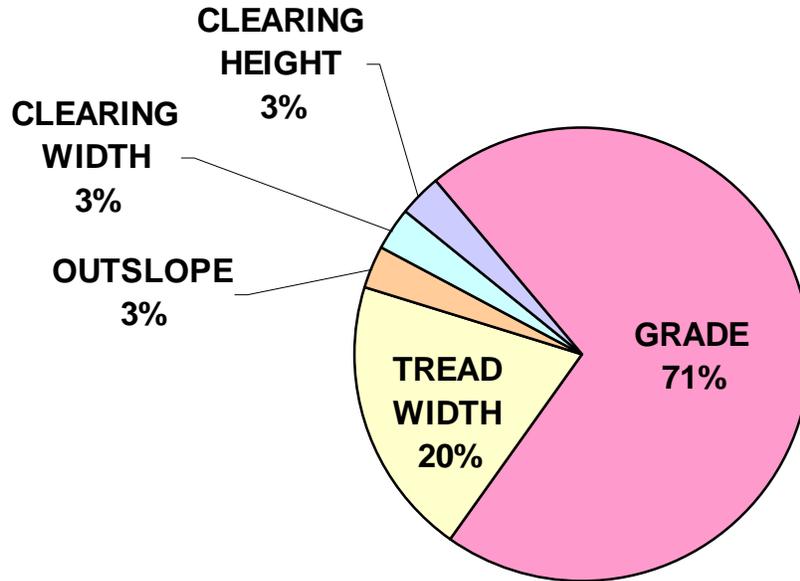
Figure 2: Contribution of various trail sustainability factors to **non-compliance** in the North TSA. (total distance of trail out of compliance = 2,653ft or 809m)

Trail grade was responsible for almost three-fourths of the non-compliant portions while erosion contributed to over half of the maintenance issue portions. This is not surprising, as erosion is more likely to occur where grades are steeper and run-off is moving more rapidly. Also, the sandy soils underlying these trails could be a major reason for the extensive erosion problems.

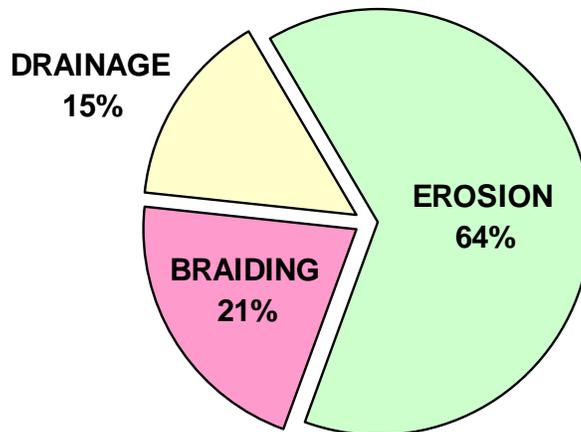
Figure 3: Contribution of various **maintenance issue** categories in the North TSA. (total distance of trail with maintenance issues = 965ft or 294m)

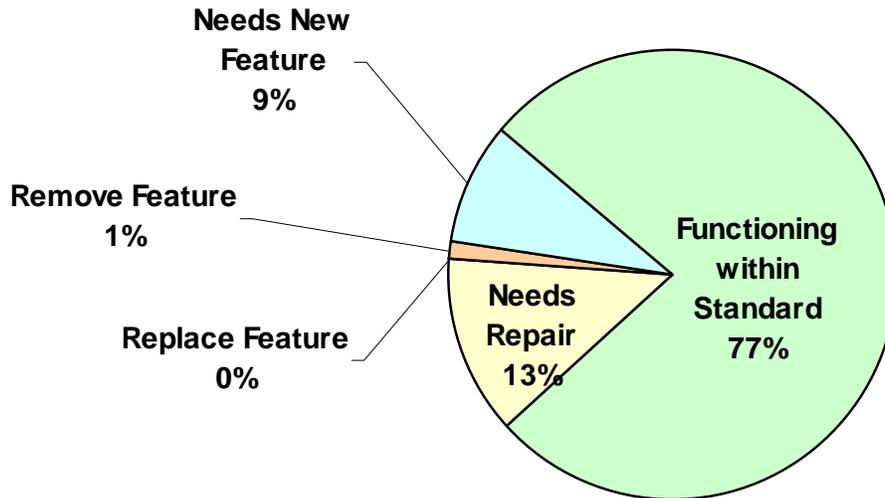
Figure 4: Condition class of constructed features in the North TSA.

Three fourths of the 735 constructed features associated with trails in the North TSA are functioning within standard. The most common features in need of repair are drain dips and culverts, which will require extensive cleaning to regain proper function. Approximately 60 drain dips are recommended to be installed to assist with grade or erosion issues associated with certain trail segments.
