Trail Condition Monitoring

Boulder Open Space and Mountain Parks

Southern Trail Study Areas

Southern Trail Study Areas Trail Condition Monitoring Report

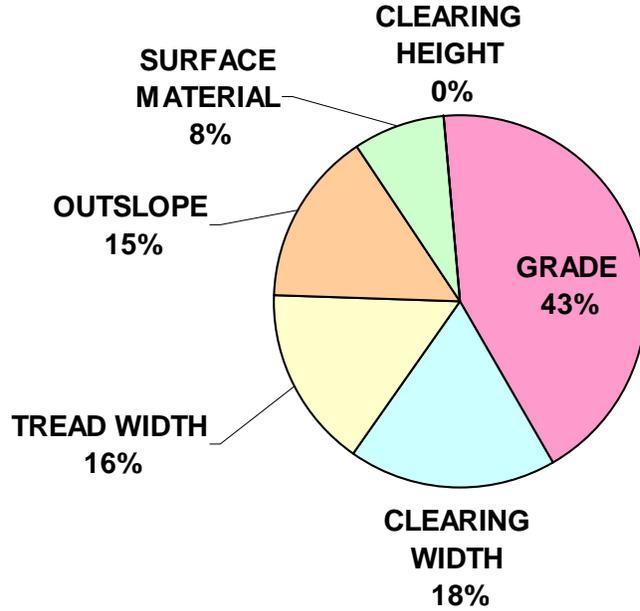
Figure 2: Contribution of various trail sustainability factors to **non-compliance** in the MM/SG TSA. (total distance of trail out of compliance = 2,653ft or 809m)

Trail grade is the contributing factor to almost half of the non-compliant portions, and trail braiding contributed to about half of the maintenance issue portions. Steep grades can cause many problems if not addressed properly. Water run-off traveling unobstructed down steep grades gains velocity, which then leads to erosion: ruts, gullies, and abundance of loose rock. People avoid these areas by traveling around them. This response results in trail braiding and/or widening.

Steep grades can be addressed either by installing steps or drain dips/waterbars to decrease the velocity of run-off to help prevent erosion.

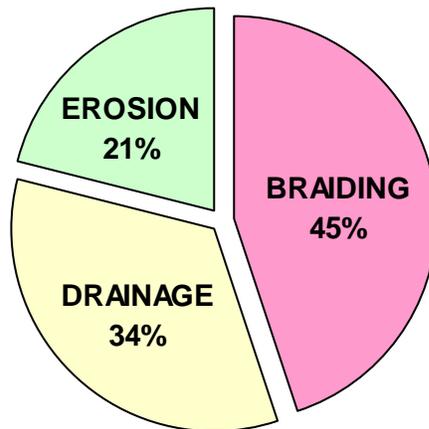
Figure 3: Contribution of various **maintenance issue** categories in the MM/SG TSA. (total distance of trail with maintenance issues = 965ft or 294m)

Drainage problems contributed to about a third of the maintenance issues. The types of soil found in the MM/SG TSA could be one of the reasons for this, but also the placement of the trail accounts for this as well. Some portions are in low-lying or flat areas. Constructing small drains combined with applying fill material can mitigate many of these drainage issues.

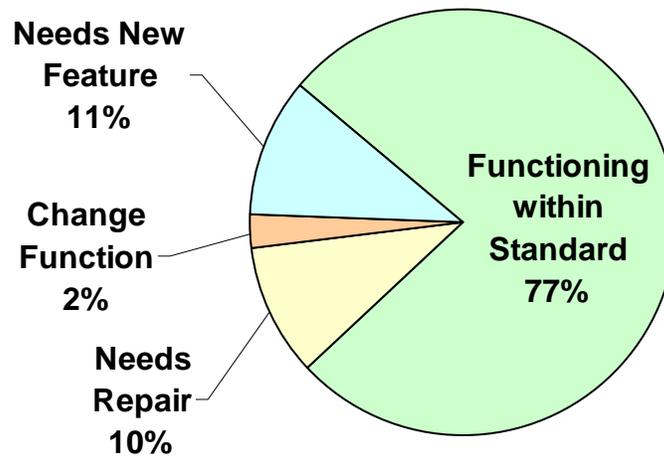
Figure 4: Condition class of constructed features in the MM/SG TSA.

Three fourths of the 122 constructed features associated with trails in the MM/SG TSA are functioning within standard. One-tenth are in need of repair, such as drain dips and culverts requiring extensive cleaning to regain proper function. A wooden bridge on the Community Ditch Trail segment 102.02 and one on the Greenbelt Plateau Trail segment 103.02 are in need of repair. Approximately 13 drain dips are recommended to be installed to assist with grade or drainage issues associated with certain trail segments.

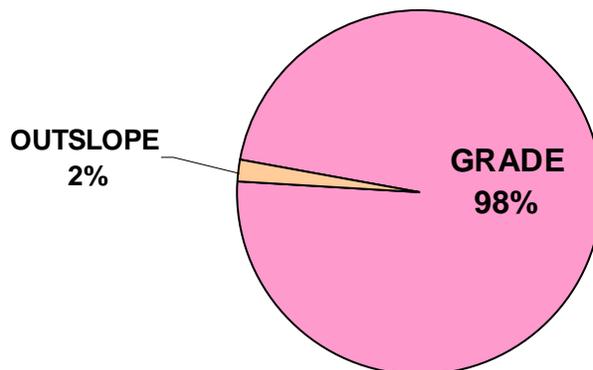
Figure 5: Contribution of various trail sustainability factors to **non-compliance** in the EM/DD TSA. (total distance of trail out of compliance = 962ft or 293m)

Trail grade contributed to the majority (98%) of the non-compliant portions documented along the surveyed trail segments within the EM/DD TSA. These grade issues are all located on the Douby Draw Trail segment 101.04. This trail segment's improved surface (roadbase) might help in slowing down the rate of erosion, but some of the steep grades will need to be addressed to achieve sustainability.

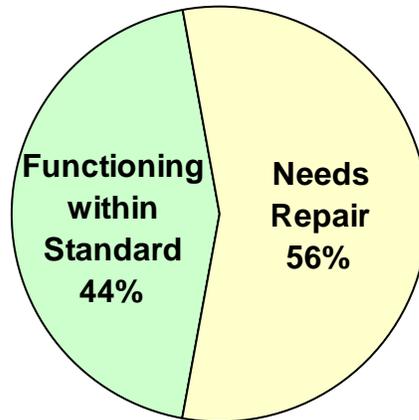
Figure 6: Condition class of constructed features in the EM/DD TSA.

There are 9 constructed features associated with the trail segments surveyed in EM/DD TSA. Four features are functioning within standard and five are in need of repair, which are all culverts requiring extensive cleaning to regain proper function.
