Trail Condition Monitoring

Boulder Open Space and Mountain Parks

West Trail Study Area

October 2008

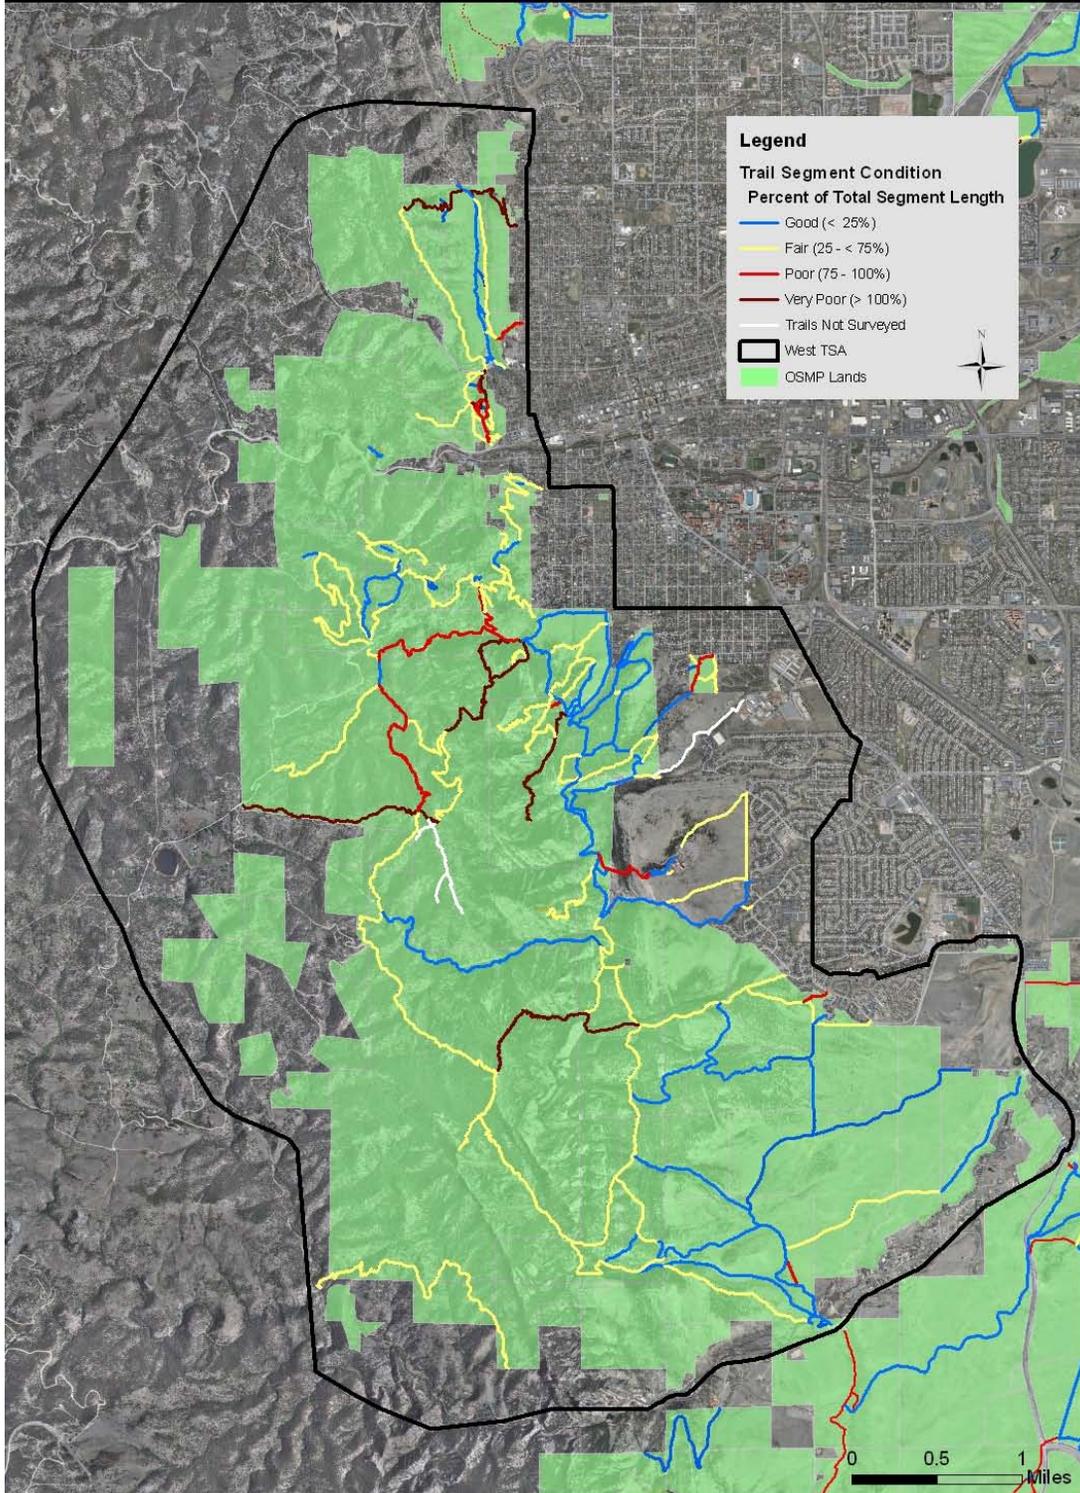
Trail Segment Condition - West Trail Study Area

OSMP staff developed a ranking system based upon the percentage of the trail that is designated as an area of concern. In this system “Good” refers to trail segments which exhibit areas of concerns along less than 25% of their total segment; “Fair” means approximately 25% to 75% of the segment length exhibits an area of concern; “Poor” means 75% to 100% of the segment length exhibits an area of concern; “Very Poor” means there are overlapping areas of concern and summing to a coverage of greater than 100% of the trail segment. Attachment B contains a map showing the condition by color for the trail segments in the West TSA.).
