September 27, 2011

Subject: Hogan-Pancost Property: Neighborhood Event Timeline and Response to Specific Questions Raised by Adjacent Neighbors

Telesto Solutions, Inc.

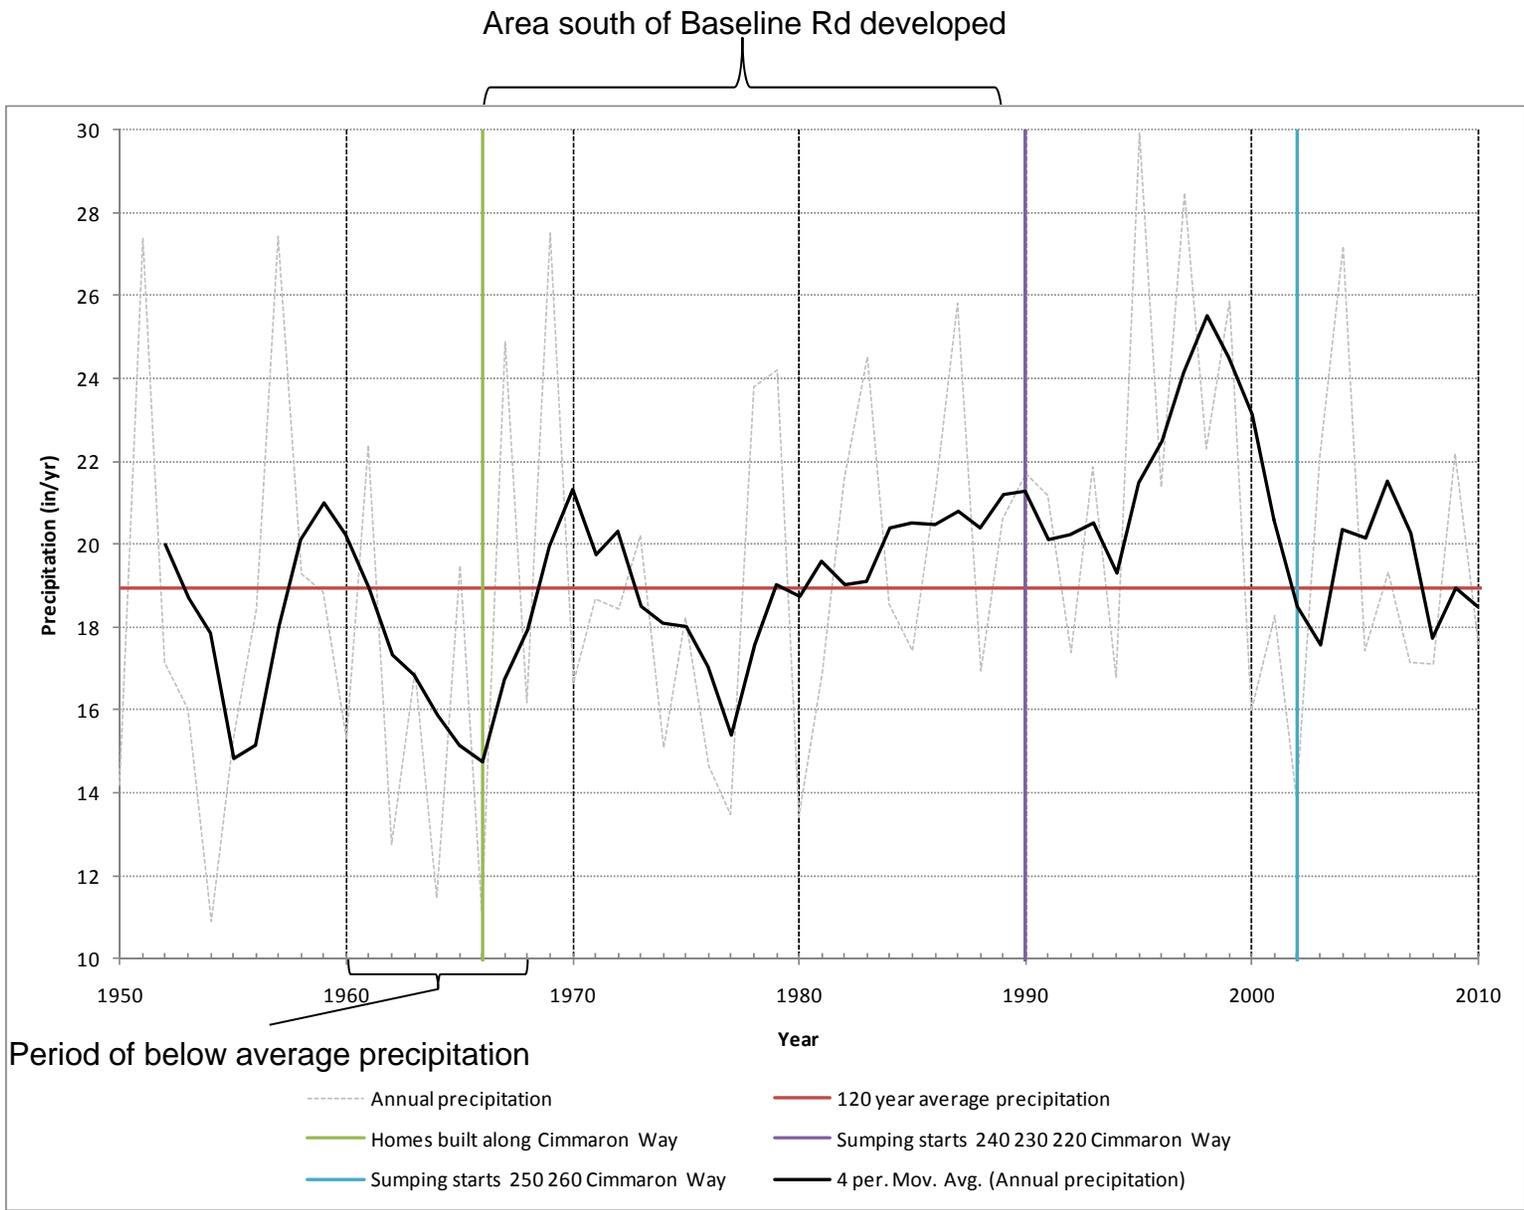
FIGURE 2
 PRECIPITATION AND EVENT HISTORY

The Long Response: The homes along Cimmaron Way were constructed in 1966 with basements and without basement sumps. From 1960 through 1968 the City of Boulder, and the South Boulder Creek watershed, had 6 of 9 years with below average precipitation (Figure 2). This is reflected in the spring flows (March-June) in South Boulder Creek which were 22% lower than average during the same period. At the time the homes were constructed, it is hypothesized that the ground water levels were low due to the multiple years of below average precipitation. In 1969, precipitation was significantly higher and South Boulder Creek flooded. Water from the flood recharged ground water but it was not enough to raise the ground water to a level that required sumps and pumping. Precipitation in 1970 was below average, 1971 and 1972 were near average and 1973 was above average. From 1974 through 1977 precipitation was below average and the ground water levels remained low. From 1978 to 1990 there was a trend of increasing precipitation with 8 of 13 years having higher than average precipitation.

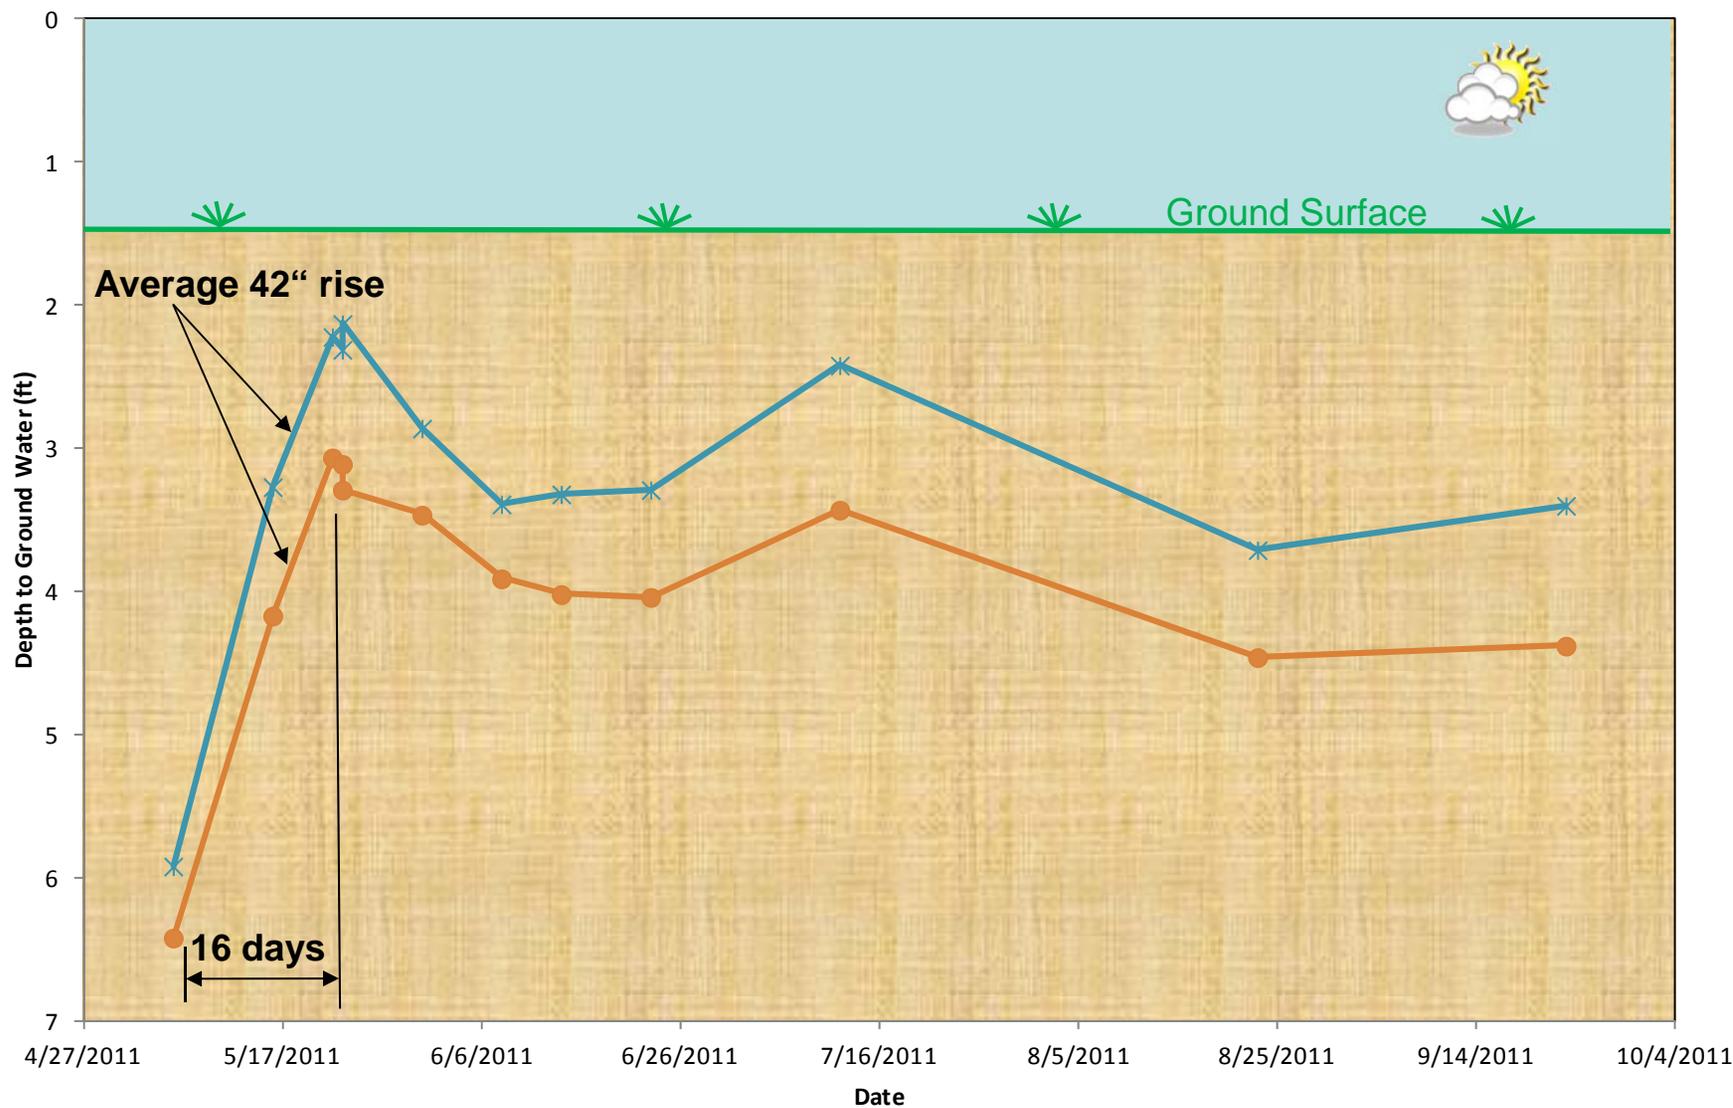
FIGURE 3
 2011 MEASURED DEPTH TO GROUND WATER

This concept is supported by model simulations which demonstrate that even if ground water flow below the South Boulder Community Park was cut off completely, the ground water level below the adjacent homes would increase by only about 3 inches. This is small compared to ground water level changes observed on site of 40 to 44 inches (Figure 3, May 2011) and cannot account for a significant change in ground water level.

The average ground water level rise between 5/6/11 & 5/22/11 was 42.3" (PVC-SE = 44.4", PVC-SW = 40.3")
