MEMORANDUM

SUBJECT: Public hearing and consideration of issuance of a demolition permit for the house and three accessory buildings located at 1035 Kalmia Ave., non-landmarked buildings over 50 years old, pursuant to Section 9-11-23 of the Boulder Revised Code (HIS2014-00364).

1. Site: 1035 Kalmia Ave.
2. Date of Construction: c. 1913
3. Zoning: RR-2 (Rural Residential – 2)
4. Lot Size: 41,312 sq. ft.
5. Owner: Bill Cannon
6. Applicant: Carlo Gallegos, AGR Building

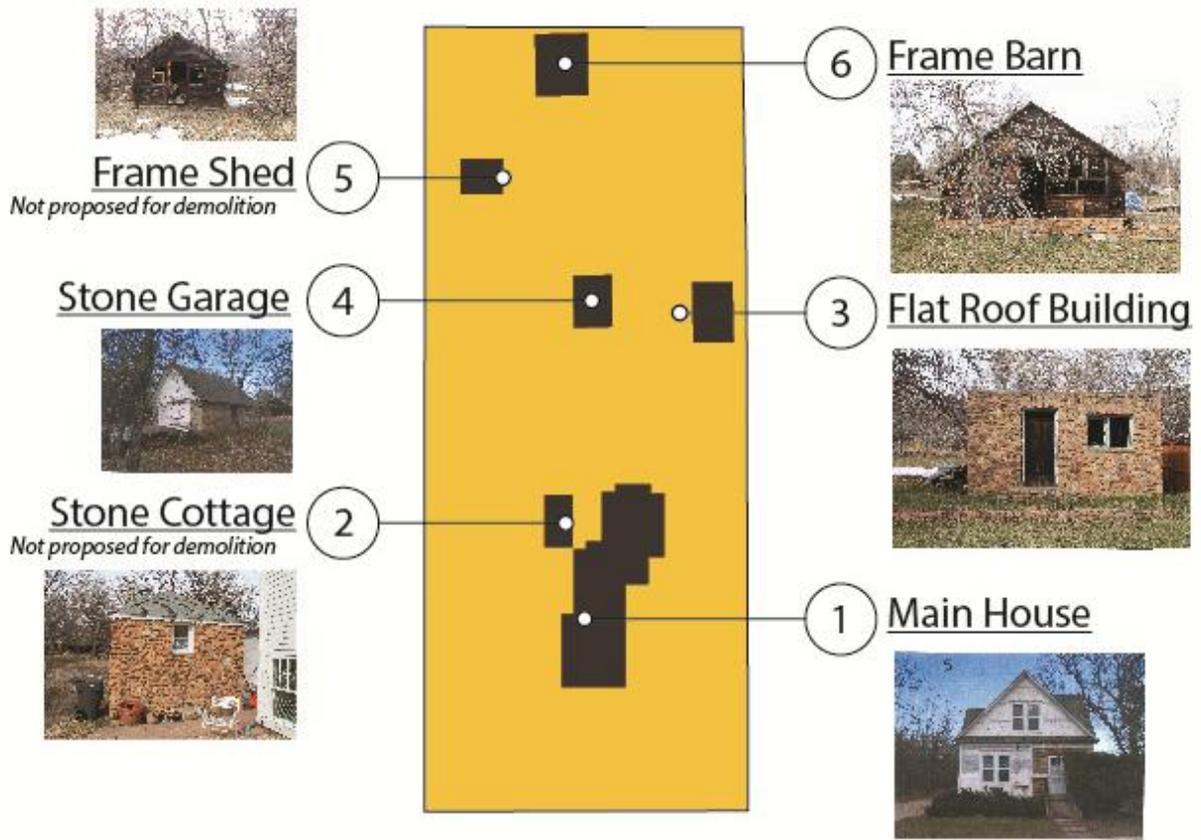
Figure 2. Site Map identifying the six buildings at 1035 Kalmia Ave.

The subject property is located on the north side of Kalmia Avenue near the intersection of 9th Street and Kalmia Avenue. The property is not located in a designated historic district. The 41,312 square foot lot contains the main house and five accessory buildings.

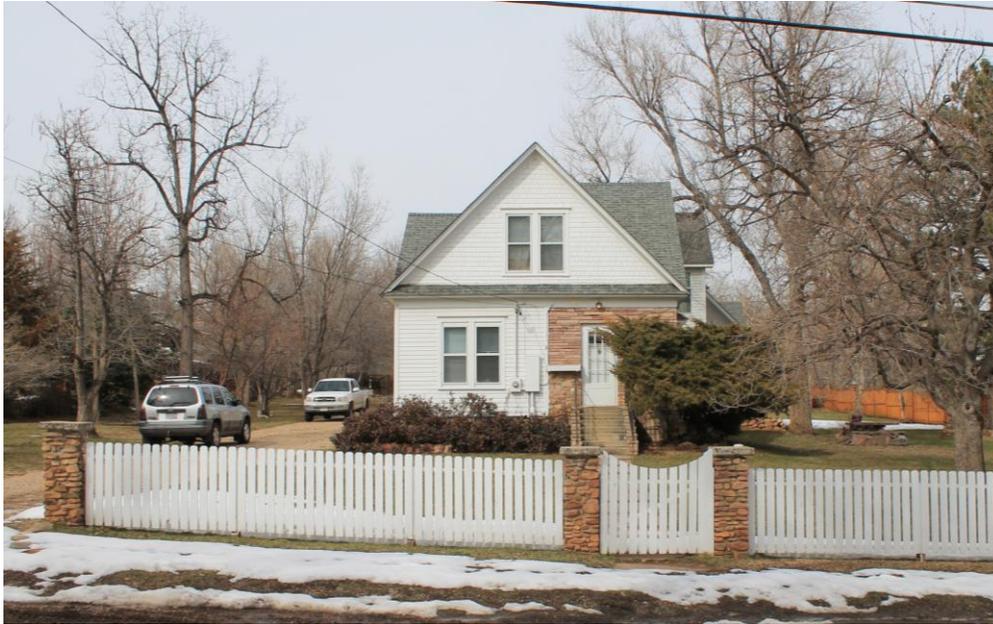
Figure 3. Building #1, Main House, South Elevation, 1035 Kalmia Ave., 2015.

The one-and-a-half story frame house at 1035 Kalmia Avenue features cross-gable roof form with slightly overhanging eaves and a pent roof above the first story façade. The gable end has wood shingles and paired double hung windows. The walls are clad in lap siding with corner boards. The porch at the southeast corner of the façade has been enclosed and clad in faux-masonry, likely dating to the 1950s. Paired, double-hung windows with an architrave surround are located at the façade. *See Attachment A: Current Photographs*

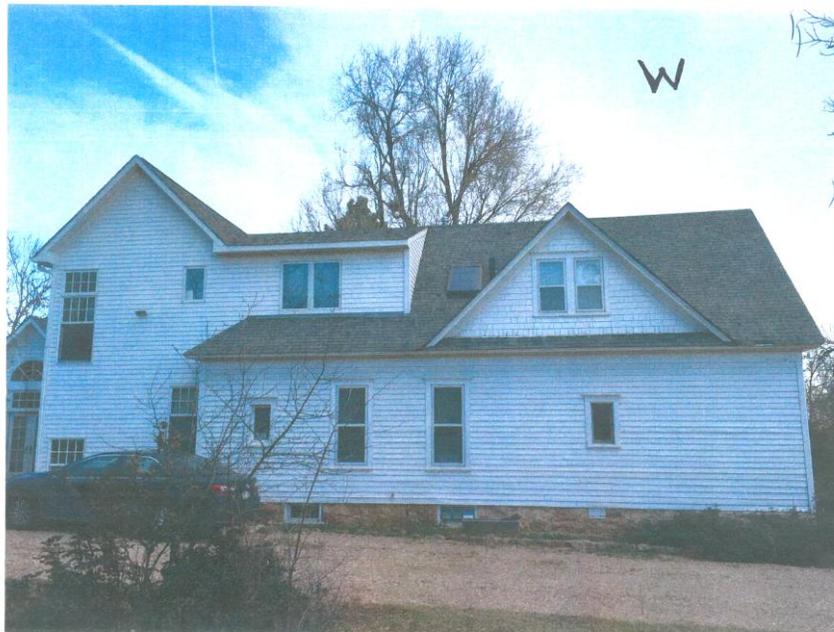
Figure 4. Building #1, Main House, West Elevation, 1035 Kalmia Ave., 2014.

The west elevation features a second story gable with paired double-hung windows and shingle sheathing. The first level of the original house features two double-hung windows flanked by smaller, off-centers casement windows. The building rests on a rough-face stone foundation. In 1993, a rear addition was constructed. The two-story, gabled volume of the west elevation of the addition features three multi-light double-hung windows and a casement window. The second level is connected to the main house by a shed roof, which features paired casement windows. The addition is clad in lap siding. The eave depth appears similar to that of the original house.

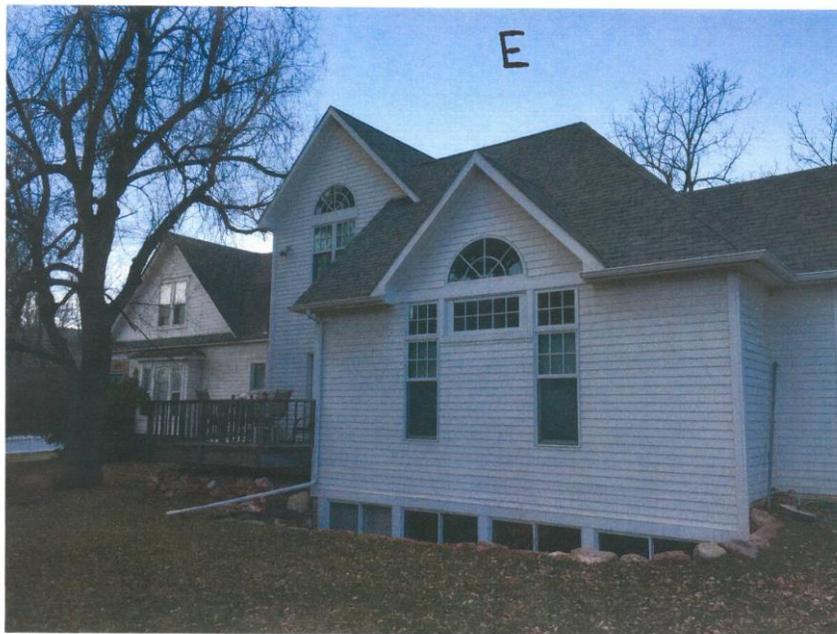
Figure 5. Building #1, Main House, East Elevation, 1035 Kalmia Ave., 2015

The east elevation features a second story gable with paired double-hung windows. A bay window with three double-hung windows is located beneath the gable. The east elevation of the addition features a two story side-gable volume with a paired multi-light double-hung window with a multi-light arched window above and a pair of patio doors below. A one story hipped-roof volume with a gabled wall dormer extends to the east and features a symmetrical configuration of multi-light windows, including an arched multi-light window. Windows at the basement level are exposed.

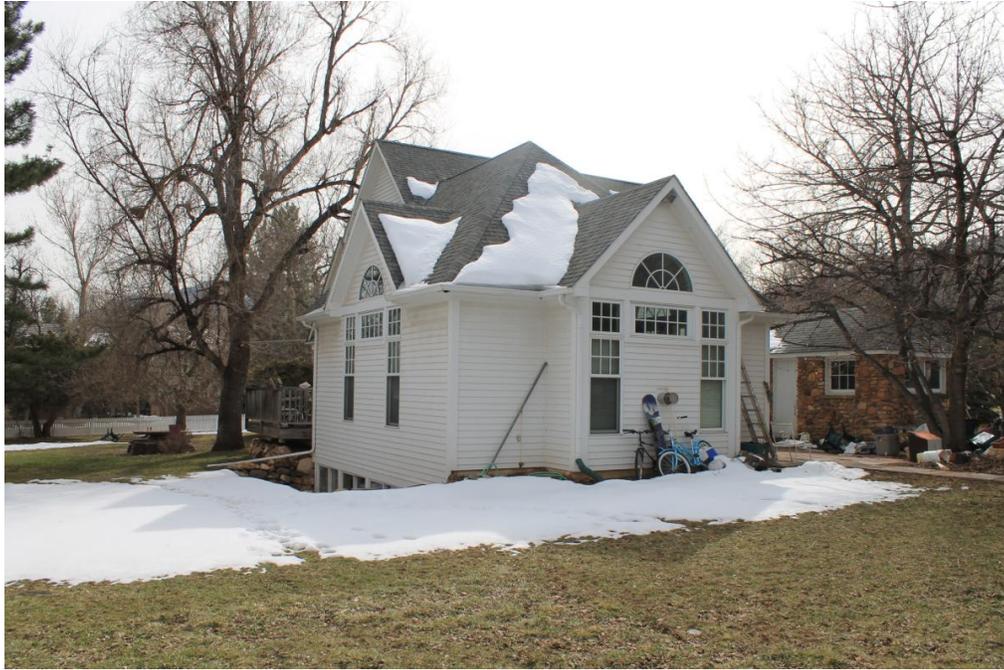
Figure 6. Building #1, Main House, Northeast corner, 1035 Kalmia Ave., 2015

The north (rear) elevation features a gable roof projection with a window configuration similar to that found on the east elevation.

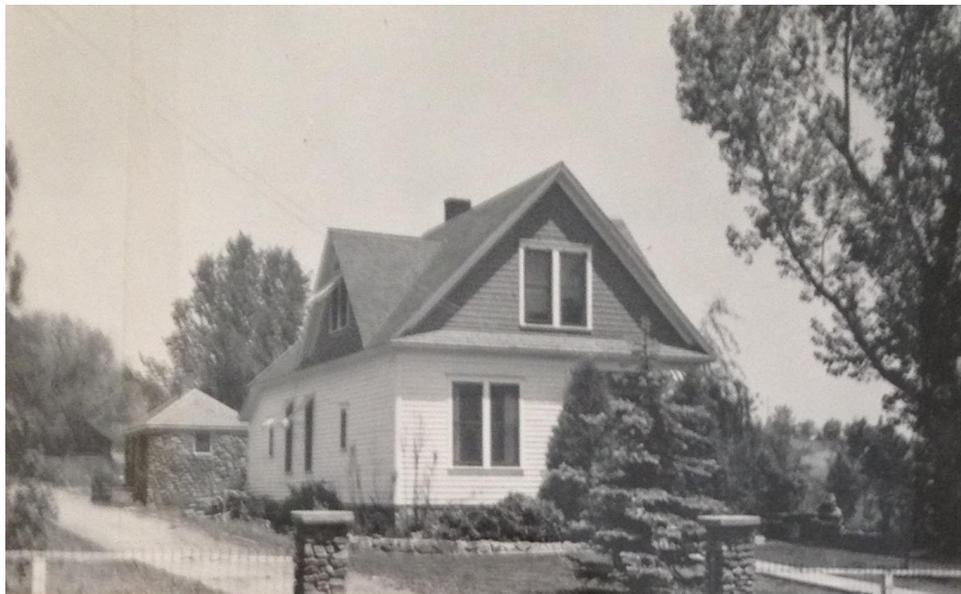
Figure 7. Building #1, Main House, 1035 Kalmia Ave., Tax Assessor Photograph, c.1958.

The 1995 Historic Building Inventory Form notes that the main house was in good condition but with major alterations. The statement of significance notes that “Alterations to this house have diminished its historic integrity.”

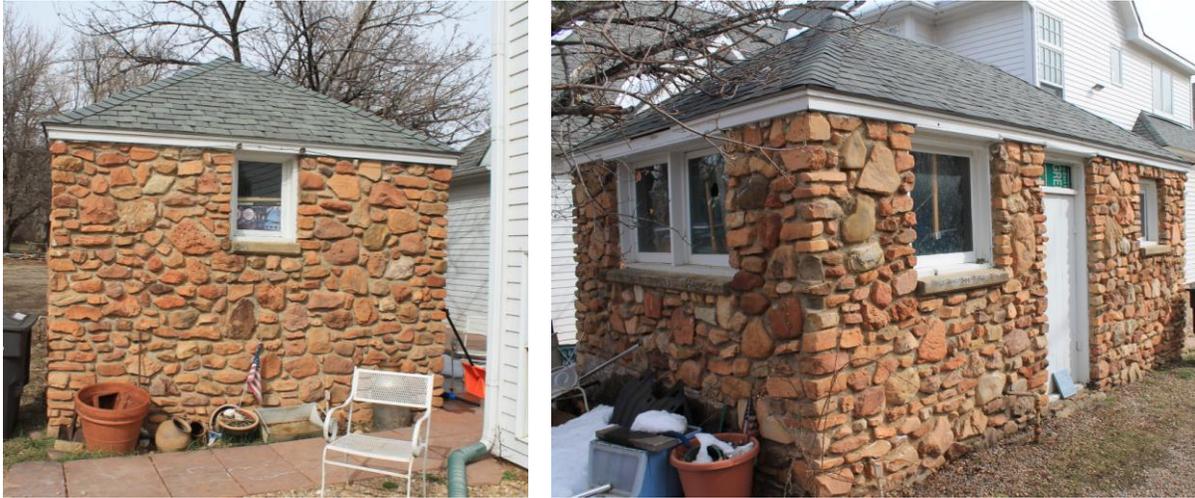
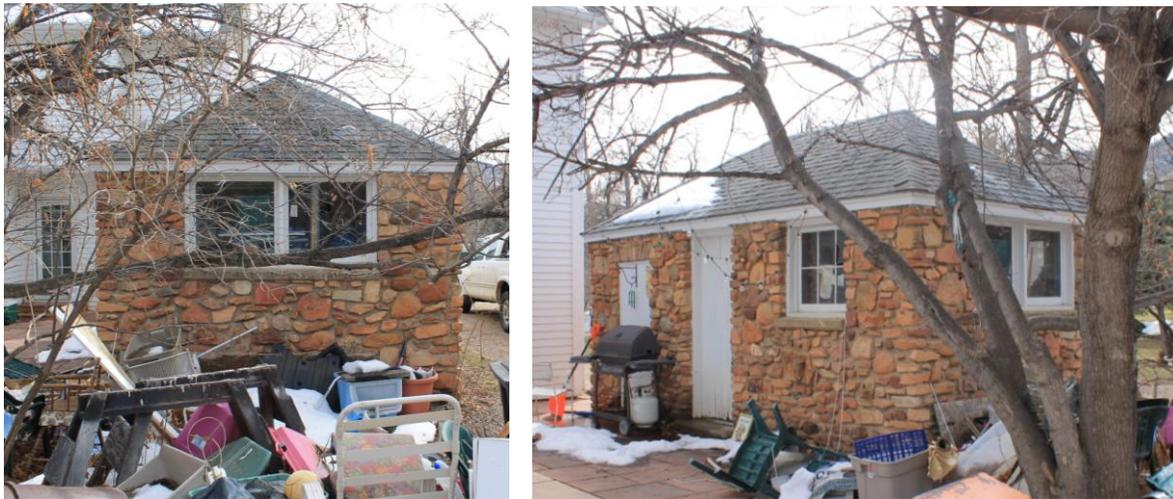
Figure 8. Building #2, South and West Elevations, 1035 Kalmia Ave., 2015.

A one-story, hipped roof cottage is located at the northwest corner of the addition to the main house. Its form and materiality is typical of 1920s construction with concrete sills typical of that era. Its exact date of construction is unknown. The building measures approximately 11 ft. by 20 ft. (220 sq. ft.) and is constructed of field stone. The window and doors do not have lintels, but rather the openings meet the trim board of the hipped roof and have concrete sills below. The south elevation features a single wood casement window. The west elevation features a centrally located wood door with a transom above. Single-light wood casement windows are located on either side of the door. The north elevation features a pair of single-casement windows. The east elevation mirrors the west elevation with a centrally-located wood door. A six-light casement window is located to the north of the door, and a second door is located to the south. This opening appears to be boarded up. The opening features a lintel of stacked stone.

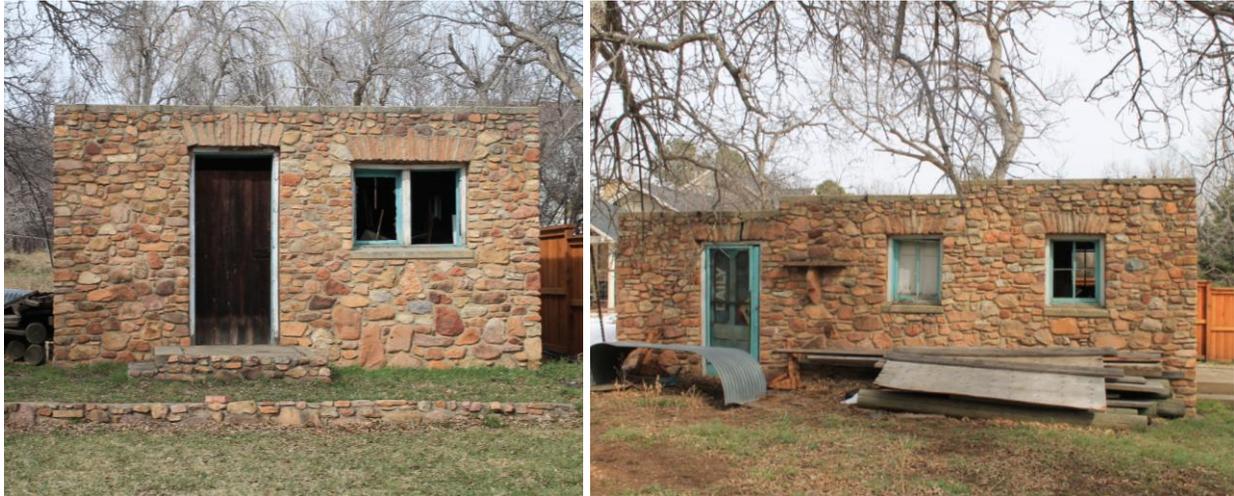
Figure 10. Building #3, South and West Elevations, 1035 Kalmia Ave., 2015.

A one-story, parapet-roof stone building is located approximately 190 ft. from the south property line, on the eastern edge of the property. The vernacular masonry building is similar in construction to the hipped roof stone cottage (Building #2), with rough faced stone laid in irregular courses and concrete sills. The building features decorative lintels above the doors and windows and the parapet roof is capped in concrete. Although the exact date of construction is unknown, its construction and style is typical of the 1920s.

The entry is located on the south elevation (façade), and is accessed by the low, concrete stoop with rough faced stone cladding. A pair of casement windows (glazing missing) is located to the east. Both openings feature decorative stone lintels.

The west elevation features a stepped parapet roof and three openings. Two four-light wood casement windows (glazing and muntins missing) are located toward the front of the building, with a door located at the rear. The wood panel door has two lights above and a wooden screen door. A mantel element/shelf is located between the door and casement window. Its original purpose is unknown.

The east elevation features three window openings with four-light casement windows and concrete sills and decorative lintels. An original wooden screen window exists on this elevation.

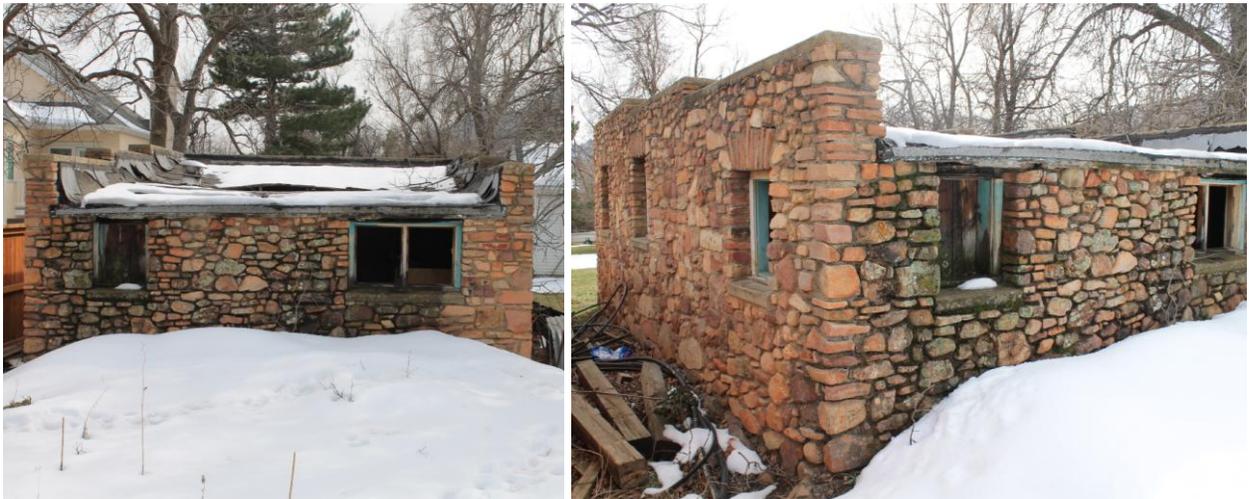
Figure 11. Building #3, North and East Elevations, 1035 Kalmia Ave., 2015.

The north (rear) elevation appears to have sustained long-term moisture issues, as the roof drains to the north and the building does not have gutters. The rear elevation features two window openings. The original configuration of the windows is unknown, but likely matched the four-light casement window on the west elevation.

The building's stone elevations are in fair condition, save for some water damage on the north elevation. The roof, however, is in poor condition due to a large opening and substantial water damage.

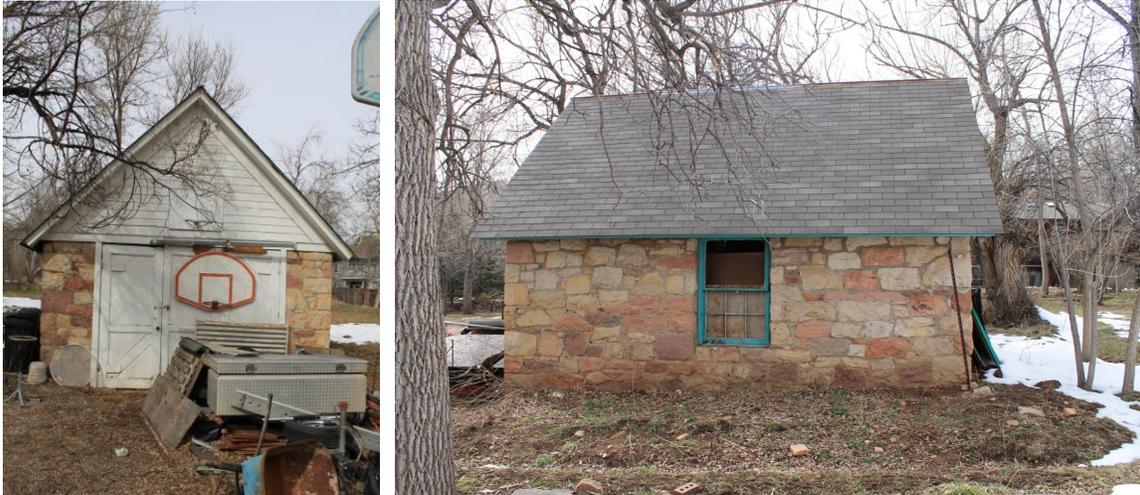
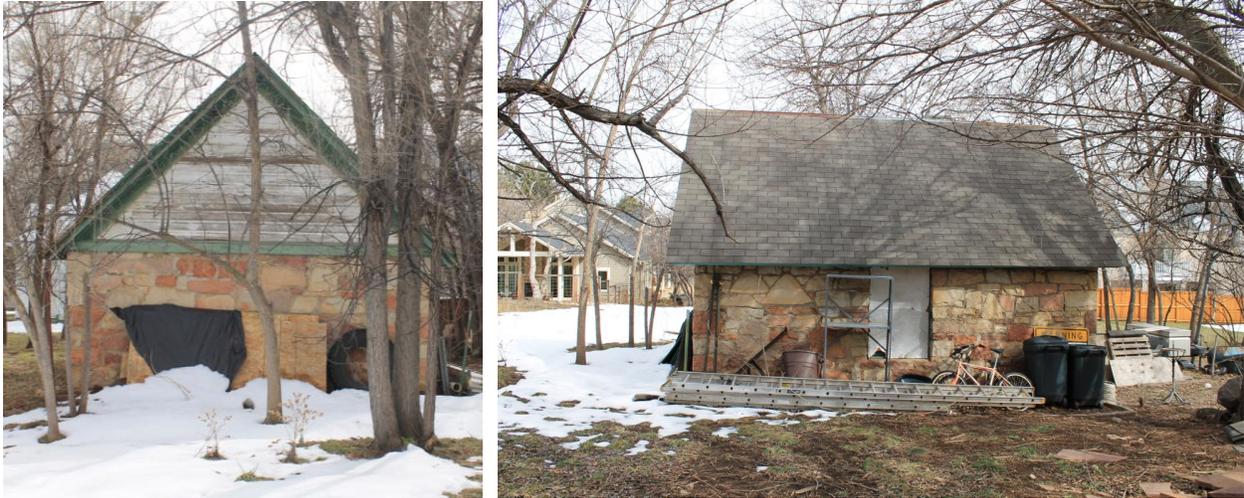
Figure 12. Building #4, South and East Elevation, 1035 Kalmia Ave., 2015.

A one-and-a-half story gable roof stone garage is located west of the stone parapet building toward the middle of the property and approximately 200 feet from the south property line. The building is constructed of heavy masonry with a frame gable roof and overhanging eaves. The gable ends are clad in horizontal wood lap siding. Due to its method of construction and style, the building was likely constructed around the same time as the main house in the 1910s. A portion of the building appears in the 1956 tax assessor photograph (Figure 14).

The south elevation (façade) features a tri-folding wooden door with diagonal bead board. All materials, including the hardware, appear original. The east elevation features a single door opening that has been boarded over. The north (rear elevation) does not have any openings and a single divided light, wood double-hung window is located on the west elevation. The upper light is damaged and has been boarded over. The lower light contains six lights; some of the panes of glass are missing. The original window was likely a six-over-six configuration. The building appears to be in good condition.

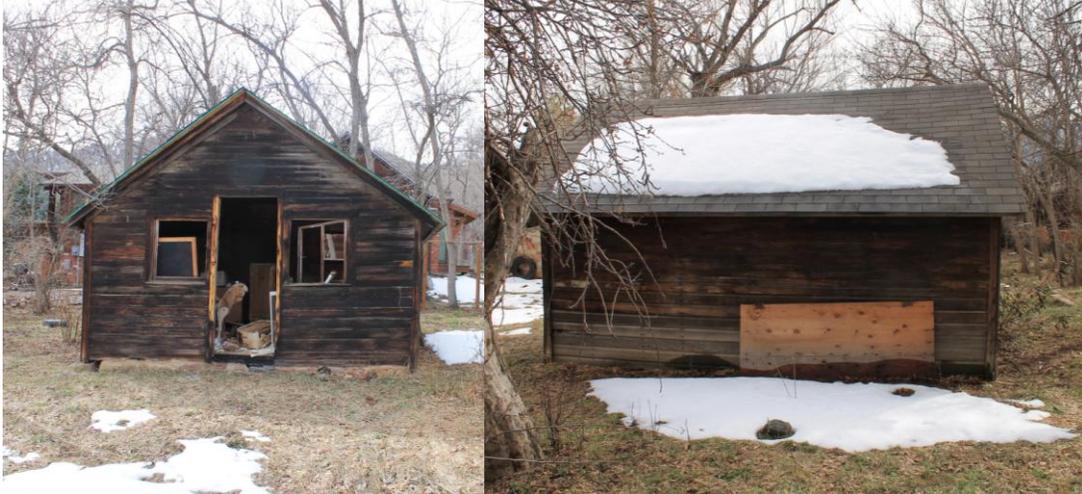
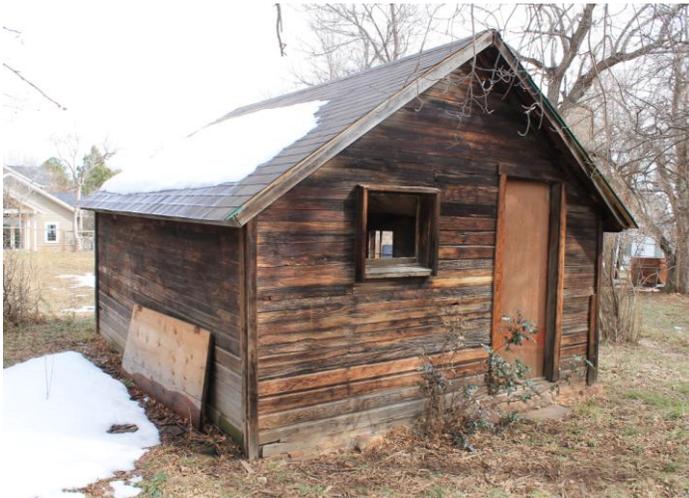
Figure 15. Building #5, South and East Elevation, 1035 Kalmia Ave., 2015.

A wood frame accessory building is located at the western edge of the rear of the property, approximately 250 feet from the south property line. The date of construction of the building is unknown, but was likely constructed before 1940. It appears in the 1956 tax assessor photograph. The simple, one-story building has a gable roof and horizontal siding and rests on a stone foundation. The east elevation (façade) features a centrally located door opening flanked by two square window openings. The east elevation does not have any openings and one door and one window opening are located on the south elevation. The west elevation features two four-light casement windows. The building is in a state of disrepair and does not appear to have been maintained.

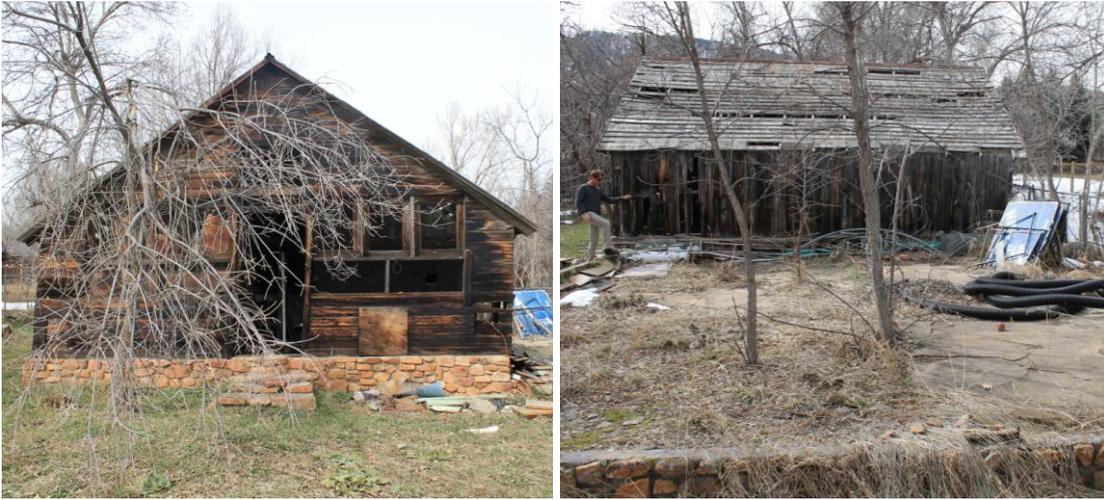
Figure 18. Building #6, South and East Elevations, 1035 Kalmia Ave., 2015.

A large, gable-roofed frame barn is located at the rear of the property at the north property line. The one-and-a-half story building rests on a stone foundation. The stone walls continue to the east and likely were the foundation for an attached enclosure. The south elevation (façade) features a centrally located door opening, flanked by window openings. The openings are covered with chicken wire and the original door does not exist. The east elevation has a small, animal door but otherwise the north, east, and west elevations do not have openings. The building is in a state of disrepair and does not appear to have been maintained.

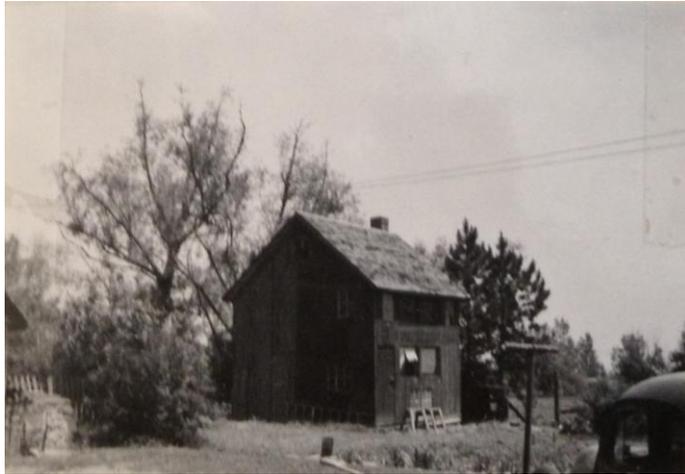
Figure 20. Demolished Barn, 1035 Kalmia Ave., Tax Assessor Photograph, c. 1958.
The tax assessor card includes a photograph of a two story barn that has since been demolished.

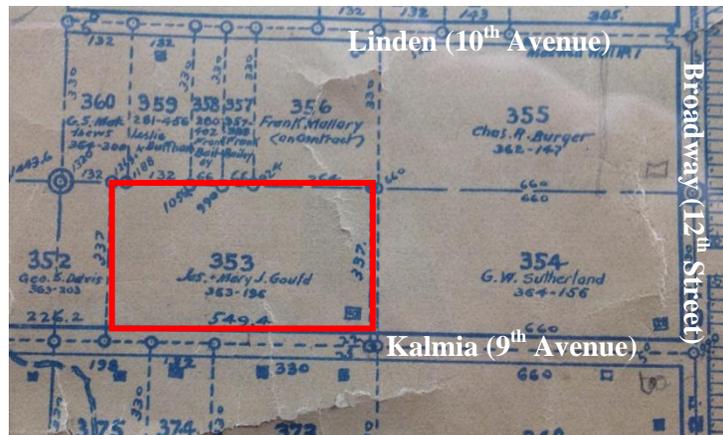
The 1915 Drumm Map shows Tract 353 measuring approximately 550 ft. by 337 ft. with a building footprint in the approximate location of the existing main house. Joseph and Mary Gould are shown as the owners.

Figure 21. Photo of 1915 Drumm Map showing Tract 353 outlined in red.

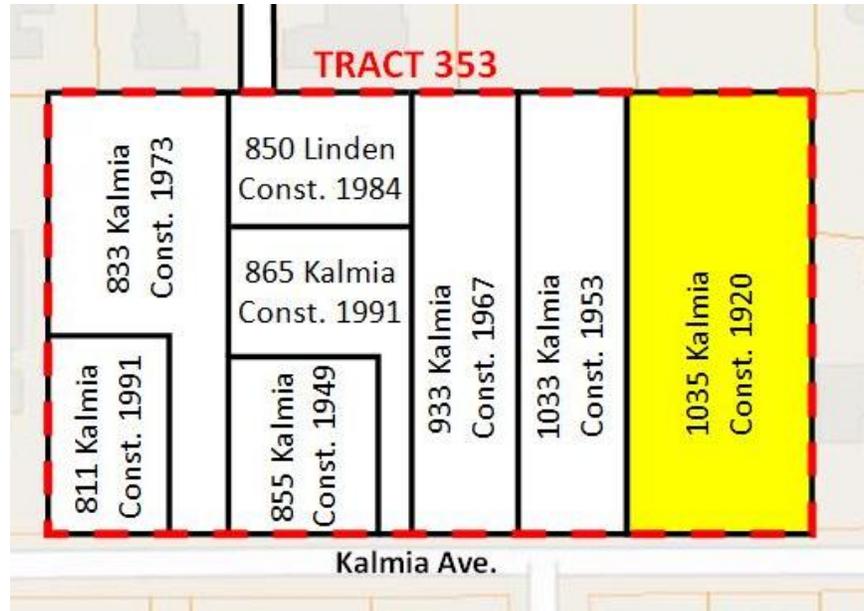
According to deed research, the Snyders were most likely responsible for dividing tract 353 into separate lots. Exactly how it was divided is unclear, but the 1949 city directory is the first year two new residences (811 and 1033 Kalmia) appear in addition to 1035 Kalmia on tract 353. Presently there are eight lots within tract 353.

Figure 22. Current map of tract 353 with 8 divided lots showing address and year of construction of the main house.

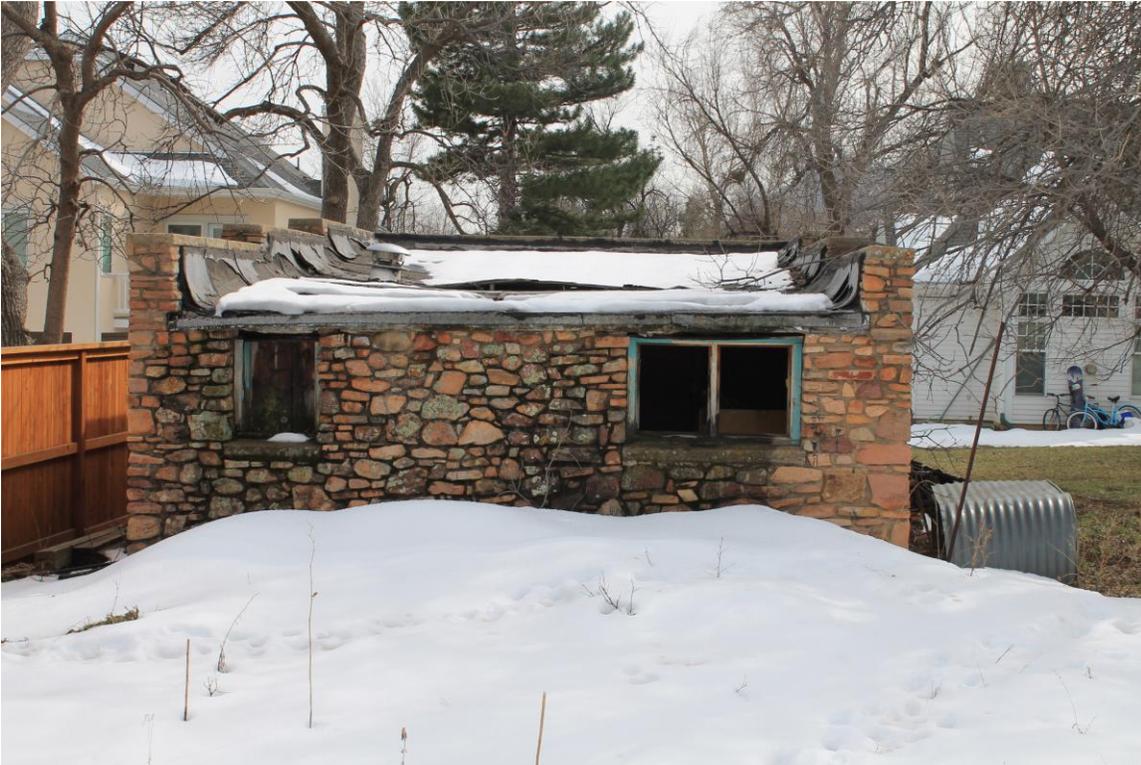
Photo 22. North elevation of flat roof building, 1035 Kalmia Ave, 2015.
