**CITY OF BOULDER
LANDMARKS BOARD MEETING**

DATE: Wednesday, November 4, 2015

- C. Public hearing and consideration of a Landmark Alteration Certificate application to construct an addition to the building, replace non-historic windows and restore the historic façade of Whittier School at 2008 Pine Street an individually landmarked property, per section 9-11-18 of the Boulder Revised Code (HIS2015-00243). Applicant: Rodwin Architecture, Owner: Boulder Valley School District

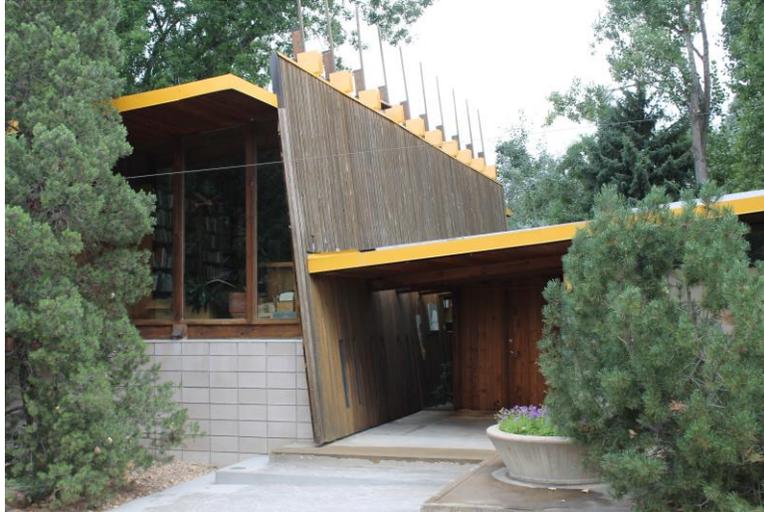
Figure 1. North elevation (façade), 1900 King Ave., 2015.

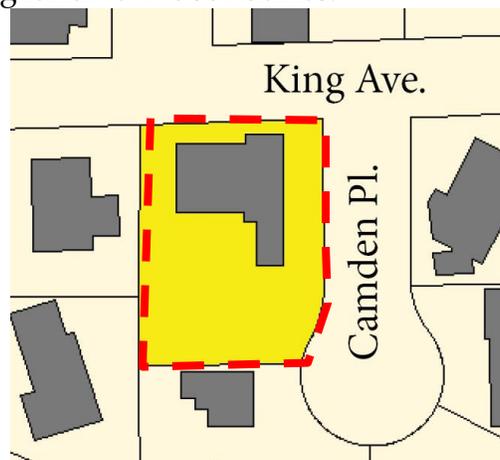
Figure 11: Proposed Landmark Boundary (dashed line).

The building sits on a residential lot measuring approximately 15,000 sq. ft. in size. Staff recommends that the boundary be established as proposed to follow the property lines of the lot, which is consistent with current and past practices and the National Register Guidelines for establishing landmark boundaries.

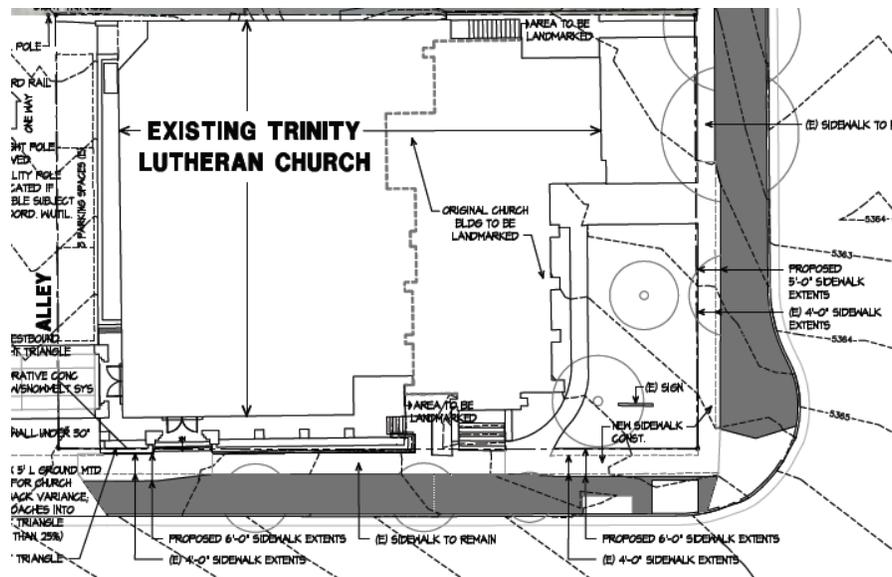
Figure 2. Sheet A1.00, landmark boundary as approved by Planning Board May 1, 2014 as a condition of Site Review.

Prior to a building permit application, the Applicant shall submit to the City an application for and pursue in good faith Individual Landmark designation of the historic portion of the church building located at 2200 Broadway with a designation boundary as shown on sheet A1.00 of the approved plans dated Feb. 3, 2014.

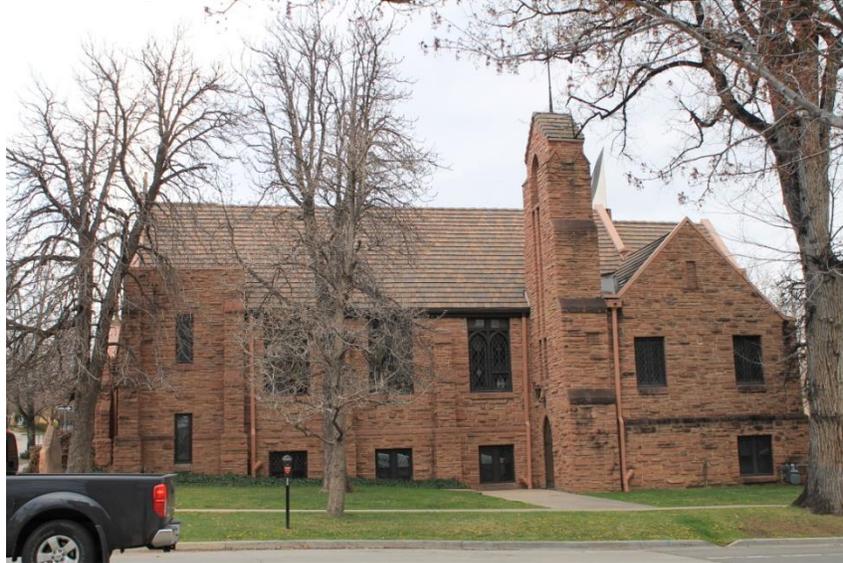
Figure 6. South elevation, 2015.

The south elevation (facing Pine St.) features structural buttresses, windows with stained-glass laid in a diamond pattern. The gable roof of the transept and altar protrudes to the south, with a bell story element located to the west. A large arched stain glass window with Gothic tracery is located on the east elevation. External lights are located below the window. The north elevation of the original church is obscured by the 1966 addition.

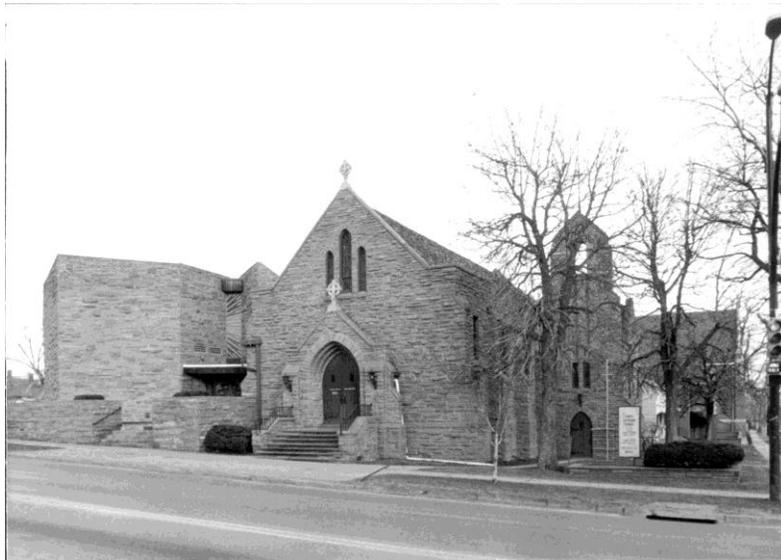
Figure 10. West elevation taken from the 1986 Historic Building Inventory Record. Photo shows the church before the construction of the 1989 addition.

The 1986 Historic Building Inventory Form found the property to be in excellent condition with minor alterations (the survey was recorded prior to the 1989 addition). The form notes that “this building is significant for its association with the history of the development of the religious community in Boulder.” See Attachment C: Historic Building Inventory Record.

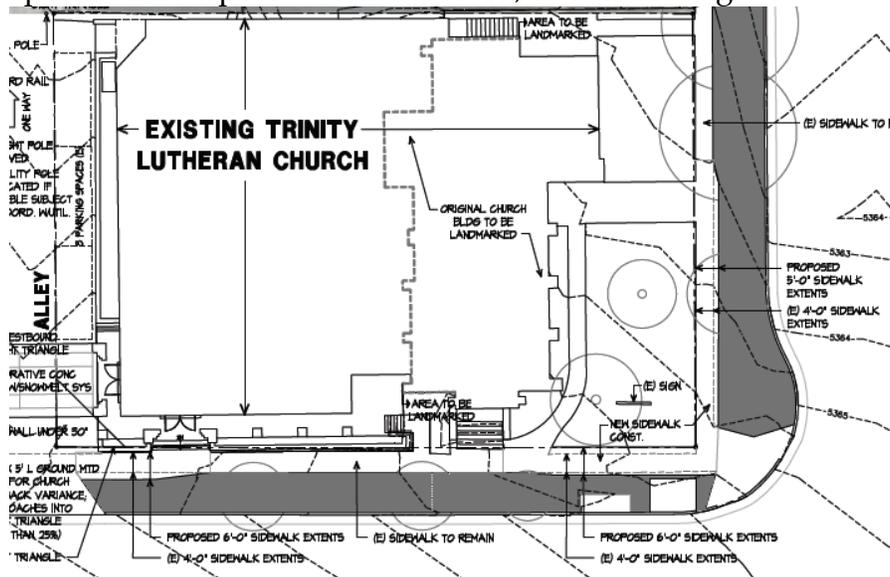
Figure 18. Proposed Landmark Boundary (red dashed line).

The building sits on a lot measuring approximately 13,931 sq. ft. in size. The church also owns approximately 18,101 sq. ft. of parking space across the alley to the north of the church. Staff recommends that the boundary be consistent with the proposed landmark boundary that was made a condition of Site Review by Planning Board. The boundary would encompass the 1929 portion of the church, as show in Figure 18 below.

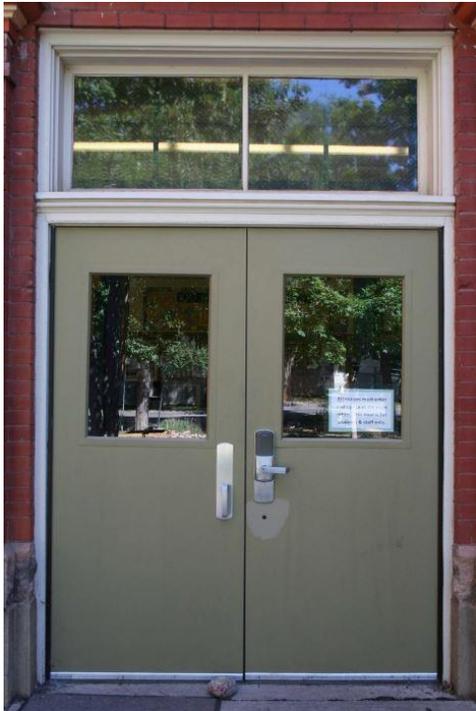
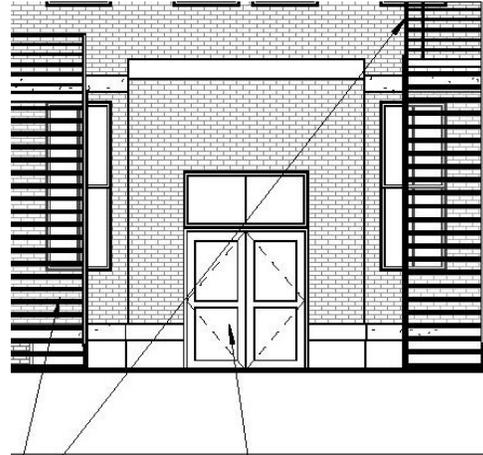
Figure 13. Detail of existing (l) and proposed (r) west entry doors on 1916 addition

The non-historic doors of the original 1882 building and the 1916 addition are shown to be replaced with energy efficient doors that closely replicate the historic doors shown in historic photographs. A door and window assessment submitted with the application shows the non-historic doors having being installed in either 1997 or 1998. The other non-original openings in the 1916 building, which are currently metal, will be replaced with painted wood doors with a clear glass half-lite.

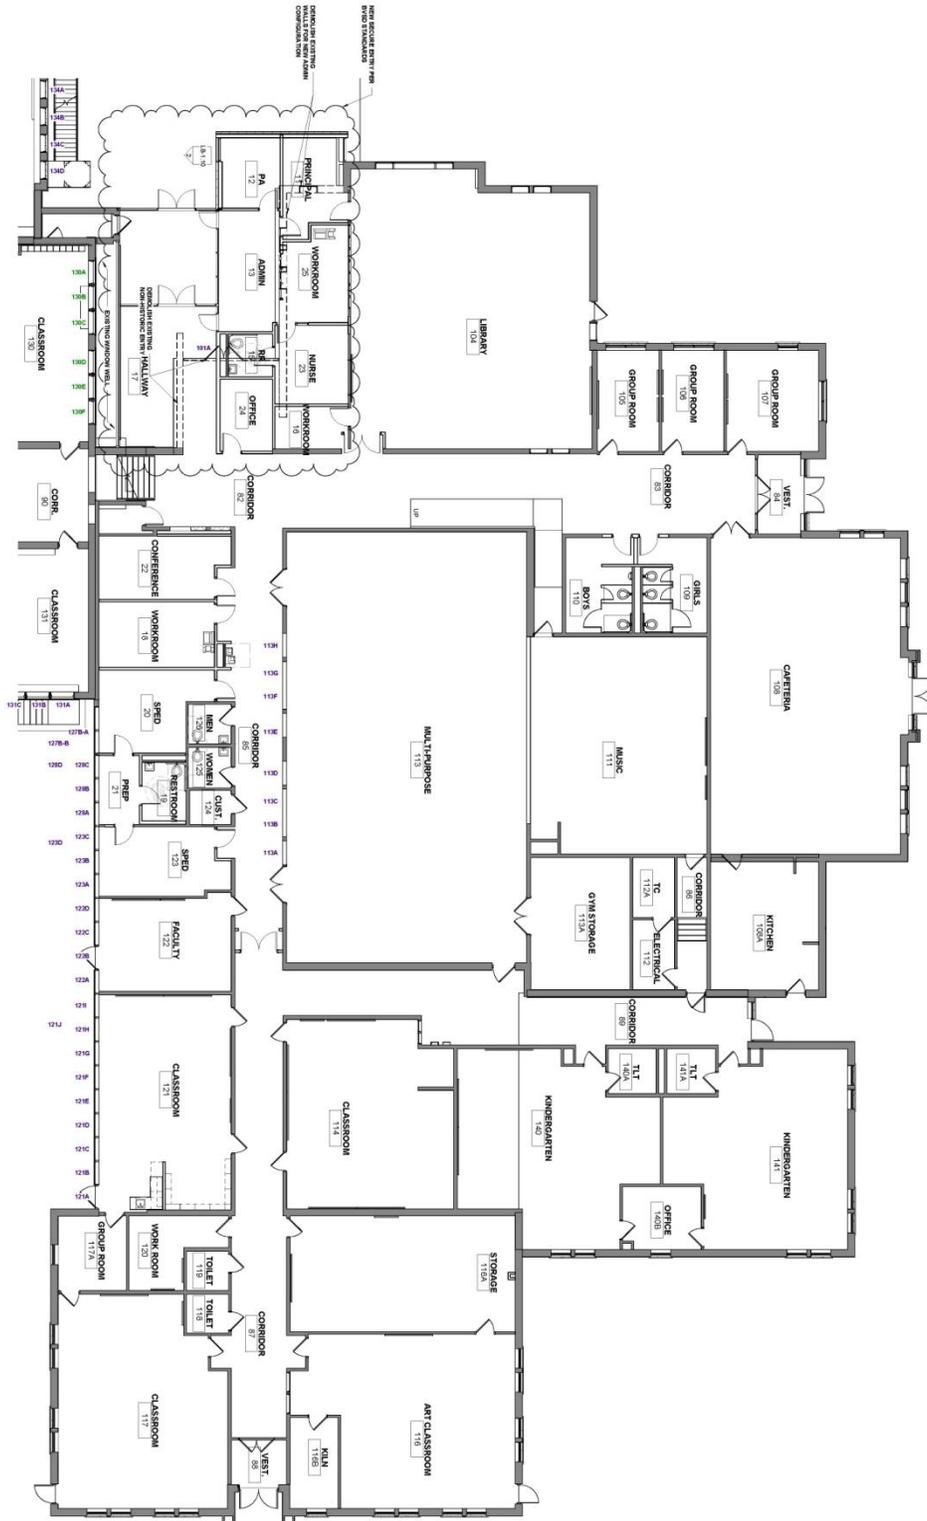
Floor plan of southeast portion of building (the 1950, 1983, and 2010 additions).

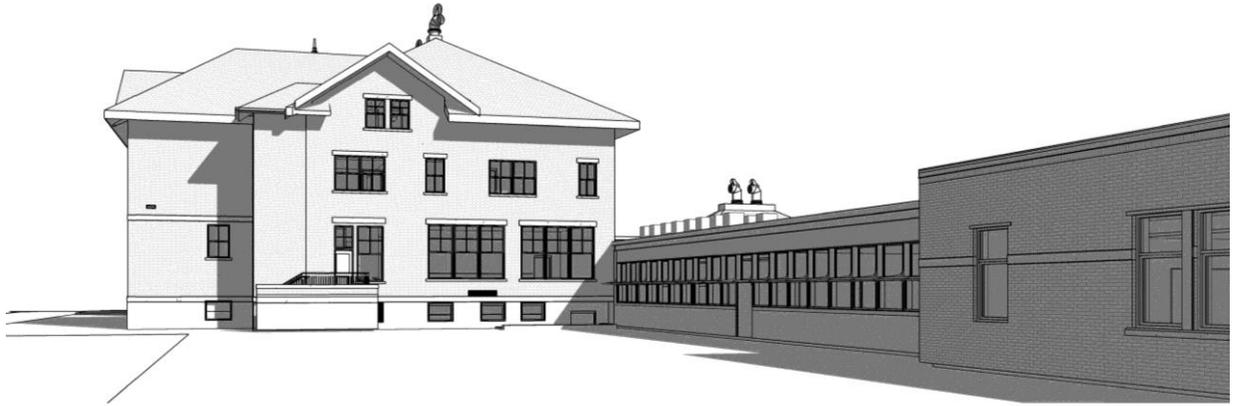
Rendering of south elevation of 1916 addition and west elevation of 1950 addition with glass blocks replaced.

Applicant proposes the replacement of doors & windows on the 1950 addition of Whittier School. This includes the Gym clerestory windows and the infill portion of glass block on the west elevation. The 1950 addition is directly south of the 1916 addition and the 2010 addition abuts the south of the 1950 addition. The request calls for replacement with energy-efficient insulated windows with a metal storefront and will have painted metal light louvers.

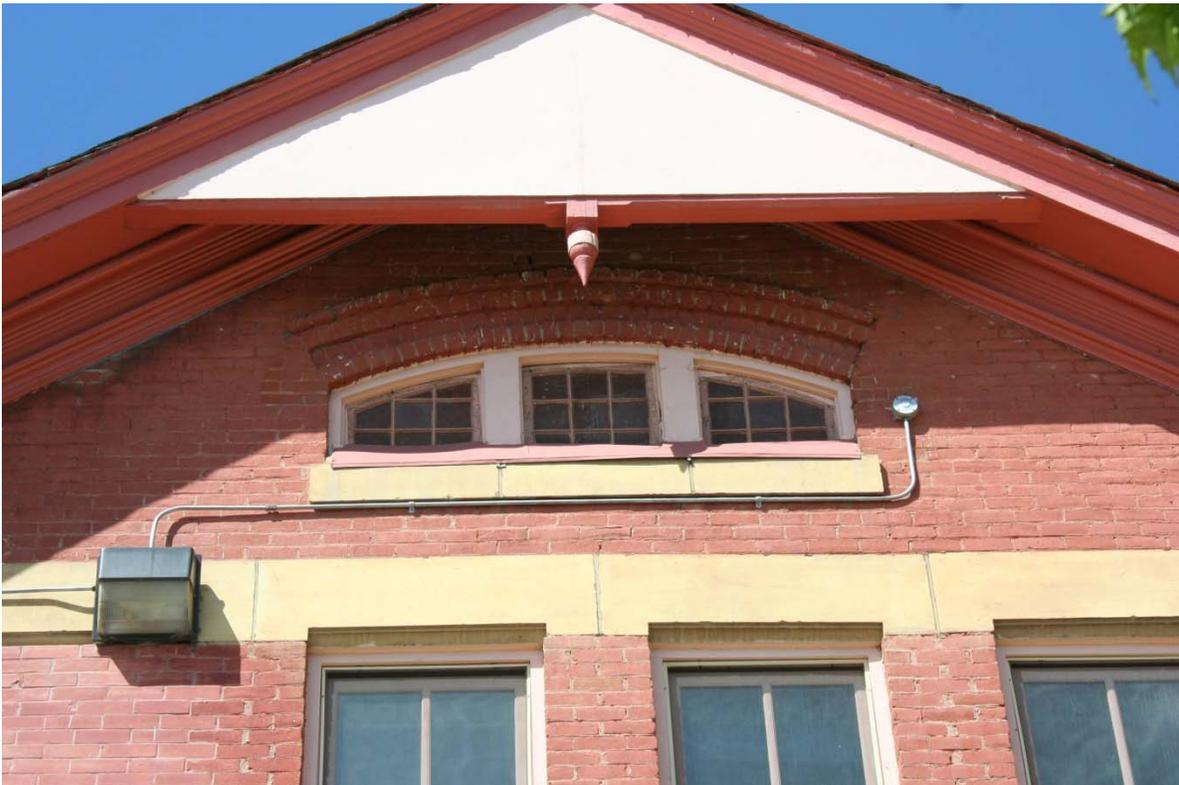
5. Typical existing West facing window on original 1882 building. Part of 1997 window replacement [East windows are similar]

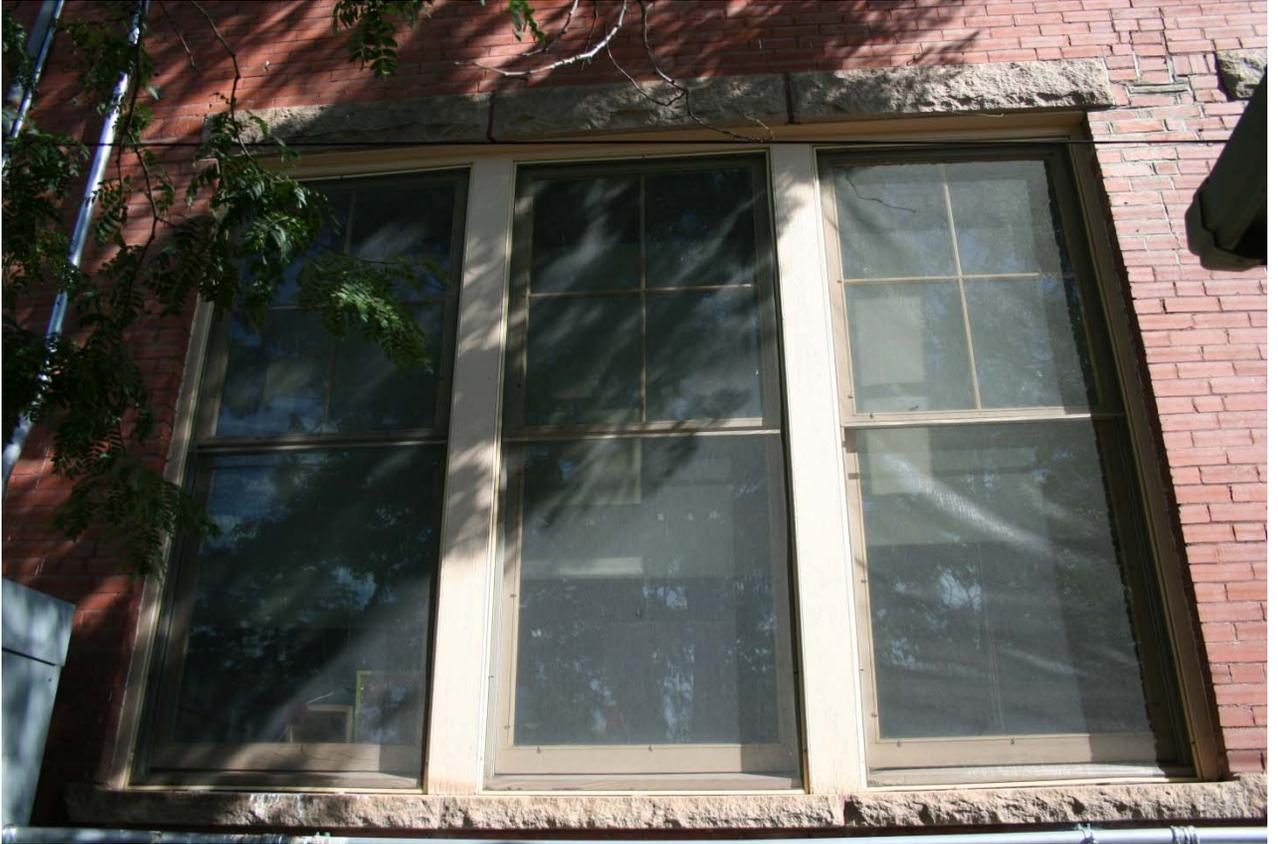
23. Existing South basement window on 1916 addition
