**M E M O R A N D U M**  
**August 6, 2014**

**SUBJECT:** Public hearing and consideration of a Landmark Alteration Certificate to demolish a contributing accessory building, construct a 6' x 26' rear deck, flagstone patio, and basketball court, retaining walls and fire pit with concrete base at 437 Highland Ave. in the Mapleton Hill Historic District, per section 9-11-18 of the Boulder Revised Code (HIS2014-00176).

| 1. Site: | 437 Highland Ave. |

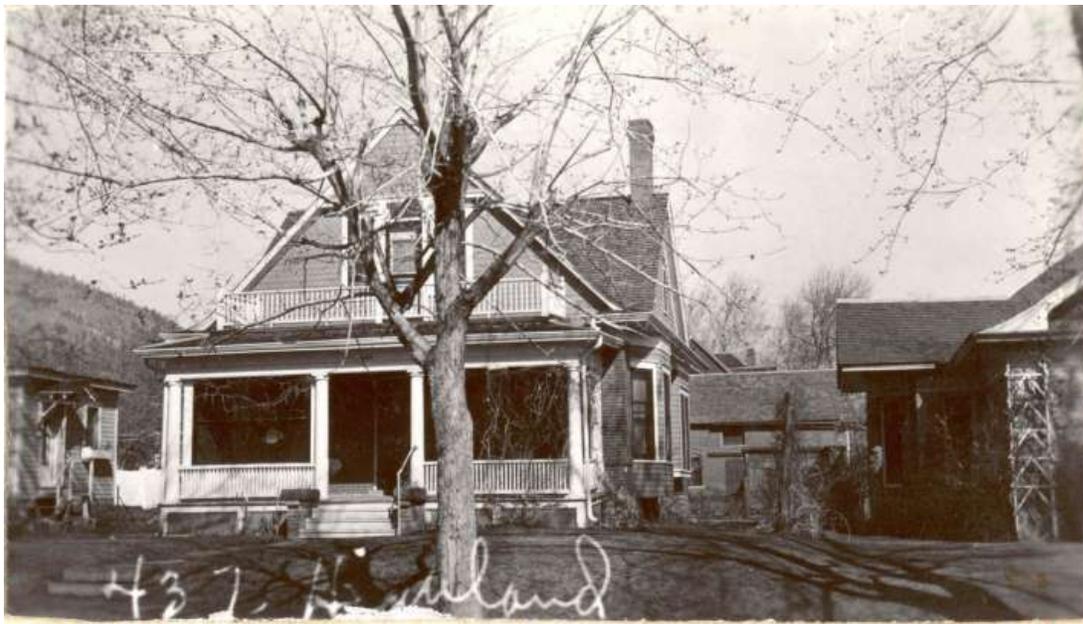
*Figure 2. Tax Assessor Photograph, 437 Highland Ave., c.1929*

Historically, two accessory buildings were located at the rear of the lot. A garage was located on the northwest corner of the lot and a shed was located at the northeast corner of the lot (see figures 4 and 5). The one-and-a-half story garage featured a hipped roof, novelty lap siding and a multi-light garage door. In 2005, the Landmarks Board approved a request to demolish the garage and in its place construct a new, single-car garage. The request to demolish the shed building was denied. In 2013, the shed was demolished without a Landmark Alteration Certificate or a building permit. Most of the rear yard area has also recently been paved without Landmark Alteration Certificate approval or an application for a building permit. An athletic court was constructed in the area at the south end of the lot. A number of retaining walls have been constructed, as has a fire pit.

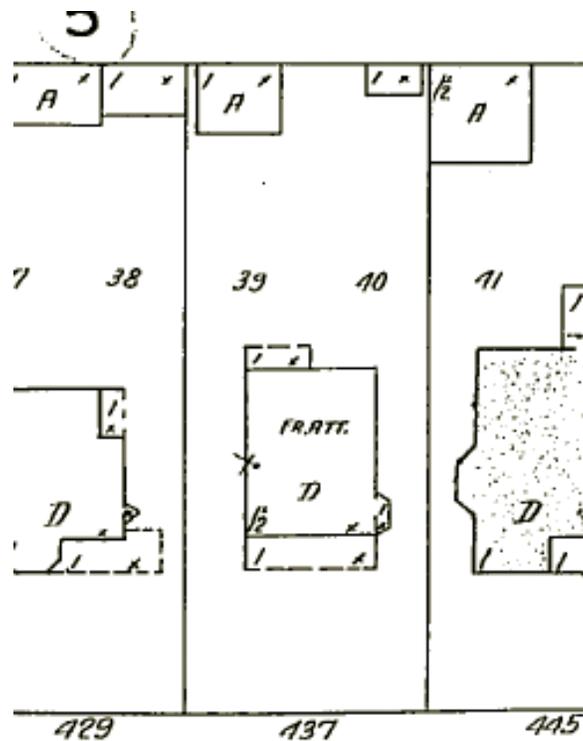
Figure 3. 437 Highland Sanborn Map, 1931.

The shed building located at the northeast corner of the lot first appeared on Sanborn Maps in 1931. The Aug. 4, 2004 memo describes the building as such:

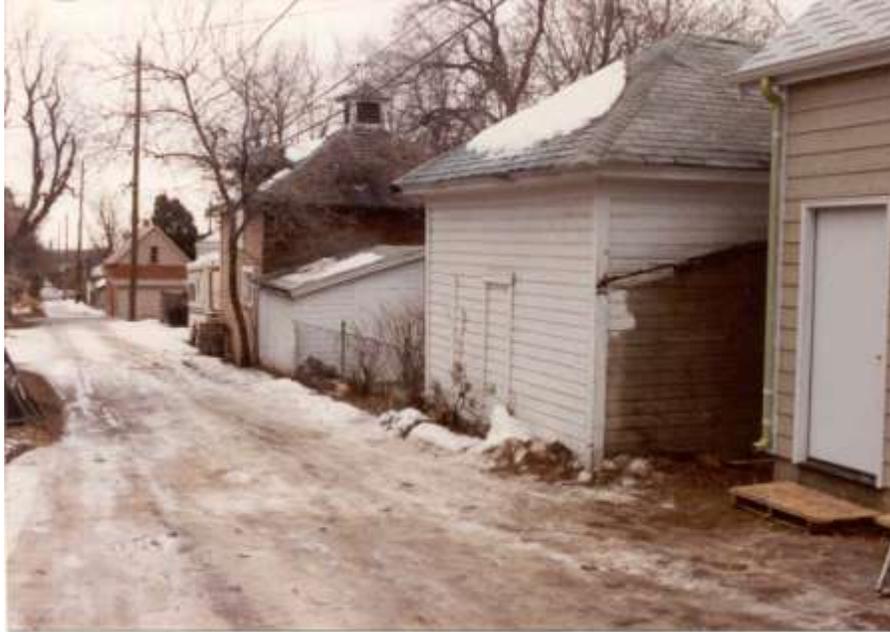
*Figure 4. 437 Highland Ave., Facing east, North faces of garage (demolished 2005) and shed building (demolished 2013).*

*A shed is located on the east property line and extends slightly over the rear property line into the alley. It measures 8 feet deep and 12 feet across the alley. Character-defining features of the shed include its simple rectangular form, low shed roof angling towards the alley, horizontal wood siding, band of screened windows on the south elevation and low door with simple wood surround on the west elevation. A building in this location is also first evident on the 1931 Sanborn map. The similarity in materials and construction techniques suggest that both buildings were constructed at about the same time.*

*The existing shed is a contributing building to the district. It was constructed during the period of significance and retains a high degree of historic integrity. It adds historic character to the alleyscape and the site. The removal of the building will have an adverse impact on the character of the site and the district which is not mitigated by any other policy concerns. The removal of the building is not required as part of the site redevelopment.*

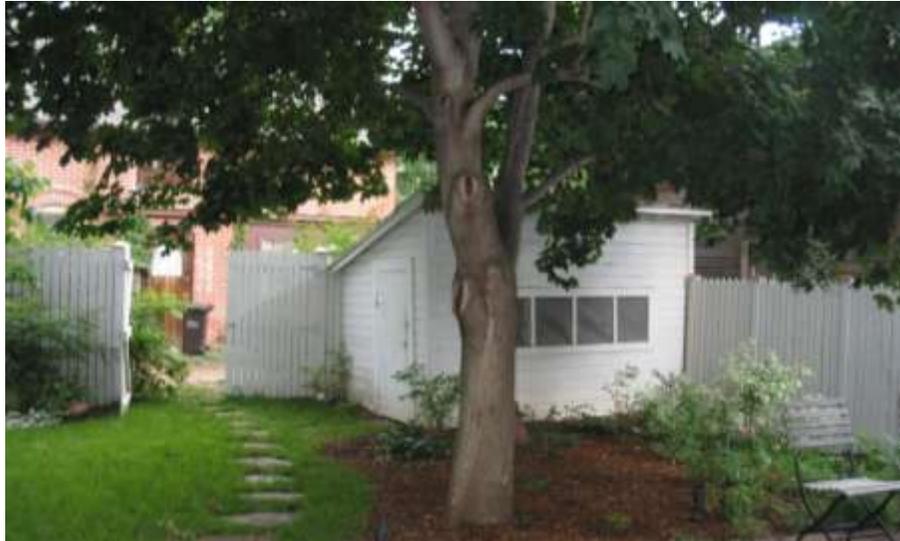
Figure 5. 437 Highland Ave. rear yard landscaping and shed building, 2004 prior to demolition and paving.

The 2005 Accessory Building survey was conducted after the demolition of the garage and identifies the shed building as being constructed pre-1931, with composition roofing, wood siding, corner boards and a door trim. It was identified to be in good condition and contributing to the Mapleton Hill Historic District. See Attachment A: Accessory Building Survey and figure 5.

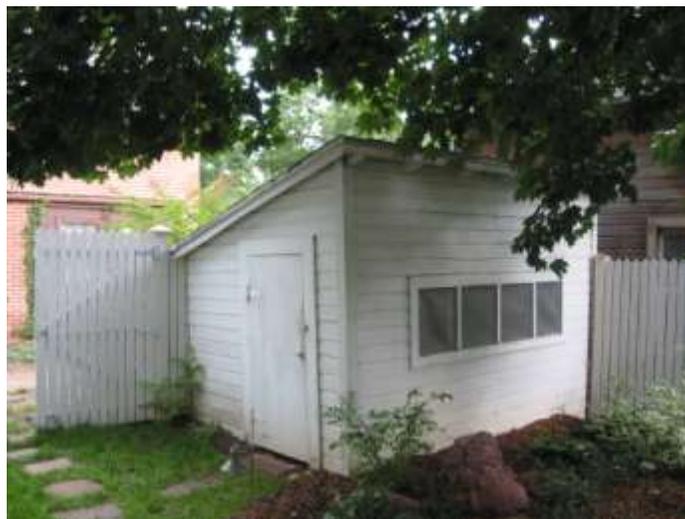
Figure 6. 437 Highland Ave. Southwest corner of demolished shed, July 2004

The applicant is requesting after-the-fact approval for demolition of the historic shed building based upon their assessment that the building was in very poor condition and a hazard. Photographs from July of 2004 (*see figures 5 & 6*), indicate that the shed was in relatively good condition at that time. The 2005 historic building survey of the building identifies it as being in “good” condition also. The applicant indicates that the building was in very poor condition prior to its demolition in April of 2013 having been “held together with license plates.” The applicants submitted one undated photograph showing the interior framing of the shed (*figure 7*) showing 2” x 4” framing approximately 18” on center.

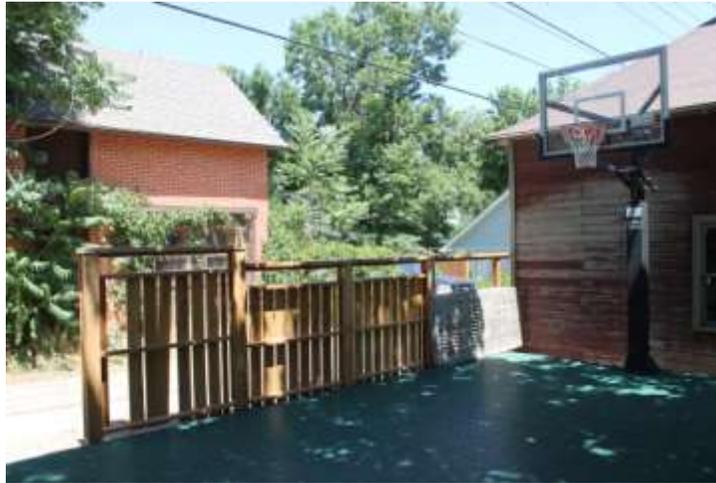
Figure 7. 437 Highland Ave. Northeast corner of property where shed was previously located, July 2014.

The northeast corner of the existing athletic court currently occupies the location of the demolished shed.

Staff considers that demolition of the contributing shed does not meet this standard and that the applicant should carefully reconstruct the shed in its original location to reestablish this aesthetic feature on the property and alley-scape.

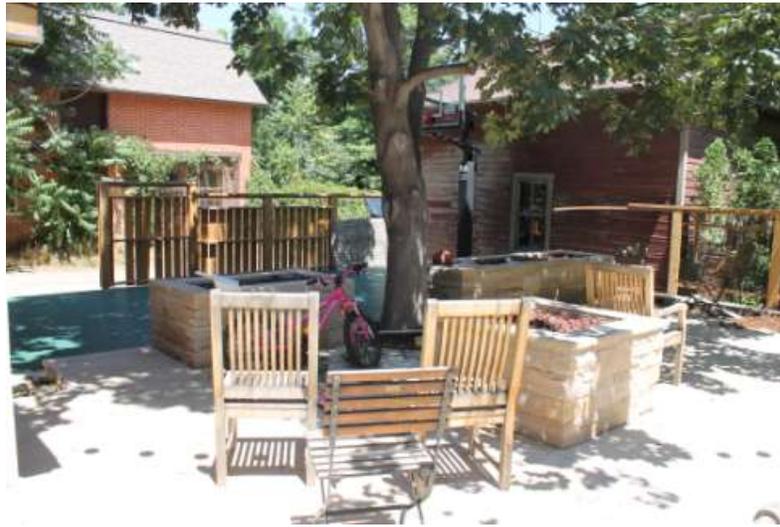
*Figure 8, 437 Highland Ave. Northeast view of backyard, July 2014.*

The applicant is requesting an after-the-fact Landmark Alteration Certificate for approximately 825 sq. ft. of paved area, to provide for an athletic court (450 sq. ft.) and a flagstone patio (300 sq. ft.), all set upon a raised concrete pad between 4" and 20" in thickness from north to south. In addition, approximately 75 sq. ft. of flagstone pathway is located in the back yard area. Approximately 275 sq. ft. of planted area remains in the backyard area, some of which is enclosed by sandstone and "Allen Block" retaining walls up to 30" in height. The athletic court has a basketball hoop at the east end and "rebounder" wall on the east wall of the garage. A fire pit is located in the center of the patio. Submitted drawings indicate its height will be reduced to 20". No details were provided about the proposed water feature, though it is referenced on the 02/16/2014 landscaping plan for the property.

Staff recommends that the shed be reconstructed base upon photographs and the 2005 description of the building and that half of the hardscaping, including the entire concrete slab, be removed. This will preserve a backyard area between the house and accessory buildings and restore the general proportion of built mass to open space found in the area. Reconstruction of the historic should occur in a manner consistent with the *Secretary of the Interior’s Standards for the Treatment of Historic Properties, 1995 (Reconstruction)*, see Attachment F.

Staff also recommends that a revised landscape plan, showing approximately a 50% reduction of the current hardscaping in the back and side yard and a lower fence height, be reviewed by the Ldrc to ensure consistency with the design guidelines. The installation of pavers set into sand rather, than upon the concrete slab, should be undertaken as revisions to the landscaping plan.

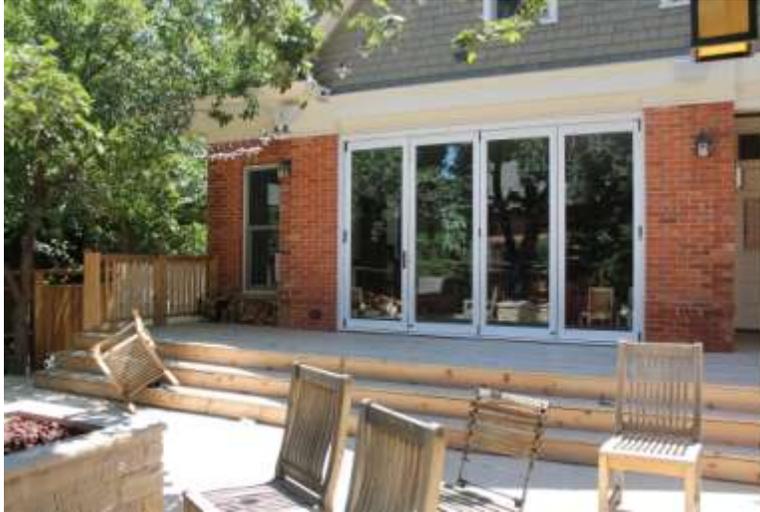
*Figure 9. 437 Highland Ave. North elevation (rear) showing deck, July 2014.*

The Landmark Alteration Certificate drawings dated 02.06.2013 (HIS2012-0213) specified a 22' x 4" (88 sq. ft.) landing where a 26' x 6' (approximately 200 sq. ft. with steps) landing was constructed. The applicant is requesting the existing landing (to be painted white) to be approved as constructed.

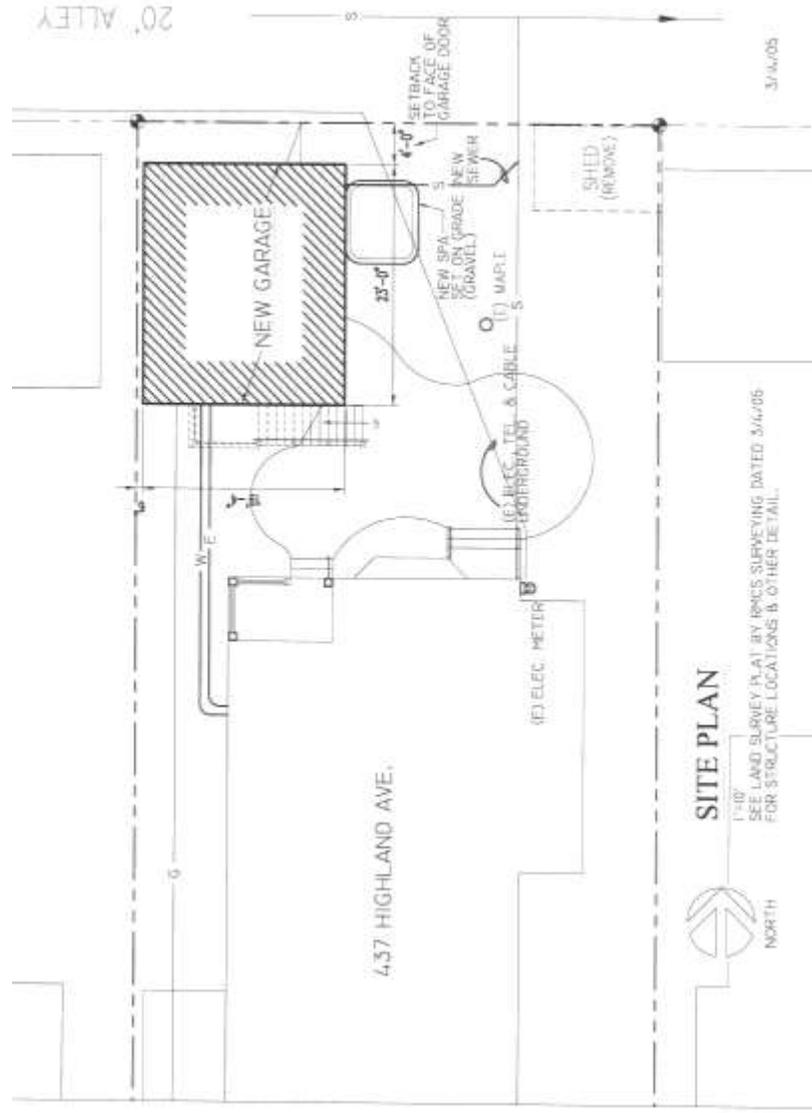
Figure 8. 437 Highland Ave., Landscape Plan for Landmark Board Review, 2005.

This change, which resulted in the stair run leading north/south where it was originally constructed to run east west, was not reviewed through the Landmark Alteration Certificate review process (*see figures 8 & 9*).
