MEMORANDUM

December 3, 2014

SUBJECT: Public hearing and consideration of issuance of a demolition permit for the building located at **1103 6th St.**, a non-landmarked building over 50 years old, pursuant to Section 9-11-23 of the Boulder Revised Code (HIS2014-00301).

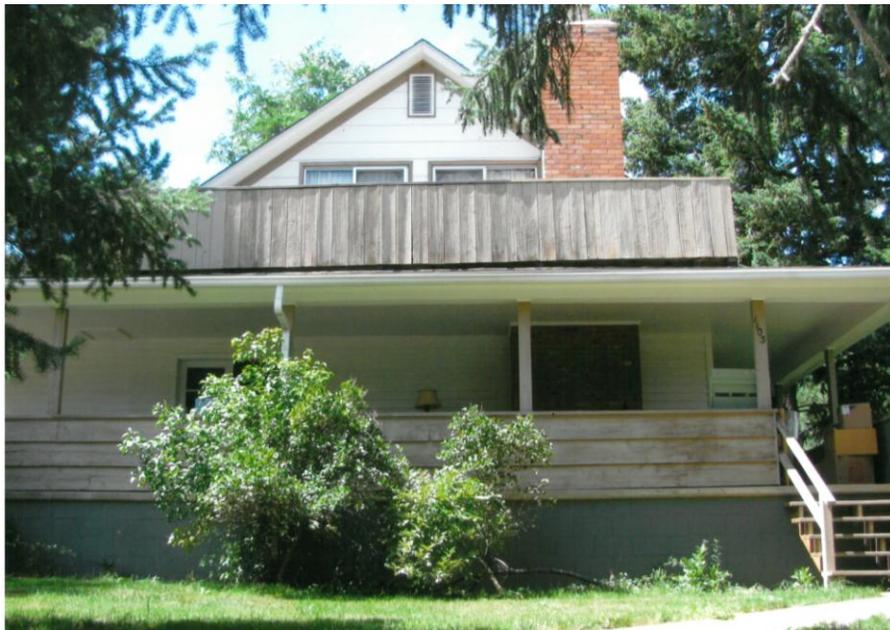
Figure 2. East Façade, 1103 6th St., 2014

The one-and a half story frame house at 1103 6th St. is clad is horizontal clapboard siding and features a front gabled roof with flared, overhanging eaves. A front porch with post supports spans the width of the façade and wraps around to the north side. The porch can be accessed by two sets of stairs, one at the northeast corner and one at the north

elevation. The double front door is off-centered towards the south end of the façade. A 1960s chimney is located to the right of the front door. The front gable end is clad in vinyl siding and has two non-historic sliding glass doors and a louvered gable vent added in the early 1960s. A balcony above the front porch extends from the gable.

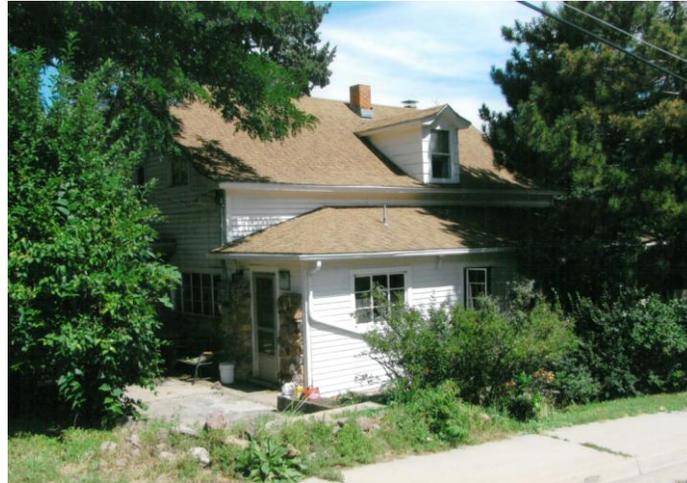
Figure 3. South Elevation, 1103 6th St., 2014

The south elevation, along College Ave., features a gable roofed dormer that is clad in vinyl and features a double hung window, and a hipped roof addition that extends the length of the first story of the south elevation. The owners note that a sleeping porch was enclosed in 1948 to create a kitchen and two bedrooms. The south elevation features a large picture window and two metal divided light casement windows. The east and south walls of the addition are clad in wooden lap siding, while a rubble stone cladding was added to the west elevation in the 1960s. The rubble stone cladding continues around a one-story flat-roofed addition with a door and metal sliding windows. Originally constructed as a garage, it was later converted to living space.

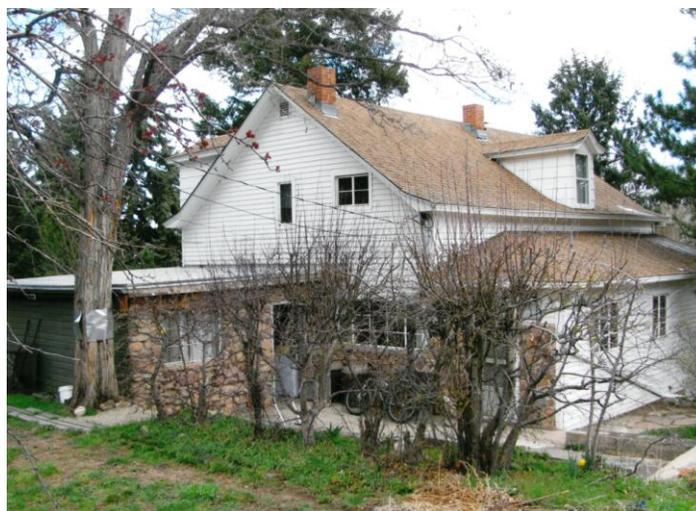
Figure 4. West (rear) and South elevations, 1103 6th St., 2014

The west elevation of the garage features wooden lap siding. The second story of the west elevation of the house features two casement windows and a louvered vent. Two brick chimneys protrude on the south slope of the roof.

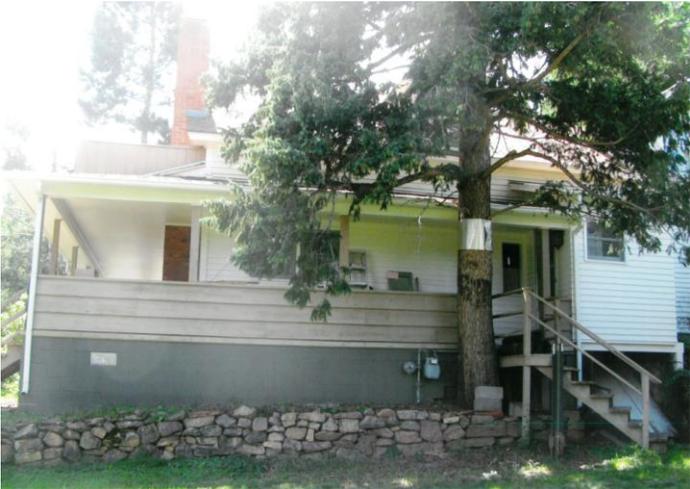
Figure 5. North Elevation, 1103 6th St., 2014

The north elevation features two dormers with flared eaves and double-hung windows. The first story features a pair of double-hung windows at the east end of the elevation, and a narrow casement window on the west end. A small shed roof addition is located at the west end of the elevation and features an east-facing door and a double-hung window on the north elevation. A hatch to access a basement/crawl space is located beneath the addition.

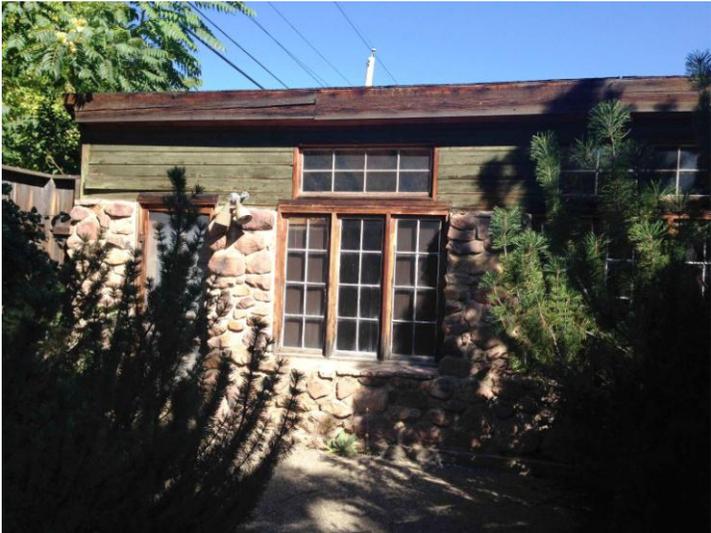
Figure 6. South Elevation of Shed, 1103 6th St., 2014

A shed roof accessory building is located at the rear of the property and features a door at the west end, and groupings of divided light windows. The shed, like the garage, was clad with stone in the 1960s. At that time, the window openings were significantly altered. The age of the shed is unknown, other than it existed by the time of the 1947 Tax Assessor Card. It was likely constructed prior to 1930 and used for agricultural purposes. See Attachment A: Current Photographs.

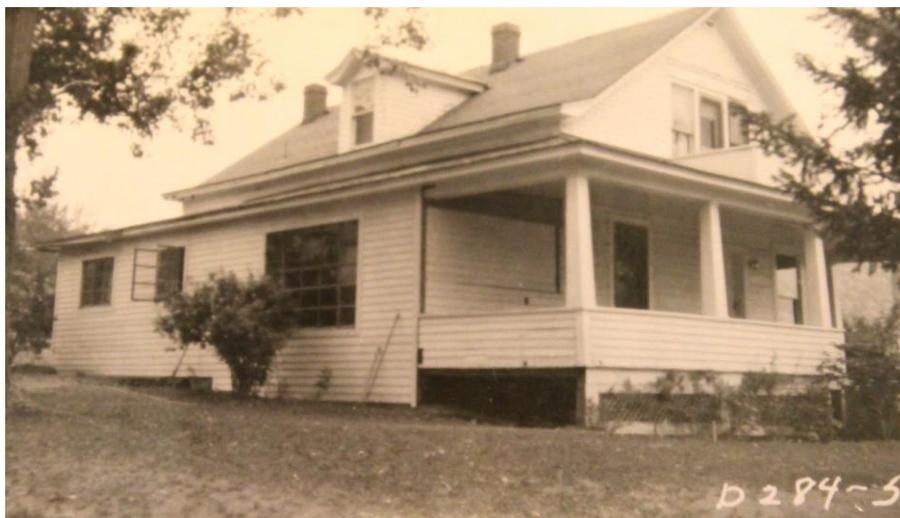
Figure 7. Tax Assessor Photo, 1103 6th St., c. 1949

The gable end of the east façade originally featured a central door flanked by double-hung windows. A louvered vent and vinyl siding has been added to this portion of the building. The second story openings have been altered to accommodate two sliding glass doors. A small porch on the second story featured a low wooden railing; today, the second story porch extends the width of the east elevation and has a solid stockade railing. The porch, with battered porch columns, originally extended the width of the east façade and did not wrap the corner. The area underneath the porch has been filled with CMU block. The front door, originally located in the center of the east façade, was relocated south and replaced with a wider double glass door. A wide chimney was constructed on the north end of the east façade, altering a portion of the original wall finish and building eave.

The south elevation originally featured a sleeping porch, but was enclosed and remodeled into the current kitchen in 1948. The west wall of the addition was clad in rubble stone in the 1960s. The one-story, flat-roof attached garage was converted to living space in the 1950s. At the time of the conversion, the south elevation featured a pedestrian door and a small, double-hung window. The south wall of the garage addition was clad in rubble stone and the window was enlarged to accommodate a larger aluminum sliding window. A stone retaining wall was added along the south property line in order to cut off the driveway that was originally accessed from College Ave. The extent of alteration to the west elevation is unknown; the metal casement windows appear to be of 1950s vintage and the original fenestration pattern is unknown.

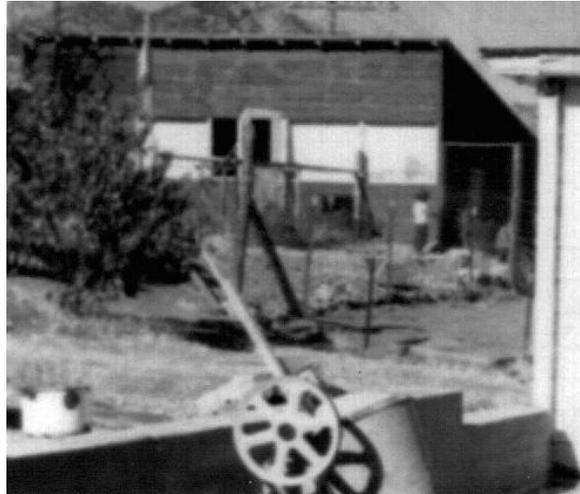
Figure 9. South elevation of shed before modifications, 1103 6th St., c. 1950s

The accessory building was significantly remodeled in the 1960s. The general shed-roof form remains, but the character has been dramatically modified through the application of rubble stone cladding and reconfiguration of addition of window openings. Little intact original material remains.

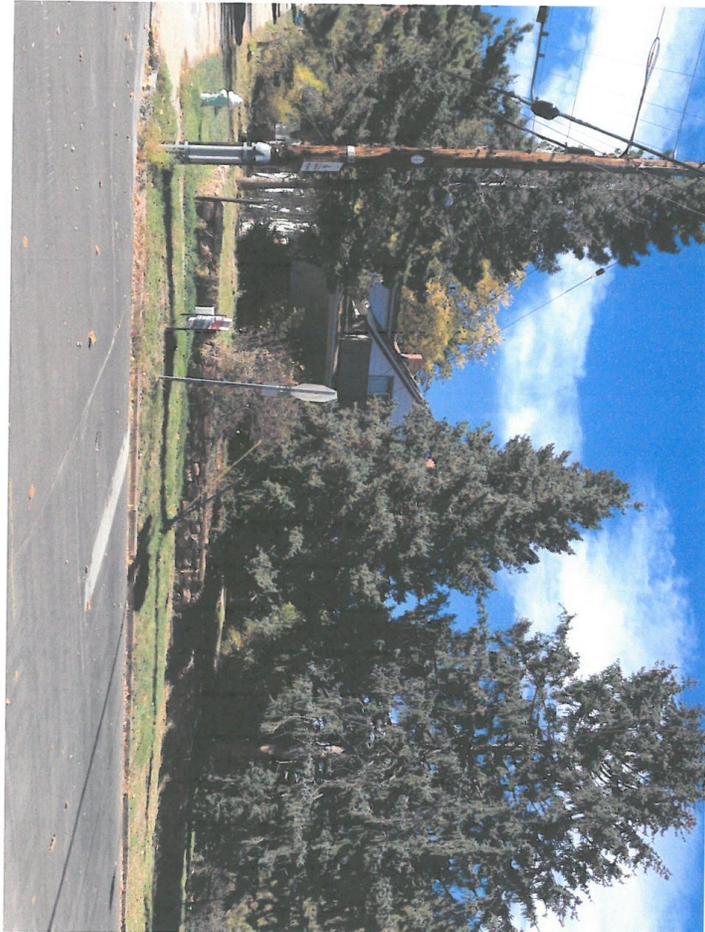
1103 6TH ST,
EAST VIEW

EXISTING EVERGREEN
COVER MOST OF THE
EAST FACADE;

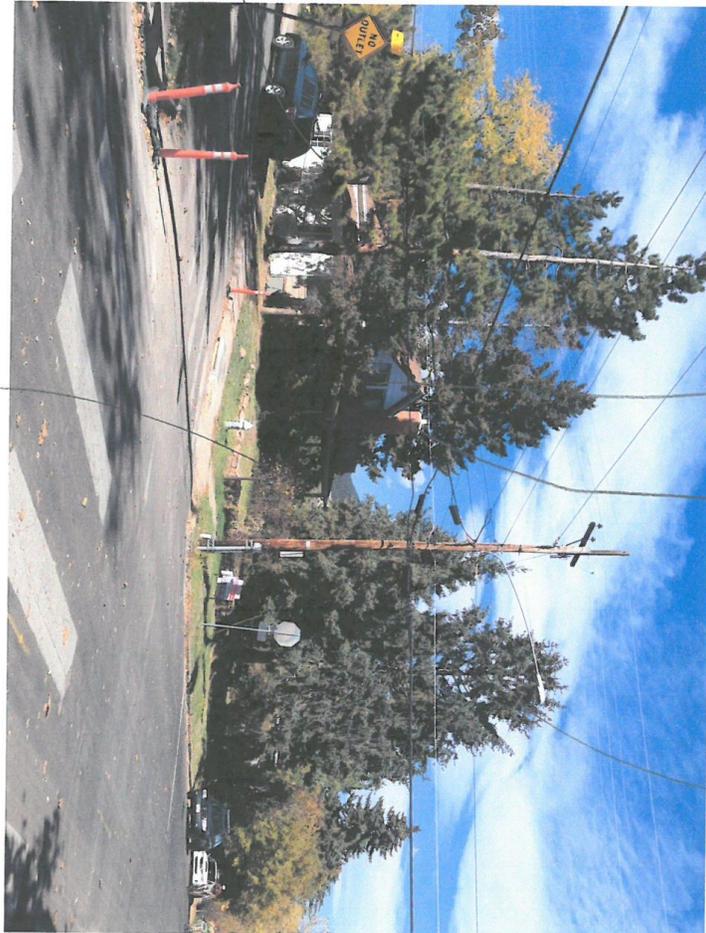
1103 6TH ST.
VIEW FROM SOUTH/EAST CORNER

PORCH ENCLOSURE

TOP WINDOWS WERE ALTERED

— PORCH COLUMNS NOT ORIGINAL
— PORCH WAS EXTENDED TO THE NORTH
— PORCH ROOF WAS EXTENDED/ADDED ON TO THE NORTH

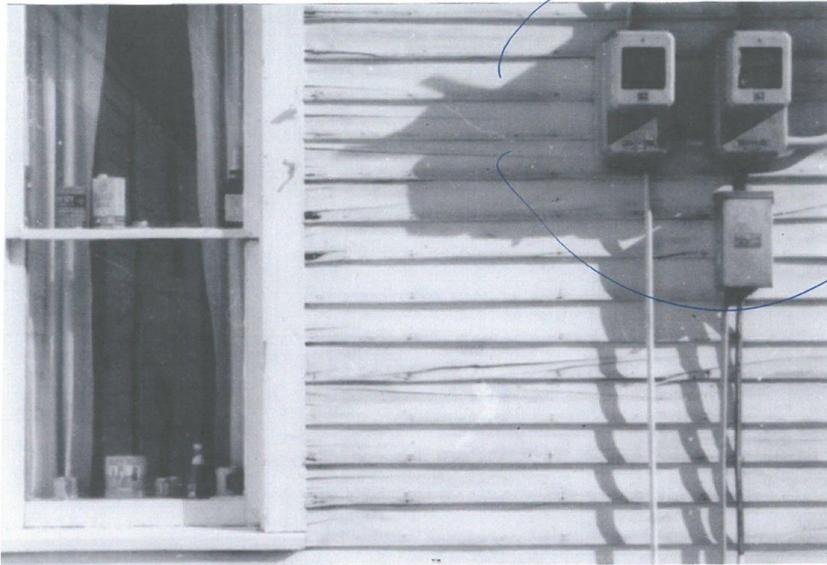
← DOUBLE
ELECTRIC
METER
(THIS WAS A DUPLEX,
IF RESTORED
WOULD NOT
CONFORM WITH
CURRENT ZONING)

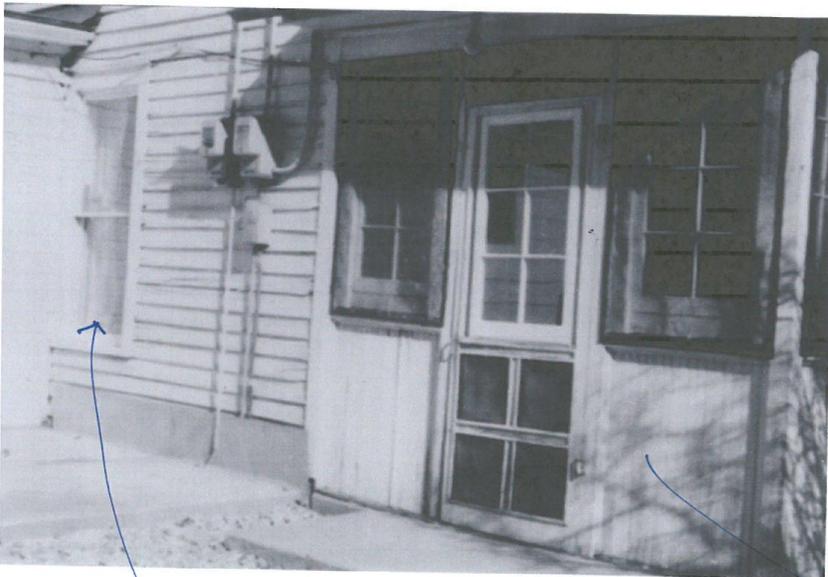
ORIGINAL WINDOW, CHANGED LATER TO
CURRENT HORIZONTAL WINDOW

THIS WAS
HAS BEEN
CHANGED 100%.

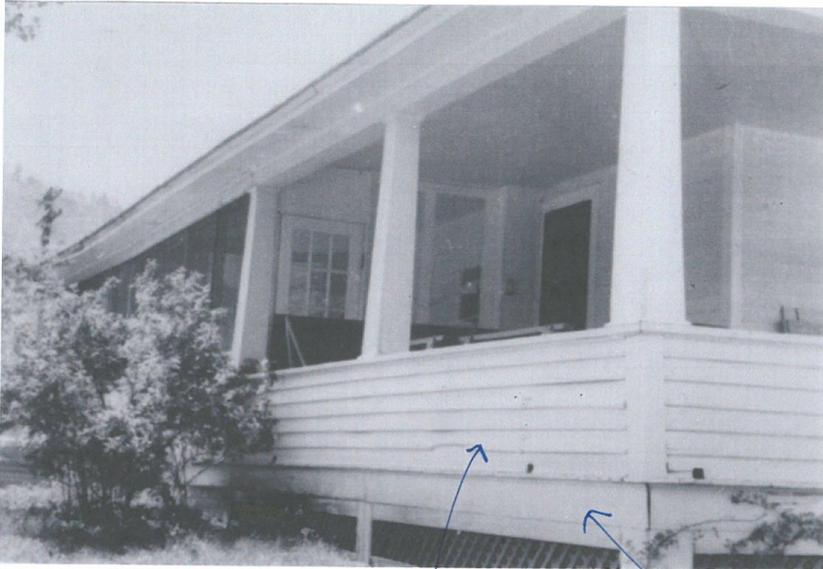
1103 6TH ST.
SOUTH/EAST CORNER

WHEN PORCH WAS
ENCLOSED THE
ORIGINAL PORCH
FOUNDATION WAS
NOT REINFORCED.

SOUTH/EAST PORCH AND
"SLEEPING" PORCH BEFORE
IT WAS ENCLOSED.

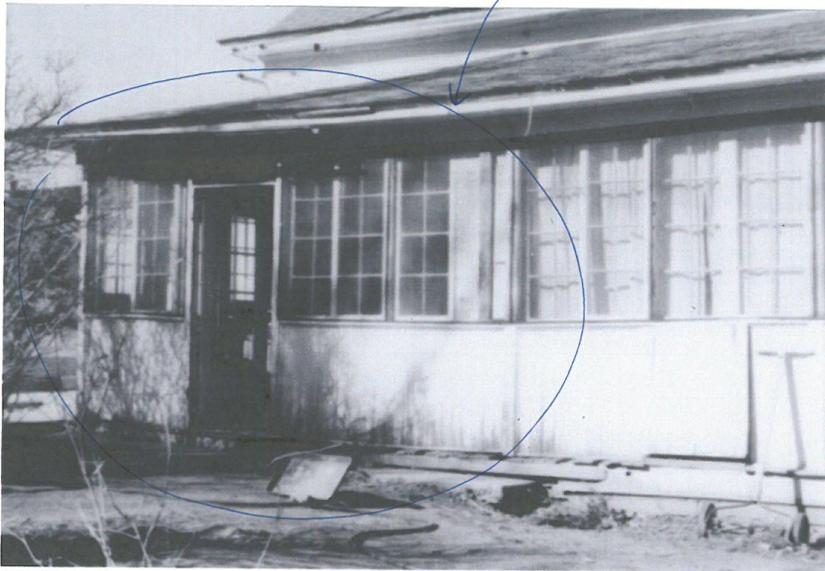
CURRENT KITCHEN HAS BEEN MOVED
TO THIS LOCATION

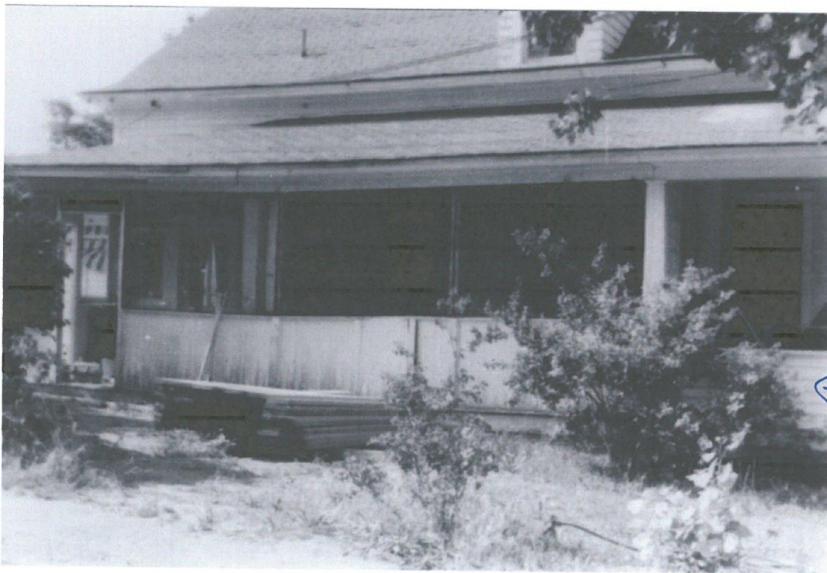
1103 6TH ST.
SOUTH ELEVATION

SOUTH PORCH
BEFORE IT GOT
ENCLOSED

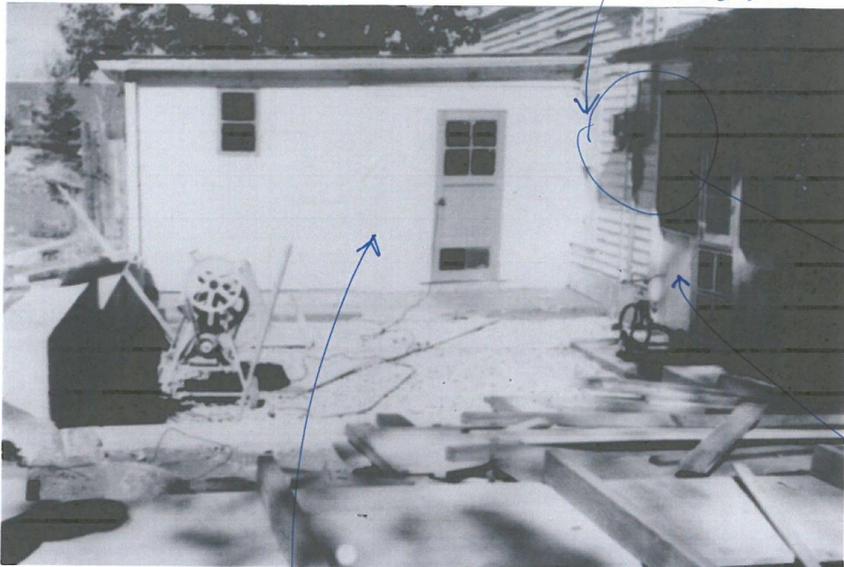
WINDOW BEFORE IT WAS
CHANGED TO HORIZONTAL
WINDOW

DOUBLE
POWER METERS
(FROM DUPLEX)

NEW WINDOW
ADDED AFTER FRONT
ENCLOSURE

STONE NOT
ORIGINAL
(ADDED IN THE
60'S)

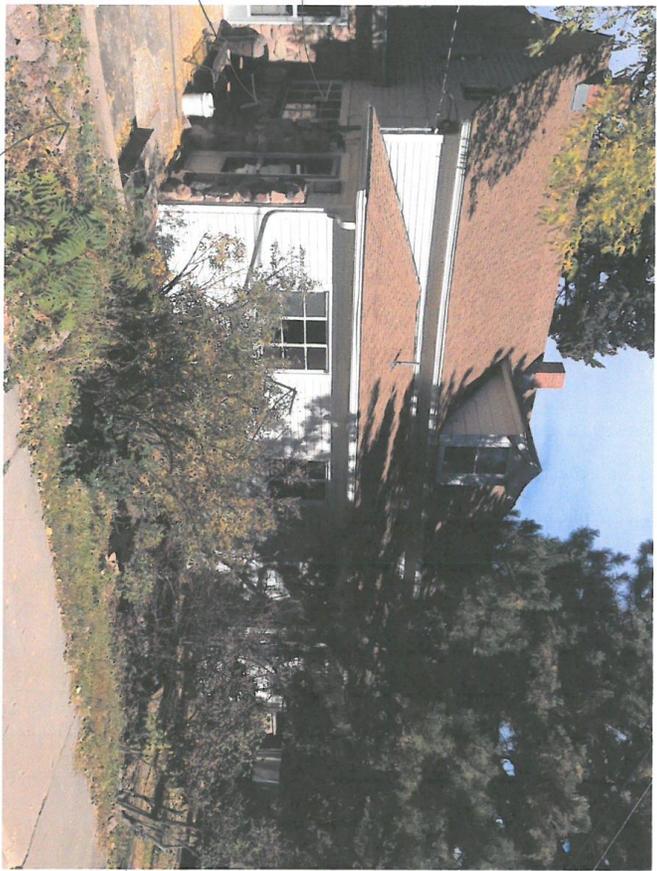
1103 6TH STREET
SOUTH ELEVATION (VIEW FROM
COURTNEY AVE.)

RETAINING WALL ADDED
TO CUT OFF EXISTING
DRIVEWAY TO THE GARAGE

ORIGINAL GARAGE
ENCLOSED BY
FAUVENBER FAMILY
TO CREATE
PHOTOGRAPHY
STUDIO FOR DAD.

STONE IS NOT ORIGINAL
(IT WAS
ADDED IN THE 60'S)

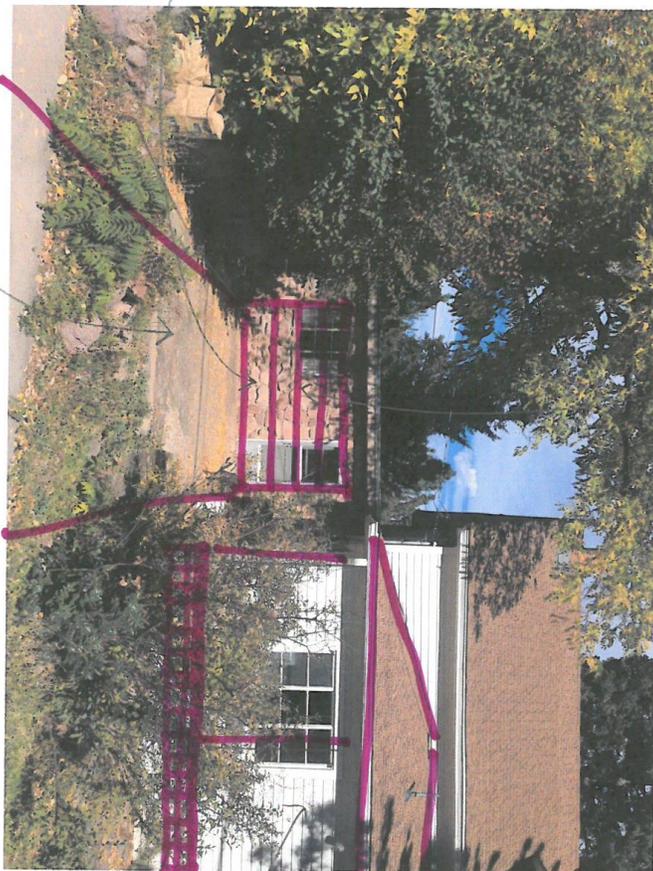
1103 6TH STREET
SOUTH ELEVATION (VIEW FROM
COURSE)

ORIGINAL DRIVEWAY TO GARAGE
(IF RESTORED BACK TO GARAGE
WOULD REQUIRE CURB CUT ON COURSE (?))

ORIGINALLY THIS
WAS A PORCH
(IF BROUGHT BACK
TO ORIGINAL STATE
WALL WOULD NEED
TO BE REMOVED
AND KATIE N
WOULD NEED TO
BE RELOCATED)

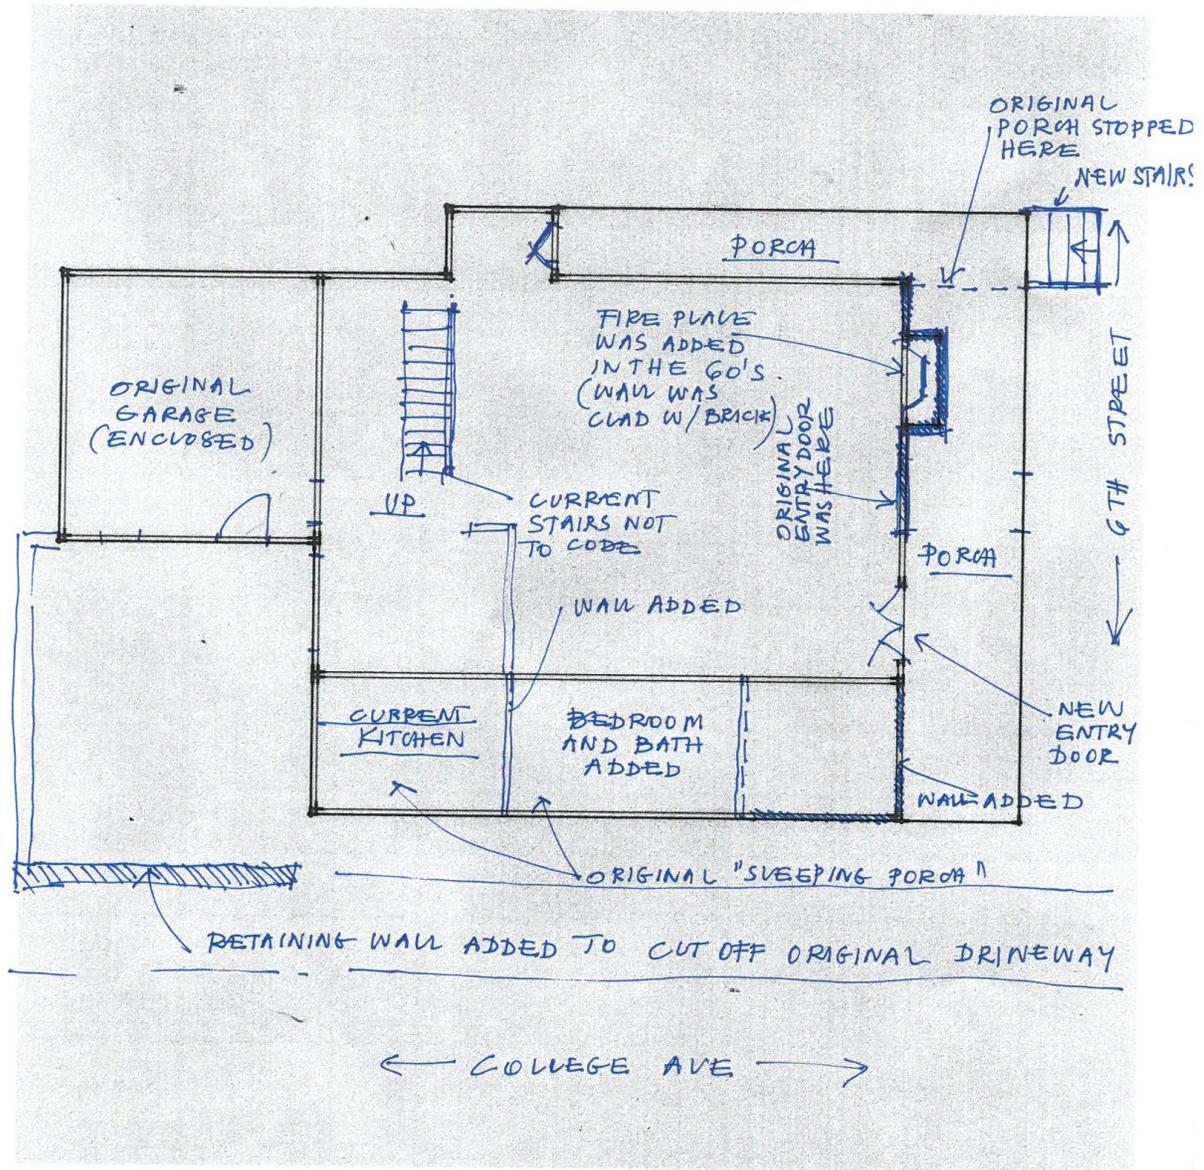
1103 6TH ST.
MAIN LEVEL PLAN, NOT TO SCALE

FIREPLACE
WAS ADDED
BY FAULKNER
FAMILY

PORTION OF
EAST WALL
WAS CLAD
WITH BRICK
FOR FIRE PROOFING
(BRICK IS
CRACKED AND
THERE ARE
SIGNS OF
BRICK SEPARATING
FROM WOOD FRAMING)

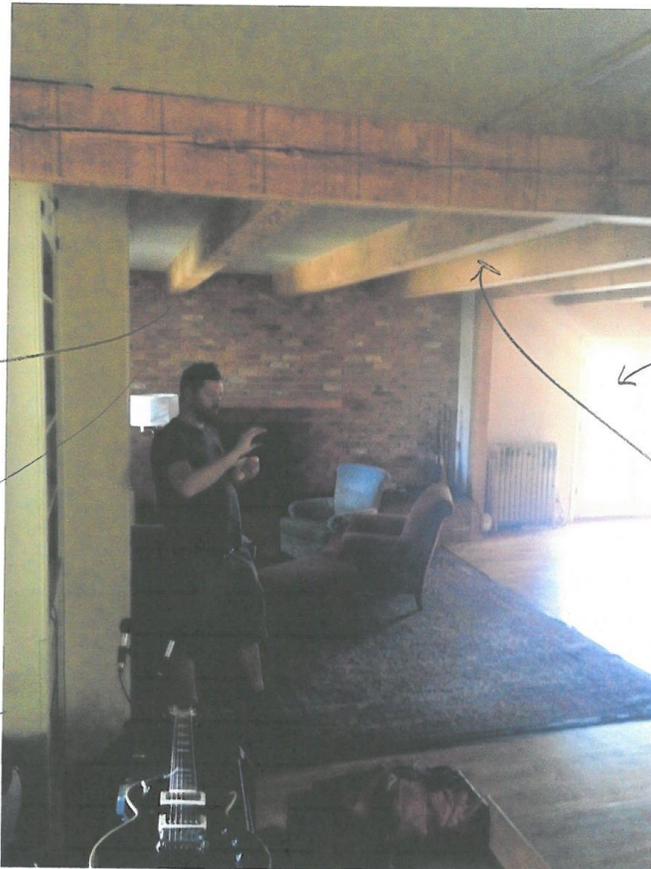
1103 6TH ST.
INTERIOR VIEW OF
MAIN LEVEL

NOT ORIGINAL
ENTRY DOOR

WOOD BEAMS
WERE ADDED
TO REINFORCE
SECOND LEVEL
FLOOR WHICH
IS UNDER-
ENGINEERED
FOR CURRENT
USE.

* THERE WERE ADDITIONAL
ALTERATIONS MADE (IN FLOOR
LEVELS) TO ACCOMMODATE
MRS. FAULKNER'S LIMITED
MOBILITY DURING HER LAST YEARS.

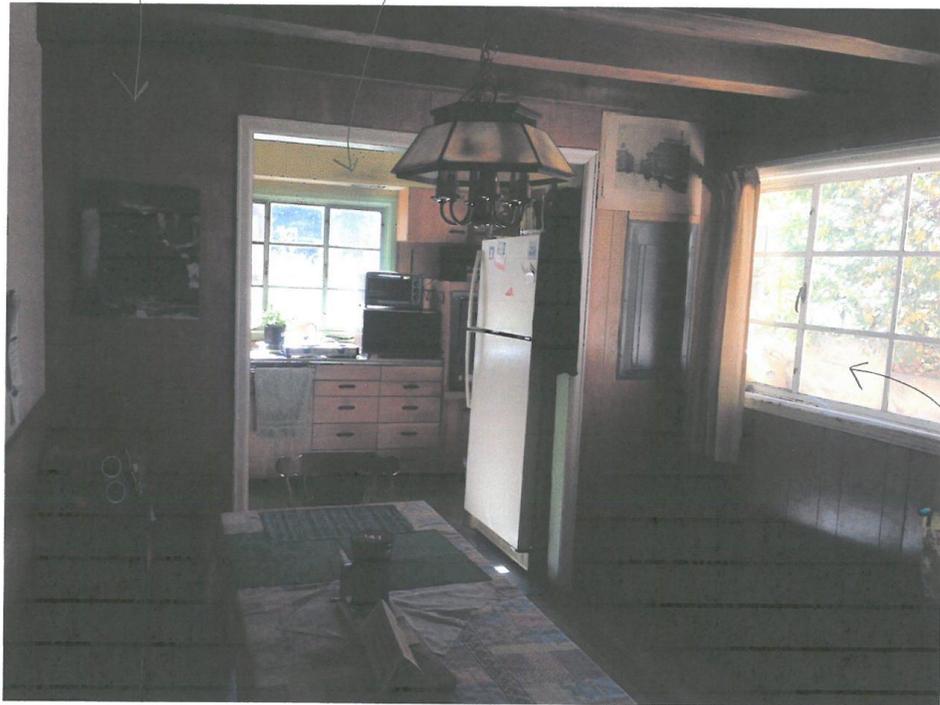
INTERIOR VIEW OF
KITCHEN AND DINING

NOT AN
ORIGINAL
WINDOW
(WEST
SIDE)

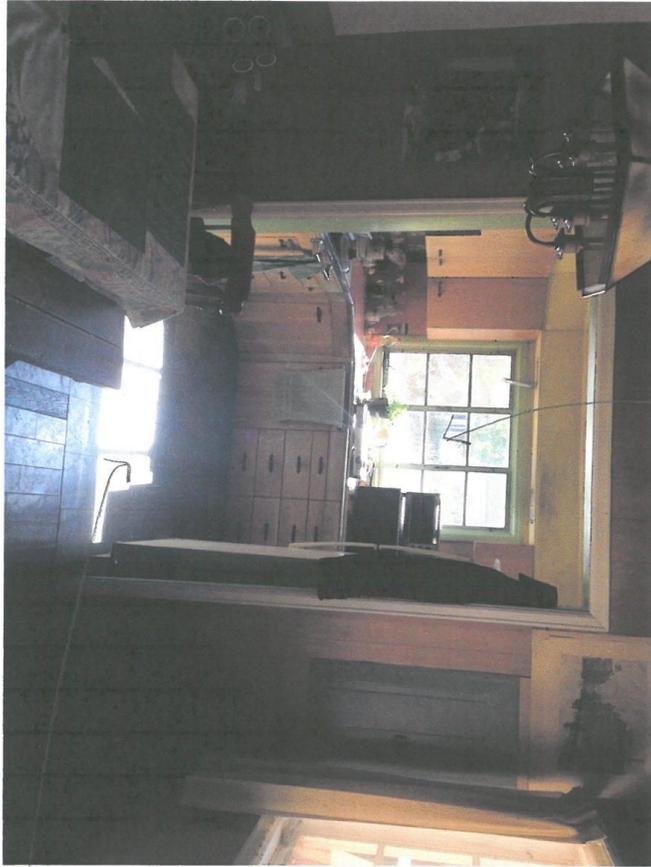
VIEW INTO ORIGINAL "SLEEPING PORCH" WHICH BECAME CURRENT KITCHEN. (NON CONFORMING FOUNDATION, ORIGINAL PORCH FOUNDATION)

FOODING TRANSITION FROM ORIGINAL HOUSE TO ENCLOSED PORCH.
