MEMORANDUM

June 23, 2016

SUBJECT: Public hearing and consideration of a motion to adopt a resolution to initiate the process for the designation of the property at 717 17th St. (on which a stay-of-demolition was imposed on February 3, 2016), as an individual landmark pursuant to Section 9-11-3, B.R.C. 1981 (HIS2015-00337).

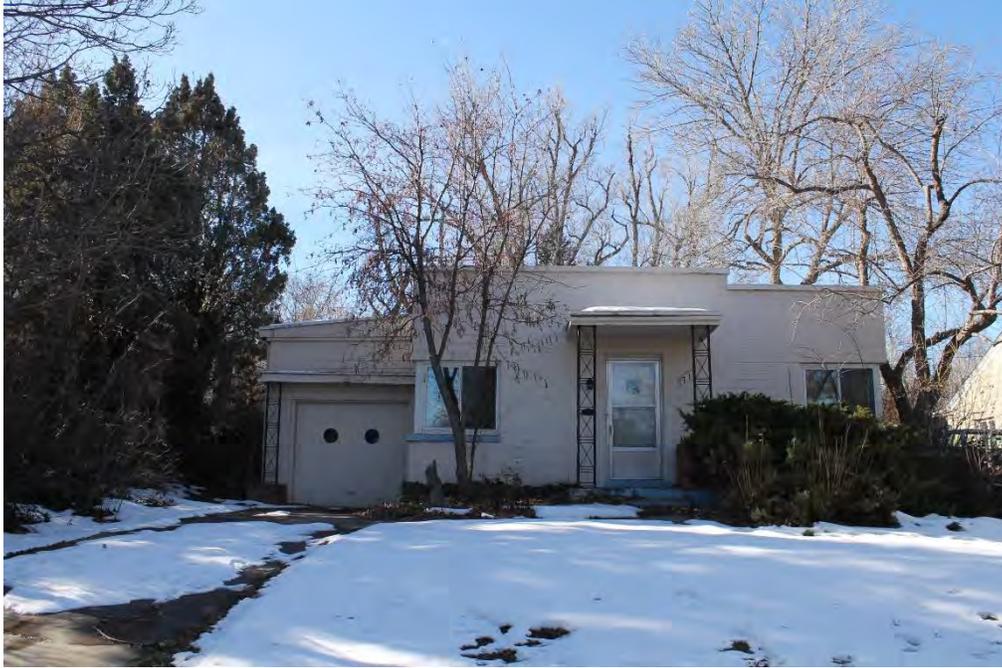
Figure 3. East Elevation (façade), 717 17th St., 2016.

Constructed in 1939, the one-story house at 717 17th St. shows influence of Moderne and International design elements. Influence of the Moderne design include the curved corners, windows that run the corner, and round windows. Elements of the International style include the flat roof, wrapping windows set flush with outer wall; smooth, unadorned wall surfaces, and asymmetrical façade.¹

The asymmetrical house is of unadorned clay-tile construction with a centrally located paneled door with a port-hole window. A flat hood with iron supports over the forms a portico over the front door. Early photos indicate that the iron supports were a later addition and the flat hood above the front door was originally semi-circular and cantilevered. A band of large, non-historic vinyl casement windows wrap around the southeast corner of the house. An attached garage with a low-pitched shed roof is located on the south elevation of the house and features an overhead door with two port-hole windows.

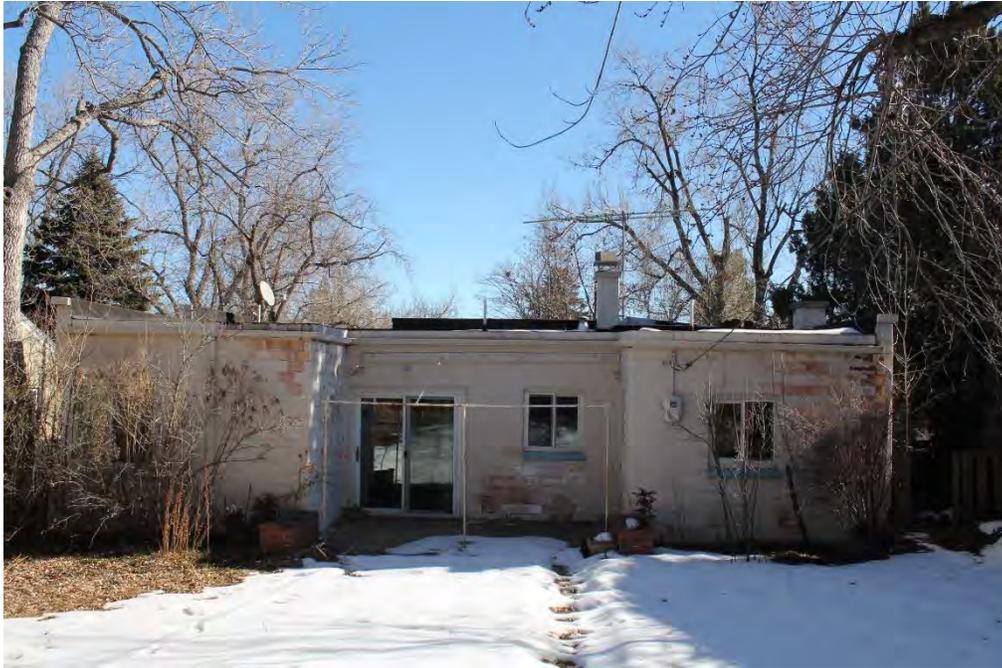
Figure 4. West Elevation (rear), 717 17th St., 2016.

The rear (west) elevation of the house features vinyl casement windows with brick sills and a sliding glass door. The owner indicates the sliding glass door was installed around 1998. The opening features rounded corners and appears to be original. A patio is centrally located and is flanked by brick planter boxes.

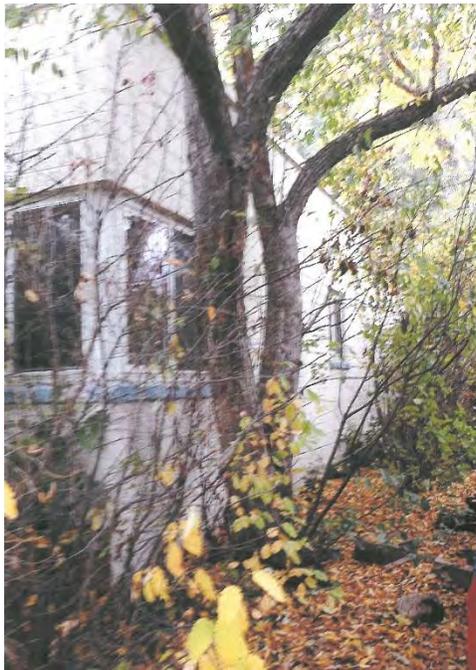
Figure 5. North Elevation, 717 17th St., 2015.

The north and south elevations are unadorned with the exception of casement windows with concrete sills. The owner indicates that the vinyl windows were installed around 1998. One original window remains on the south elevation. The other nine windows have been replaced. The 1992 survey photograph (*Figure 7*) and the 1940s photograph (*Figure 2*) shows the original divided light steel casement windows. The 1992 survey notes that the windows were installed flush with the wall.

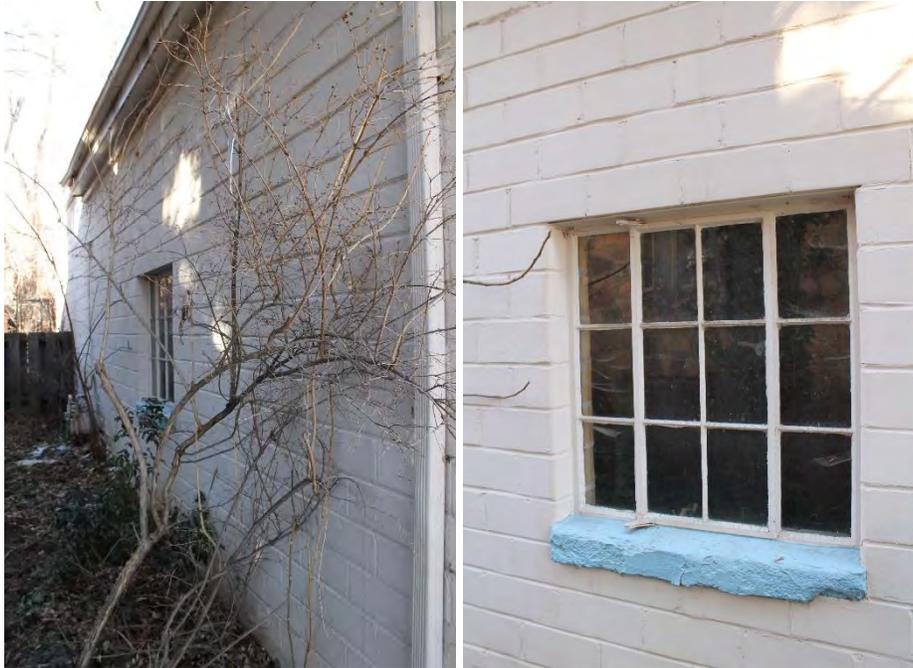
Figure 6. Left: South Elevation, 717 17th St., 2016. Right: Detail view of original window, 2016.

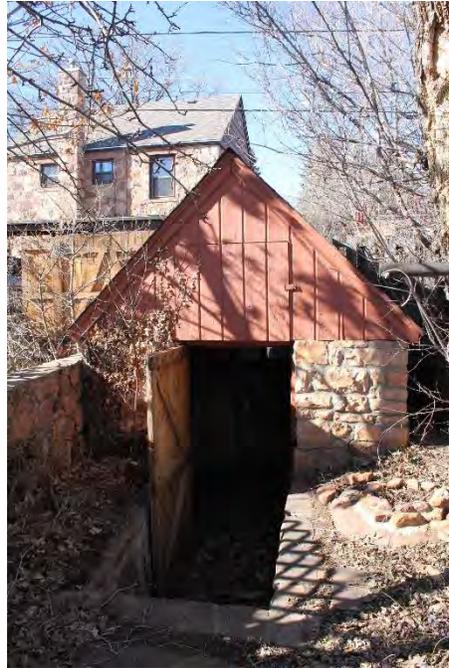
Figure 8. Stone accessory building, East Elevation, 717 17th St., 2016.

A small, stone accessory building is located at the southwestern edge of the property along the alley. Its date of construction is unknown, and first appears on the tax assessor card in 1949. It is possible that it was constructed at the same time as the house located to the south (711 17th St.), which is of similar stone construction, with a stone accessory building on the west property line. The tax assessor dates the main house as being constructed in 1937, two years before the house at 717 17th St. was constructed. It is likely the stone accessory building at 717 17th St. was constructed between 1937 and 1949.

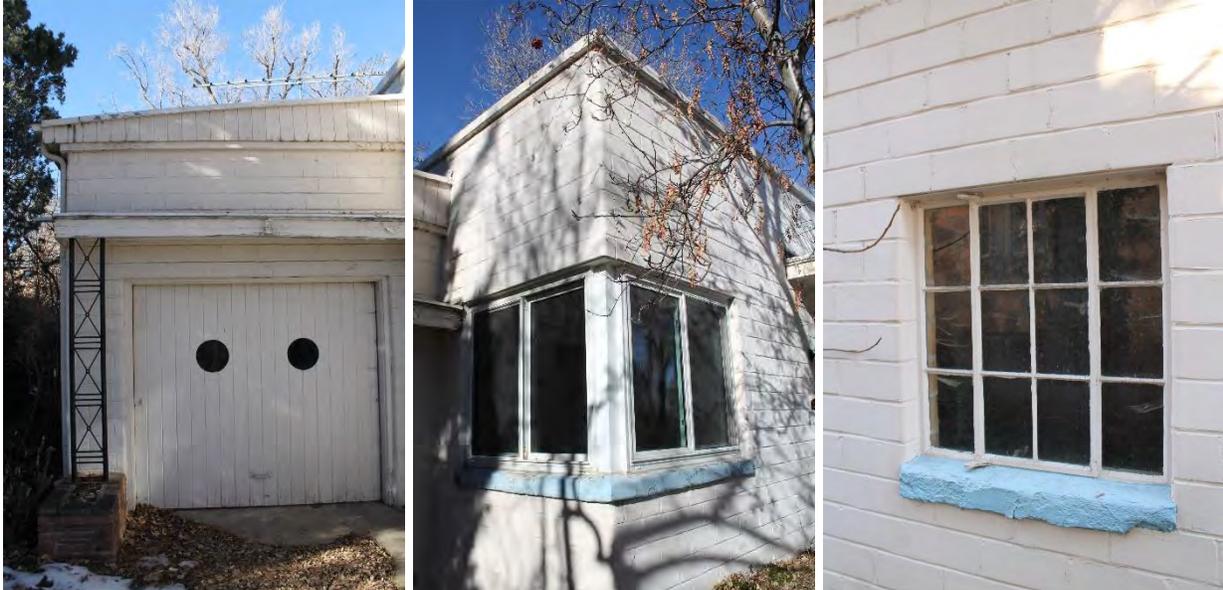
Figure 9. Characteristics of the Moderne/International Style include porthole windows, windows that wrap the corner, and divided-light steel casement windows.

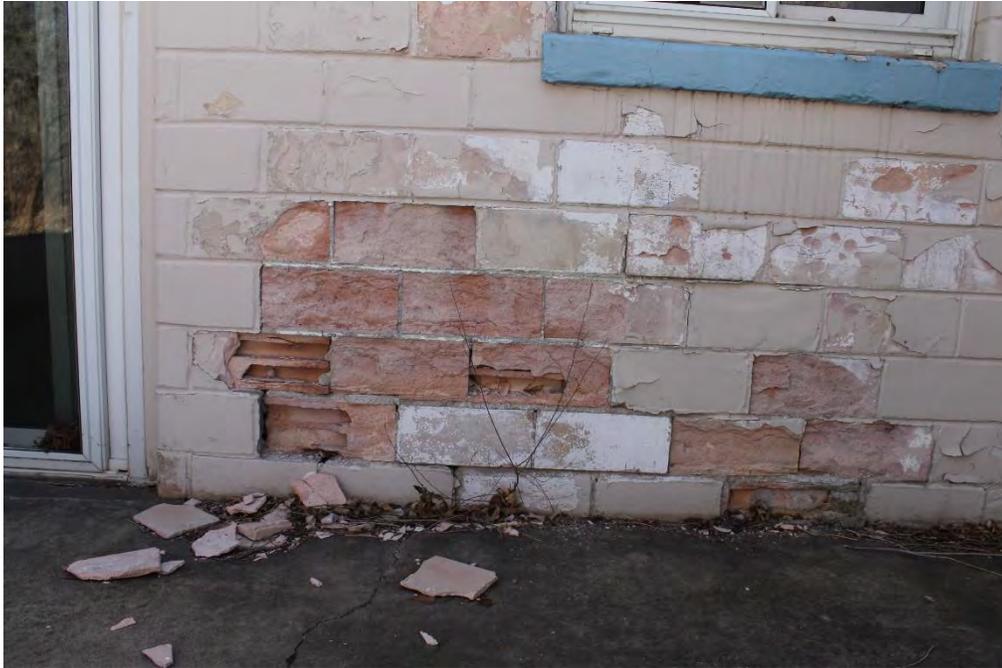
The applicant’s letter states that the house is currently uninhabitable due to roof leaks and subsequent water infiltration: “As a result of the water leaks, there has been a massive contamination of mold which is airborne and penetrated throughout the house. It is anticipated that the interior of the house will require complete remediation as the house is currently uninhabitable.” Other condition issues include the deterioration of the exterior tile, which is most evident on the rear (west) elevation. *See Attachment F: Applicant Materials.*

Figure 9. Detail of deteriorated clay tile at west elevation, 2016.

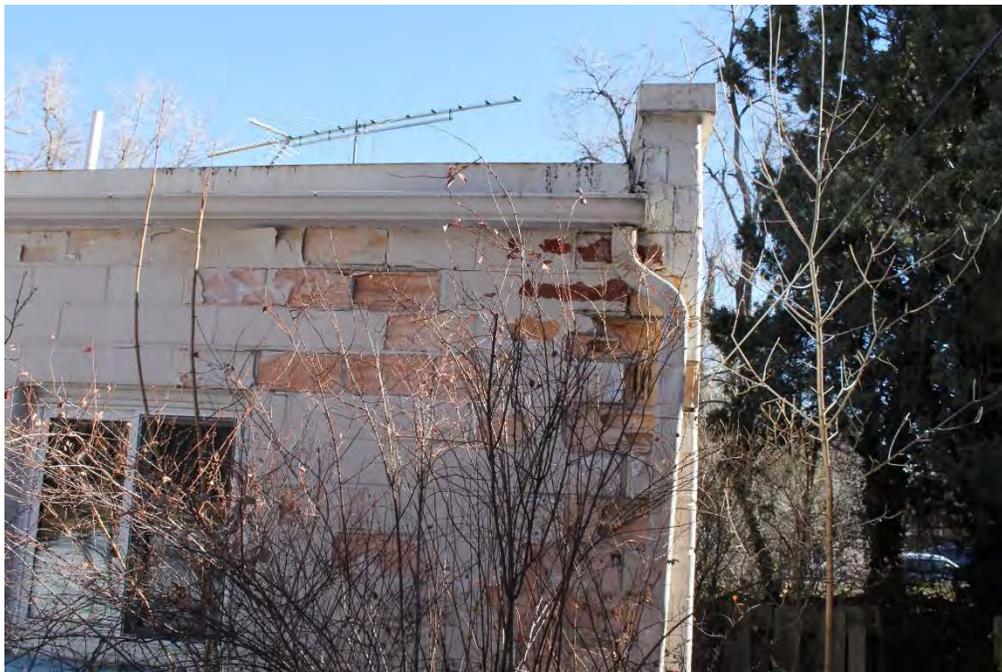
Figure 10. Detail of deteriorated clay tile at southwest corner (left) and south wall near sliding glass door, 2016.

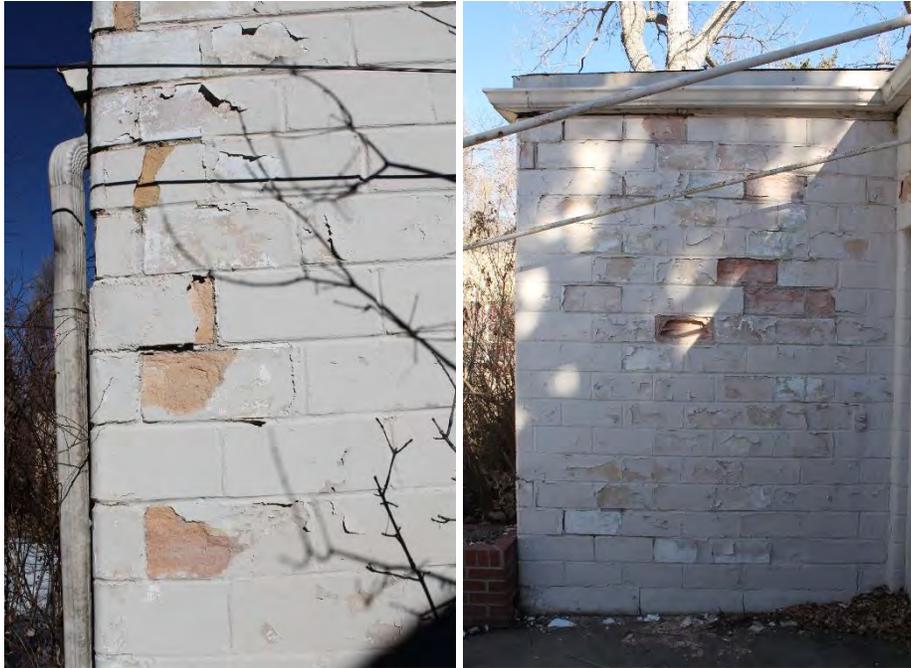
Figure 11. Detail of deteriorated clay tile at southwest corner (left) and south wall near sliding glass door, 2016.

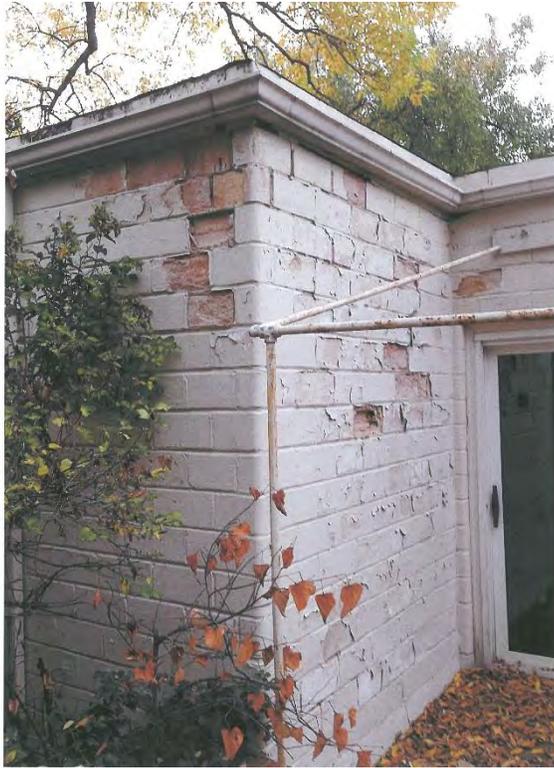
Signs of deterioration are evident in the crumbling tile, particularly on the west side of the building. The applicant's representative has submitted a letter outlining the alterations and conditions of the building. It states that due to the flat roof design, leaking was evident in 1966 and the roof above the garage was altered from a flat roof to a shed roof. Additionally, there are cracks on the west elevation, particularly around the sliding glass door. *See Attachment F: Applicant Materials.* The applicant's representative has indicated that they are planning to submit a structural report by the Feb. 3 Landmarks Board meeting.

Photo 6. West elevation, detail of deterioration of tile, 717 17th St., 2015.

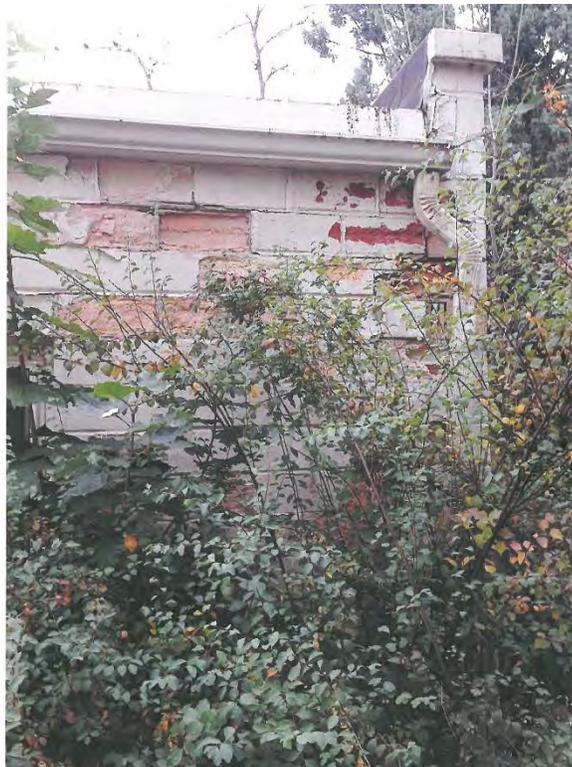
Photo 7. Detail of deteriorated tile, 717 17th St., 2015.

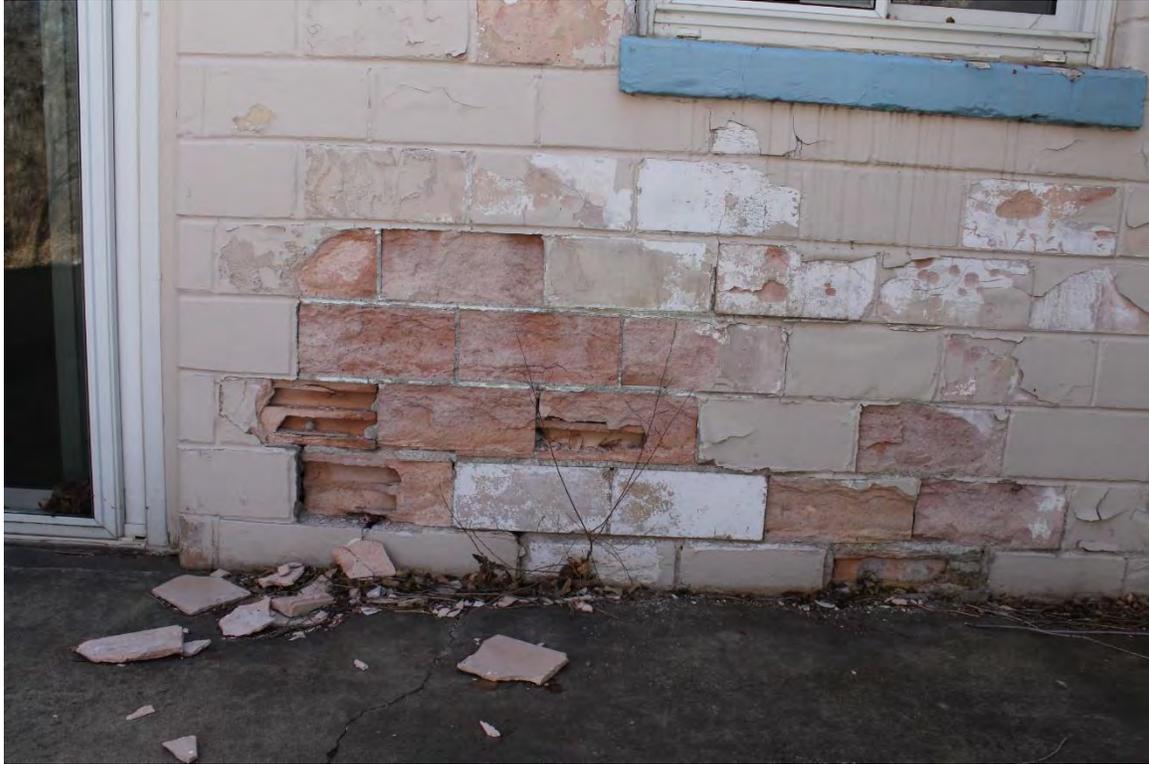
Photo 8. West elevation, detail of deteriorated tile, 717 17th St., 2015.
