Canyon Boulevard

Complete Streets

Existing Conditions Summary

City of Boulder

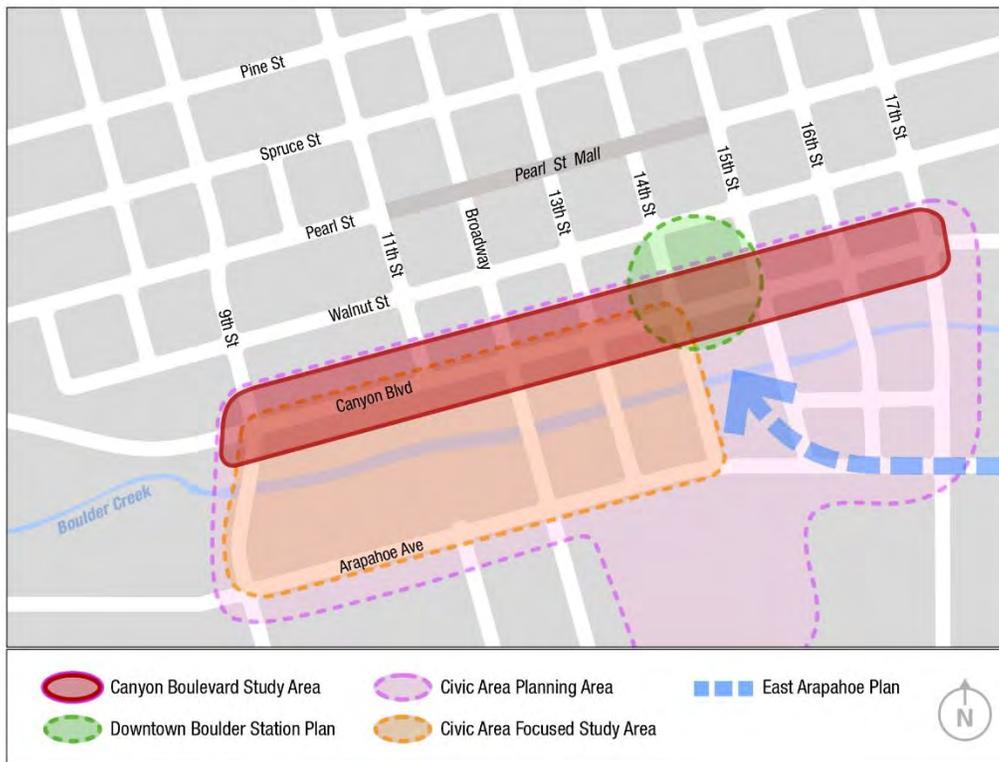
Figure 1. Study Area Map

Several current planning studies impact the decisions that are made throughout the Canyon Boulevard study area. These planning studies are described in more detail below. Although many City-wide plans generally support the development of Complete Streets, several plans are directly related to the study area for Canyon Boulevard or have direct design and functional implications for the ultimate design of the corridor. The study area for Canyon Boulevard, as well as the study areas for each of the related plans, are shown in Figure 1.

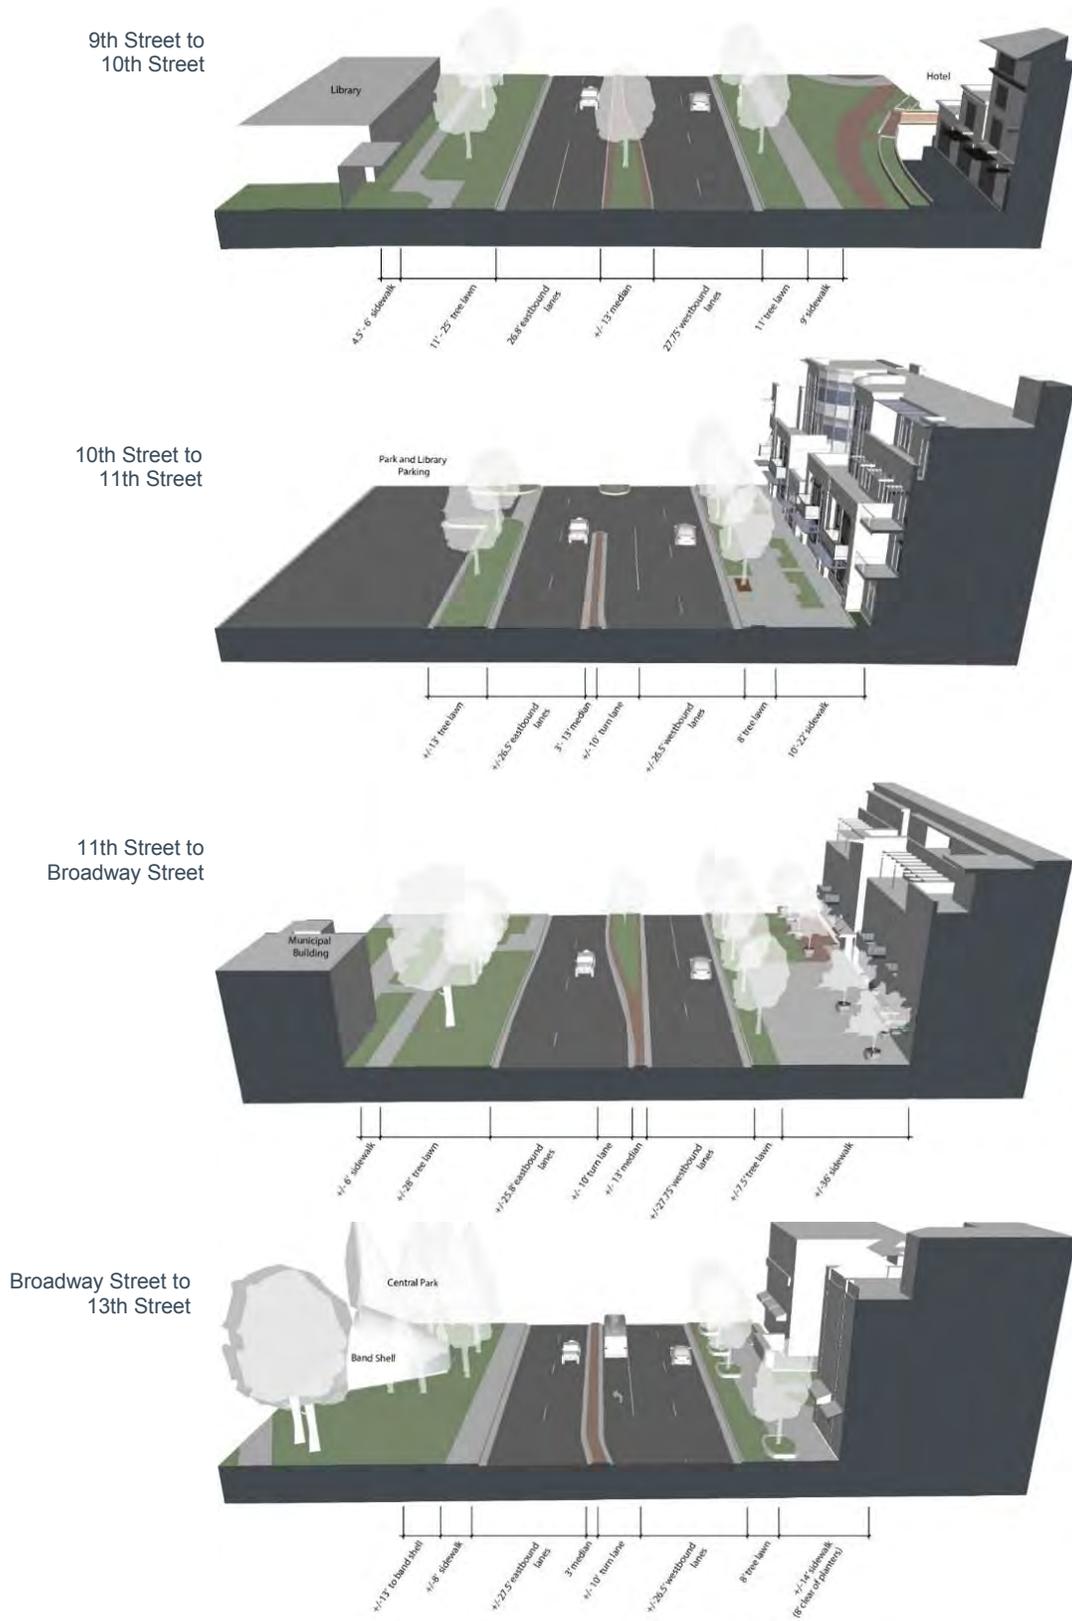
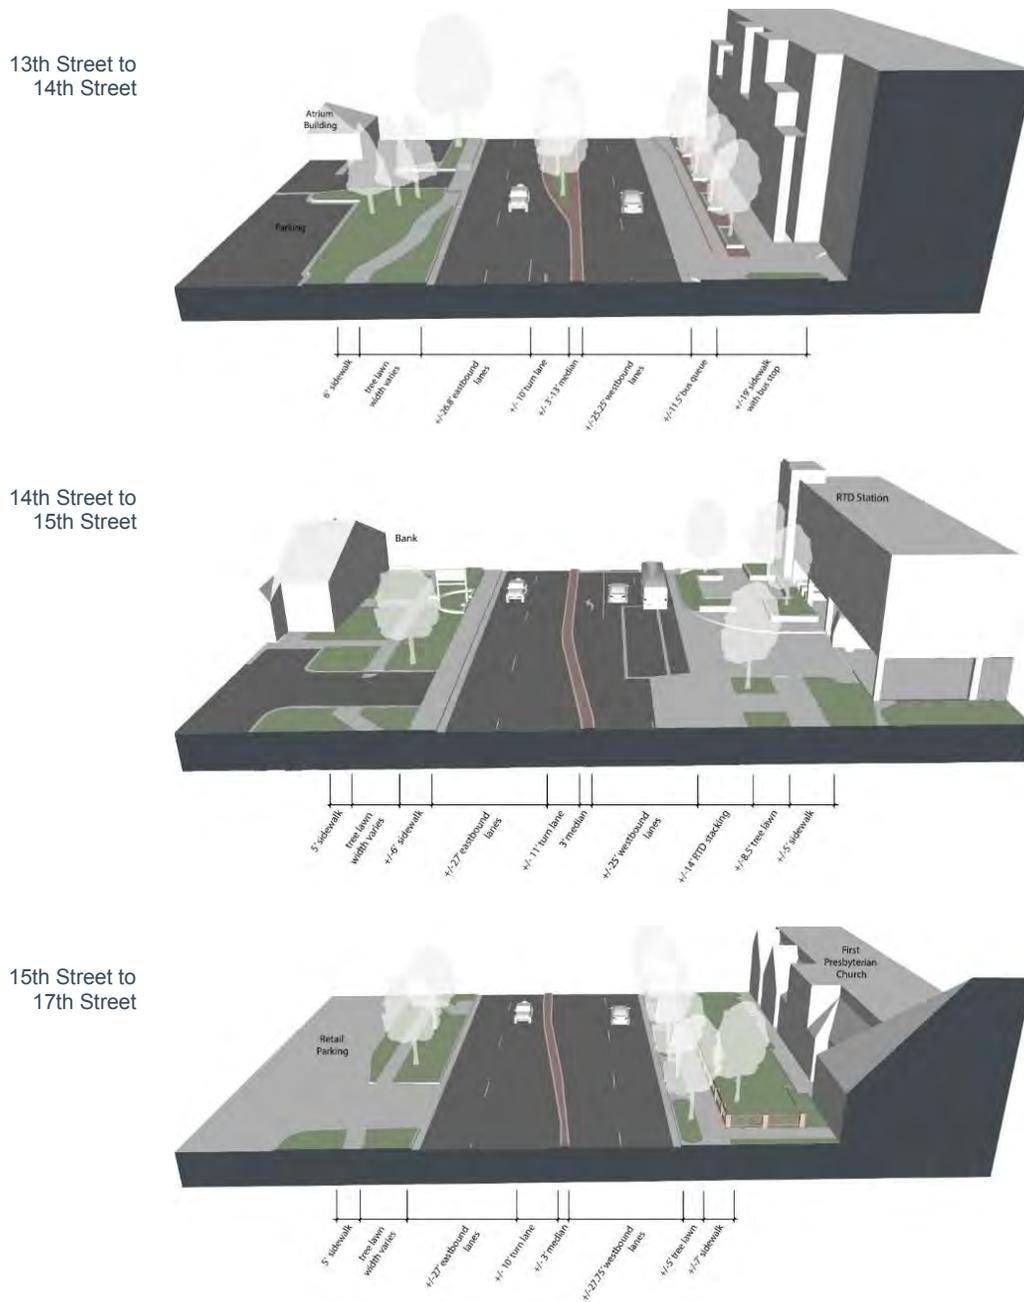
Figure 4. Canyon Boulevard Typical Cross Sections (shown West to East)

The cross-section of the corridor changes from block to block. Figure 4 shows typical dimensions for blocks along Canyon Boulevard. Pedestrian zone conditions vary from five- to six-foot-wide, curb-attached sidewalks to nine-foot-wide paths with six- to eight-foot tree lawns and larger expanses of hardscape at newer developments. Hardscape treatment changes from block to block in layout and materiality. The pedestrian realm is mostly poured-in-place concrete, with interludes of brick and stone paving at entrances to newer buildings. The north side exhibits a formal, urban character while the south side is more informal with a meandering path at times. Multiple vertical design details exist within and out of the right-of-way line on the northern side of the street: picket fences within the Chamberlain neighborhood, a wooden fence with brick piers at the First Presbyterian Church, raw cast-in-place (CIP) concrete retaining walls at the Downtown Boulder Station, painted CIP planter walls with stone caps from 14th Street to Broadway Street, and large, round planter pots between Broadway Street and 11th Street. In addition, various corner markers appear at major intersections (sandstone markers at Broadway Street and brick markers at 13th Street) and monument signage is located at multiple commercial sites and institutions. Street lighting shows consistency throughout the corridor, with a typical “hockey puck” style roadway light. Pedestrian-scale lighting, where present, is a typical 12-foot-tall globe fixture. Site furniture varies by property owner with a consistent use of wood slat and steel tube, steel strap and tube, and recycled plastic benches.

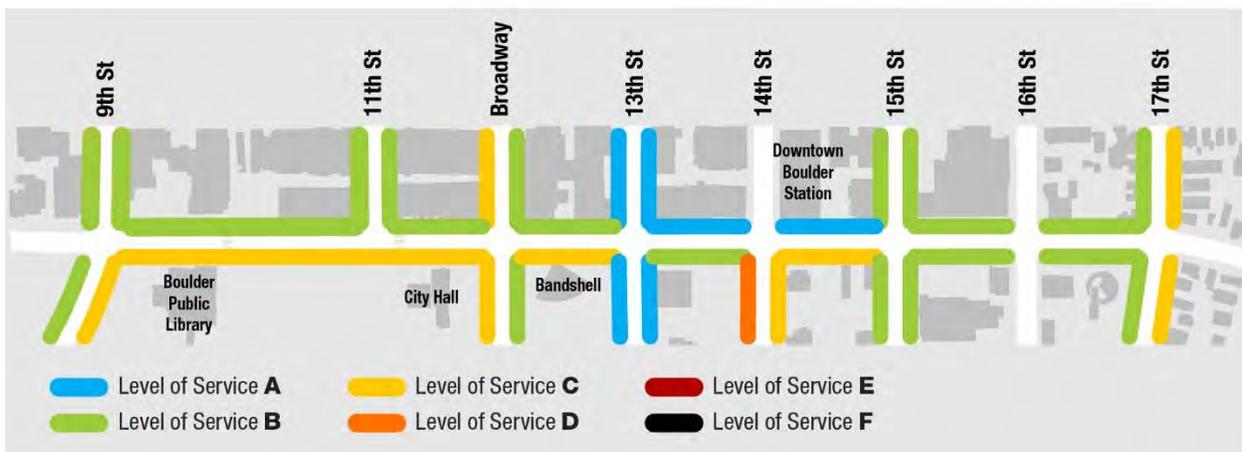
Figure 5. Pedestrian LOS

To fully capture the pedestrian experience across the corridor, two pedestrian level of service analyses were conducted. The first analysis, using the standard PPM methodology, was applied to a corridor-wide evaluation. This resulted in an overall pedestrian LOS B for the corridor. The second analysis modified the PPM methodology then was applied to individual segments of the roadway. A modification was required to the original PPM model because it does not traditionally distinguish between the different conditions on each side of a street. Because of the variability in sidewalk characteristics between the north and south side of Canyon Boulevard, the PPM model was modified to supplement the analysis. It was determined that this modification would be applicable for use on this project as long as the modification was applied consistently to both existing conditions and any future considered alternatives. The results of the modified segment analysis are shown in Figure 5. The individual scoring tables, included as Appendix B, show the points each segment received for each criterion evaluated. The appendix also shows the original and modified scoring tables used for this analysis.

In general, the existing pedestrian facilities are adequate for transportation purposes, but do not always provide a comfortable experience. The best-scoring pedestrian facilities are those located around 13th Street and near the Downtown Boulder Station. These segments scored better than the others due to the increased separation from vehicle traffic and presence of human-scaled amenities. The worst-performing pedestrian facility is the southbound 14th Street sidewalk south of Canyon Boulevard. This section scored poorly due to the narrow sidewalk, lack of amenities, and high volume of driveways.

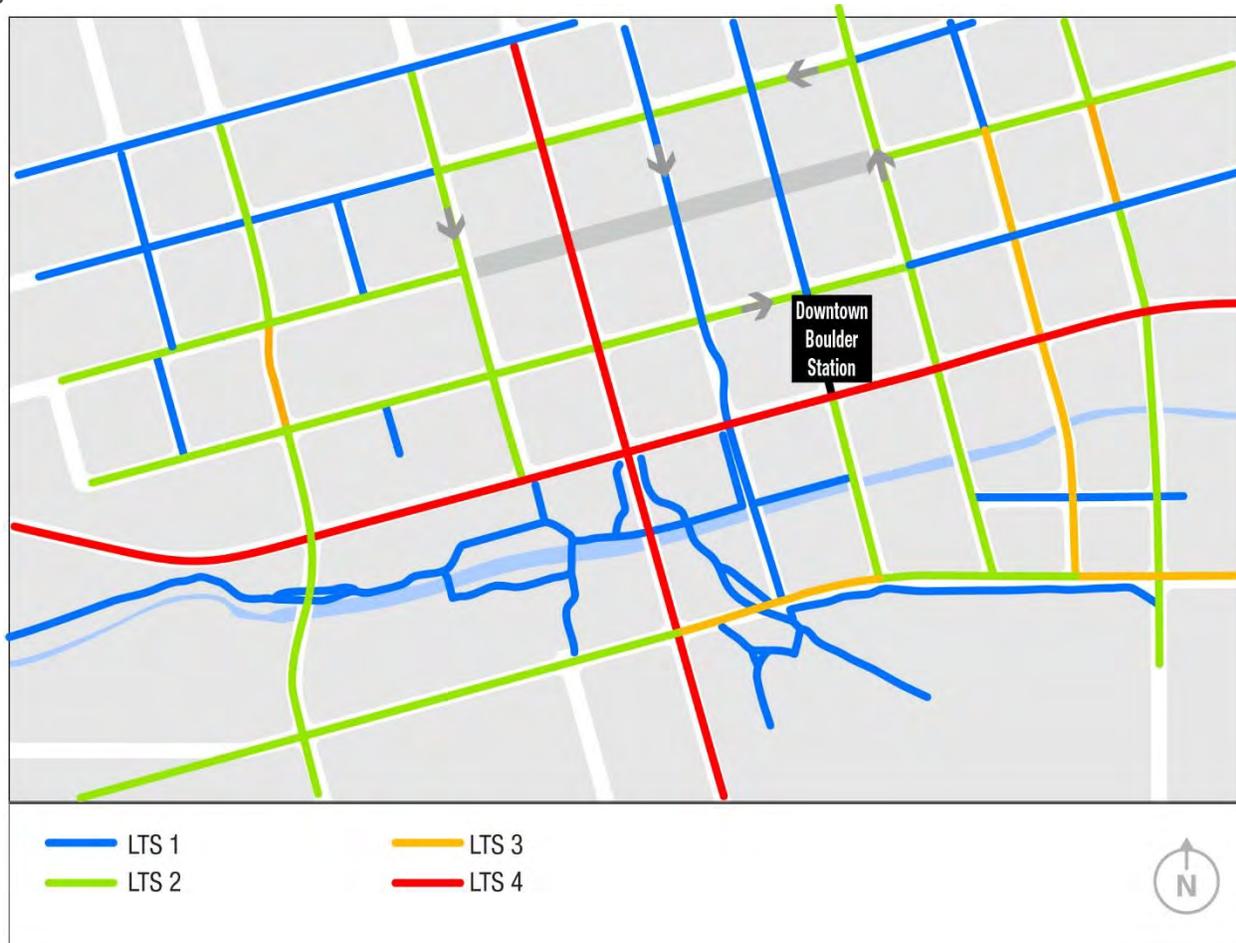
Figure 7. Level of Traffic Stress

Because of the lack of dedicated bicycle facilities, speeds of 35 mph and greater, and four lanes of traffic, Canyon Boulevard received an LTS 4, only providing a connection for the most experienced bicyclist. A majority of the network received an LTS 2, with speeds on many of the roads between 20 mph and 25 mph, no more than two lanes of vehicular traffic, and varying accommodations for bicyclists provided. The cycle track on 13th Street and the Boulder Creek Trail received an LTS 1 because of the separation from traffic provided by those facilities.

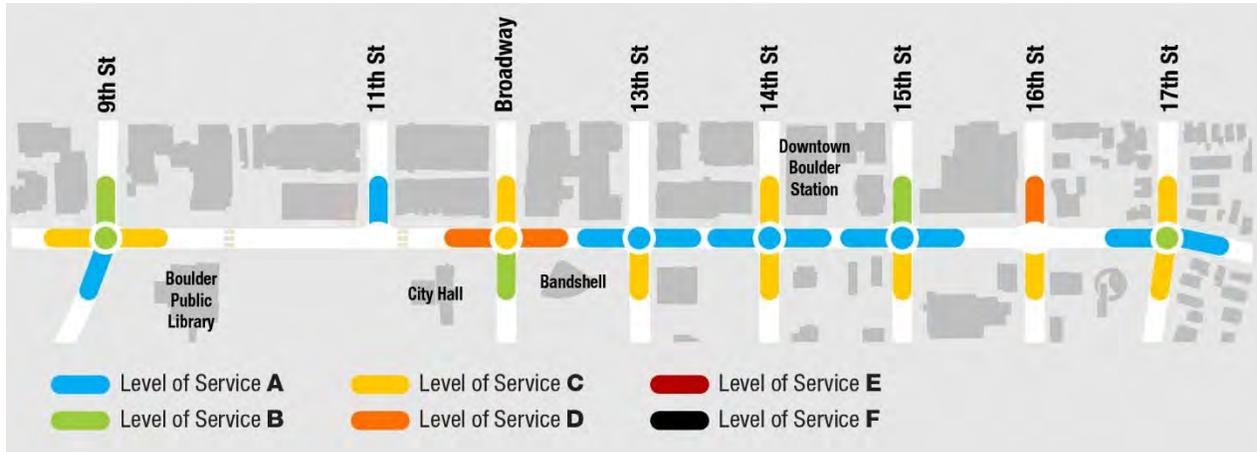
Figure 14. AM Peak Period LOS

During the morning peak period, all intersections operate at LOS C or better. The intersection with Broadway Street experiences the most congestion, with some approaches operating at LOS D. During the mid-day period, the corridor operates slightly better than the morning peak, with all intersections operating at LOS C or better. The evening peak period is the most congested time for the corridor. During this period, the intersection at Broadway Street degrades to LOS E, with all approaches operating at LOS D or worse. The individual movements for Broadway Street indicate that all movements along Canyon Boulevard operate at LOS D in the PM peak, but the movements on Broadway operate at LOS E and F with the exception of the northbound left-turn movement. Because of this delay, both the northbound and southbound approaches queue to the adjacent streets. On the northbound approach, the queue was observed at 550 feet, south to Arapahoe Road. Similarly, on the southbound approach, the queue extends north past Walnut Street to Pearl Street. The eastbound and westbound approaches along Canyon Boulevard do not experience the same queue length as the northbound and southbound approaches. On the westbound approach, queues reach back to 13th Street and, on the

eastbound approach, they reach 11th Street. These queues, however, do not cause 11th Street or 13th Street to queue significantly.

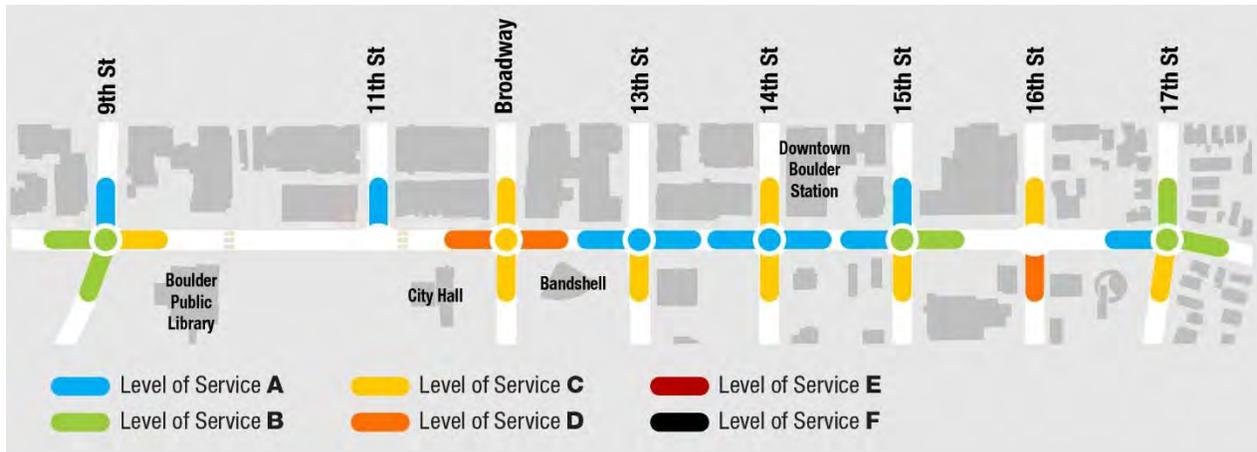
Figure 15. Mid-Day LOS

Synchro 9 software was used to analyze the existing congestion along the corridor. Synchro models were provided by the City of Boulder and were updated and used to evaluate the morning peak period (7:00 a.m. to 8:00 a.m.), the mid-day period (12:00 p.m. to 1:00 p.m.), and the evening peak period (5:00 p.m. to 6:00 p.m.). The *2010 Highway Capacity Manual* (2010 HCM) methodology was used to calculate the LOS for the 9th Street and Broadway Street intersections. This methodology was unable to produce LOS for the other intersections due to its limited ability to analyze non National Electrical Manufacturers Association (NEMA) standard signal phasing; therefore, the *2000 Highway Capacity Manual* (2000 HCM) methodology was used to evaluate all other intersections. The results of this analysis are shown in Figure 14 through Figure 16 and in Table 6.

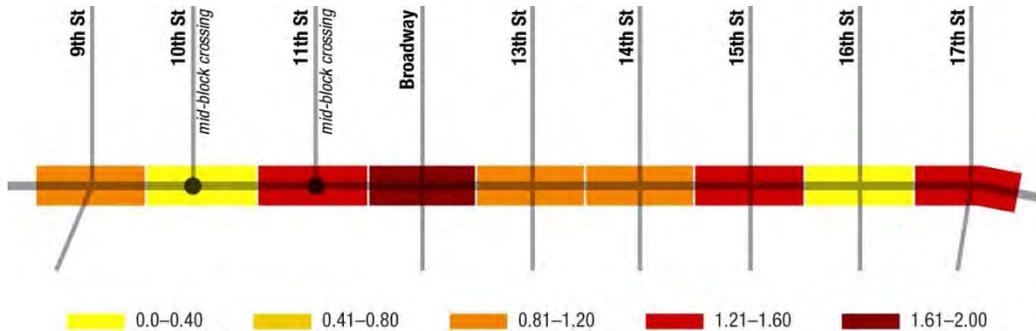
Figure 18. Normalized Crash Rates

To normalize the crash data for comparative analysis between intersections, the crash rate per million entering vehicles (MEV) at each intersection was calculated. The PM peak hour TMC data were used to calculate daily volume through the intersection. It is assumed that 10 percent of the daily traffic occurs during the PM peak hour. The results of this normalization yielded an average crash rate for the corridor of 0.98 crashes per MEV and an average injury crash rate for the corridor of 0.23 crashes per MEV. Additional injury crash data were gathered from CDOT for other, similar roadways within the state that have similar characteristics to Canyon Boulevard.

The highest crash rate was at Broadway Street, which had a rate of 1.80 crashes per MEV (+83.67 percent¹) with the lowest crash rates being at 10th Street (0.04 crashes per MEV, -85.71 percent) and 16th Street (0.25 crashes per MEV, -74.49 percent). The range of crash rates within the corridor per MEV at each intersection is shown in Figure 18.

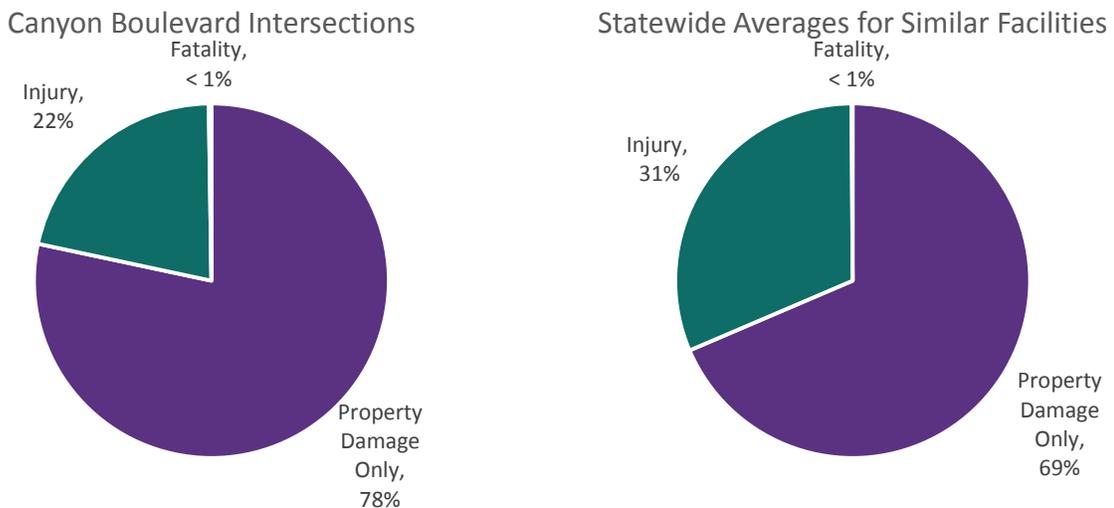
Figure 19. Severity of Crashes

Most crashes along the corridor were minor and did not result in injuries. Crashes involving injuries represent 22 percent of all crashes in the corridor. There was one fatality in the corridor. This fatality occurred near the 14th Street intersection. Non-injury and injury crashes were evenly spread across the corridor, with each intersection having about the same percentage of non-injury and injury crashes. Figure 19 shows the number of all crashes by severity within the corridor as compared to the statewide average for similar facilities. Based on the statewide average of crash severity for facilities similar to Canyon Boulevard, the study corridor shows a slightly lower injury crash rate than the statewide average (CDOT, 2010-2014).

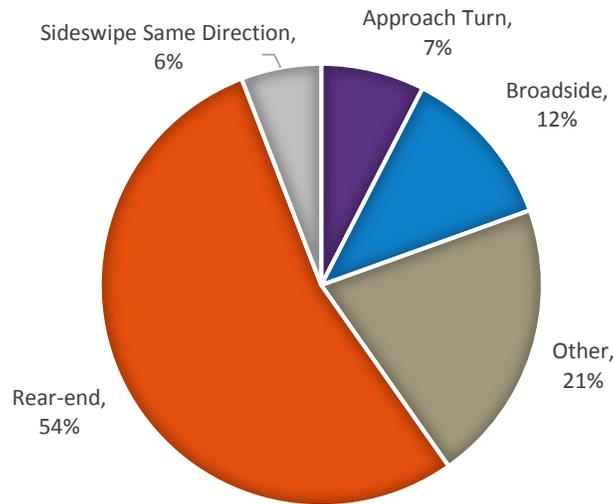
Figure 20. All Crashes by Type

The largest number of crashes within the study area were rear-end collisions. These types of crashes represent more than half of all crashes on the corridor, which is typical for signalized intersections. Sideswipes, approach turns, and broadsides represent an additional 30 percent of the crashes, with the remaining crashes being a

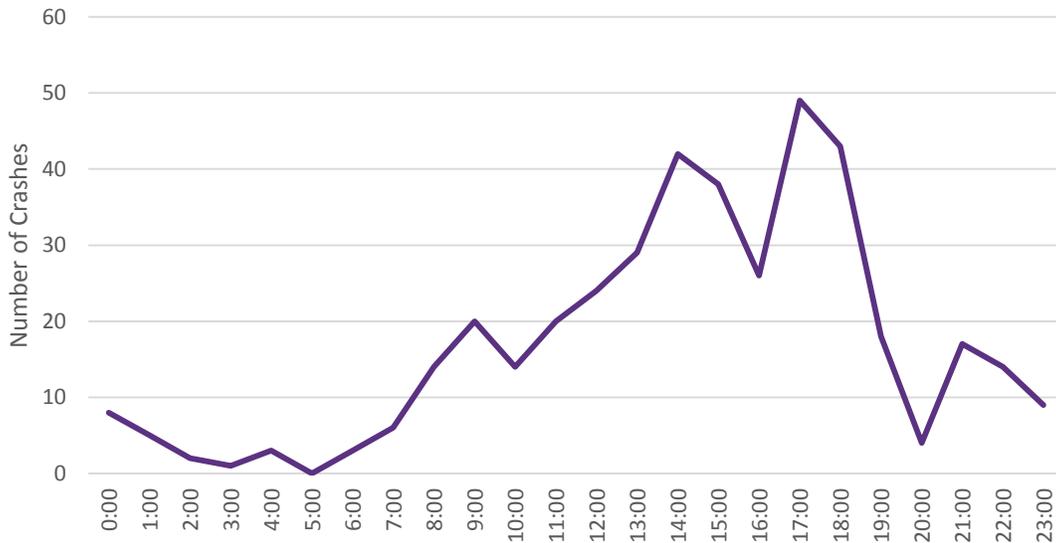
Figure 22. Crashes by Time of Day

Most crashes in the study area occurred in the afternoon and early evening hours of the day. Of the 411 total crashes that occurred during the data collection period, 198 (48 percent) occurred between 2:00 p.m. and 7:00

p.m. This time period corresponds to the highest traffic volumes and congestion within the corridor. Figure 22 summarizes the crashes by the time of day in which they occurred.

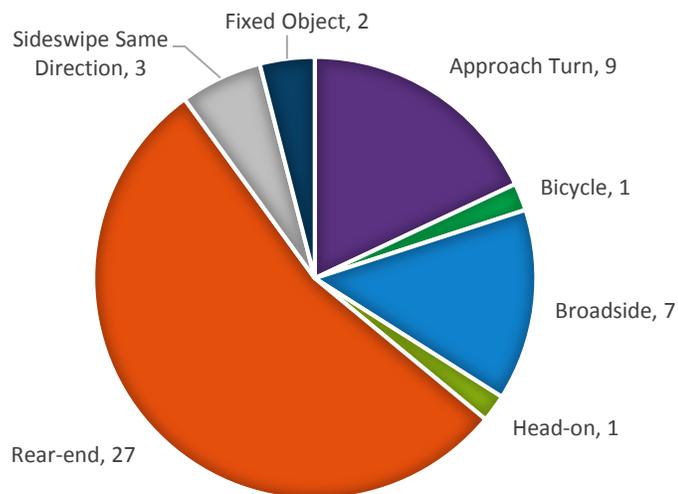
Figure 23. 9th Street and Canyon Boulevard Crashes by Type

The crash types by percentage at this intersection are similar to the standard pattern observed at similar signalized intersections within the state. Figure 23 shows the breakdown of crashes by type at this intersection. The crash rate for the intersection was 1.03 crashes per MEV (+5.10 percent) with the injury crash rate being 0.29 crashes per MEV (+26.09 percent).

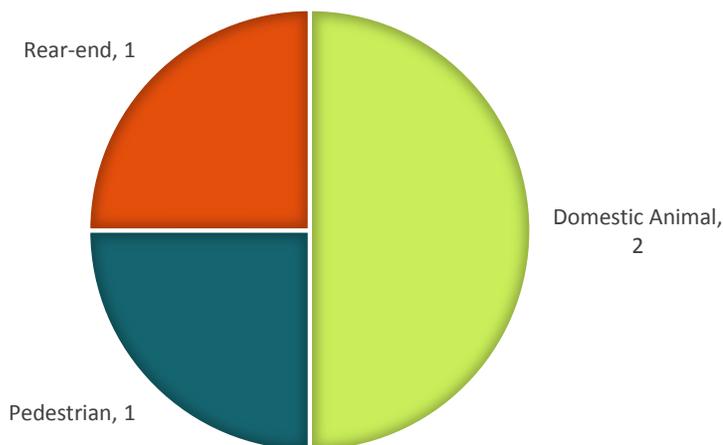
Figure 24. 10th Street Mid-Block Crossing Crashes by Type

There were four crashes at this intersection during the analysis period. The crash rate for this mid-block crossing was 0.14 crashes per MEV (-85.71 percent) and the injury crash rate was 0.04 crashes per MEV (-82.61 percent). A summary of the crash types at this intersection is shown in Figure 24.

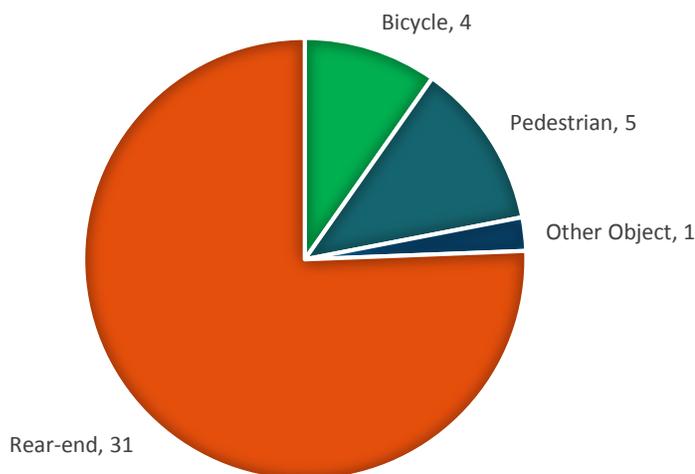
Figure 25. 11th Street and Canyon Boulevard Crashes by Type

The intersection of 11th Street and Canyon Boulevard had more crashes involving bicycles and pedestrians than the corridor average. There are no vehicular left-turns permitted at this intersection; therefore, there are fewer opportunities for the broadside and approach turn collisions observed at other intersections within the corridor. Figure 25 shows the breakdown of crashes at this intersection.

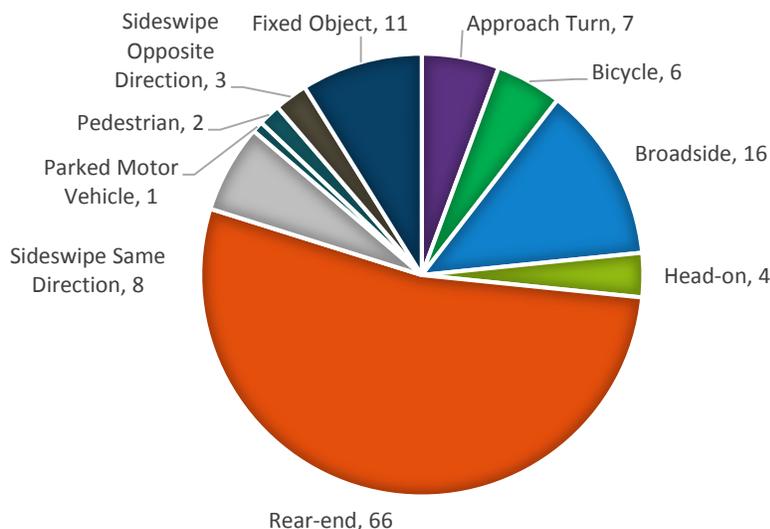
Figure 26. Broadway Street and Canyon Boulevard Crashes by Type

The intersection at Broadway Street and Canyon Boulevard had a total of 125 crashes. Similar to the corridor average, rear-ends made up a majority of the crash types. The normalized crash rate for this intersection was 1.80 crashes per MEV (+83.67 percent) and the injury rate was 0.25 crashes per MEV (+8.70 percent). A summary of the crashes by type is shown in Figure 26.

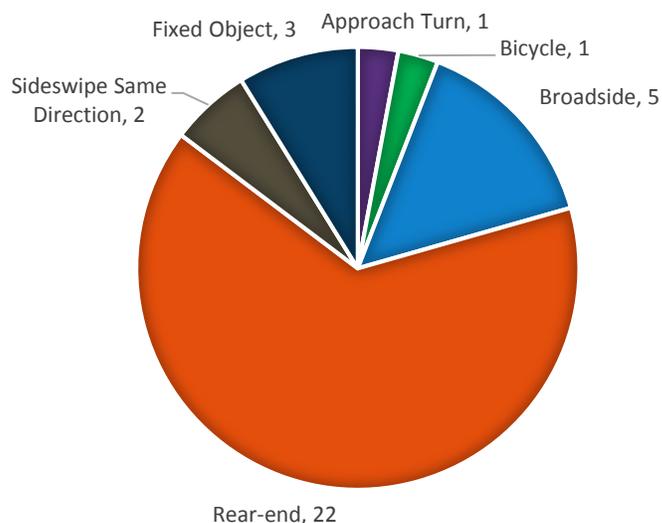
Figure 27. 13th Street and Canyon Boulevard Crashes by Type

During the data collection period, there were 34 crashes at the intersection at 13th Street and Canyon Boulevard. The crash rate for the intersection was 0.95 crashes per MEV (-3.06 percent) and the injury crash rate was 0.08 crashes per MEV (-65.22 percent). Figure 27 summarizes the crashes by type for this intersection.

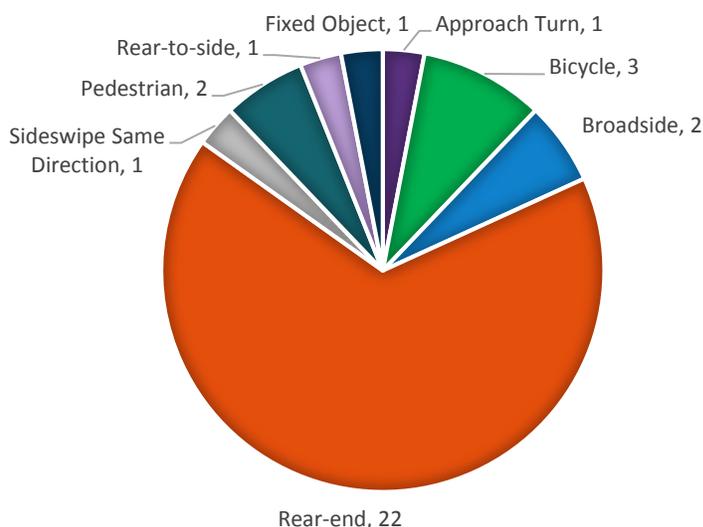
Figure 28. 14th Street and Canyon Boulevard Crashes by Type

The crash rate and injury crash rate at the intersection of 14th Street and Canyon Boulevard were 0.81 crashes per MEV (-17.35 percent) and 0.12 crashes per MEV (-47.83 percent), respectively. Figure 28 shows the type of crashes at this intersection. In late 2013, during the data collection period, the operations at 14th Street between Canyon Boulevard and Walnut Street changed. 14th Street, within this section, is now only open to transit vehicles entering the Downtown Boulder Station. The normalized crash rates were calculated using the historical volume data taken before the street was converted. Based on the one year of data collected since the modification, there has not been a discernible difference in crash patterns at the intersection.

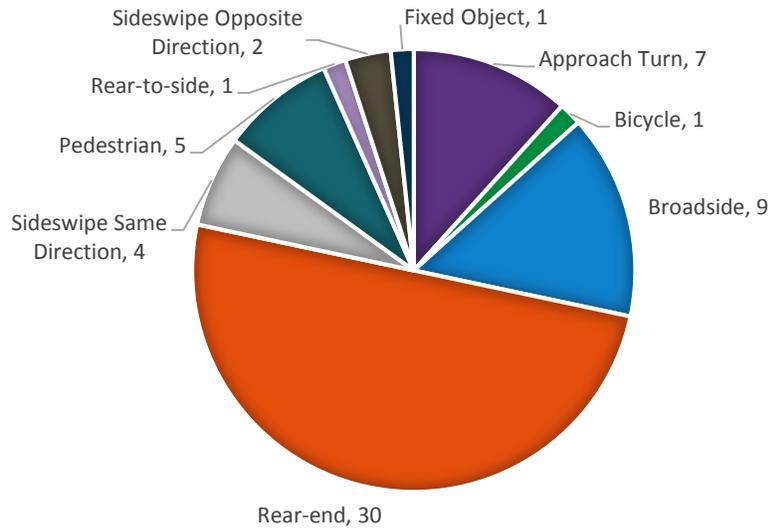
Figure 29. 15th Street and Canyon Boulevard Crashes by Type

The intersection at 15th Street and Canyon Boulevard had a crash rate of 1.37 crashes per MEV (+39.80 percent) and an injury crash rate of 0.32 crashes per MEV (+39.13 percent). Pedestrian crashes make up a higher-than-average proportion of crashes at this intersection. Pedestrian crashes are discussed in more detail in the Bicycle and Pedestrian Safety portion of this section. Figure 29 summarizes the crashes by type at this intersection.

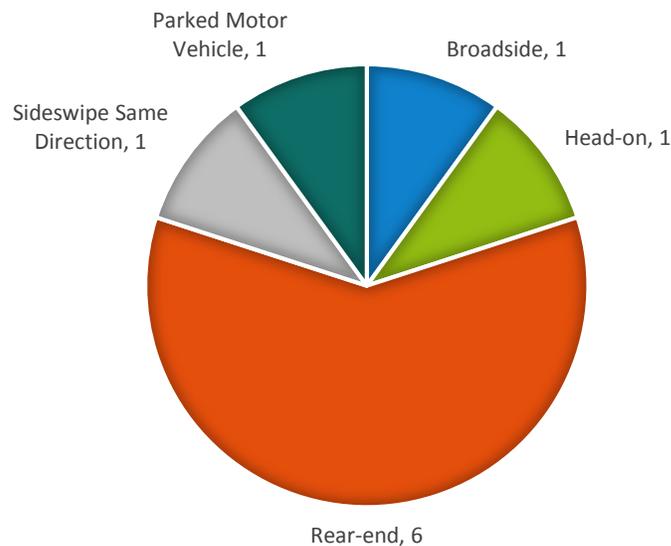
Figure 30. 16th Street and Canyon Boulevard Crashes by Type

The crash rate for the intersection at 16th Street and Canyon Boulevard was 0.25 crashes per MEV (-74.49 percent) and the injury crash rate was 0.05 crashes per MEV (-78.26 percent). A summary of the crashes by type is shown in Figure 30.

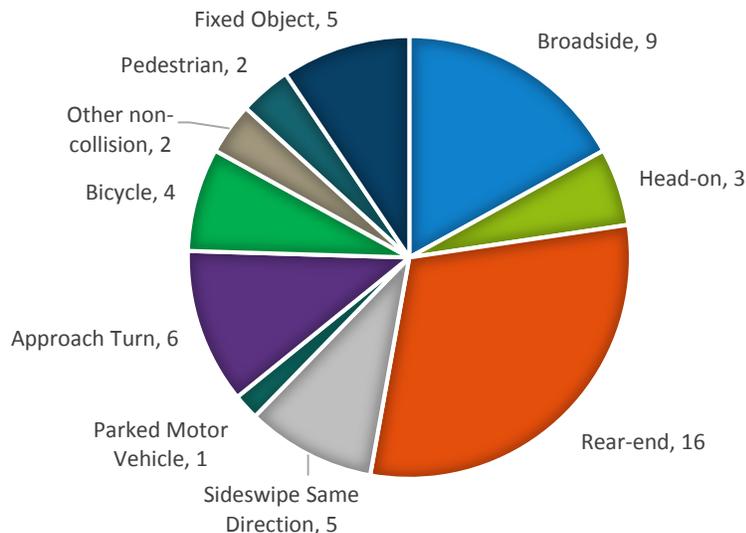
Figure 31. 17th Street and Canyon Boulevard Crashes by Type

The intersection at 17th Street and Canyon Boulevard experienced a greater variety of crash types. The overall crash rate was 1.21 crashes per MEV (+23.47 percent) and the injury crash rate was 0.30 crashes per MEV (+30.43 percent). Figure 31 summarizes the types of crashes at this intersection.

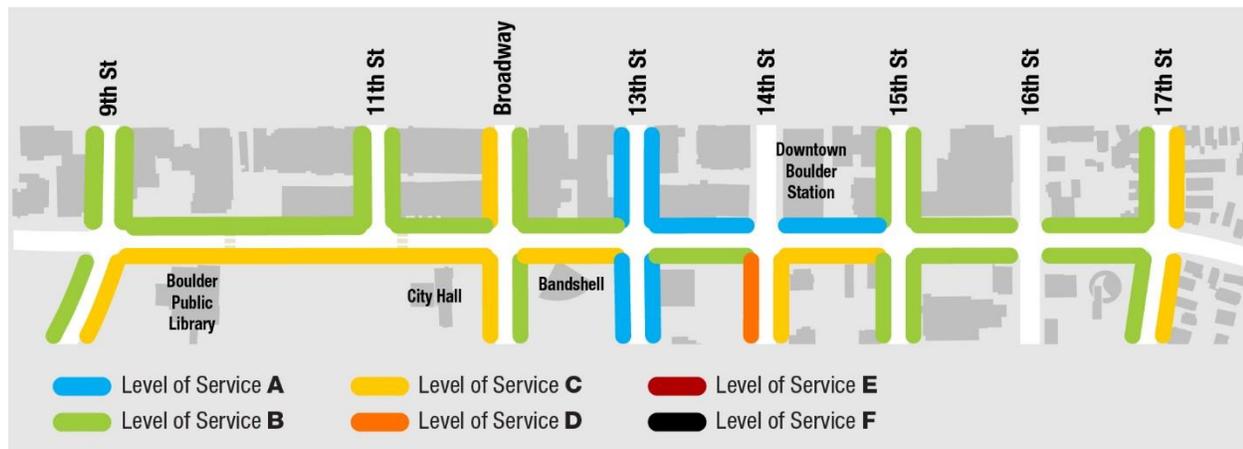
Figure 1. PPM Results

To fully capture the pedestrian experience across the corridor, two pedestrian level of service analyses were conducted. The first, using the standard PPM methodology was applied to a corridor-wide analysis. These are presented in the results summary tables. This resulted in an overall pedestrian LOS B for the corridor. A second, modified the PPM methodology to determine pedestrian conditions on each side of the street. Because of the variability in sidewalk characteristics between the north and south side of Canyon Boulevard, the PPM model was modified determine how well each side of Canyon meets the needs of pedestrians. The modification did not impact the tool’s core assumptions, and therefore it was determined that this modification would be applicable for use on this project. The individual scoring tables, included as an attachment to this Appendix, show the points each segment received for each criterion evaluated. The attachment also shows the original and modified scoring tables used for this analysis.
