# City of Boulder Planning & Development Services

## MEMORANDUM TO THE LANDMARKS BOARD

### Consideration of Demolition Permit

Public hearing and consideration of an application to demolish the building at **2111 Arapahoe Ave.**, a non-landmarked building over 50 years old, pursuant to Section 9-11-23 of the Boulder Revised Code 1981 (HIS2020-00214) and under the procedures prescribed by chapter 1-3, "Quasi-Judicial Hearings," B.R.C. 1981.

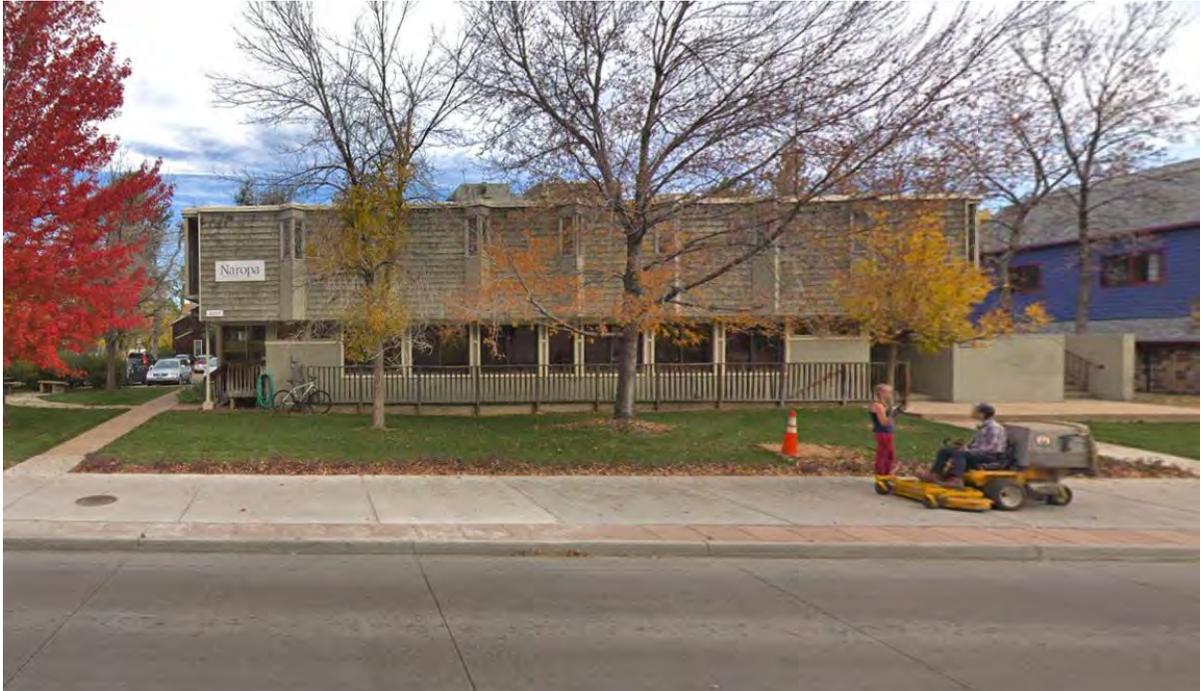
*Figure 2. 2111 Arapahoe Ave., South Elevation, Google Street View, 2017*

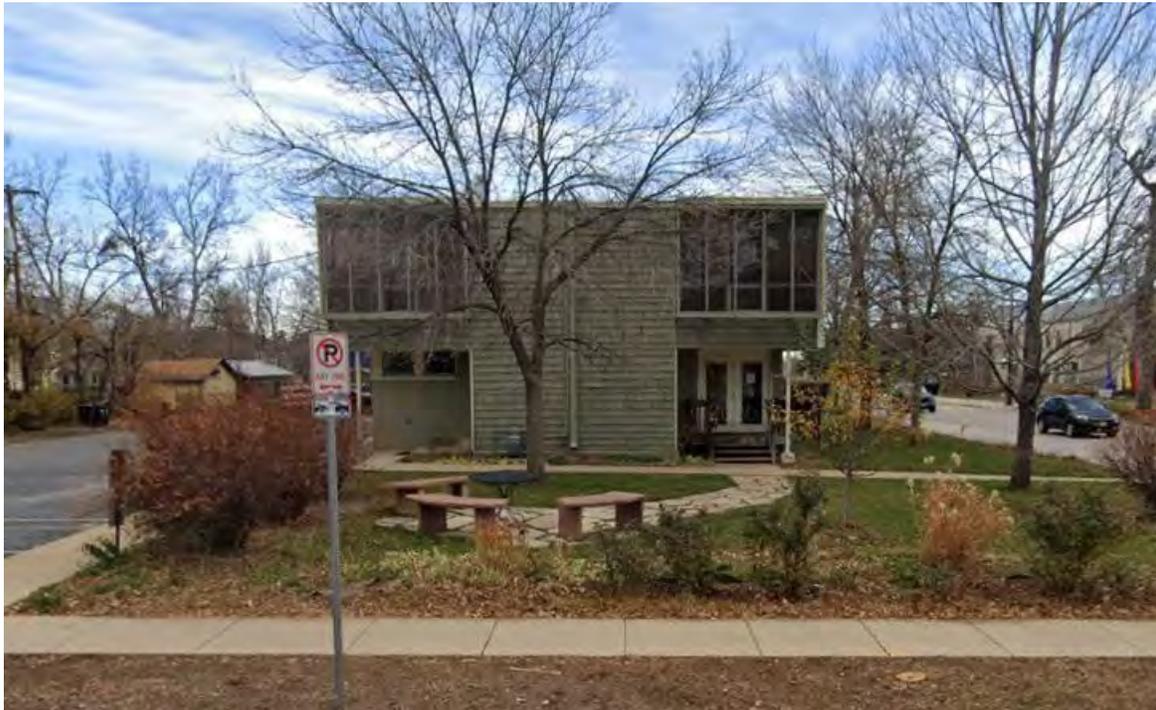
*Figure 3. 2111 Arapahoe Ave., West Elevation, Google Street View, 2018*

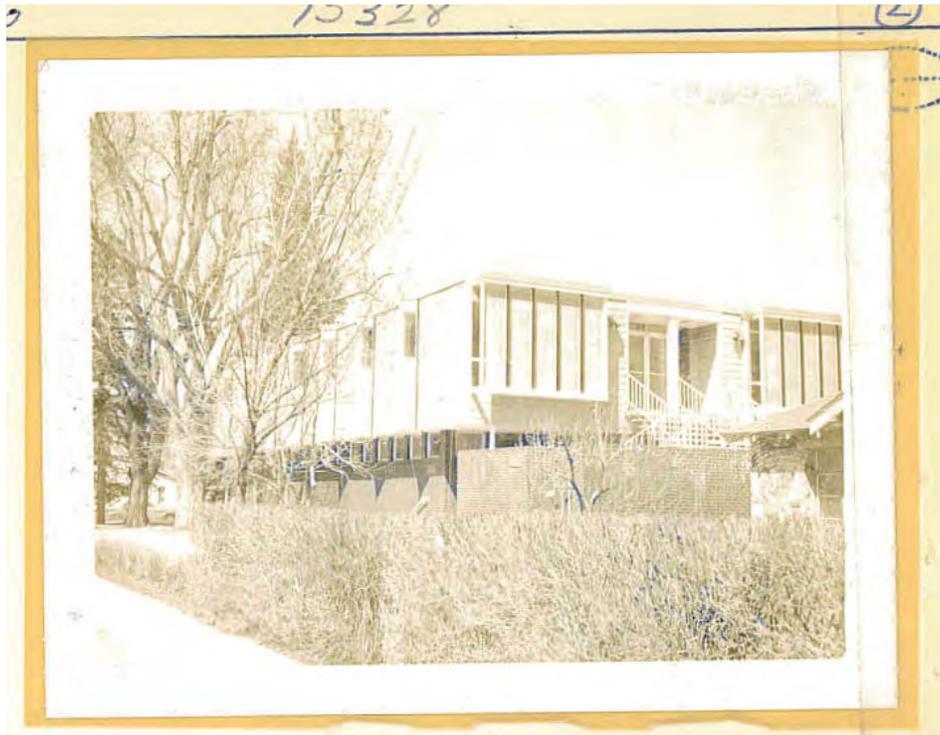
*Figure 7. Tax Assessor Card Photograph, 2111 Arapahoe Ave., c. 1964.*

- Enlarged window openings on the first level of the south elevation
- Shingle siding may have been replaced; early photograph suggests original siding was horizontal clapboard. **See Attachment A: Applicant Materials.**
- Painted brick walls

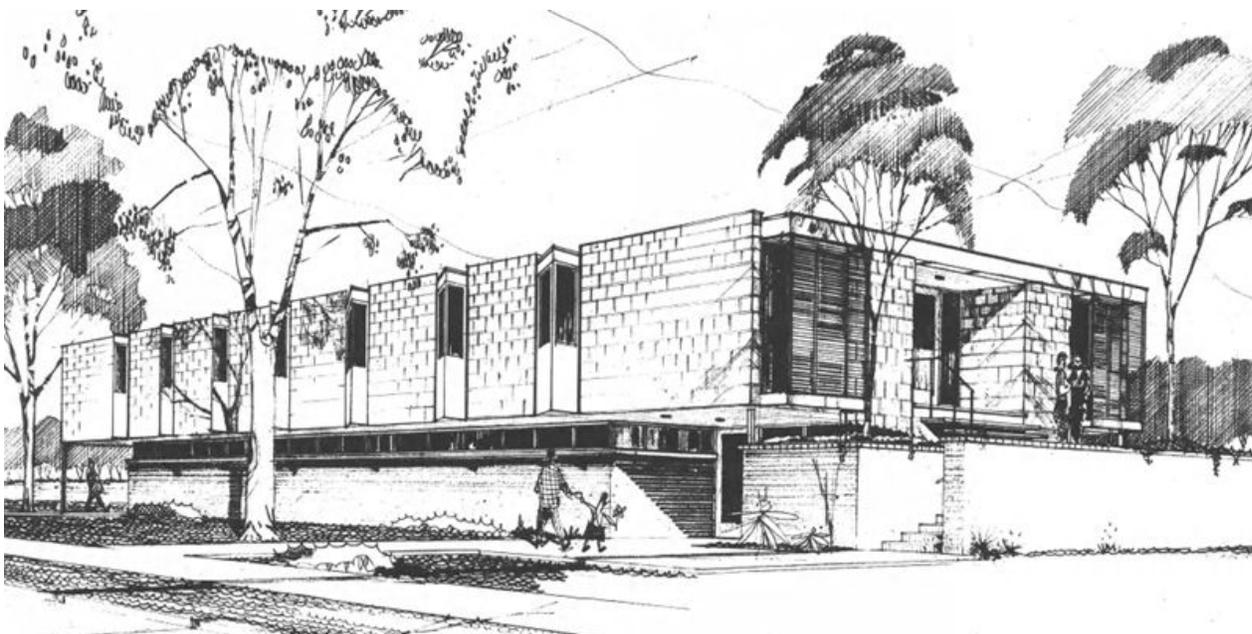
*Figure 1: 1962 Rendering of the planned building at 2111 Arapahoe Avenue. At center bottom, an adult guides a smaller figure (a child holding a toy) into the building, implying its planned use as a pediatric office. A.A. Paddock Collection, Carnegie Library for Local History.*

The resource has an architectural rendering on file at the Carnegie Library, which indicates an architect was involved in its original design and conception, but no name is included on the resource. Without access to the collection in person, it is difficult to connect the resource to the legacy of one of Boulder’s many prolific Modernist architects. Possible architects for the building include James Hunter, whose practice trained several famous modern architects at his Boulder-based practice, including Charles Haertling, Tician Papachristou, and Hobart Wagener. The most prolific in Boulder was Wagener, whose more than 90 buildings combined Modern, International, and organic architecture to create a unique architectural legacy for the city. Architects who trained or collaborated with Hunter typically emphasized the use of natural materials such as local pink sandstone and wood, long horizontal building shapes, shallow pitched or flat roofs, unique window shapes and sizes, and decorative vertical battens to create the illusion of height without the use of multiple stories. Although 2111 Arapahoe Avenue is not among the buildings credited to these architects, its styling uses several of their most common design elements including a long, flat rectangular shape and visually interesting windows. Further, the original rendering drawing includes images of adults guiding children into the building, perhaps indicating that it was purpose-built as a pediatric office. Unfortunately, no architect is listed on the rendering, and the drawing is not signed.

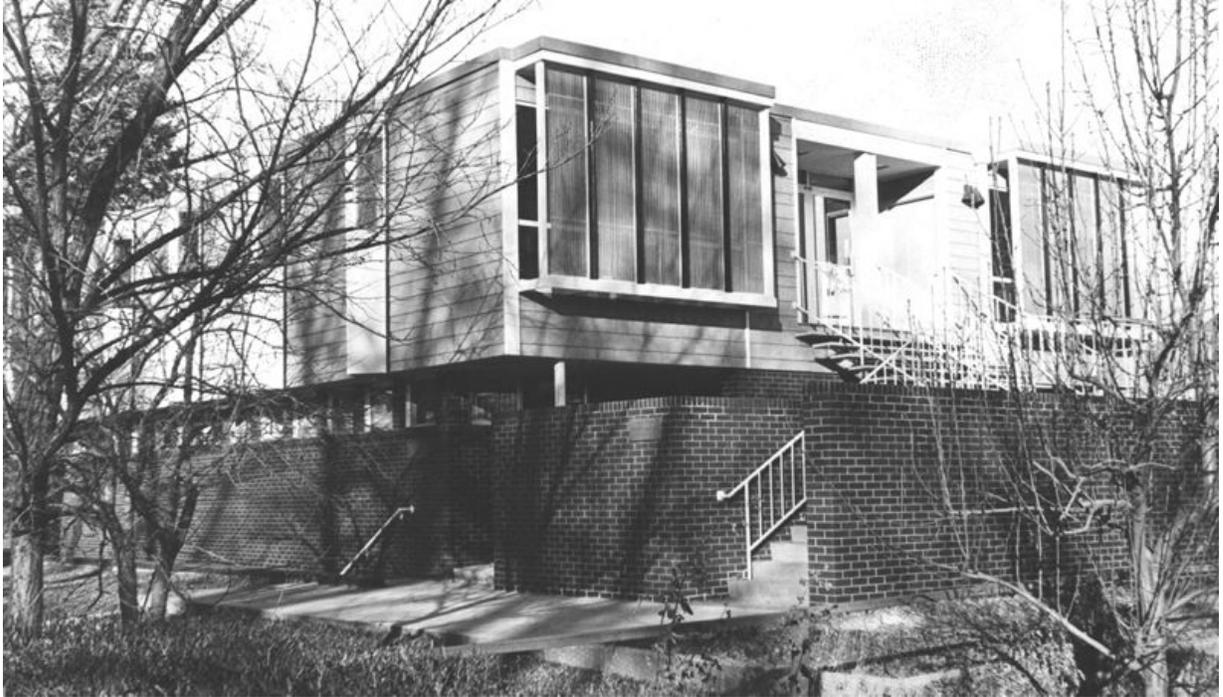
Figure 2: A 1964 photo of 2111 Arapahoe Avenue after its completion. The original exterior of the building was clad in horizontal wood siding on the second floor rather than shingles, and the first-floor windows facing south were half-height. A.A. Paddock Collection, Carnegie Library for Local History.

More importantly, the property has been updated both inside and outside in the years since original construction. For example, the building originally featured horizontal lapboard siding, which has been replaced with cedar shingles. The south-facing first floor windows are much larger than the original windows facing Arapahoe, changing the

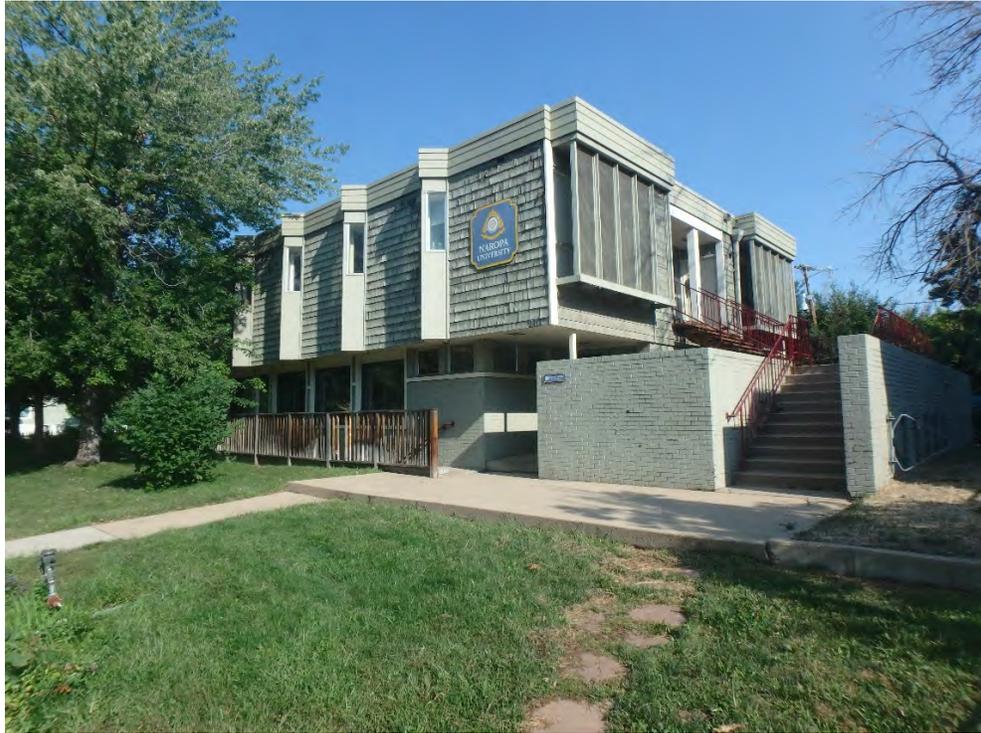
Photo 2. View northwest towards the southeast edge of the building, with close view of east entry at right.

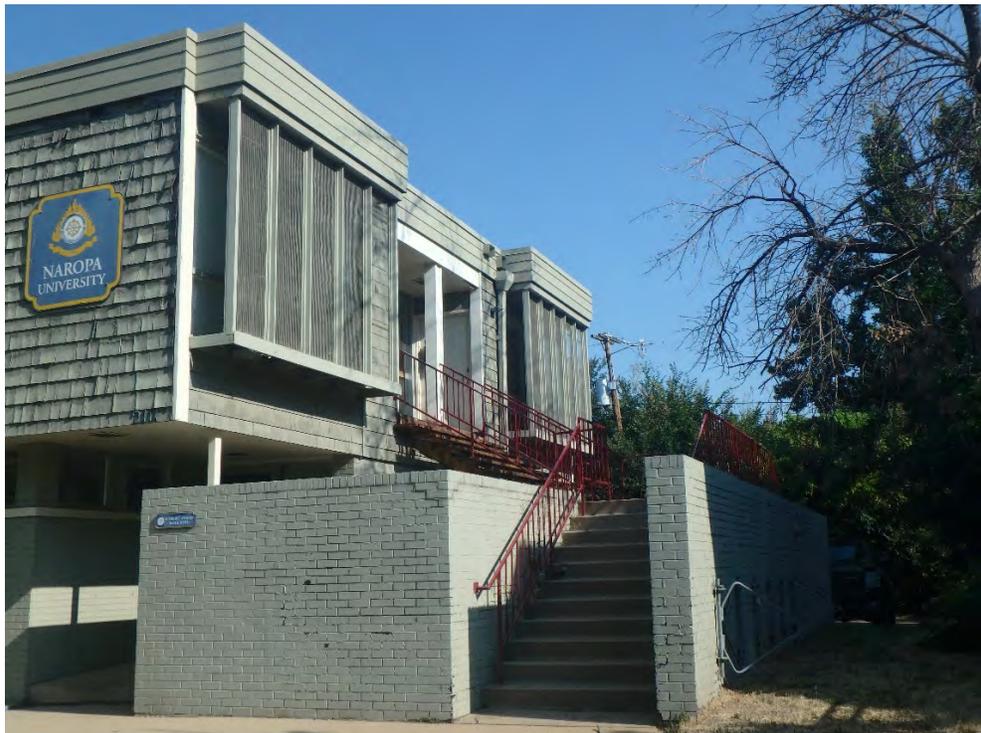
Photo 3. Closer view of shingle cladding on second story, south elevation of the building.

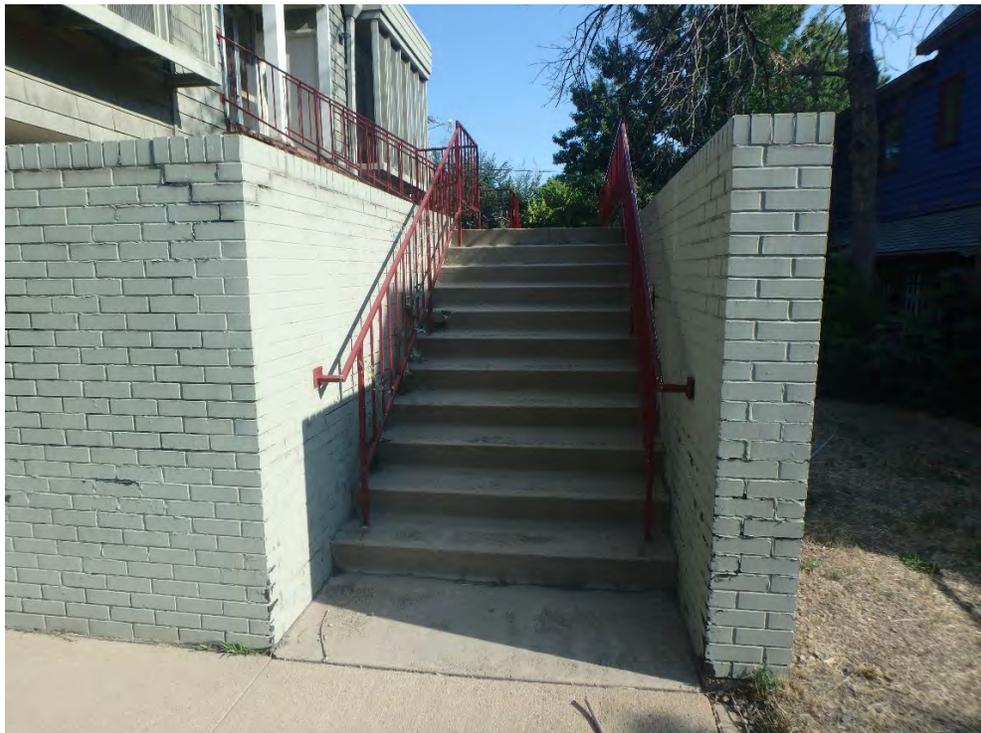
Photo 5. View of the first-floor entry, located at the east edge of the south elevation. A long brick vestibule hallway, covered by the second floor, protects the entry.

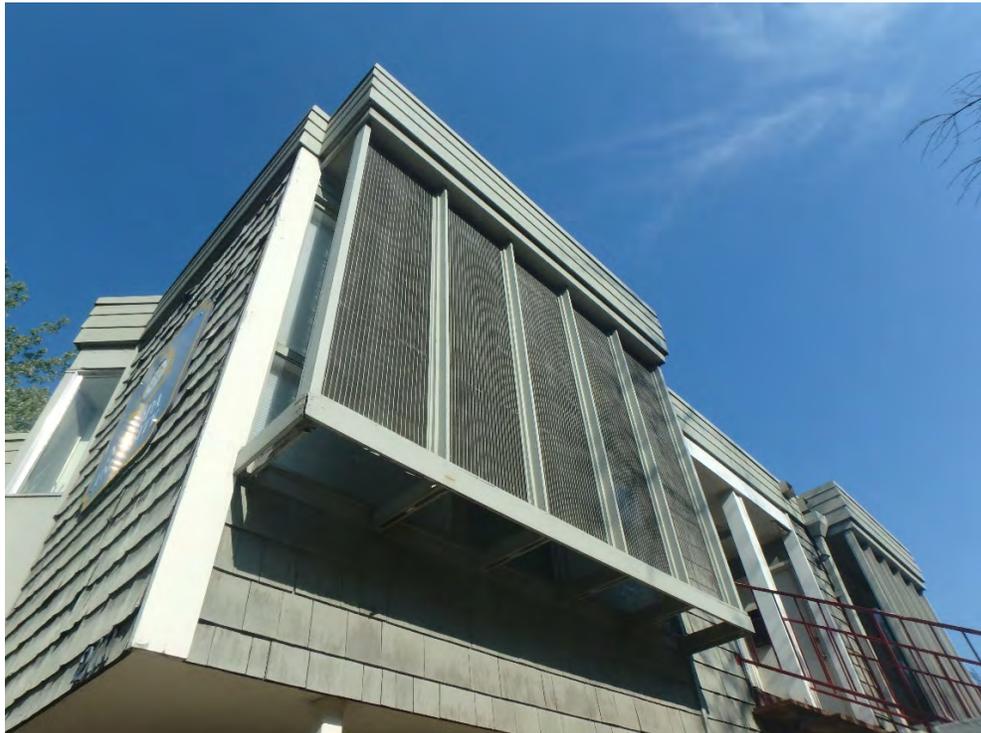
Photo 7. View of the second-story original pointed window projections, south elevation.

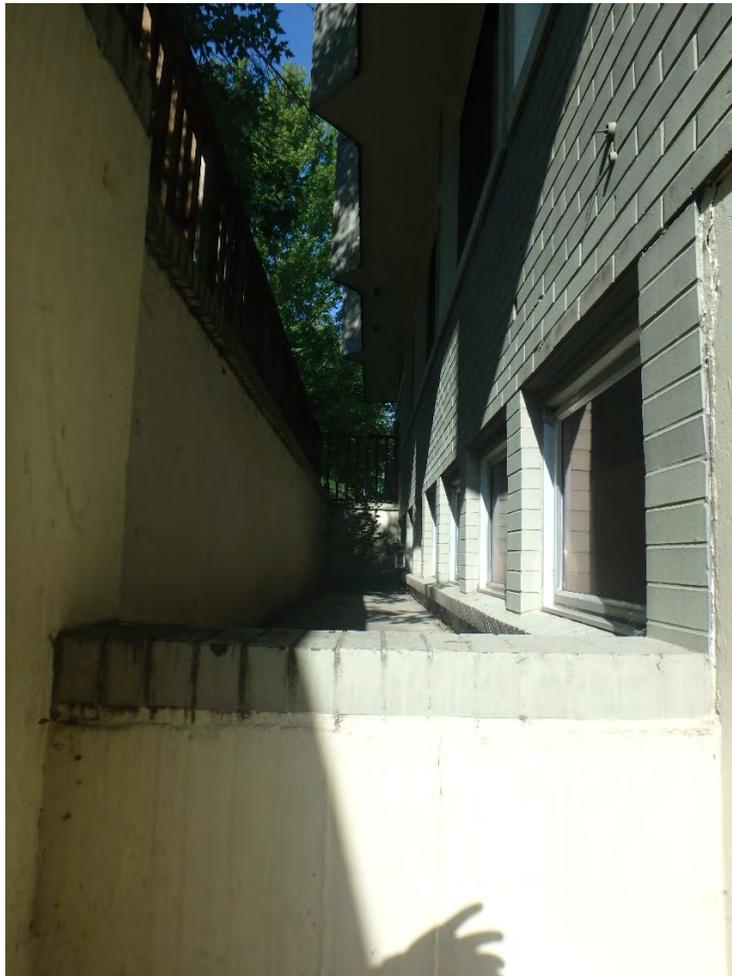
Photo 11. View south towards the east entry. Detail view of the rusting iron-edged concrete staircase that leads to the second floor.

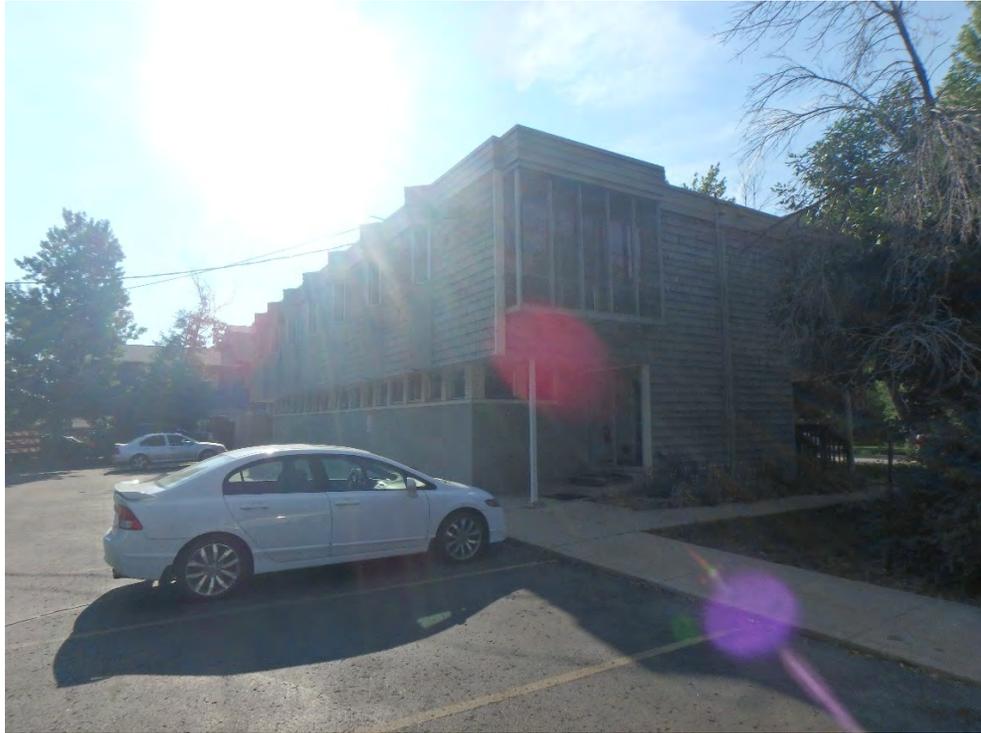
Photo 18. View looking up at the original window shields on the west elevation. On this elevation, the original screens have been replaced with looser-weave insect netting in a dark color, and the window glass appears to be tinted.

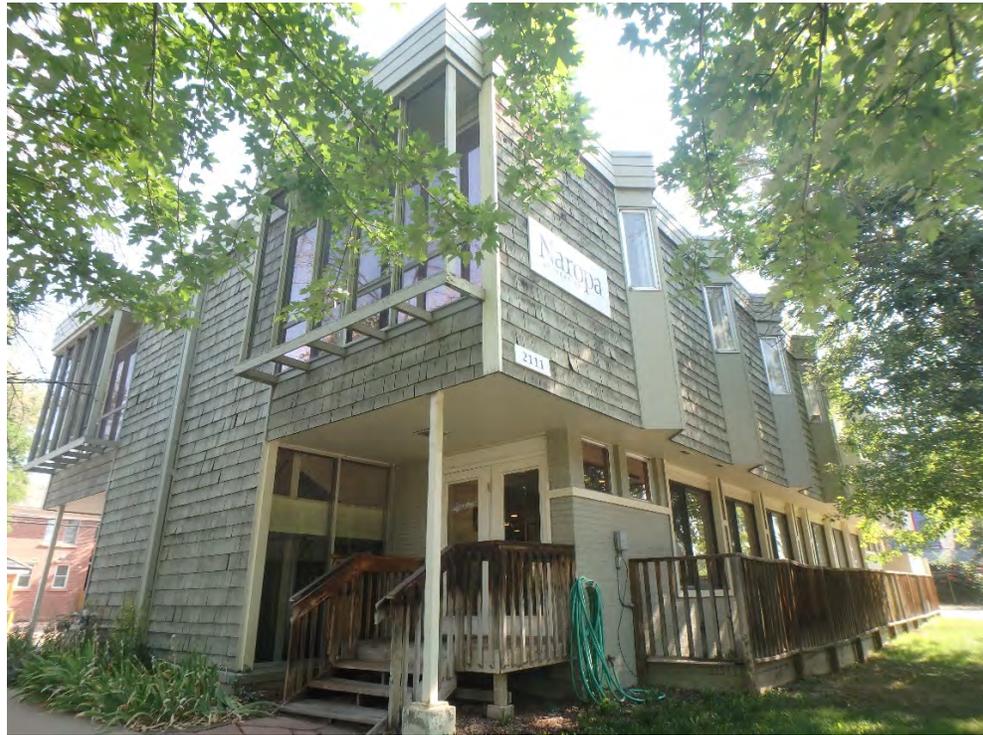
Photo 21. The southwest entry to the building is at center, supported by a wood deck with wood steps and railing. As with the northwest corner, the second story is supported by a metal pole.

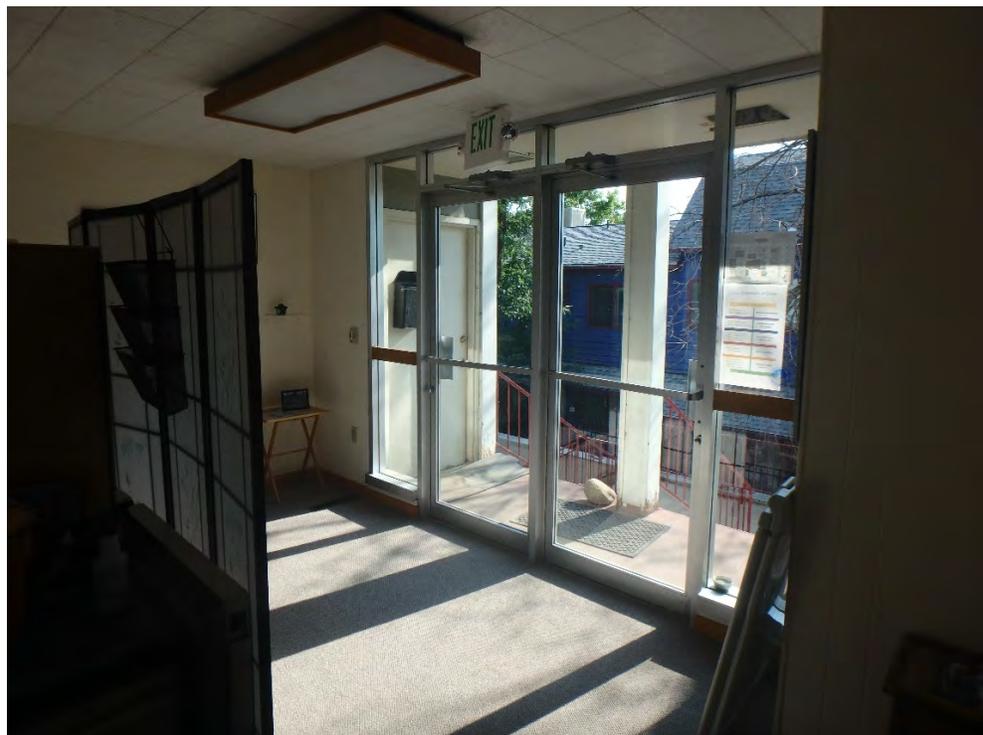
Photo 24.  
Interior of the  
original pointed  
projection  
windows. On  
both sides of the  
building, each  
window is  
composed of a  
fixed pane that  
faces east and a  
hand-crank hinge  
window that  
faces west.

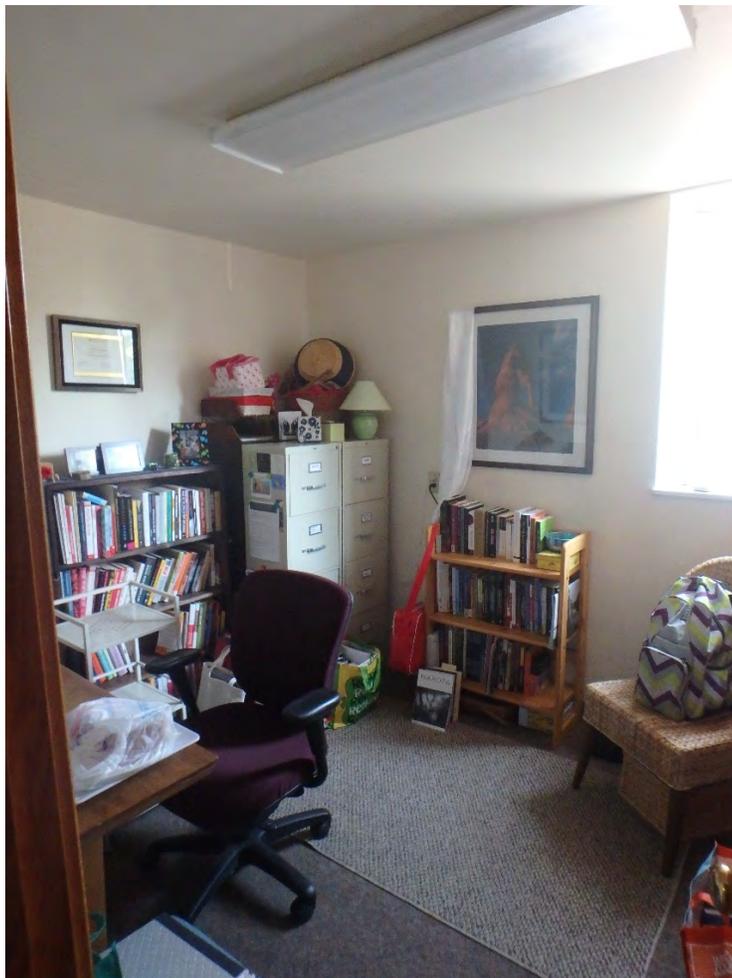
Photo 31. Additional view of interior rooms, looking north from second-floor conference room. The ceiling has been dropped to two different levels, which may have been done to conceal HVAC structures.
