**MEMORANDUM**  
**February 3, 2016**

**SUBJECT:** Public Hearing and consideration of a Landmark Alteration Certificate application for changes to the south face of the landmarked St. Gertrude's Academy including the construction of six balconies and modifying windows to door openings, per Section 9-11-18 of the Boulder Revised Code (HIS2015-00313).

1. Site: 970 Aurora Ave.
2. Zoning: RL-1 (Residential Low-1)
3. Owner: Academy Equities, LLC
4. Applicant: Jonas DiCaprio, Design Platform
5. Site Area: 104,867 sq. ft.
6. Building Area: 41,670 sq. ft. (approx.)
7. Date of Construction: 1892

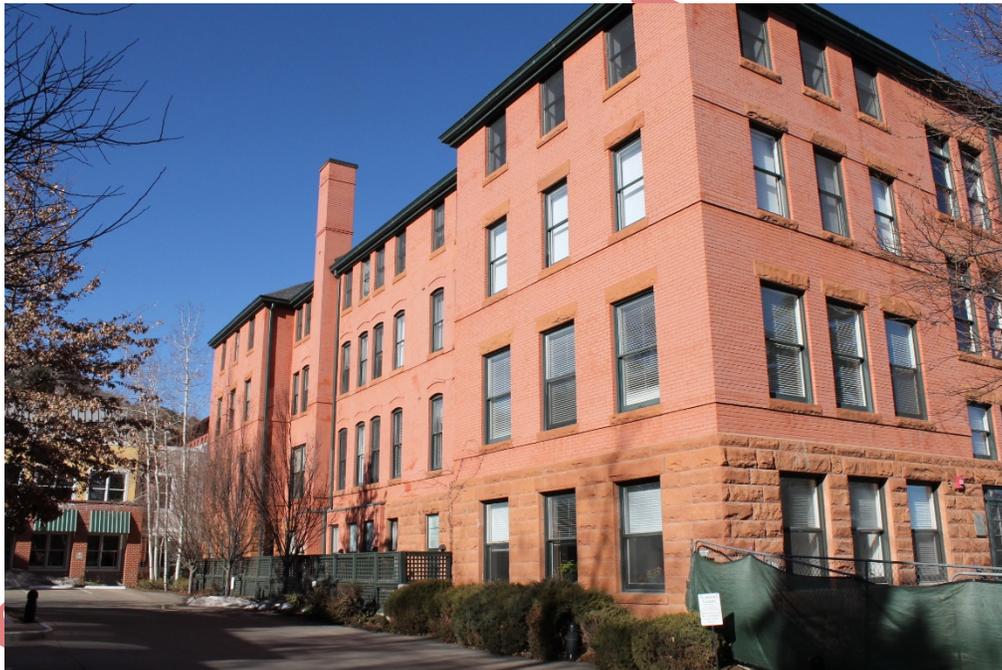
*Figure 5. View of south elevation from 10<sup>th</sup> St., Mt. St. Gertrude Academy, 970 Aurora Ave., 2016.*

The applicant proposes to convert six original window openings to door openings and install metal balconies onto the 2<sup>nd</sup>, 3<sup>rd</sup> and 4<sup>th</sup> stories on the south side of the historic 1892 building. Adjacent to the Academy’s current main entrance, the south elevation of the historic building faces a parking lot and the current entrance and is has significant visibility from 10<sup>th</sup> Street.

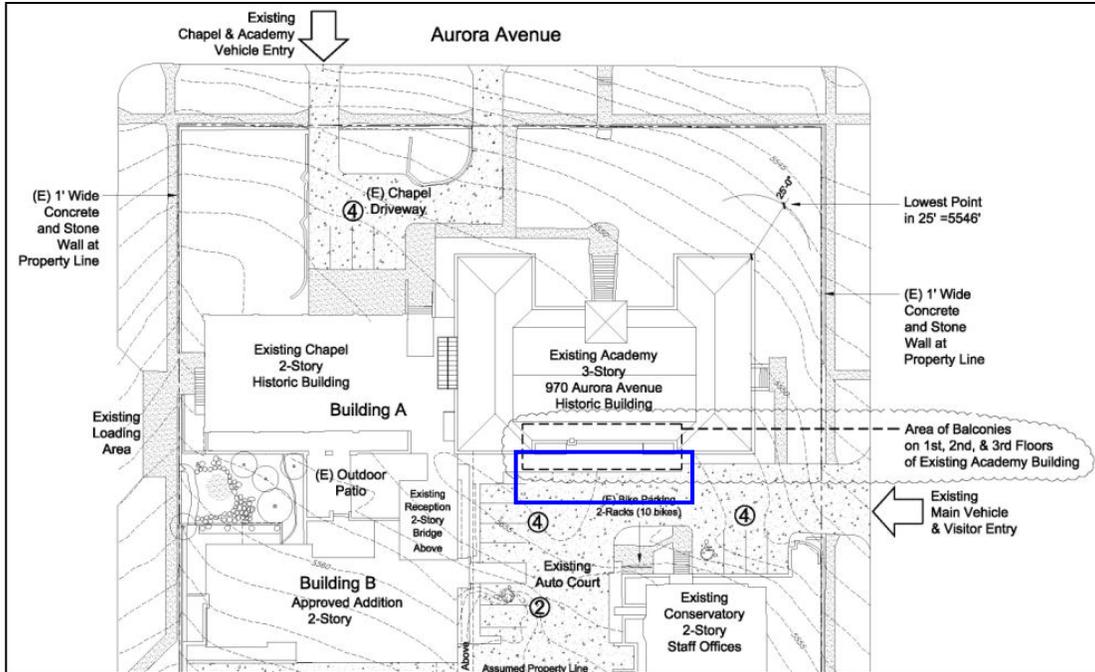
Figure 6. Northern section of proposed site plan. Blue outline marks location of south elevation of building for proposed balconies, 2015.

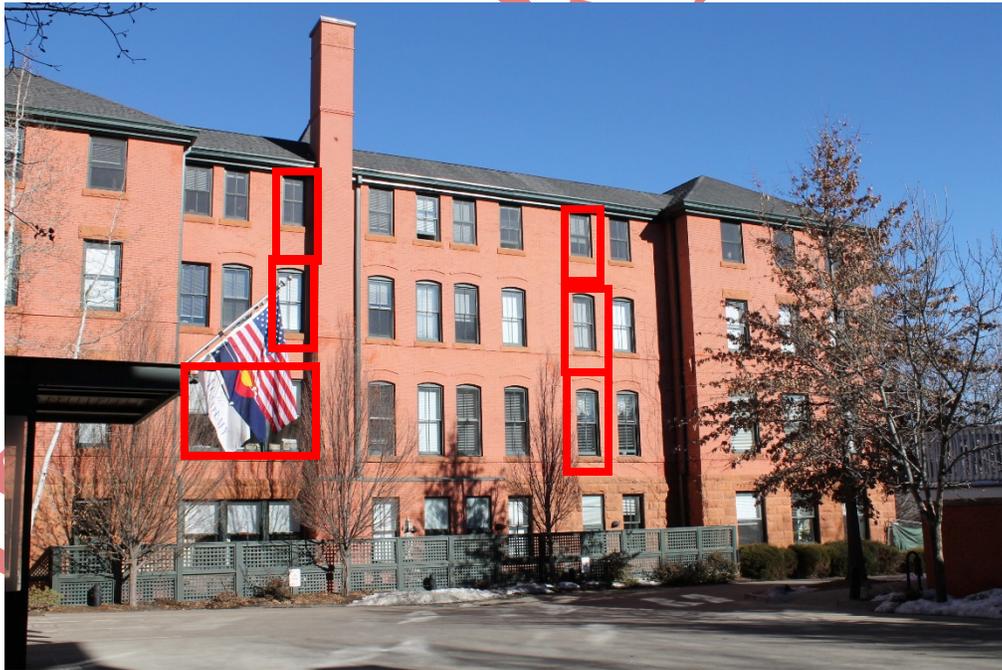
Figure 7. Existing south elevation as seen from parking lot, 2015.

Six window openings on this elevation are shown to be enlarged vertically to accommodate aluminum clad in-swing door 3 ft. in width to fit the opening of the window. Plans note that the existing 3 ft. width and head height will remain; the sandstone sill and brick below each window is to be removed.

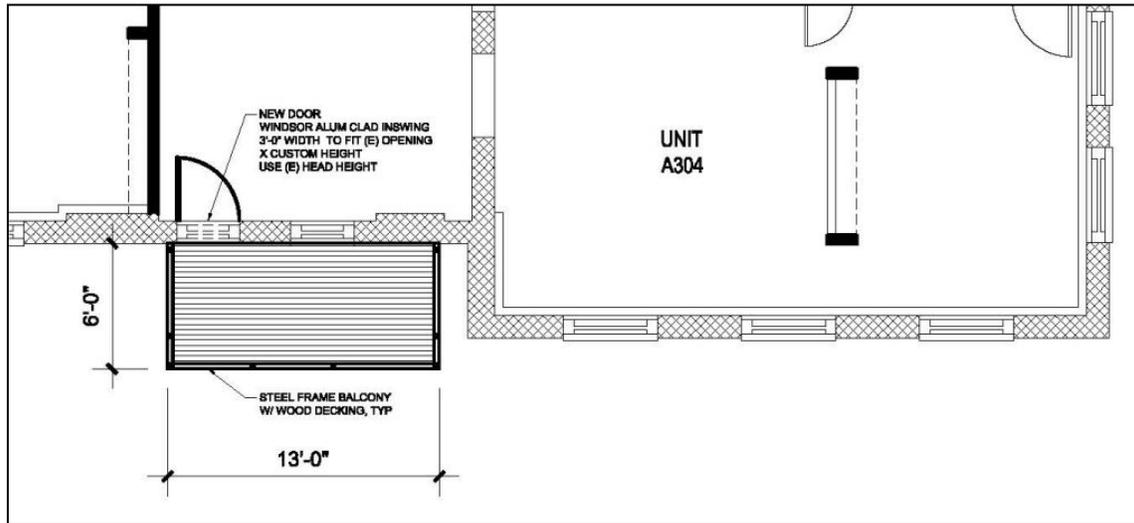
Figure 10. Proposed plan for balcony on the 3<sup>rd</sup> floor, 2015.

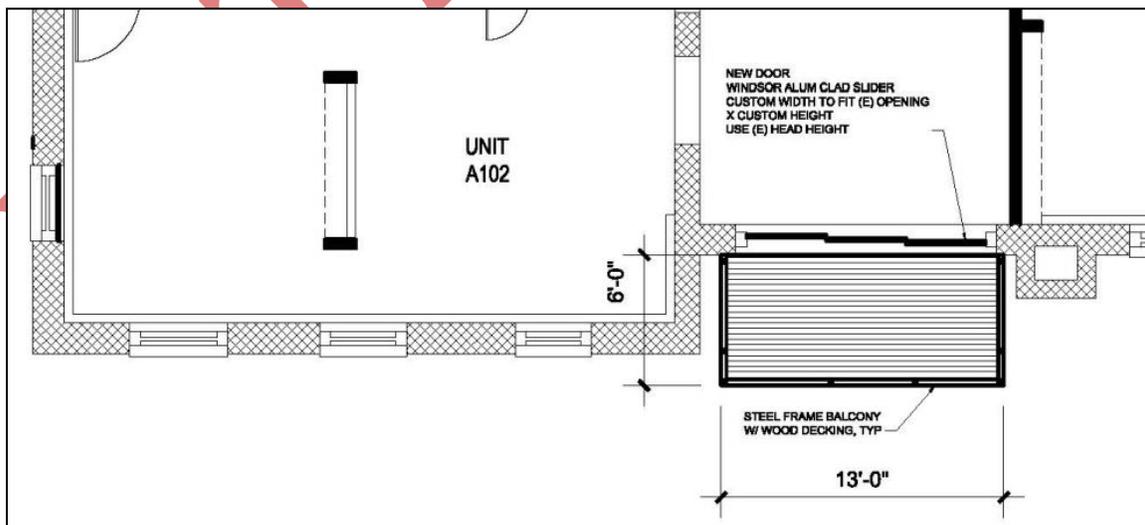
The proposed balcony on the west unit of the second floor (Unit A102) is shown to be fitted with a sliding glass door rather than a single door. Unlike the other balconies where one window will be retrofitted for a door, plans for this unit show the removal of three windows to be replaced with an aluminum clad sliding door to fit the width of the existing opening (See Figure 8).

Figure 11. Proposed plan for balcony for Unit A102 on the 1<sup>st</sup> floor, 2015.

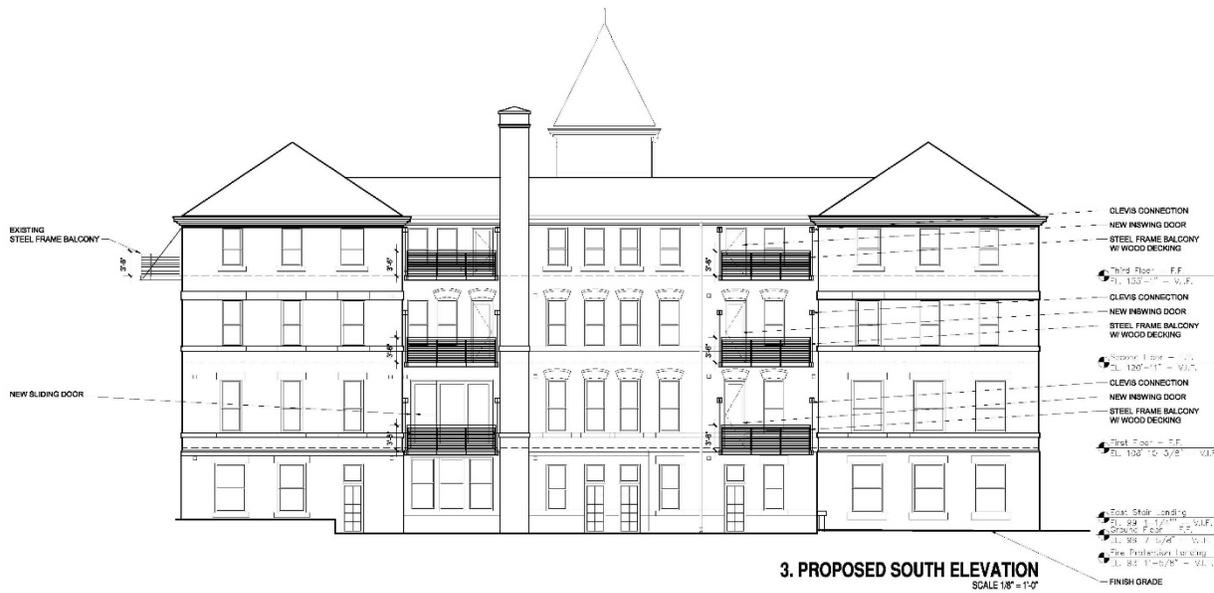
Figure 12. Proposed south elevation with expanded openings and balconies.

The balconies are shown to measure 13 ft. wide by 6 ft. long, with 3'6" railings. Proposed materials include steel frames with wood decking. Clevis connections, cables attaching the outer corners of the balconies to the masonry, are shown to secure the projecting balconies.

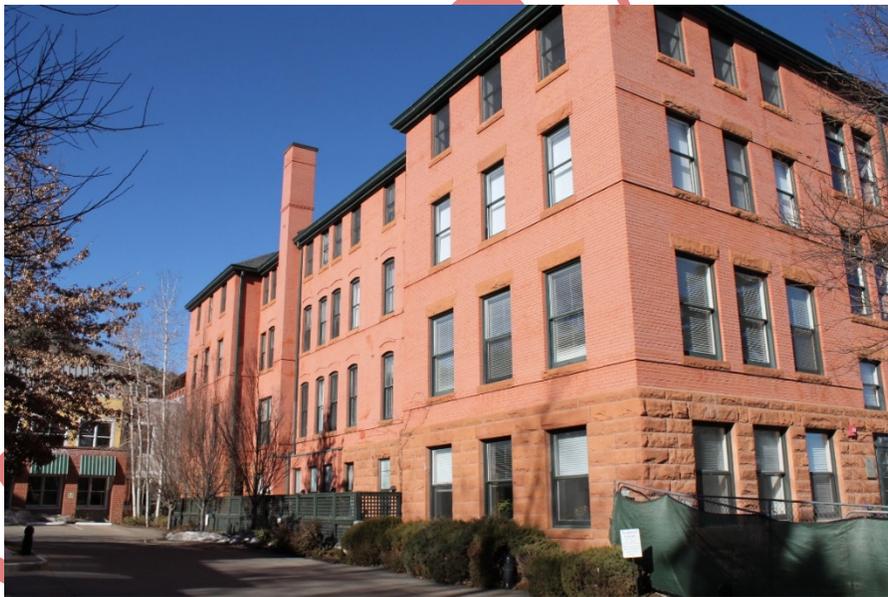
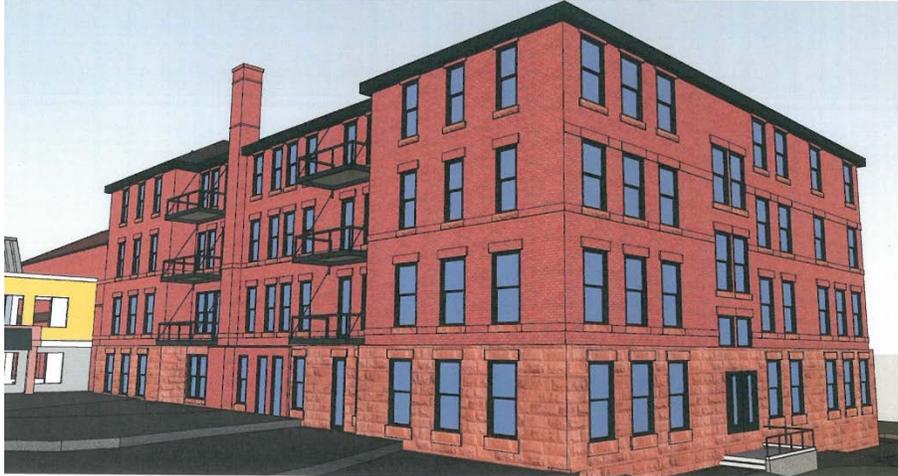
Figure 13 & 14. Left: Existing and rendering of proposed south elevation from 10<sup>th</sup> St.;

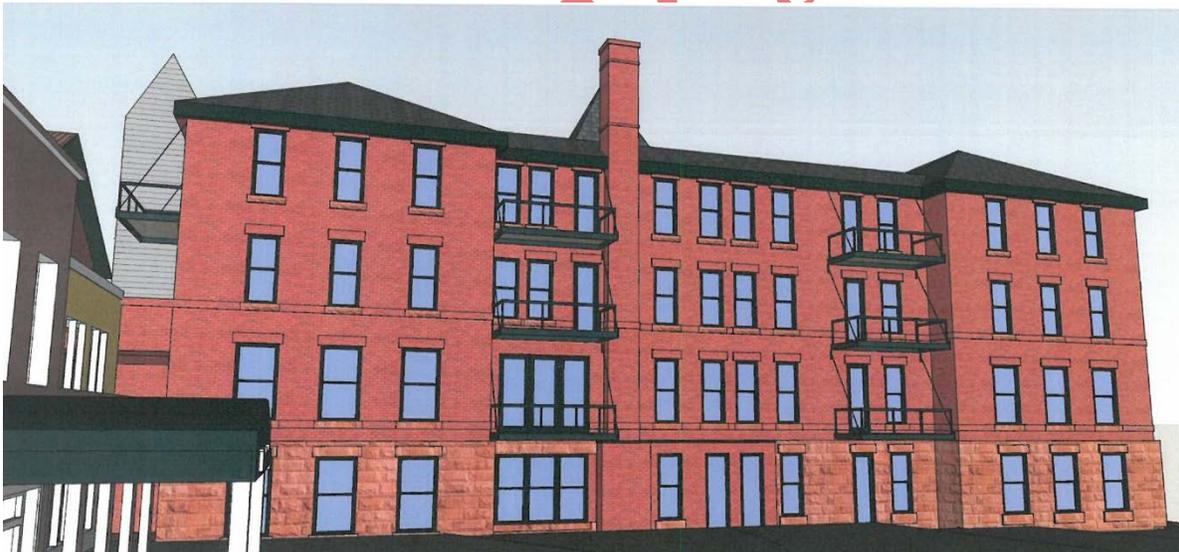
Figure 15. Rendering of proposed south elevation as seen from parking lot.

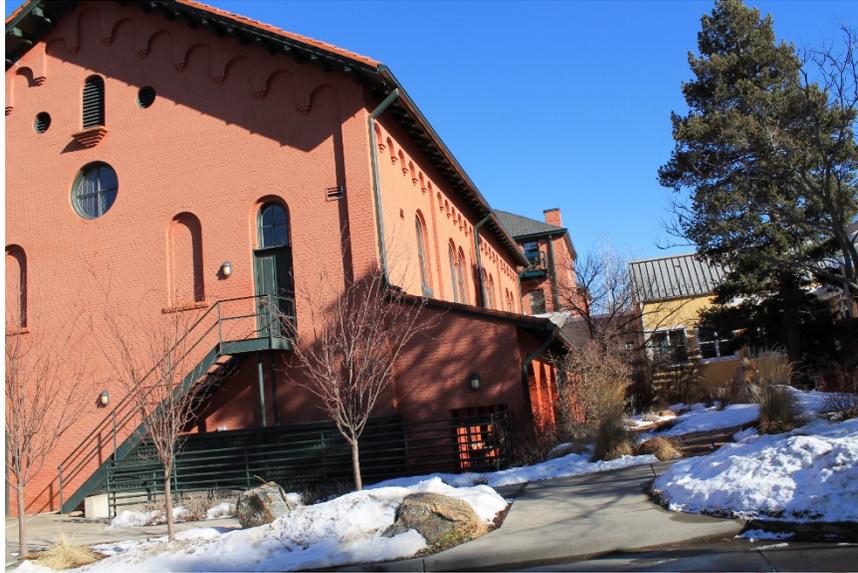
*Figure 16. Existing balcony on the west elevation of the historic building is partially visible behind the Chapel from Lincoln Place.*

An existing steel frame balcony similar in design and composition to the proposed balconies can be found on the 3<sup>rd</sup> floor of the west elevation, measuring 3'6" in height. The balcony is located approximately 120 ft. from the west property line, and is partially visually obscured by the Chapel. Other steel elements are visible on the historic chapel, including the non-historic stair and railing.

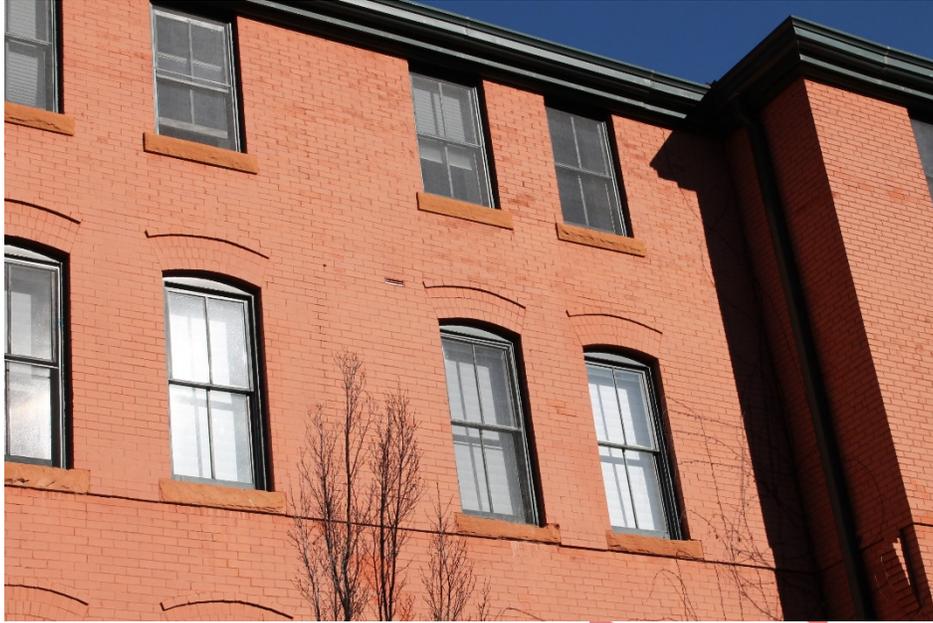
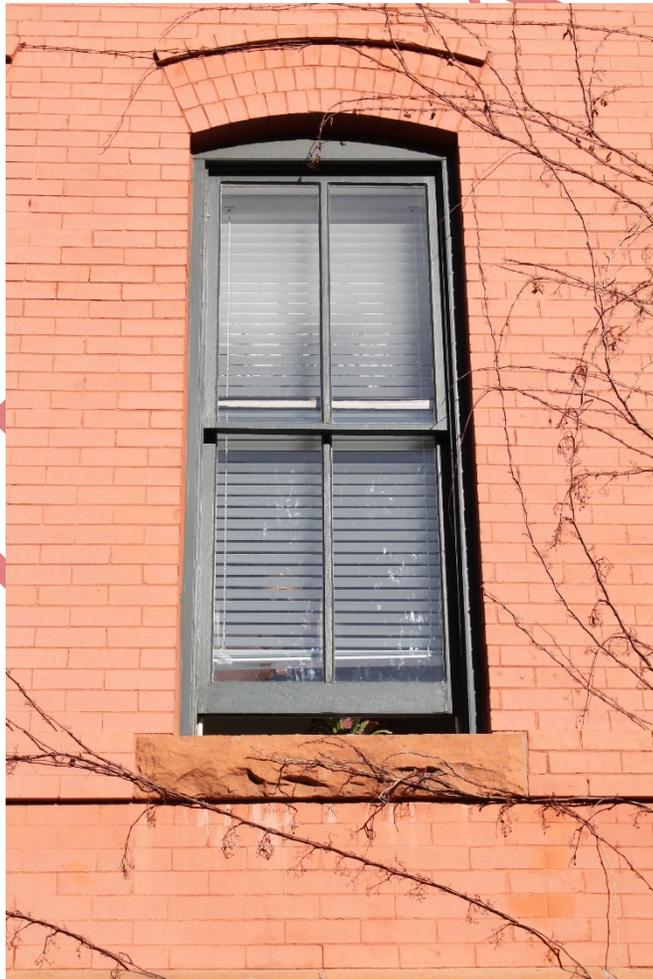
Historically Important Windows, south elevation St. Gertrude Academy 2016

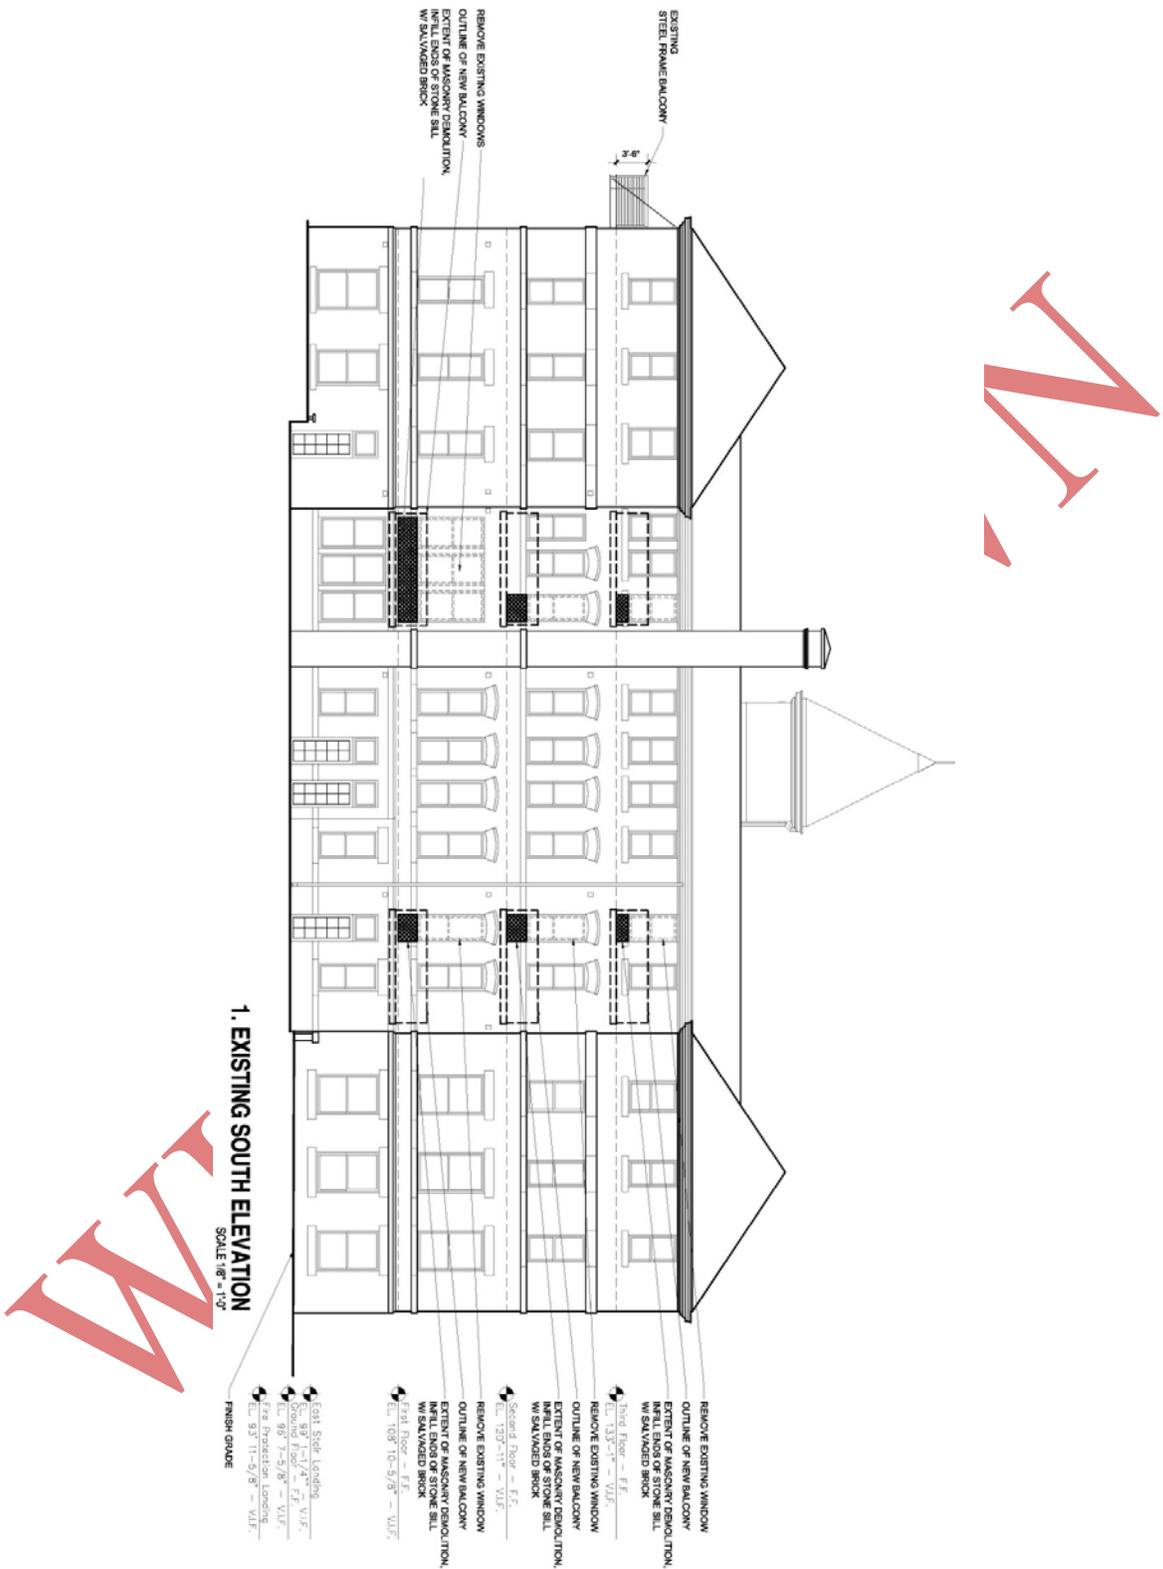
Proposed Modifications, South Elevation, 2015.

CLEVIS CONNECTION

NEW DOOR

STEEL FRAME BALCONY  
W/ WOOD DECKING

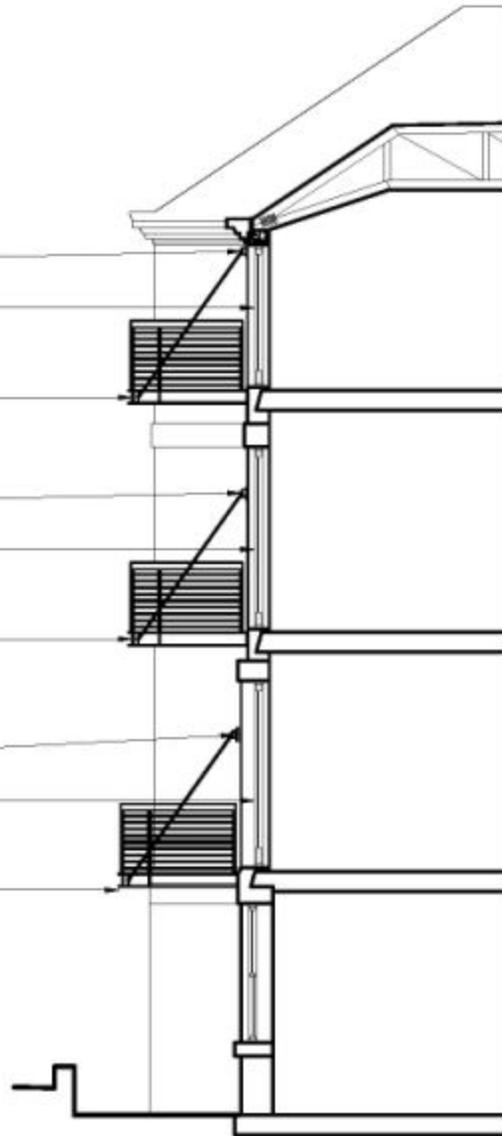
#### 4. PROPOSED SECTION-ELEVATION

Proposed Modifications, South Elevation, 2015.
