RE: Summary of Living Labs Phase I Project Findings – Before and After

Summary of Living Labs Phase I Project Findings

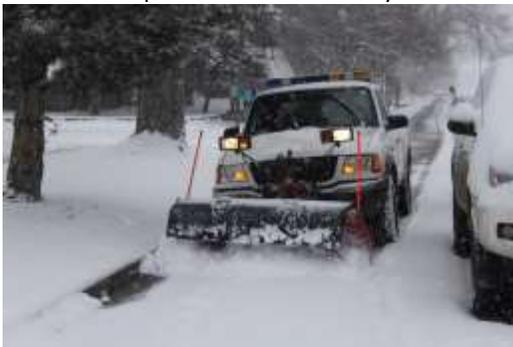
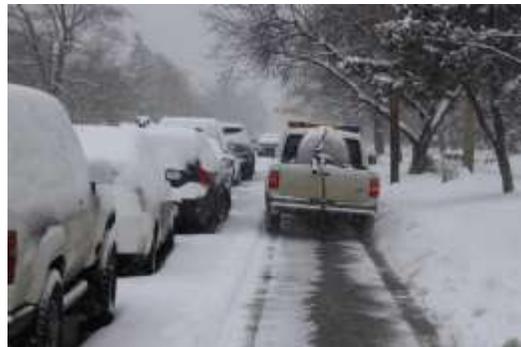
Snow Plow Operations on University Protected Bike Lanes

- When snow was not a factor, 98% of bicyclists traveled in the protected bike lanes. 1% used the sidewalk, and 1% used the adjacent vehicle lane.
- Snow events resulted in approximately half of the bicyclists using the travel lane and half using the protected bike lane.
- Bicyclist's decision to travel in the bike lane or the vehicle lane during snow events was influenced by the condition of the pavement in each, and the amount of time since the plow had cleared each.
- Plows that cleared the protected bike lanes sometimes left snow deposits in the lane at the ends of the blocks. This influenced the use of the bike lane by bicyclists.
