# BOULDER SANITARIUM

## HISTORICAL ASSESSMENT

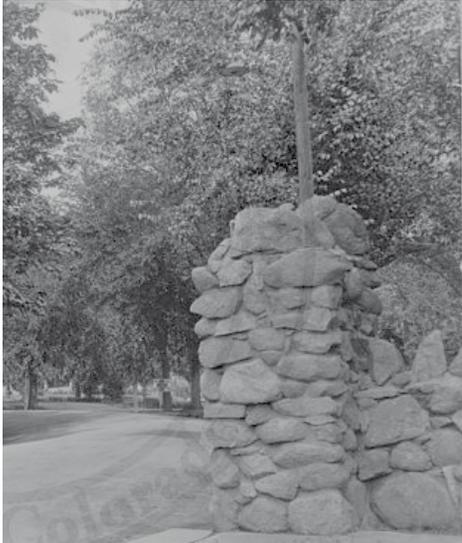
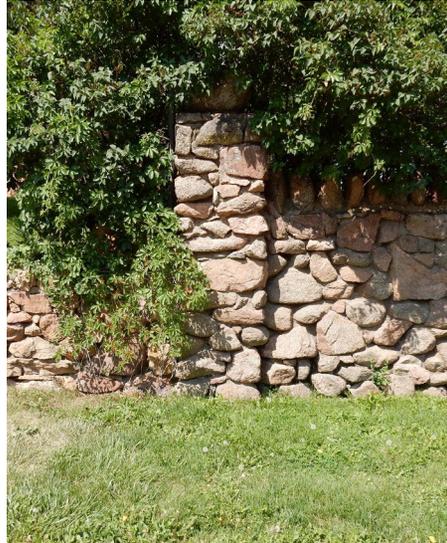
22. A portion of the stone wall appears to be original to the 1920's construction. The left picture dates to c.1929.

A fragment of a stone wall runs along the southern end of the site, fronting Mapleton Avenue. It appears to reflect periods of construction in the late 1920's when the Sanitarium shifted its main entry to allow for easier automobile access. Some portions of the current wall appear to be original to the 1920's construction, but the western-most extension of the wall appears to be more recent and is distinguishable by a change in the rock form, mortar pattern and wall height.

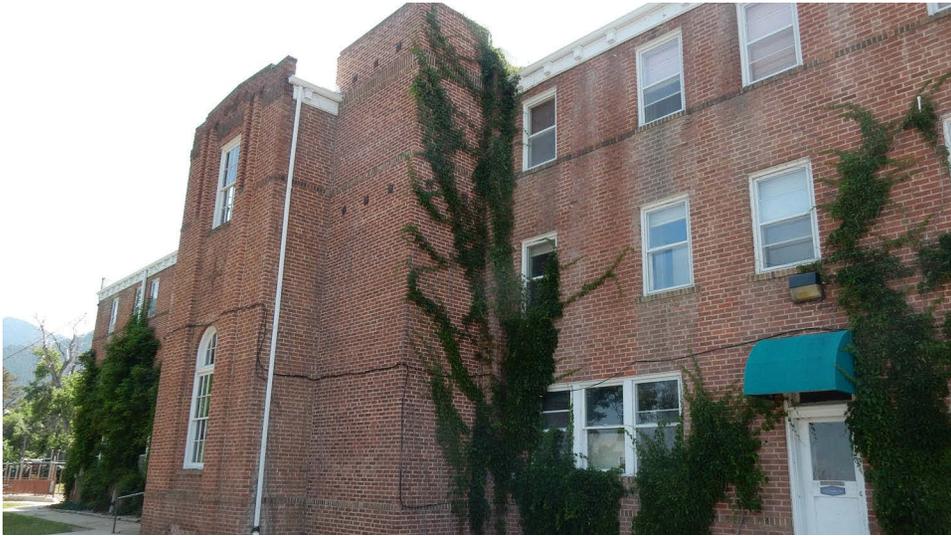
25. The nurse dormitory retains its original brick and architectural features. The only major change is the addition of the elevator shaft which can be seen as the slightly redder brick tower feature.

The nurse dormitory was built in 1930 to house nurses who had previously been living in other buildings on-site or off-site in the surrounding neighborhoods. The three-story brick building stands intact today and is by far the best preserved building on the site. The only major change to the building is the addition of an elevator shaft on the front of the building. The building retains most of its original construction materials except for doors and the addition of storm windows.

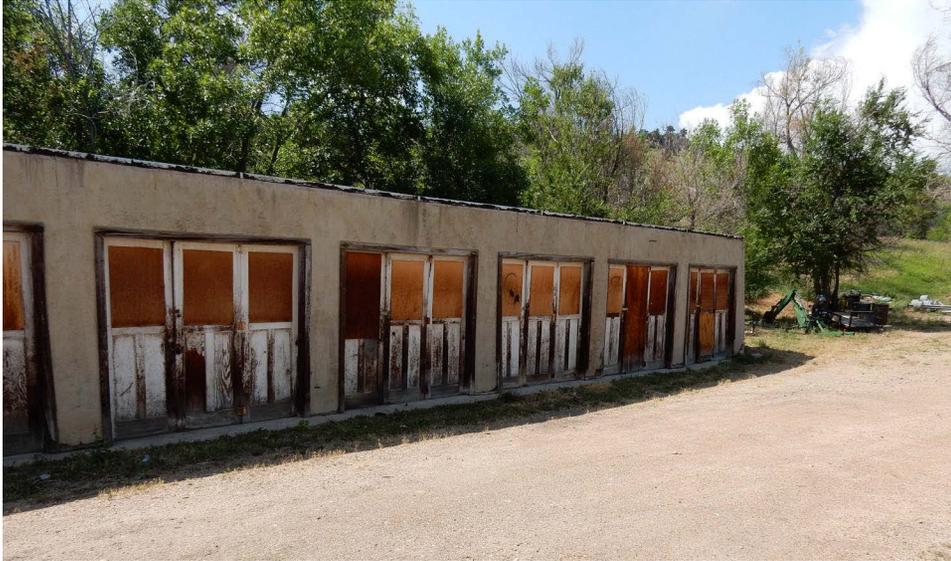
26. The garages have deteriorated greatly and have not retained their original building materials.

The garage building to the northwest of the furniture storage building was constructed c.1931. The building still has the 8 separate garage bays it was built with, but the building has deteriorated substantially.

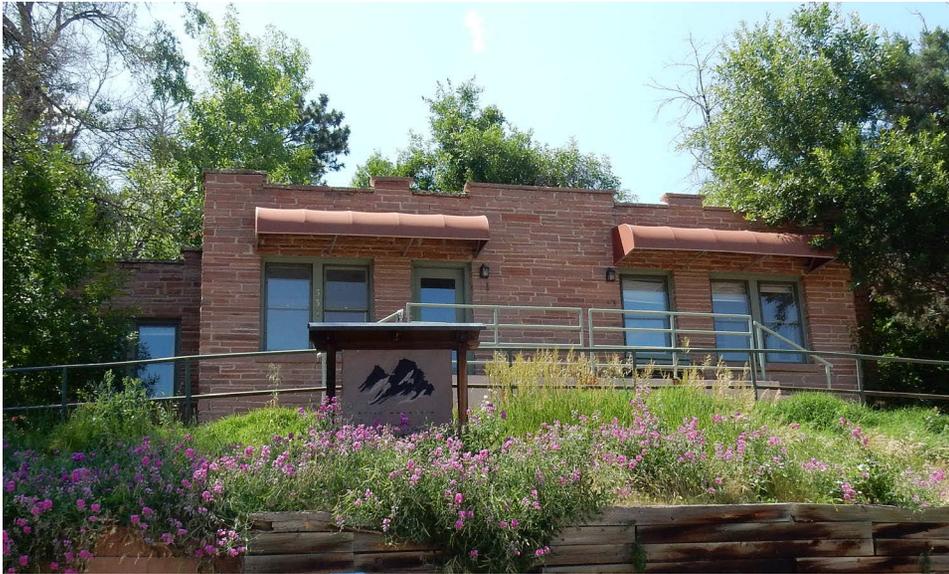
29. Cottage D has a unique flagstone construction with interesting variations in parapet height.

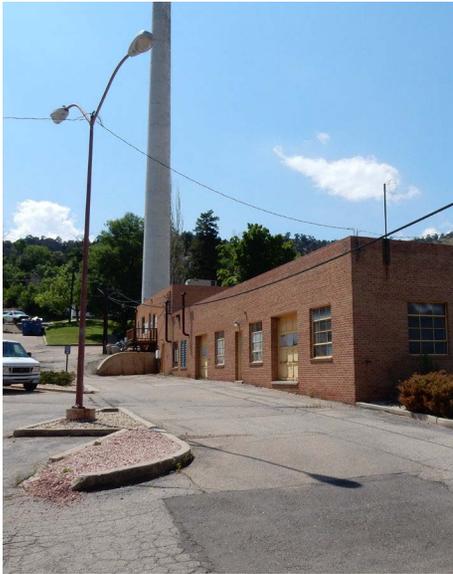
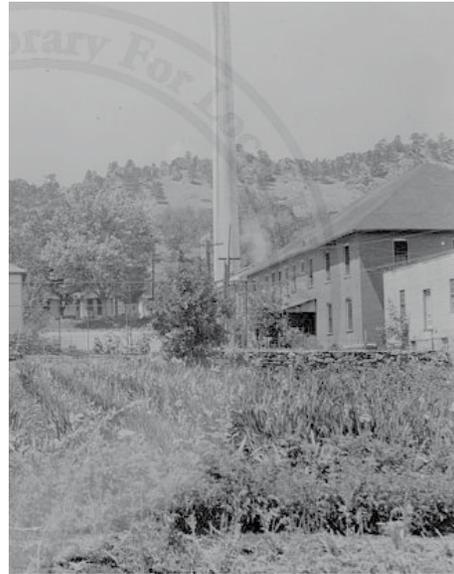
30. The current powerhouse building is completely different than the original structure. The walls openings, roof and materials are all different.

Although some of the foundation of the powerhouse building may be original from the initial construction in 1896, the current powerhouse only dates back to 1957. Various additions and demolitions have taken place and the current structure bears little resemblance to the 1896 powerhouse. The old stone foundation is only visible on the northeast corner of the building.

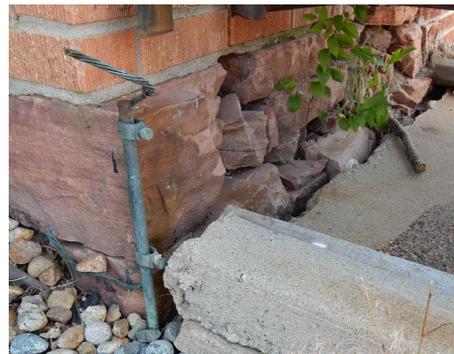
31. A part of an older stone foundation is still exposed on the northeast corner of the building.

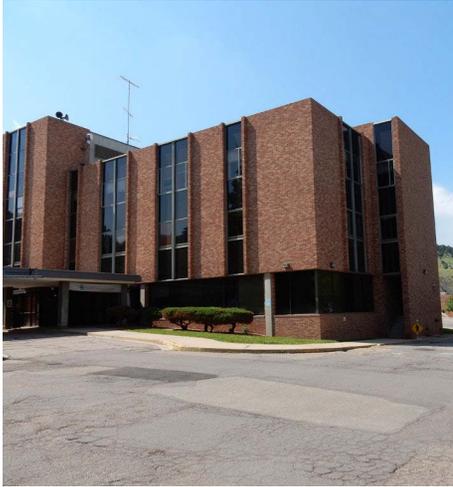
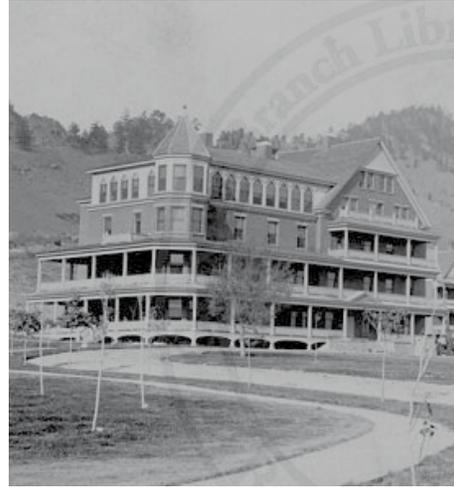
32. The main building exemplifies the constant change that has taken place on the Sanitarium site. The current building has had more than 10 additions just since 1957. None of the original Victorian-style Sanitarium building remains.

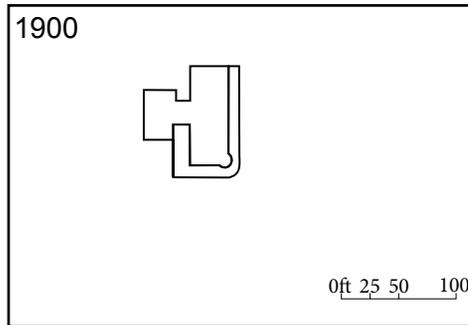
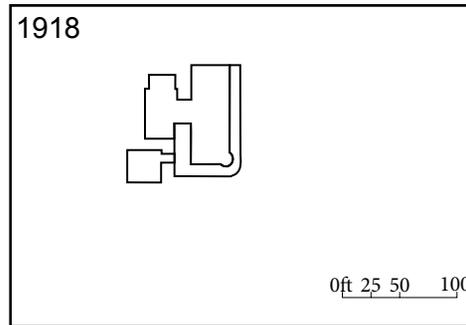
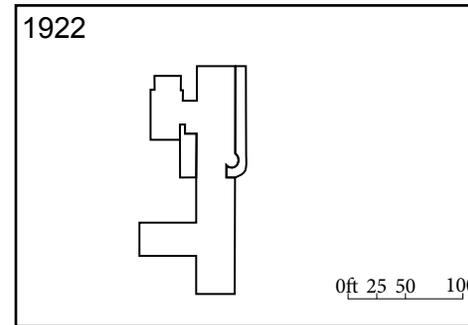
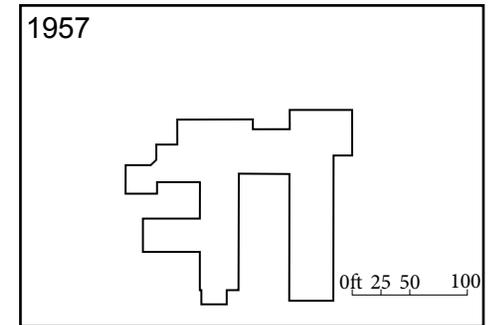
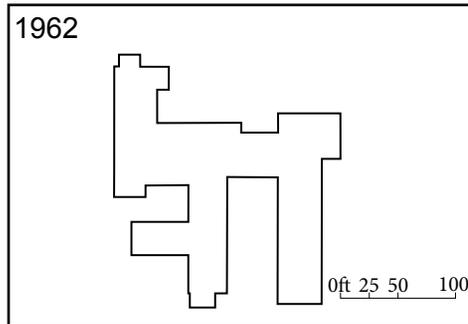
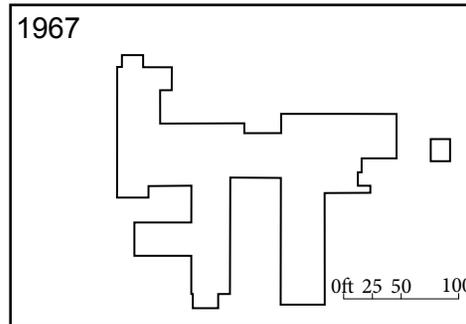
The following graphics show the evolution of the main building. The graphics are based on historical Sanborn insurance maps and building plans.
