SELF-GUIDED HIKE TO FOURMILE CANYON CREEK FLOOD DEPOSITS AND CHANGES TO THE LANDSCAPE

Sue Ellen Hirschfeld, Ph.D.

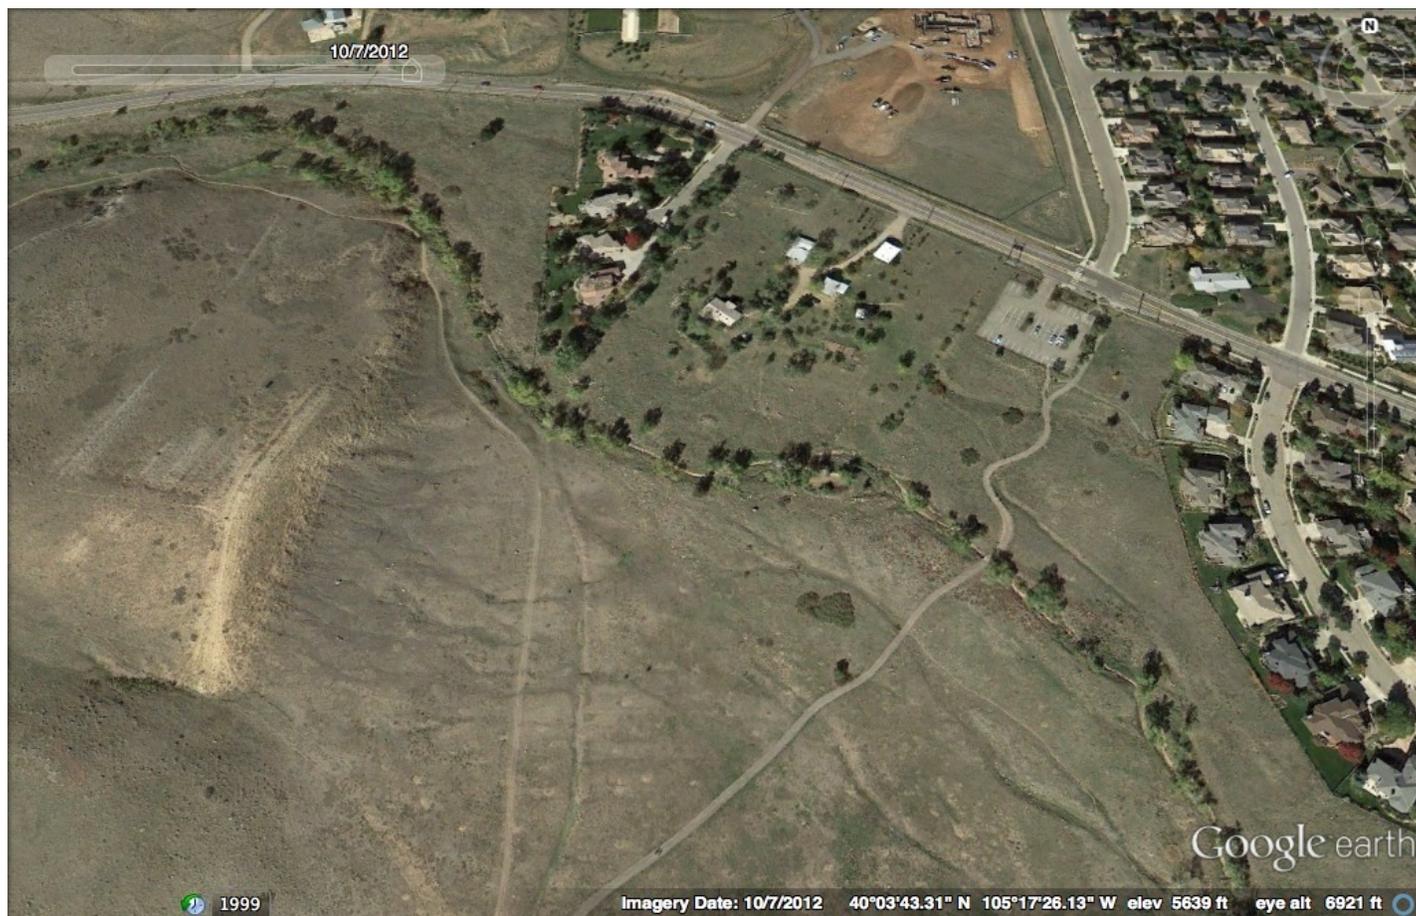
The Four Mile Creek trailhead parking lot is the gray square right of center. Pre-flood location of Fourmile Canyon Creek is outlined by the trees. Old, abandoned drainages can be seen. Refer to this photograph as you follow this guide.

As seen in the image on page 1, the pre-flood Fourmile Canyon Creek was very small. The trail from the trailhead leads to a small bridge. Fourmile Canyon Creek used to flow under this bridge. This will give you a good idea how small the stream was before the flood and the magnitude of the change afterward. The bridge is now “high and dry”. The creek bed has moved west and the flood has carved two new channels.

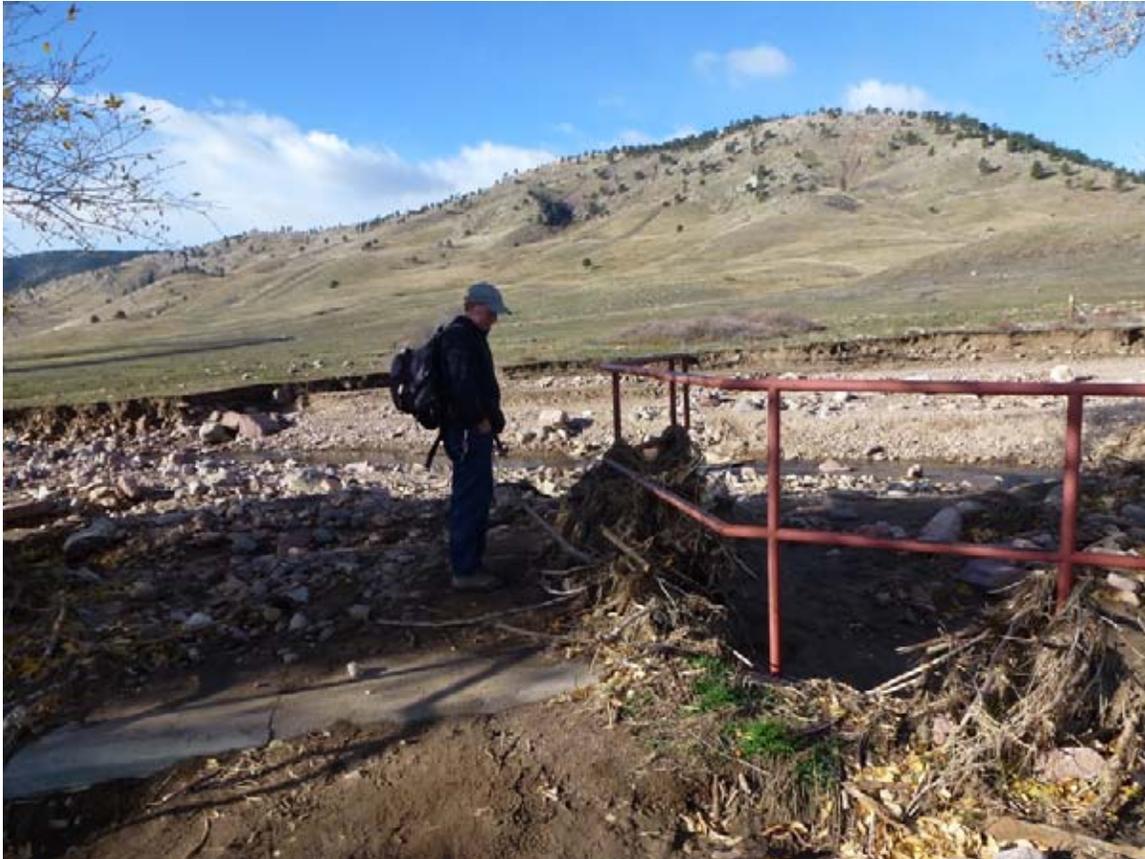
Bridge to “nowhere” and debris collected by the bridge in the September 11-13, 2013 flood.

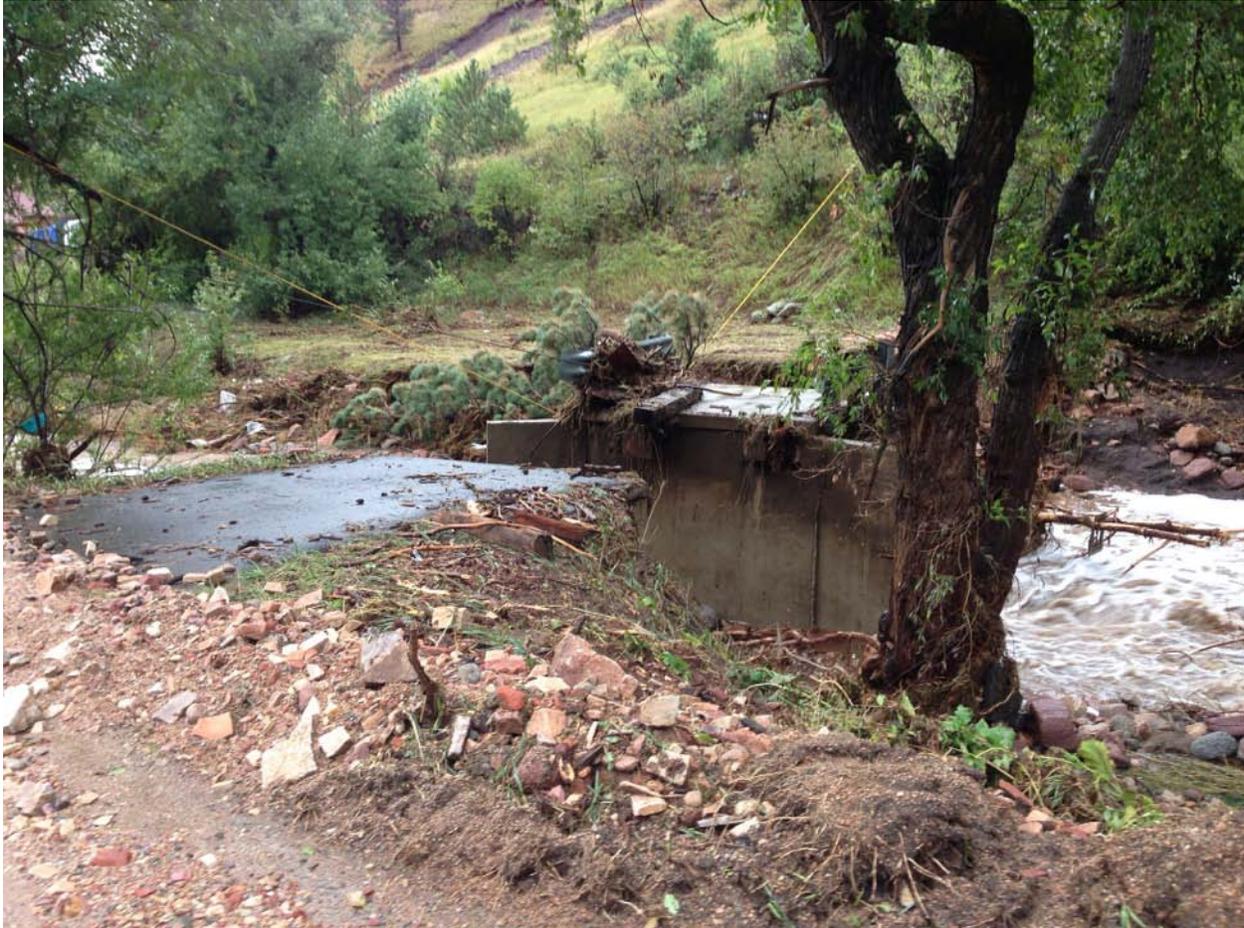
Bridge destroyed at “choke Point. Note the vegetation on the bridge deck and how high the flow was here. (photograph taken September 15, 2013 by James V. Holmes)

The height of the flow along Lee Hill Drive can be estimated near a “choke point” where the canyon narrows and the remains of a damaged bridge has debris caught on the deck. This photograph shows that flood water was flowing over the top of the bridge. Just downstream, flood water flowed across Lee Hill Drive where it carried and deposited sand and gravel on the north side of the road. On the south side of the road water covered and buried the trailhead parking lot with sand. Water continued flowing toward the houses to the east of the parking lot.

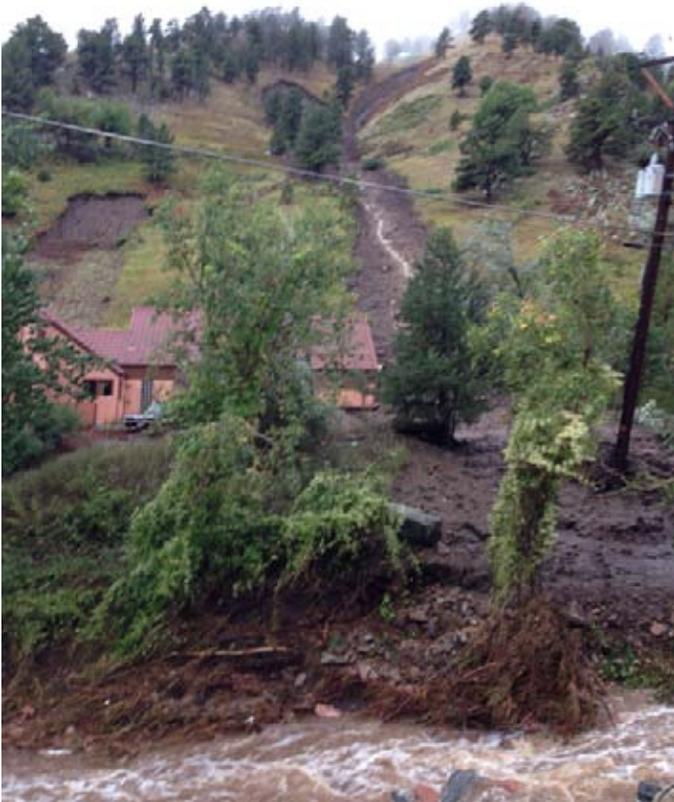
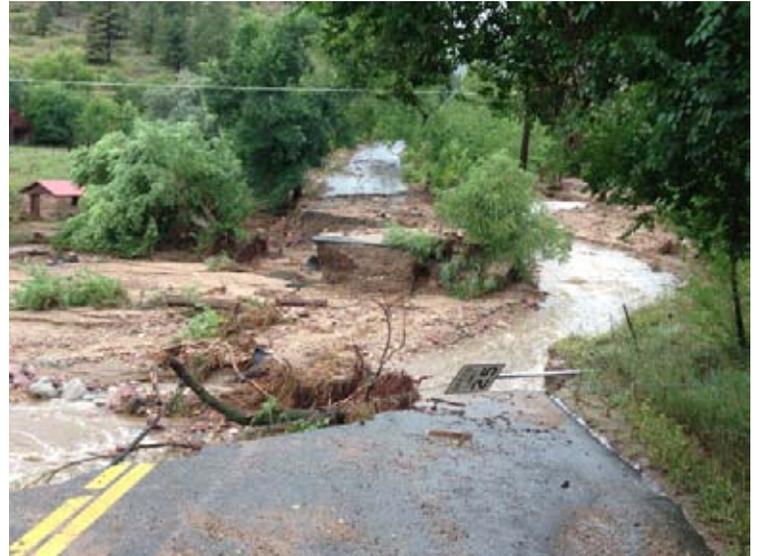
Erosion of Wagon Wheel Gap road

Two landslides contribute sand and rock debris to the floodwaters (Photographs by Jamie V. Holmes).

Many places along the trail (up ahead) and tree trunks (where the pre-flood channel is located) have been buried by sand and rock debris. A large amount of this sand has come from residents' yards that were washed away, from hill slopes that have been undercut, and from landslides (photograph above).

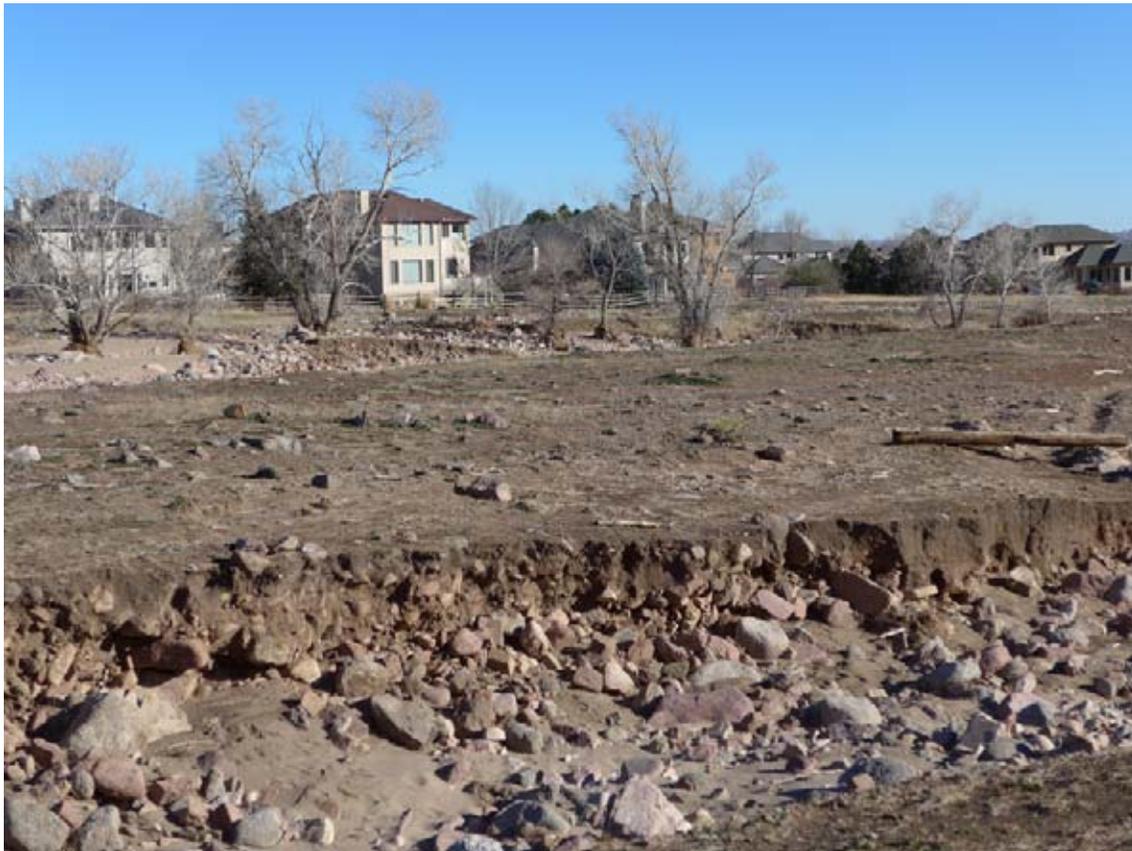
Newly carved channel by the September 2013 flood. Large rounded boulders from an older flood are exposed.

The walls of the new channels show evidence of earlier larger floods. Look for some very large boulders under a dark layer of surface soil. It takes thousands of years to form such a dark organic-rich soil. Starting with clean sand after a flood, organic matter very gradually accumulates to form a soil. Between the two channels, boulders from the older deposits are sticking out at the ground surface. The 2013 flood reworked these older flood deposits.

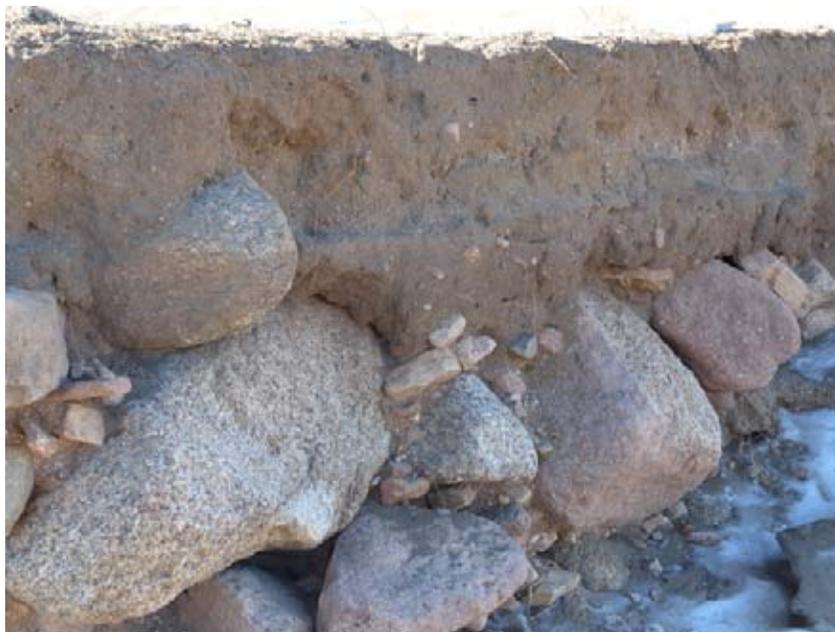
Close-up of older flood deposits with large rounded boulders and a well-developed soil above them.

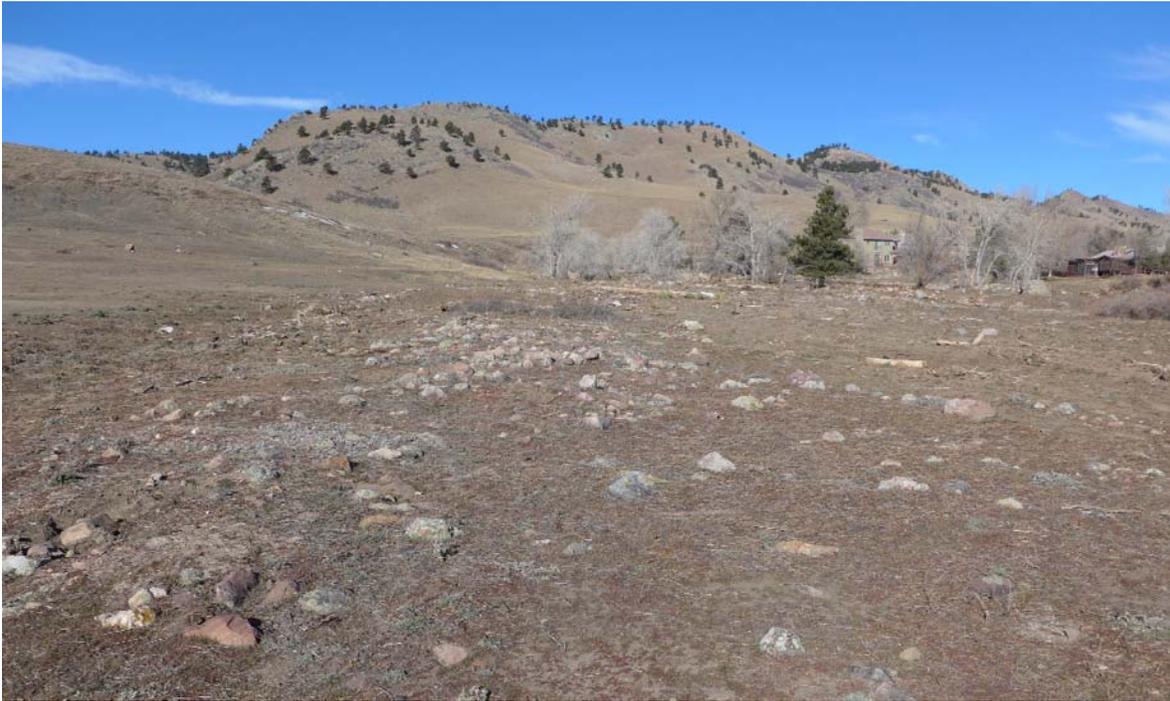
Boulders from an older flood deposit are exposed on the north side of the trail south of the creek. This area had flood water carrying logs and wood flowing over it in 2013. Note how far this is from the pre-flood channel.

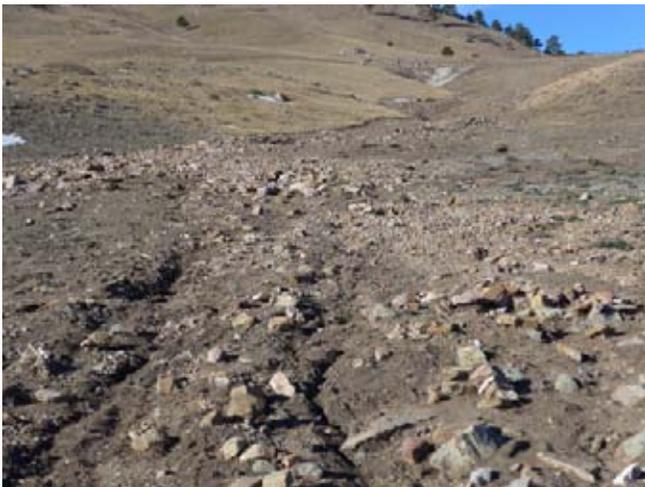
Rock debris from the debris flow.

You are walking across the debris field from a large landslide that started high up near the top of Dakota Ridge and flowed down across the trail. Farther along the Old Kiln Trail there are better views of where this slide started. What is interesting to observe here is the rock debris surrounded by mud. This slide contained a lot of water and was quite fluid as it moved. When it reached this section of the trail, most of the rock stopped moving and the mud kept flowing

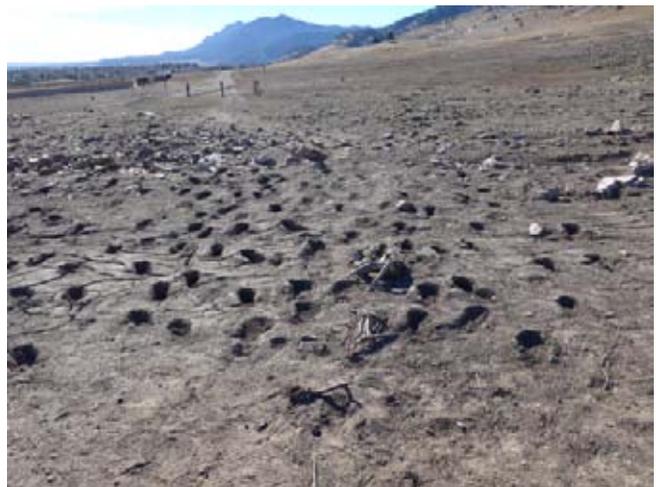
Footprints in mud that drained from the slide.

downslope until it reached a low berm where it stopped.

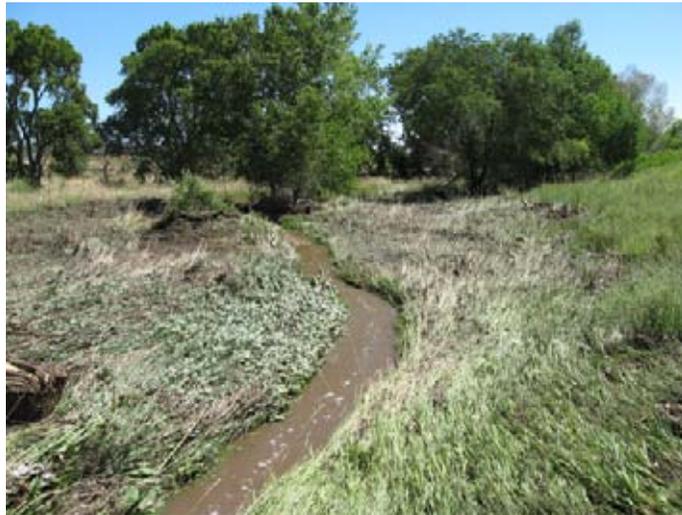
Height of flood water during 2011 flood. Note that sand and boulders were not carried downstream by the flood water.

About a third of the drainage basin of Fourmile Canyon Creek was burned in the Fourmile Fire in 2010. On July 7th 2011, a big thunderstorm produced a small flood that came down Fourmile Canyon Creek and overflowed the channel (photo). It is interesting that there was not sufficient flow to carry and deposit sand and move large rock debris.

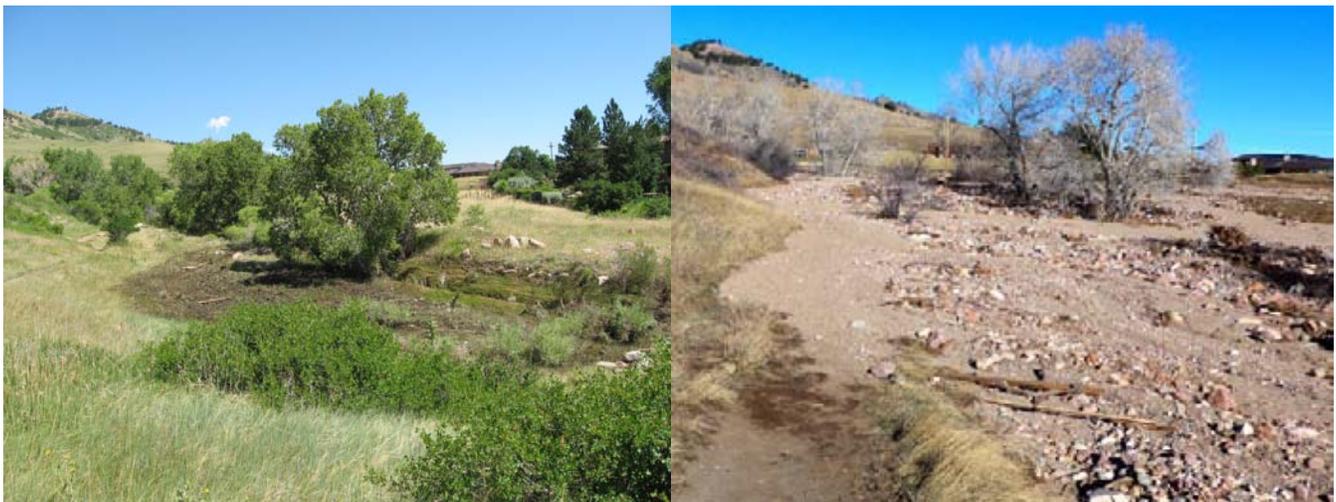
No deposition of sand in the 2011 flood.

Sand rock deposited during the 2013 flood.

Continue along the trail. Note the sand deposited over the trail as you approach the exposure of Smoky Hills Shale on your left. This is another indication of how high the flood water rose. Follow the trail around the corner parallel to Lee Hill Drive.

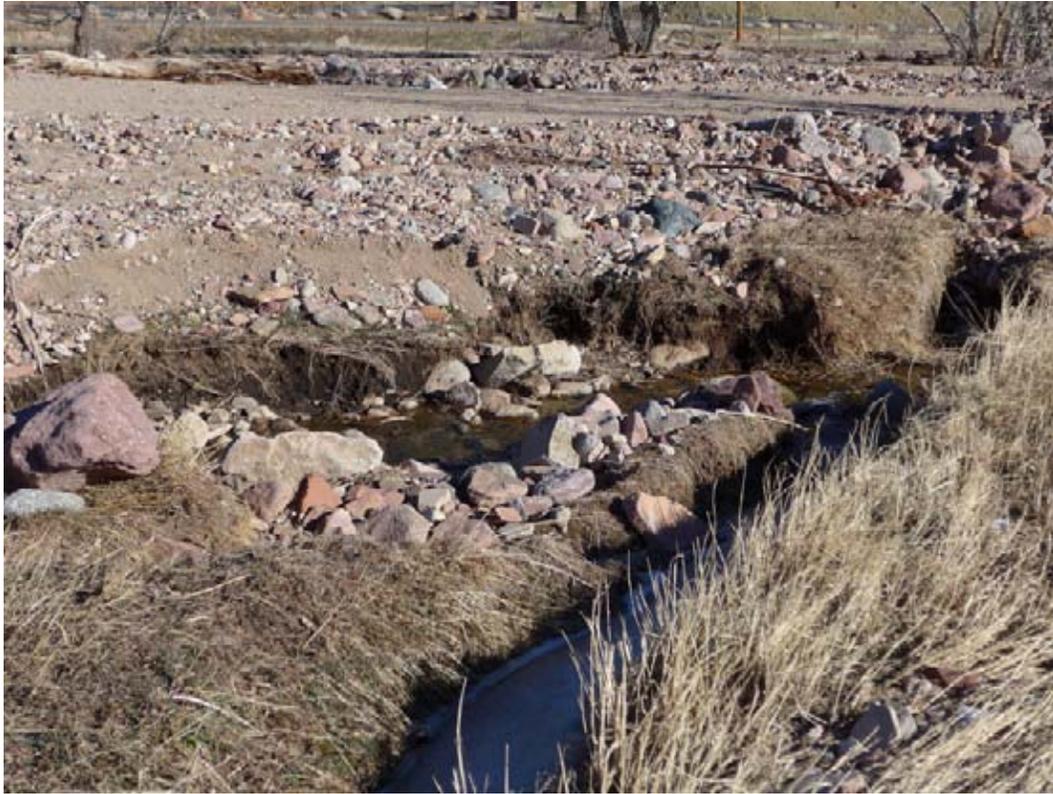
Note how boulders have been moved onto the grass in the foreground and on top of the sand in the background.

The tremendous power of the flood water can be seen along the trail where a collection of boulders has been deposited on the pre-flood grassy slope.

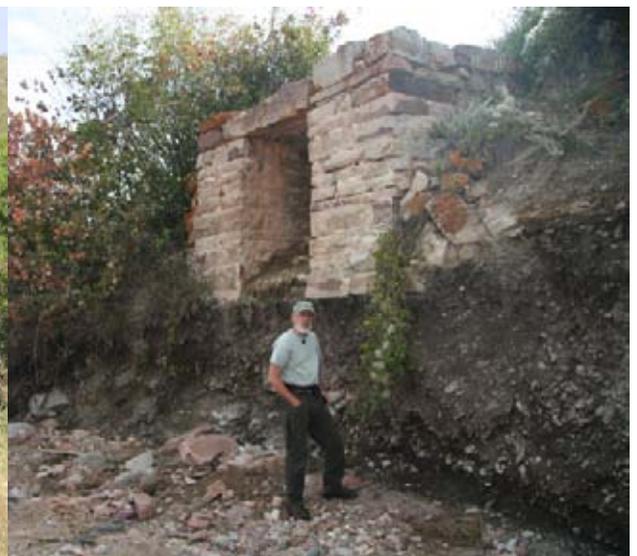
Depth of erosion caused by the 2013 flood.

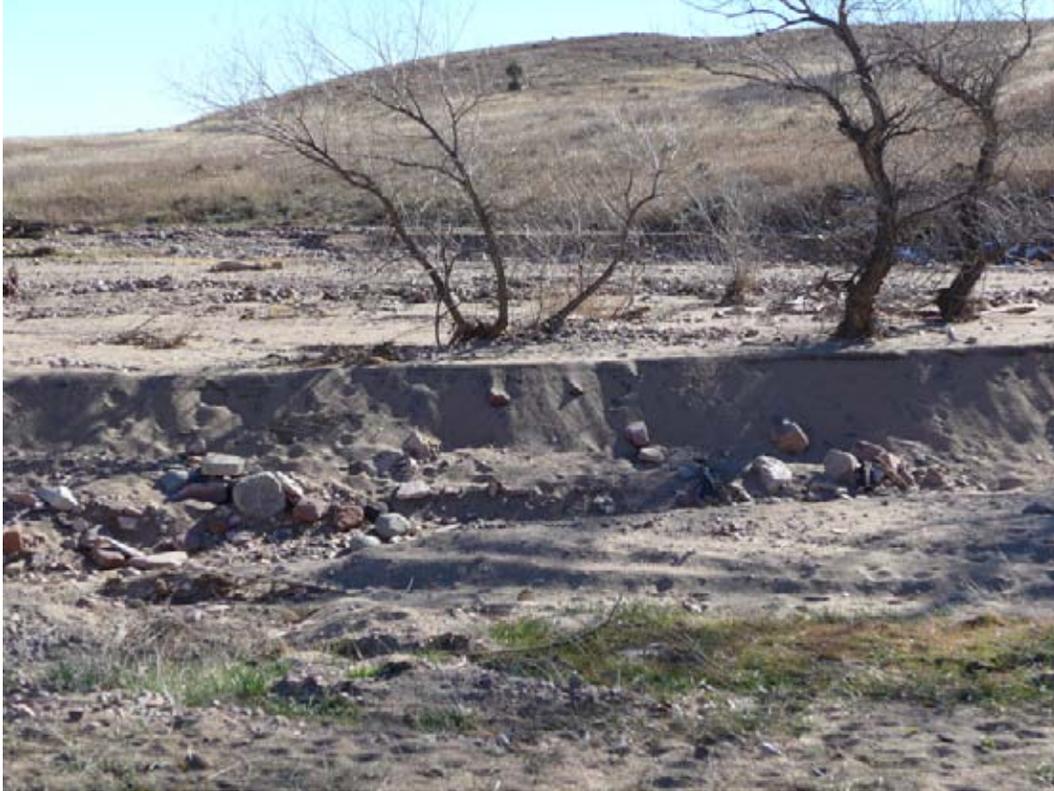
Photograph taken from Lee Hill Drive looking south. Huge amounts of sand were deposited by early surges of water. Later surges excavated these deposits and moved larger boulders and debris.

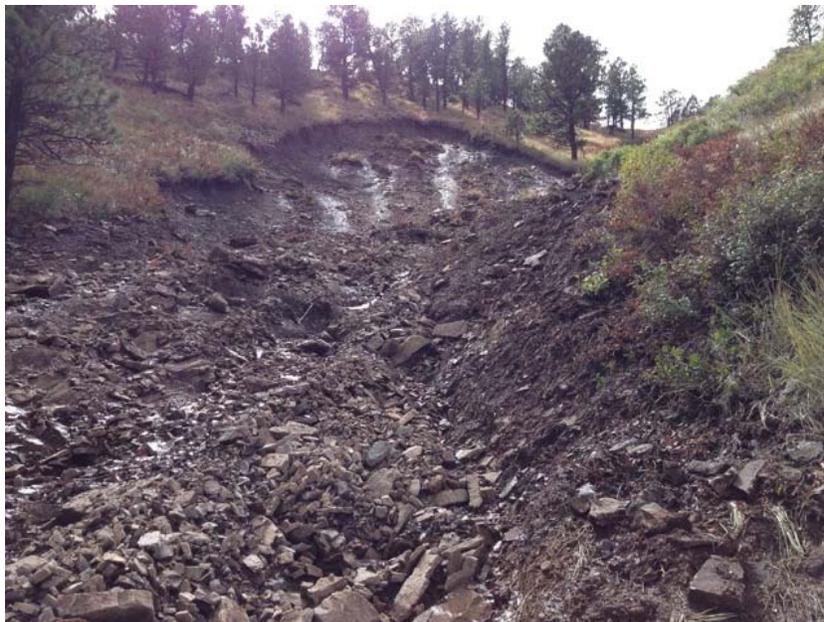
Head of landslide starting near top of Dakota Ridge (Photograph by Barbara Dobbs).

Continue walking over the flood deposits. The Old Kiln Trail continues uphill. By the split rail fence, the trail forks. Follow the Old Kiln Trail along an old road uphill to see the head of the big landslide that came down the south side of the canyon above Lee Hill Drive (see entire landslide in photograph on page 4).

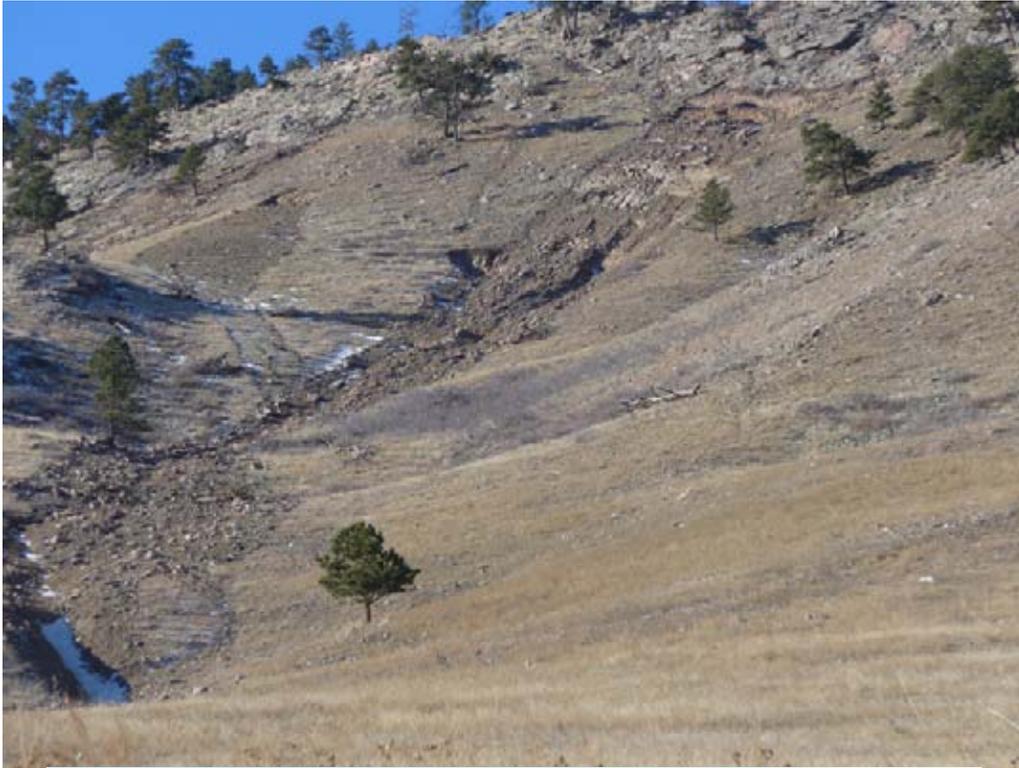
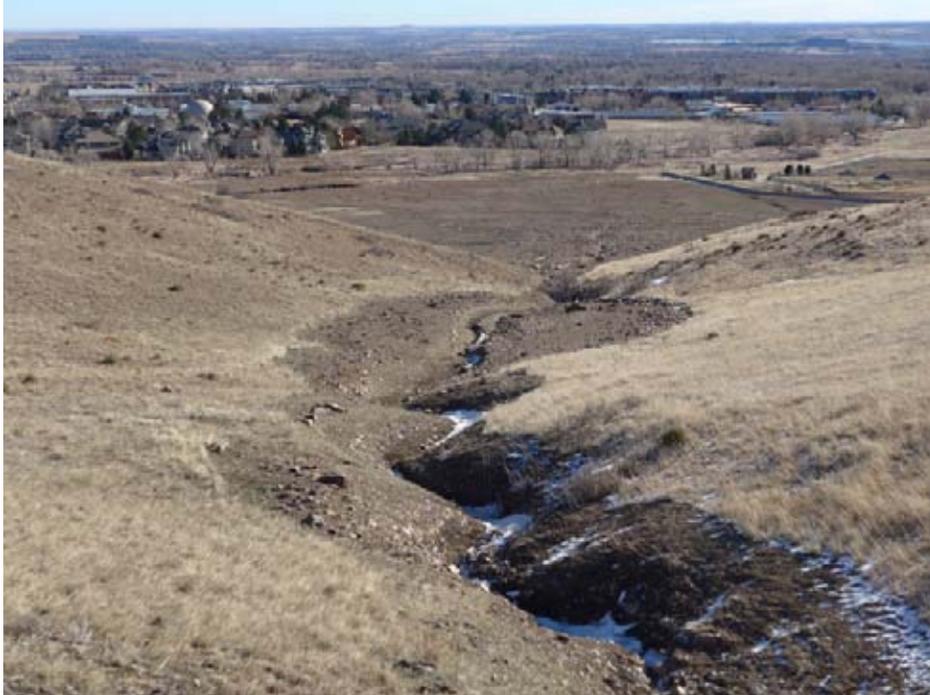
Landslide scar above and below the Fort Hays Limestone

Walk to the south end of the split rail fence where the layers of white rock (Fort Hays Limestone) are exposed. On the slope below, notice the scar of the big landslide that you walked across on the trail below. Head scars and debris trains of other landslides are apparent.
