MEMORANDUM

April 2, 2014

SUBJECT: Public hearing and consideration of a Landmark Alteration Certificate to build a fence in the front yard at 1116 Maxwell Ave. in the Mapleton Hill Historic District, per section 9-11-18 of the Boulder Revised Code (HIS2014-00049).

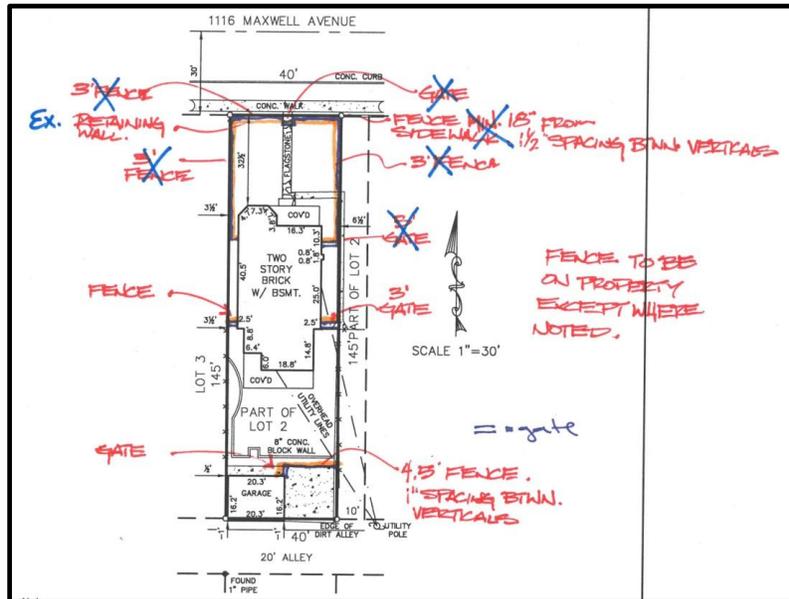
Figure 3. 1116 Maxwell Ave. Approved site plan, February, 2014

In February of 2014, a Landmark Alteration Certificate was granted for construction of a 4' 6" high fence at the rear of the property and 3' high fence and gate to connect the existing side yard fences and house to enclose the back yard area (see figure 3).

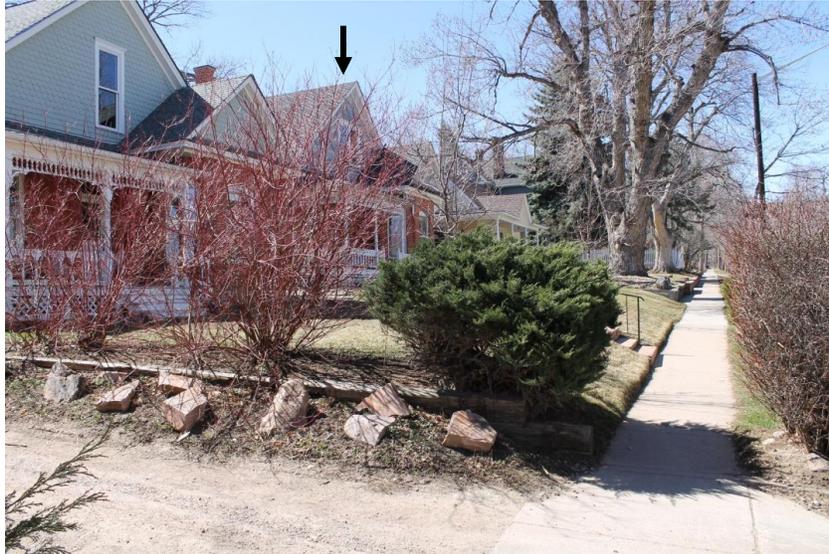
The grade to the property steps up south from the sidewalk, while Maxwell Avenue declines to the east. The result is the grade of the north edge of the property being bermed, the east portion of which is retained with a stone wall approximately 2' in height. While this wall is not visible in the c1949 view of the house, it appears historic and to date from within the defined 1865-1946 period-of-significance for the Mapleton Hill Historic District.

Figure 4. South side of 1100 block of Maxwell Ave. March, 2014 (arrow indicates 1116 Maxwell Avenue). Given the relatively modest housing stock in this eastern edge of the district, historically fences were not common in this area of the district. Currently, there are three fences on the south side of the 1000 and 1100 blocks of Maxwell Avenue and approximately the same number on the north side of the street, but the front yard scape of this section of the district can be characterized as open.

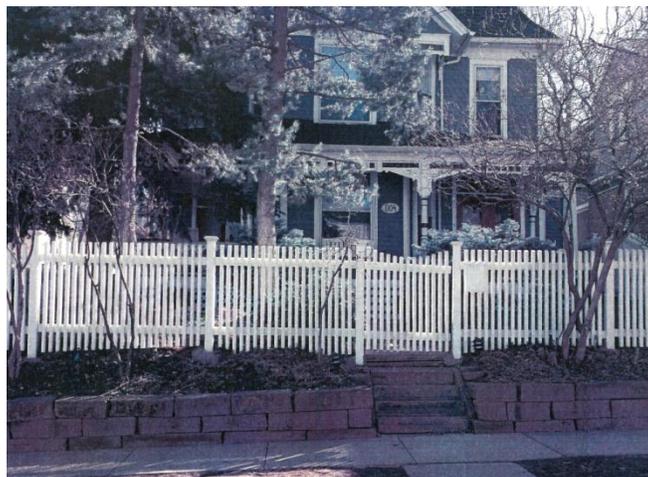
Figure 5. Type of fence proposed to be constructed to height of 3'.
Example from 1104 Maxwell Avenue.

The applicant proposes to construct a 3' high wooden picket fence around the front and sides of the property Mapleton Ave with 1 ½ inch spacing between pickets. In plan, the fence is shown to run from the northeast corner of the house to the east property line, then run to 18' from the north property line where it is shown to turn west and run to the west property line, then turn south to the house where it is shown to turn east and intersect with the west wall of the house. A gate is planned to provide access from the sidewalk to the front walk at the north side of the property. See Figure 7: Proposed Site Plan.

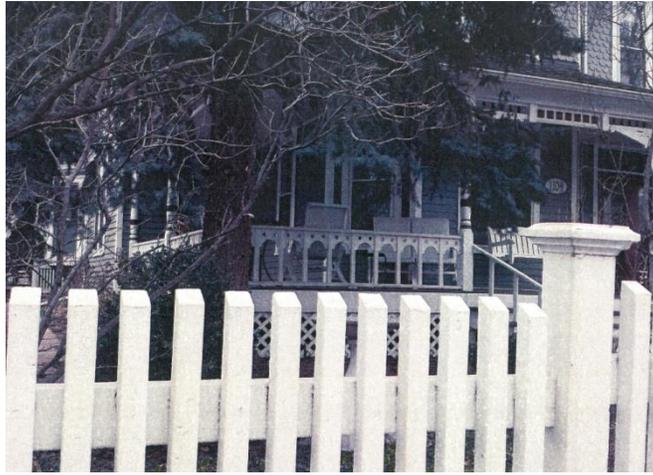
**Figure 6. Type of fence proposed to be constructed to height of 3'.
Example from 1104 Maxwell Avenue.**

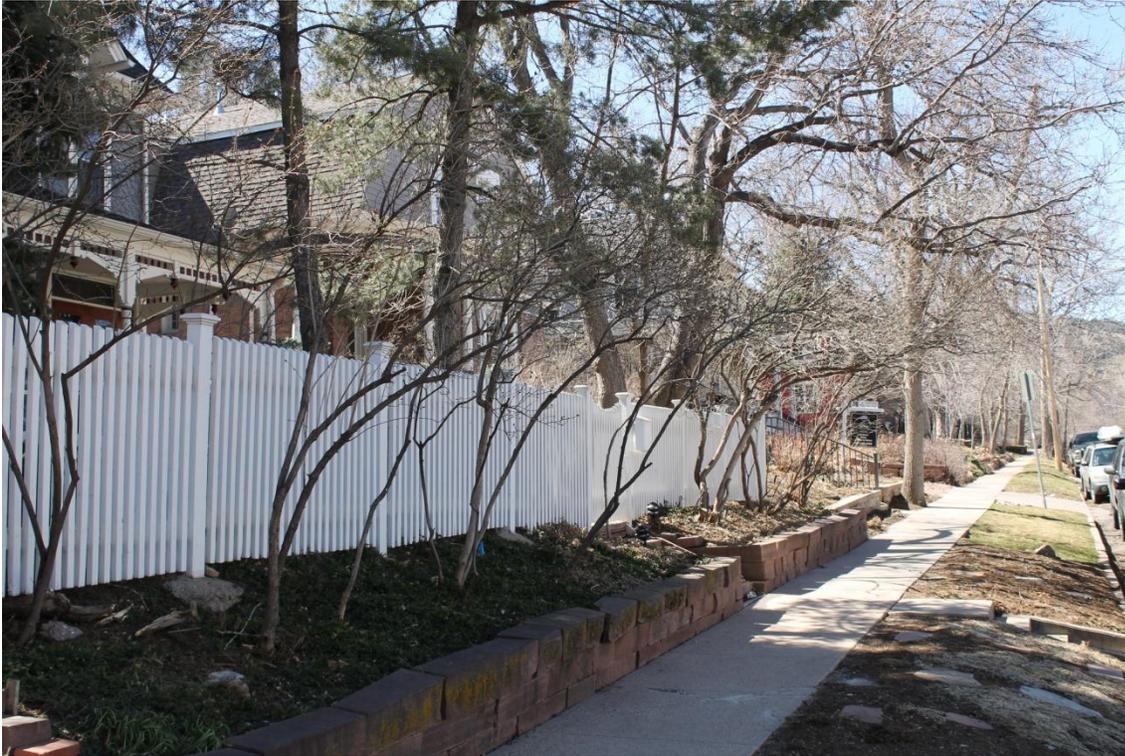
Fence at 1104 Maxwell Avenue

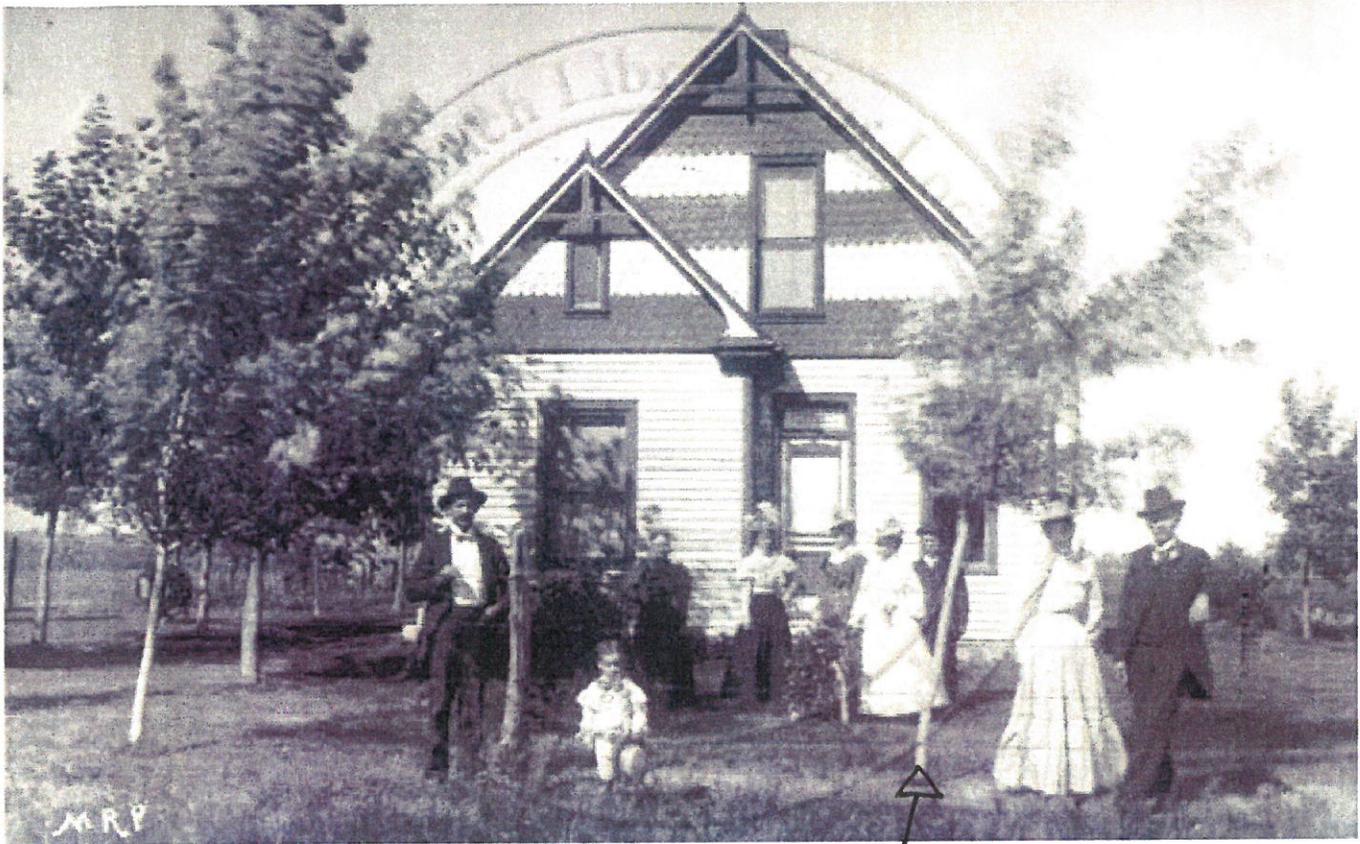
Post of
wood/wire
fence
