# Cold Climate Region: Case Study #4 City of Boulder, SmartRegs Ordinance Single Family Detached, Historic

## Boulder, CO

Program	SmartRegs Ordinance
Location:	Boulder, Colorado
Building Type:	Single Family Detached
Building Size:	2252 ft <sup>2</sup>
Foundation:	Conditioned Basement
Configuration:	3 bedrooms, 2 baths
SWA Contact:	Lois Arena

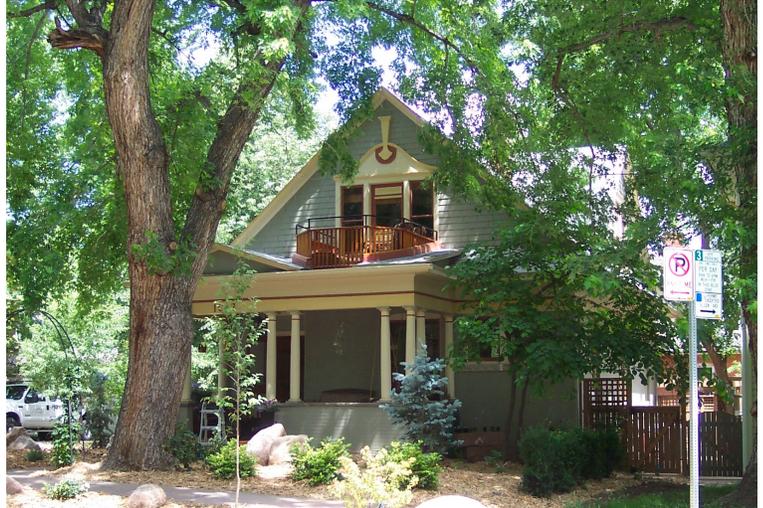
***This historic home scored 87 points on the SmartRegs checklist. The property owner must make some energy efficiency improvements to comply with Boulder's new ordinance.***

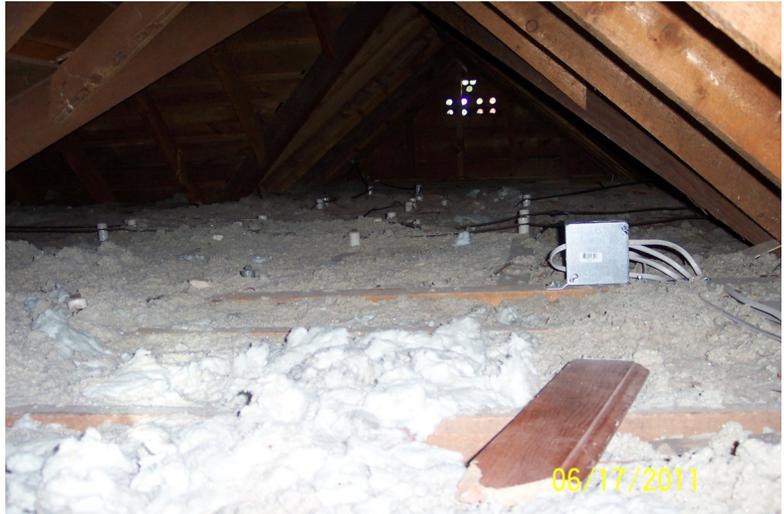
Insulation improvements to this home would be difficult in most areas, including the attic. There is no access to the knee wall areas on the 2nd floor, so insulating the sloped sections of the attic and the knee walls would not be possible without making several new access hatches. Another problem with insulating the attic is the presence of the knob and tube wiring, which should be replaced with knob wiring before any additional insulation is installed.

**Attic is only insulated to R-10 and contains knob and tube wiring.**

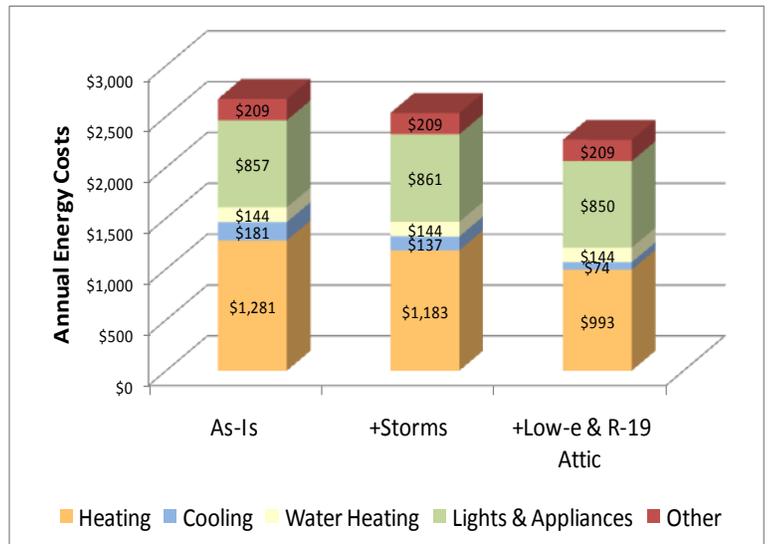
Predicted monthly utility bills for this property as it existed at the time of the initial inspection are displayed in the graph to the right. REM/Rate predicts an annual utility bill of \$2,672: about 50%, \$1,281, is attributed to heating.

Predicted utility bills from REM/Rate.

Installing storm windows (HERS index of 144) - results in predicted annual utility bill savings for the occupants of about \$138 per year.

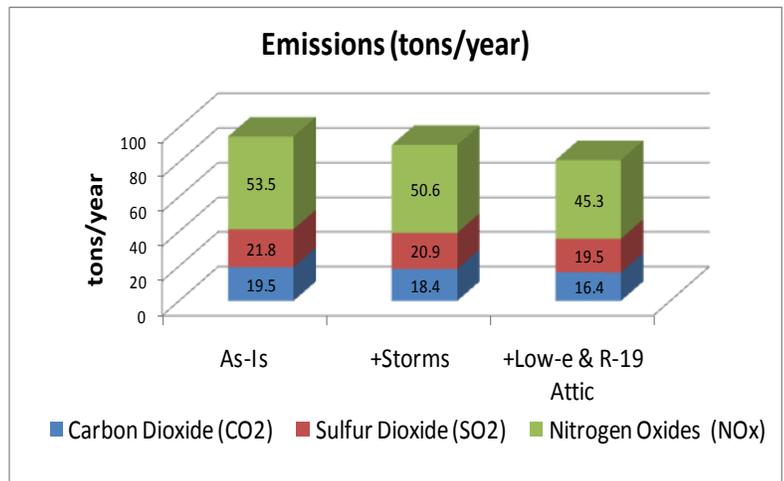
Predicted emissions reductions range from 4 to 7%. Total emissions are displayed in the graph to the right.

Predicted NO<sub>x</sub>, SO<sub>2</sub>, and CO<sub>2</sub> emissions from REM/Rate.

If efficiencies of the windows and attic were actually brought to the levels for which they are being (or would be, in the case of the windows) given credit on the SmartRegs checklist, annual savings increase to about \$400 per year, and emissions reductions range from 11 to 16% over the levels currently predicted for this property.
