CITY OF BOULDER
Facilities and Asset Management

Municipal Building and Senior Center

Structural Flood Assessment

April 22, 2013

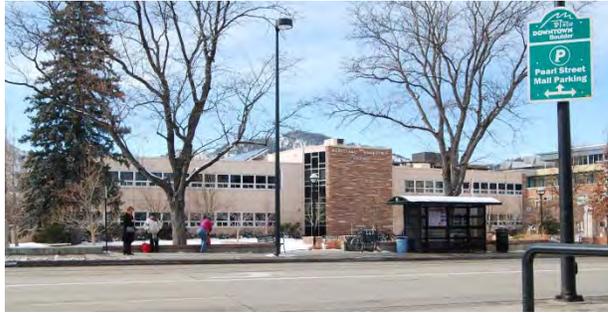
The Municipal Building is a 2-story concrete structure originally constructed in 1951 with an

addition added to the west side in 1962.

The original building was constructed with precast concrete roof and second floor panels supported on perimeter cast-in-place concrete spandrel beams and interior steel beams. The main floor is a concrete slab-

on-grade. The foundation consists of unreinforced concrete spread footings bearing approximately 10'-0" below the main floor elevation. The addition consists of 2-way cast-in-place concrete slabs on concrete columns supported by drilled piers and a perimeter grade beam. The bottom of grade beam is 3'-0" below the main floor elevation.

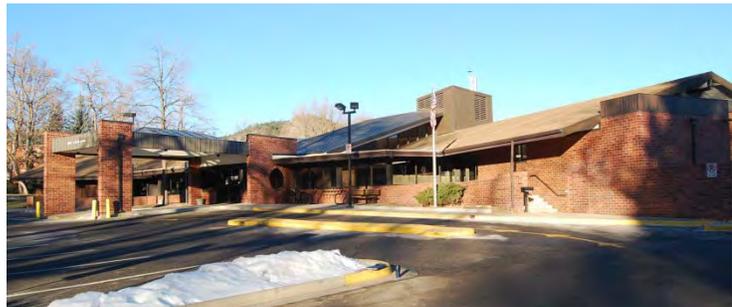
Drawings for the West Senior Center were provided by the City of Boulder. The structure is a 2-story wood, steel, and concrete structure consisting of a concrete slab-on-grade lower

level, post-tensioned concrete upper level floor slab, and wood truss roof framing. Post-tensioned concrete beams and precast concrete columns support the upper level post-tensioned

slab. Roof framing is supported on steel beams and columns. The concrete columns are founded on concrete spread footings. Based on the drawings, the footings bearing elevation is 3'-0" below the lower level elevation. Not shown on the drawings, the south and west sides of the lower level were closed off with precast concrete panels to bring grade up to the upper level. The northeast side has been enclosed with a wood fence to create a storage area.

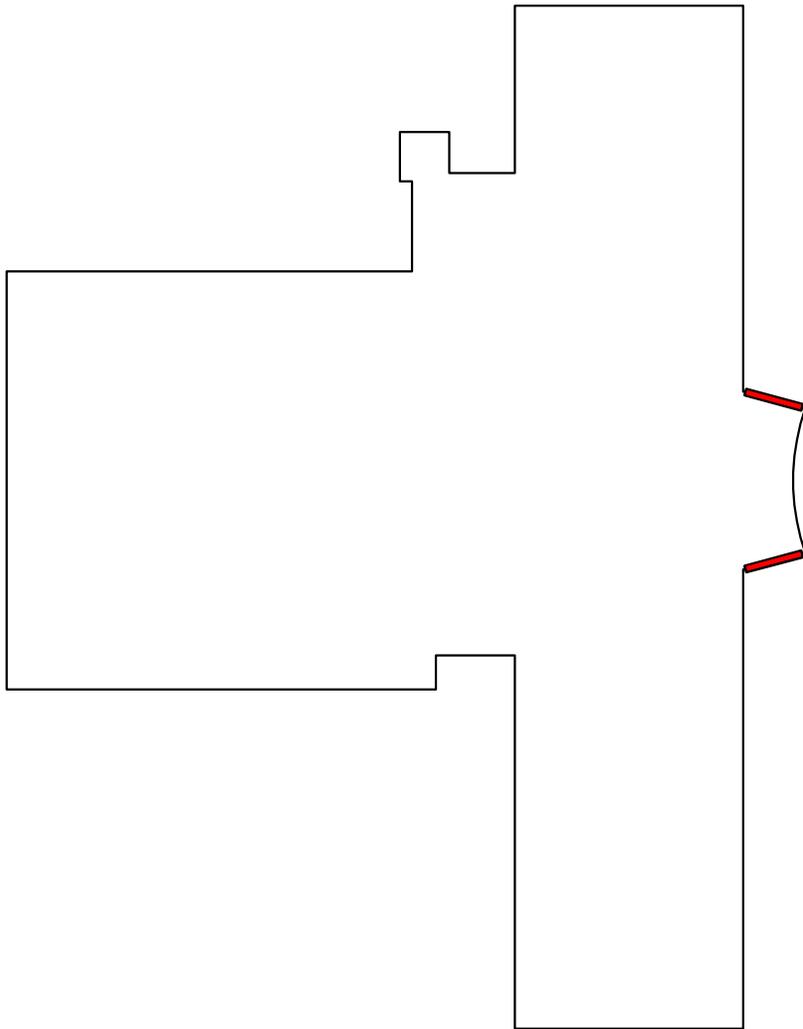
MUNICIPAL BUILDING IMPROVEMENTS

STOREFRONT INFILL/DOOR FLOODPROOFING

As indicated in table 7.1, the flood protection elevation is 2.61 feet above the first floor elevation of the Municipal building. Presently, the entrances are protected by a flood wall/passive flood gate system, which is above the flood protection elevation based on the 2012 Boulder Creek floodplain study. This system is adequate to protect the entrances from the flood loads. However, there is glazing extending to the floor elevation on the central portion of the east façade. The glazing will need to be protected by the addition of a concrete flood wall that extends to the flood protection elevation.

The City of Boulder is considering adding an entrance to the east wall of the original 1951 building. The proposed entrance can be protected from flood loads in a similar manner to the existing entrances by providing a flood wall extending out in front of the doors with a passive floodgate.

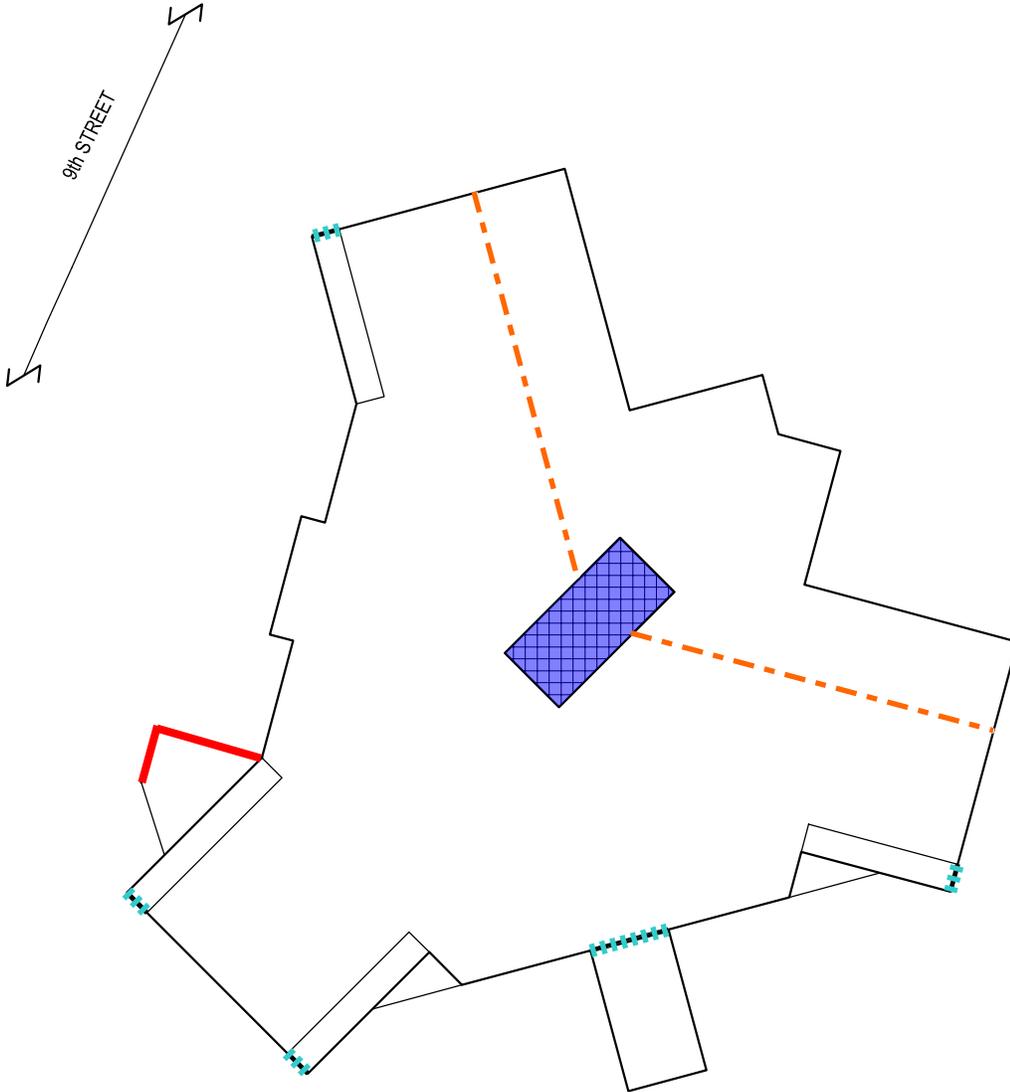
SENIOR CENTER IMPROVEMENTS

LEGEND	
	NEW FLOODWALL
	NEW PASSIVE FLOODGATE
	JOINT SEALING & DOOR FLOODPROOFING
	CORE FLOODPROOFING

As indicated in Table 7.1, the flood protection elevation is 2.50 feet above the upper level finished floor elevation, and 2.50 feet above the lower level finished floor elevation. The structure is located in a shallow flood zone with a base flood elevation defined as being 0.5 feet above grade. Much of the structure is protected to this elevation by the existing stud wall/brick veneer system. There are some lengths of wall, as well as the entrances, that would need to be protected. The entrances can be protected from flood loads by providing a flood wall extending out in front of the doors with a passive floodgate. The segments of wall which are wood-clad and not flood resistant can be infilled with masonry, or brick with wood stud back-up to match the existing brick. The storage area at the lower level would either need to be floodproofed, or abandoned. The doors to the mechanical core would need to be replaced with floodproof doors, and the precast concrete panel joints would need to be caulked to prevent water infiltration.

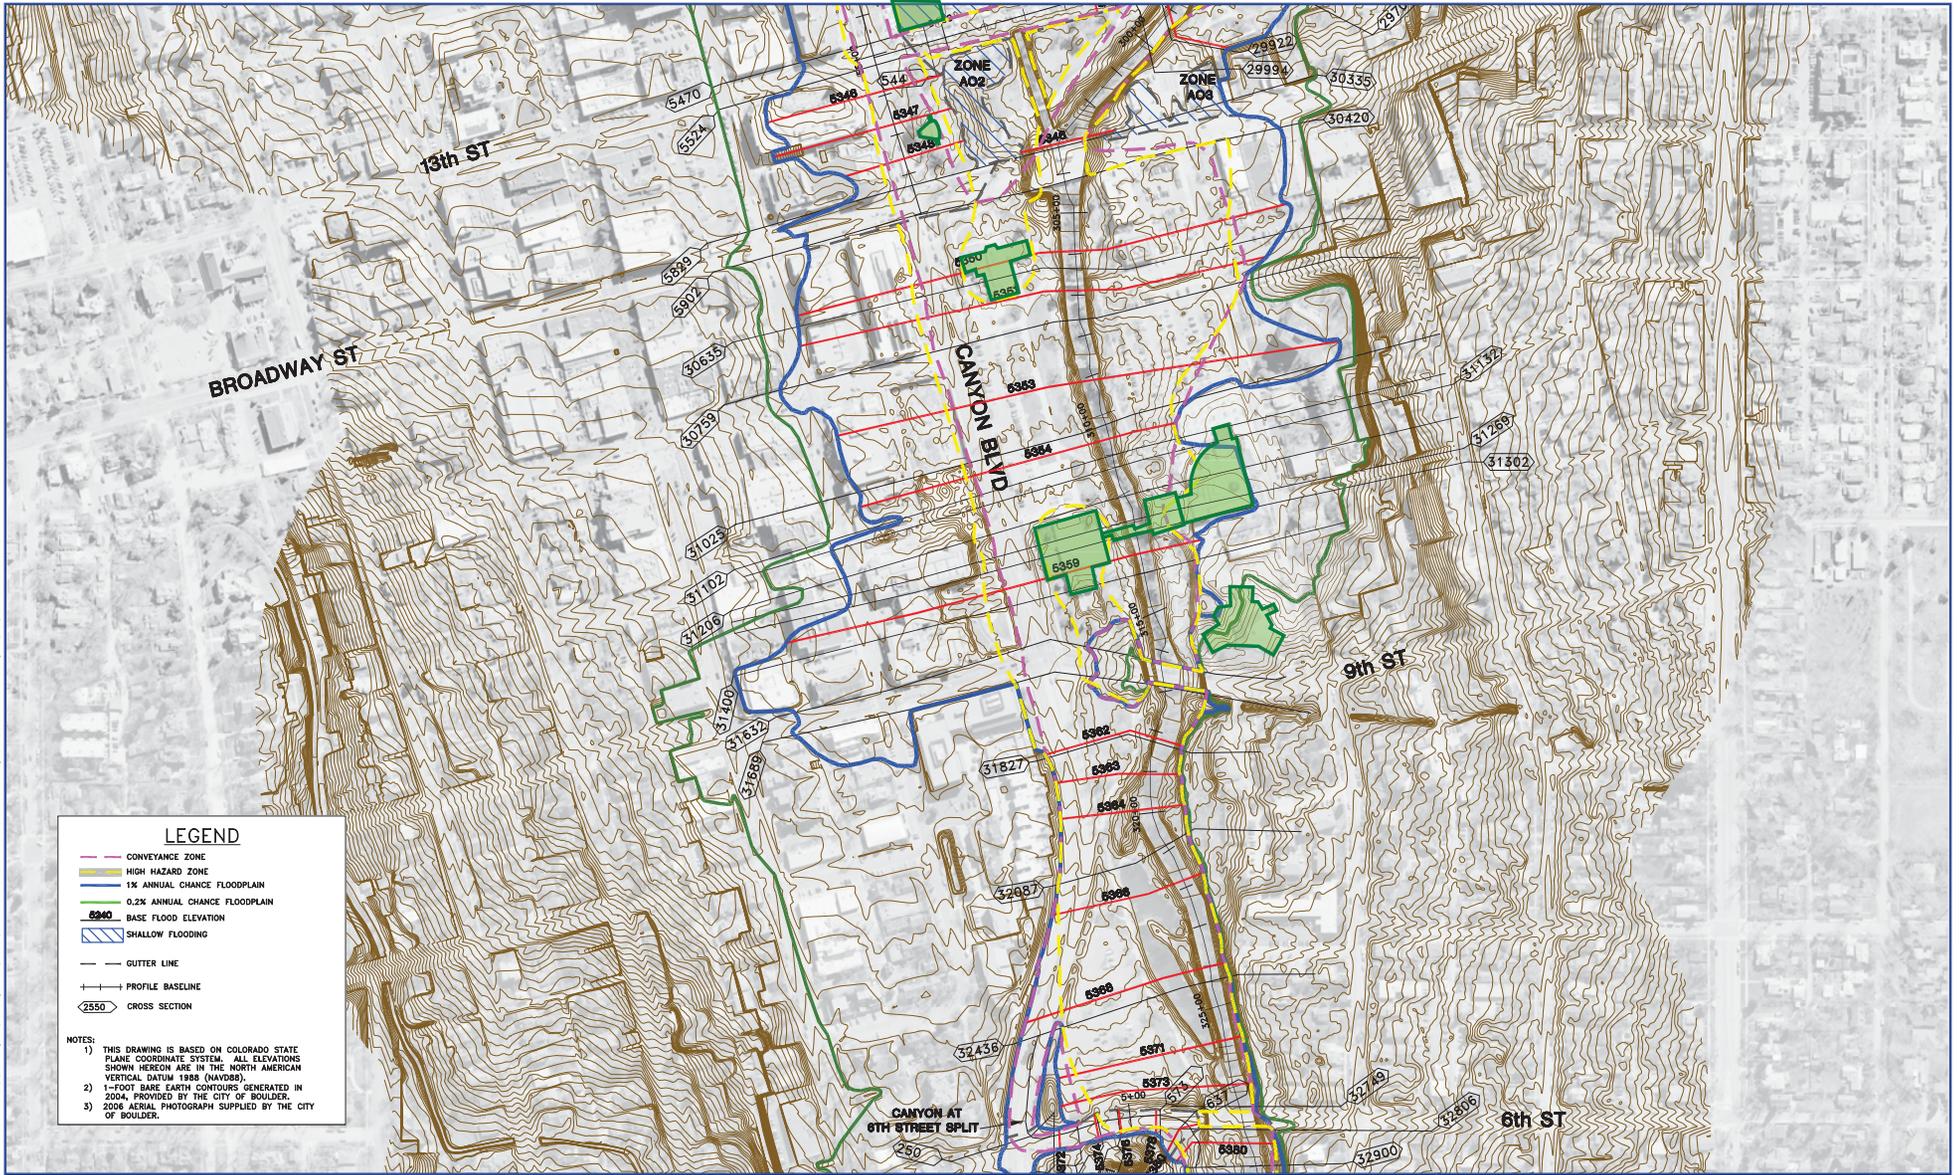
BOULDER CREEK
FLOOD HAZARD WORKMAP

- CONVEYANCE ZONE
- HIGH HAZARD ZONE
- 1% ANNUAL CHANCE FLOODPLAIN
- 0.2% ANNUAL CHANCE FLOODPLAIN
- BASE FLOOD ELEVATION
- SHALLOW FLOODING
- GUTTER LINE
- PROFILE BASELINE
- 2550 CROSS SECTION

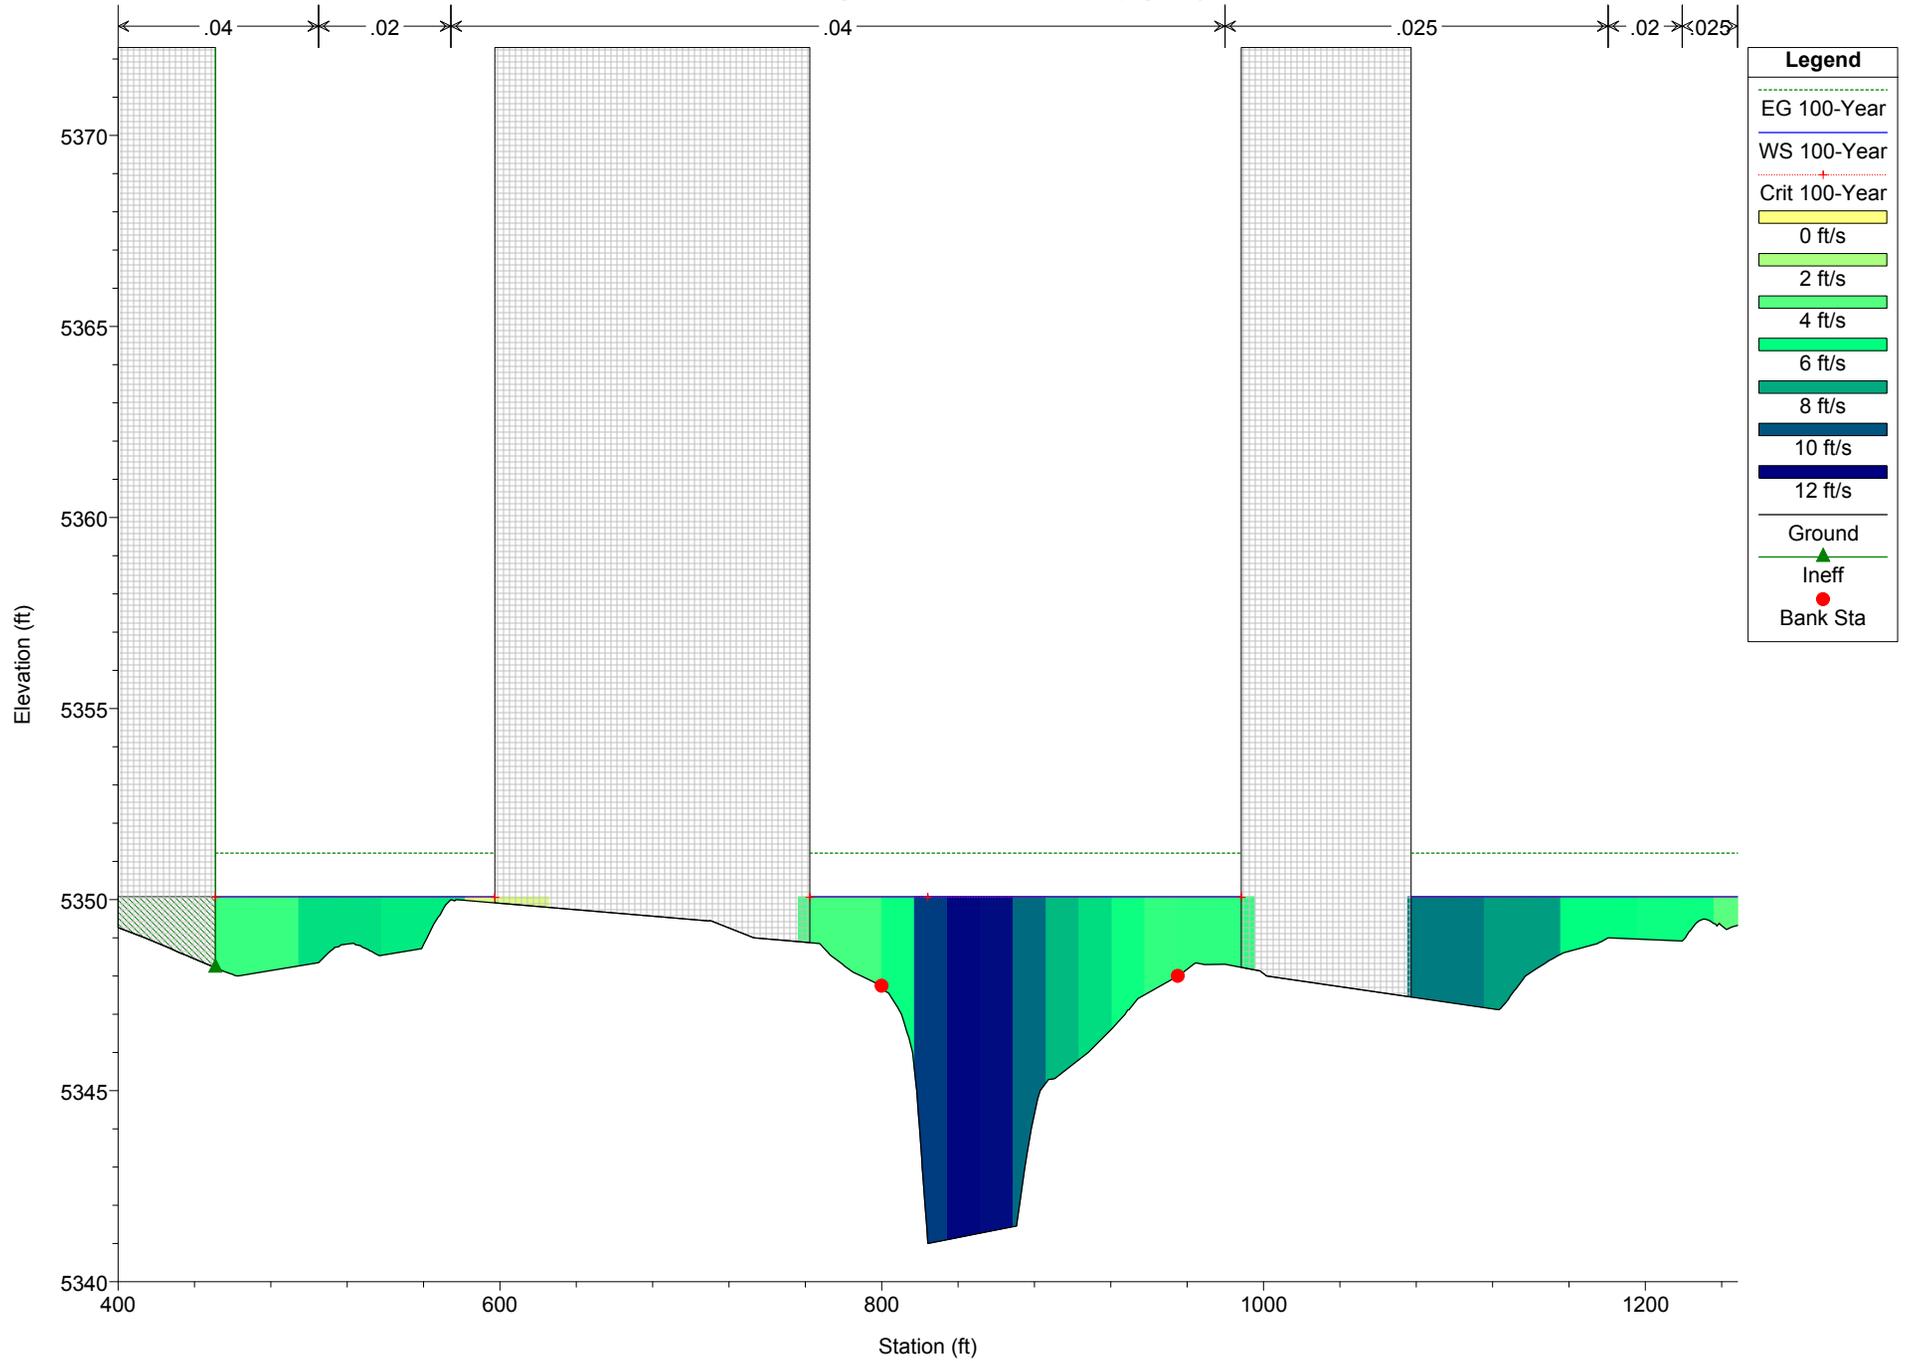
Plan: 100-yr Boulder Creek 6th-Broadway RS: 30635 Profile: 100-Year

E.G. Elev (ft)	5351.22	Element	Left OB	Channel	Right OB
Vel Head (ft)	1.14	Wt. n-Val.	0.031	0.040	0.026
W.S. Elev (ft)	5350.08	Reach Len. (ft)			
Crit W.S. (ft)	5350.06	Flow Area (sq ft)	259.19	845.31	373.19
E.G. Slope (ft/ft)	0.006854	Area (sq ft)	259.19	845.31	373.19
Q Total (cfs)	12000.00	Flow (cfs)	1388.65	7973.83	2637.52
Top Width (ft)	569.27	Top Width (ft)	183.94	155.18	230.15
Vel Total (ft/s)	8.12	Avg. Vel. (ft/s)	5.36	9.43	7.07
Max Chl Dpth (ft)	9.08	Hydr. Depth (ft)	1.41	5.45	1.62
Conv. Total (cfs)	144950.6	Conv. (cfs)	16773.9	96317.6	31859.1
Length Wtd. (ft)		Wetted Per. (ft)	187.26	157.35	235.36
Min Ch El (ft)	5341.00	Shear (lb/sq ft)	0.59	2.30	0.68
Alpha	1.11	Stream Power (lb/ft s)	3.17	21.68	4.79
Frctn Loss (ft)	0.69	Cum Volume (acre-ft)	0.64	3.99	1.74
C & E Loss (ft)	0.33	Cum SA (acres)
