**RAPID RESOURCE ASSESSMENT  
AND MANAGEMENT PLAN  
DODD OPEN SPACE  
BOULDER COUNTY, COLORADO**

ERO Project #4089

August 11, 2008

**DODD OPEN SPACE  
RAPID RESOURCE ASSESSMENT  
PHOTO POINT DOCUMENTATION – JANUARY 25, 2008**

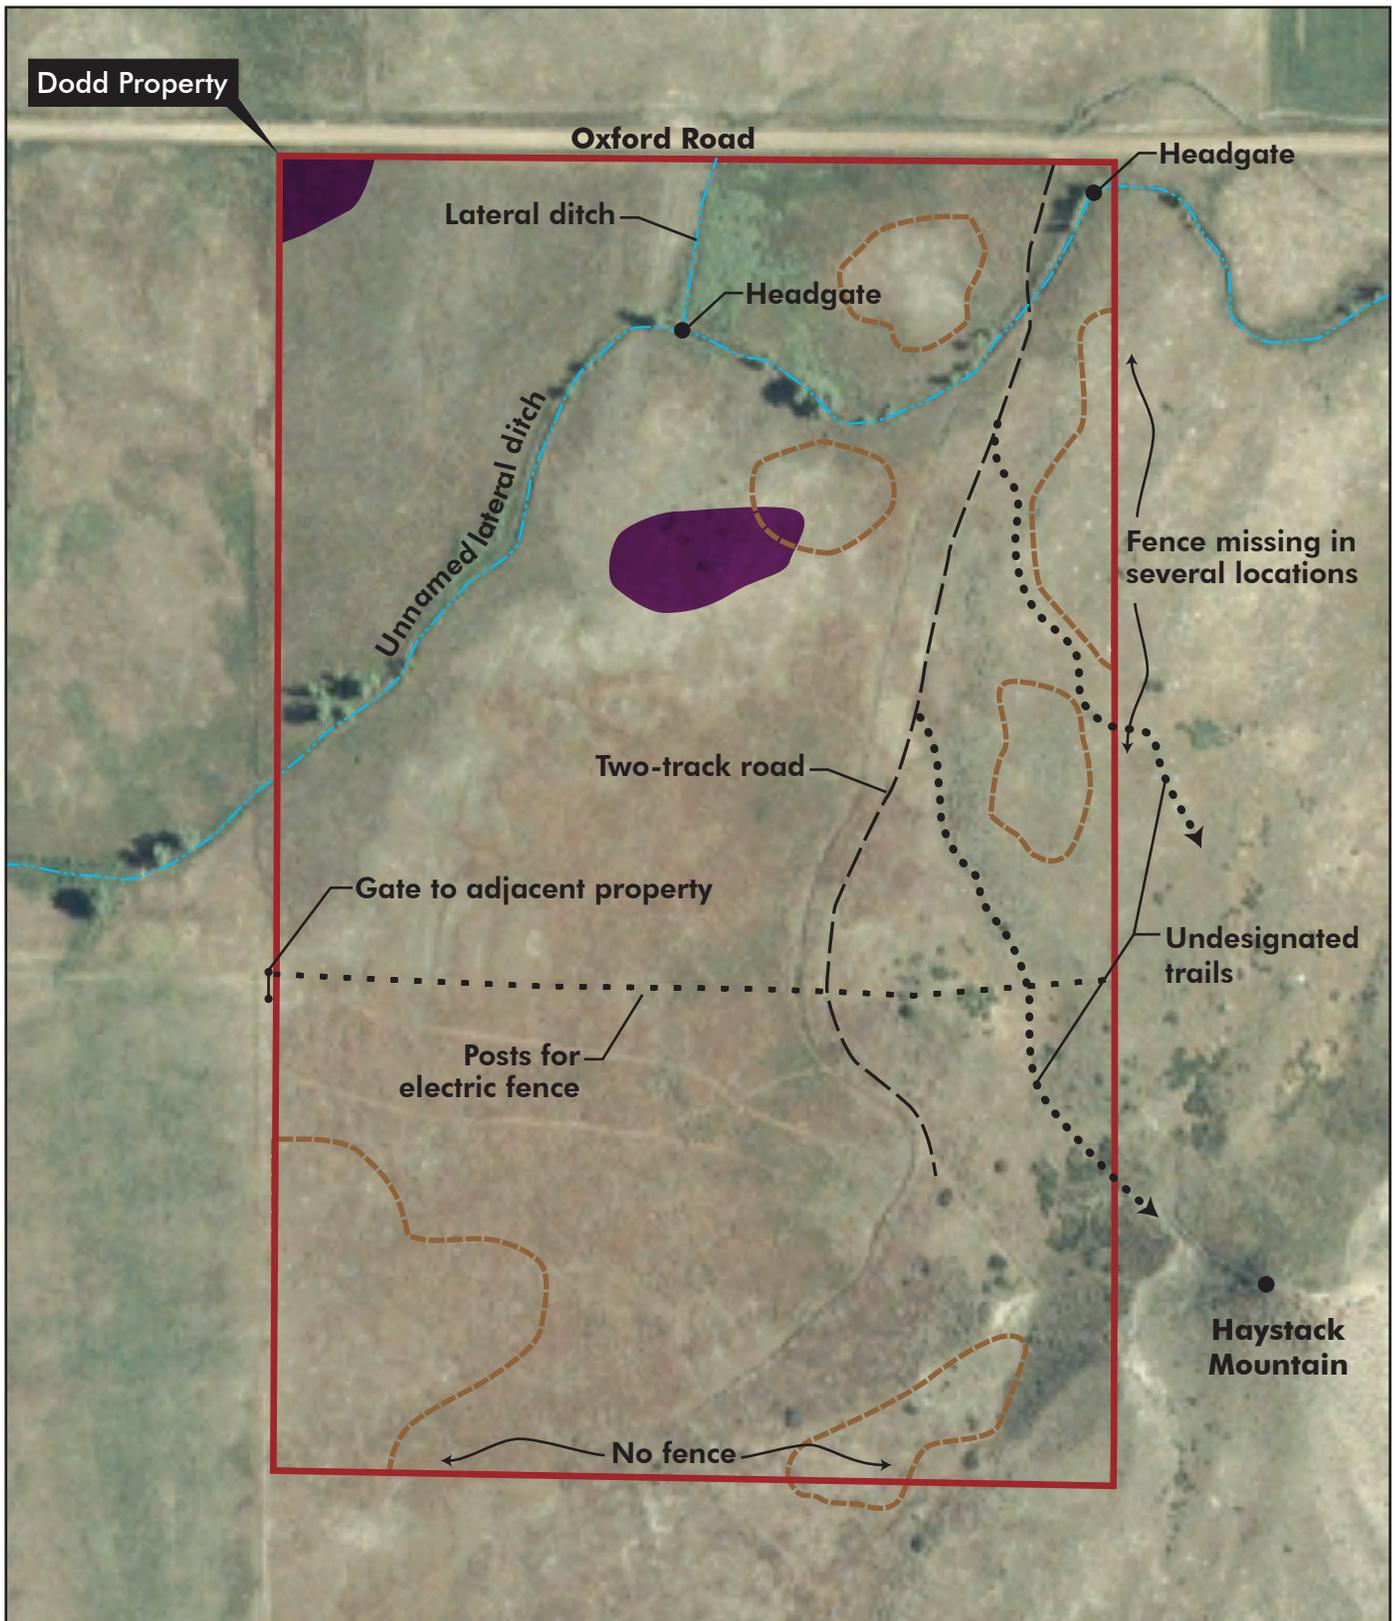
**Figure 3  
Property Features**

Fence missing in several locations

Action: Repair barbed-wire fence along eastern property boundary.

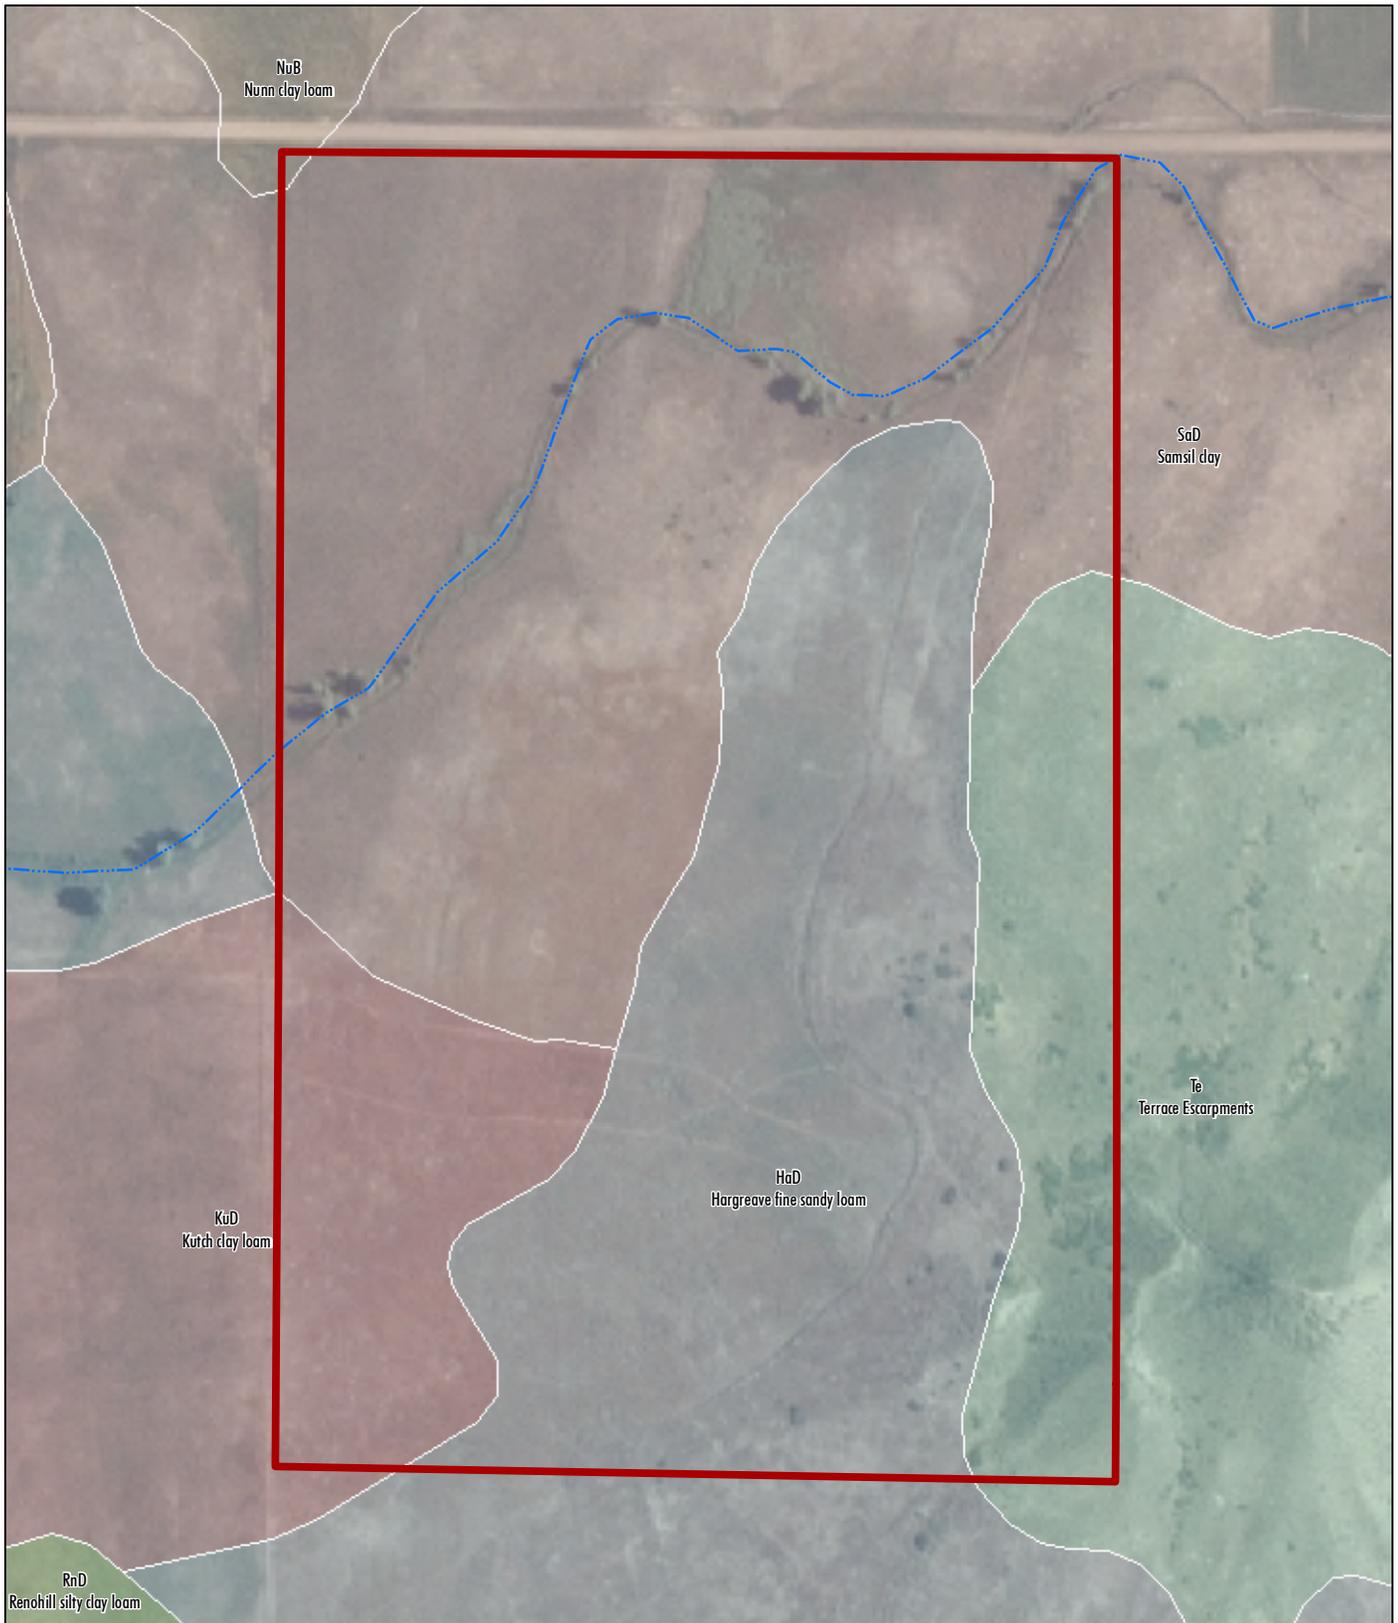
**Figure 4  
 Soils**

**Mapping Unit SaD. Samsil clay** (3 to 12 percent slopes). This soil includes small areas of shale outcrop, a few areas of Shingle loam, and a few small areas of Renohill silty clay loam. In places this soil has scattered gravel and cobbles on the surface. Runoff is rapid and the erosion hazard is

**Mapping Unit KuD. Kutch clay loam** (3 to 9 percent slopes). This soil includes small areas of Nunn clay loam, Samsil clay, Renohill silty clay loam, and Shingle loam. In some places scattered gravel and cobblestones are on the surface. Runoff is rapid and the erosion hazard is high. Native vegetation is western wheat, blue grama, sage, and cactus.

**Mapping Unit NuB. Nunn clay loam** (1 to 3 percent slopes). This soil includes small areas of Kim soils, Nunn sandy clay loam, Nunn clay loam, and Valmont clay loam. Runoff is medium, permeability is slow, and the erosion hazard is moderate. Native vegetation is blue grama, buffalograss, needlegrass and wheatgrass.

**Mapping Unit HaD. Hargreave fine sandy loam** (3 to 9 percent slopes). This soil includes small areas of shallow soils and sandstone outcrop, while many areas have scattered cobbles and gravel on the surface. Runoff is medium to rapid and the erosion hazard is moderate to high. Native vegetation is blue grama, buffalo grass, needleandthread, western wheatgrass, sage, and cactus.

**Mapping Unit Te. Terrace escarpments.** These areas consist of undifferentiated shallow soils that have many cobbles and stones on the surface. In many places there is merely a thin layer of cobbles over sandstone or shale. Only limited moisture is available for plants because these undifferentiated soils are shallow. Runoff is rapid and the erosion hazard is high.

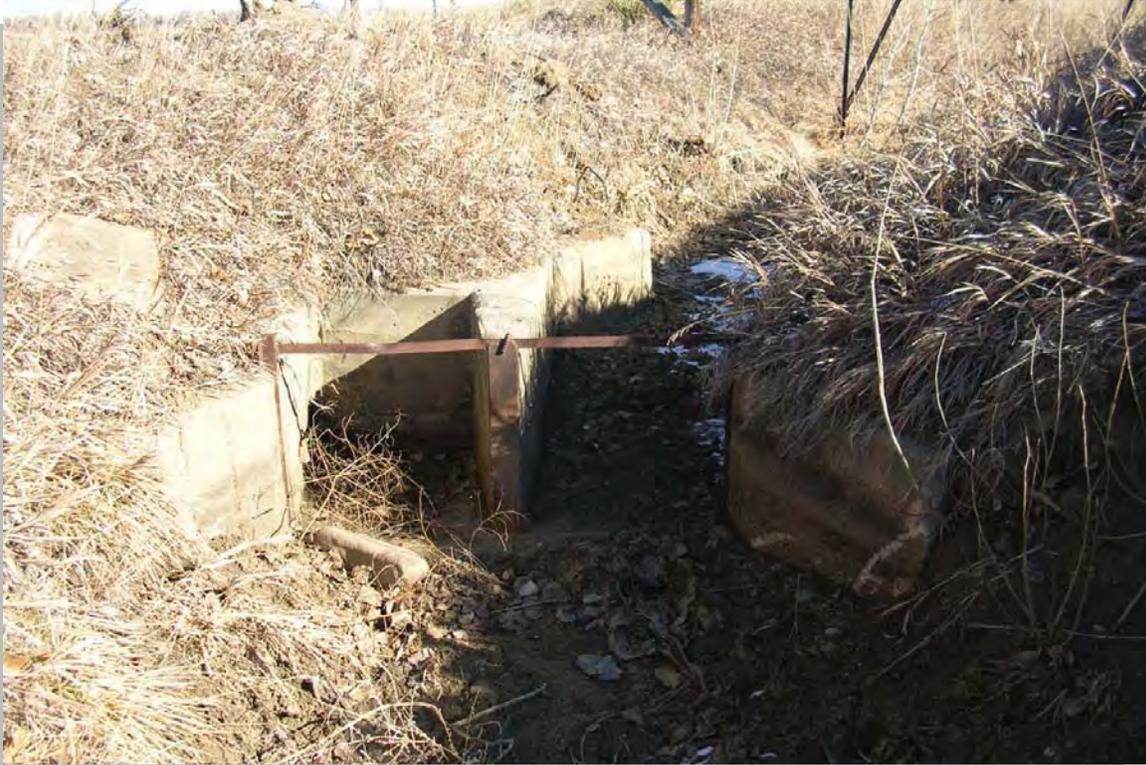
**Photo 5** - Ditch headgate in northeast corner of property.

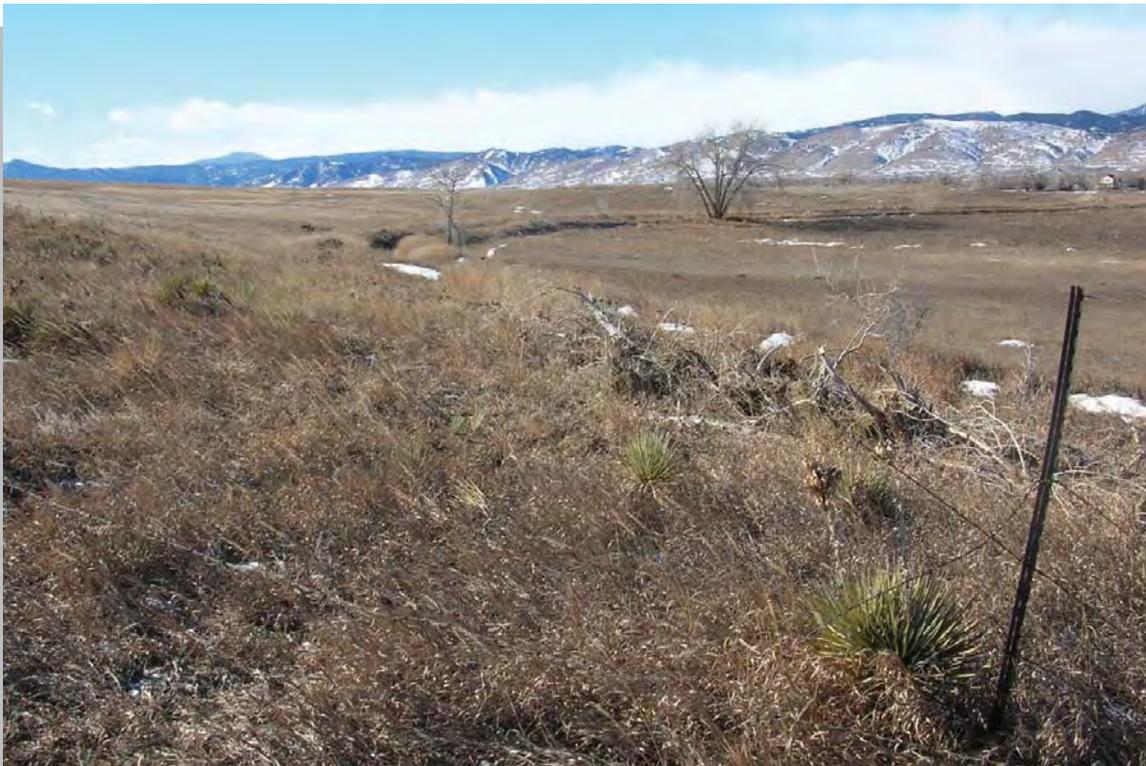
The property is bounded on three sides by barbed-wire and/or wood fences. (The southern boundary is not fenced). Several portions of the barbed-wire fence along the eastern boundary are either down or missing. A line of steel posts for temporary electric fencing crosses the center of the property in an east-west direction. An unnamed, unincorporated lateral ditch, with its associated headgates and culverts, winds through the northern half of the property.

**Photo 6** - View southwest through typical break in fence on east side of property.

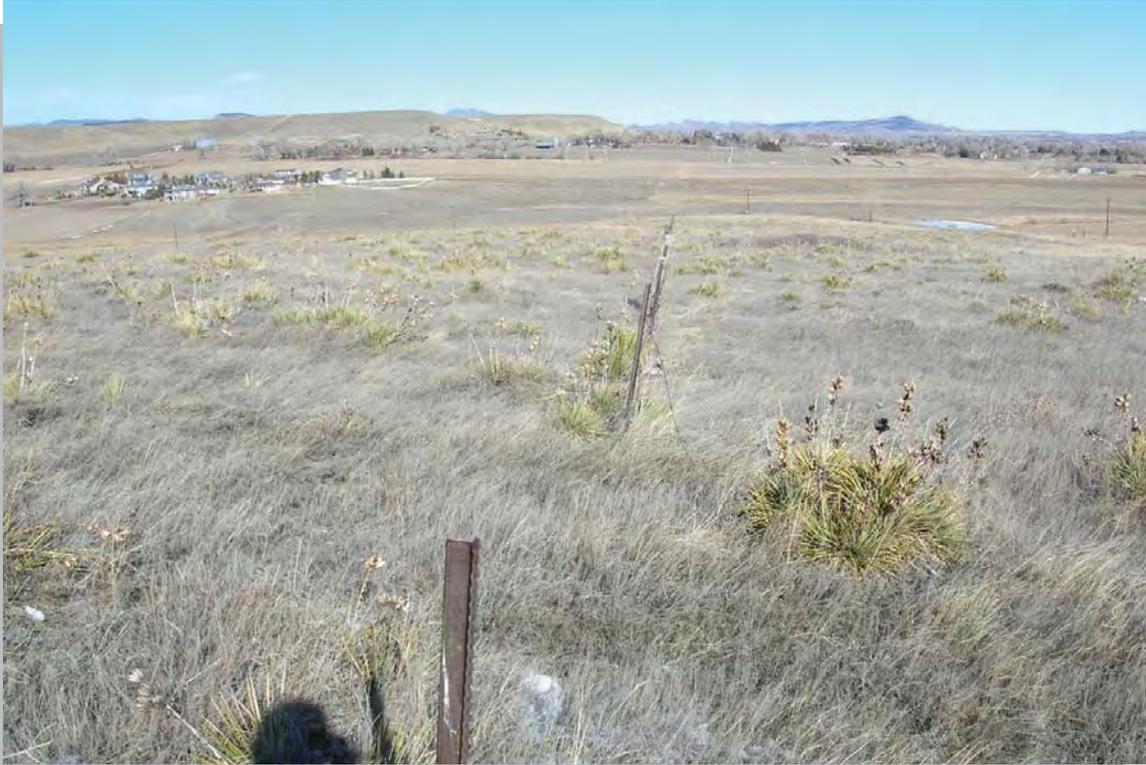
**Photo 7** - Cut fence on east side of property.

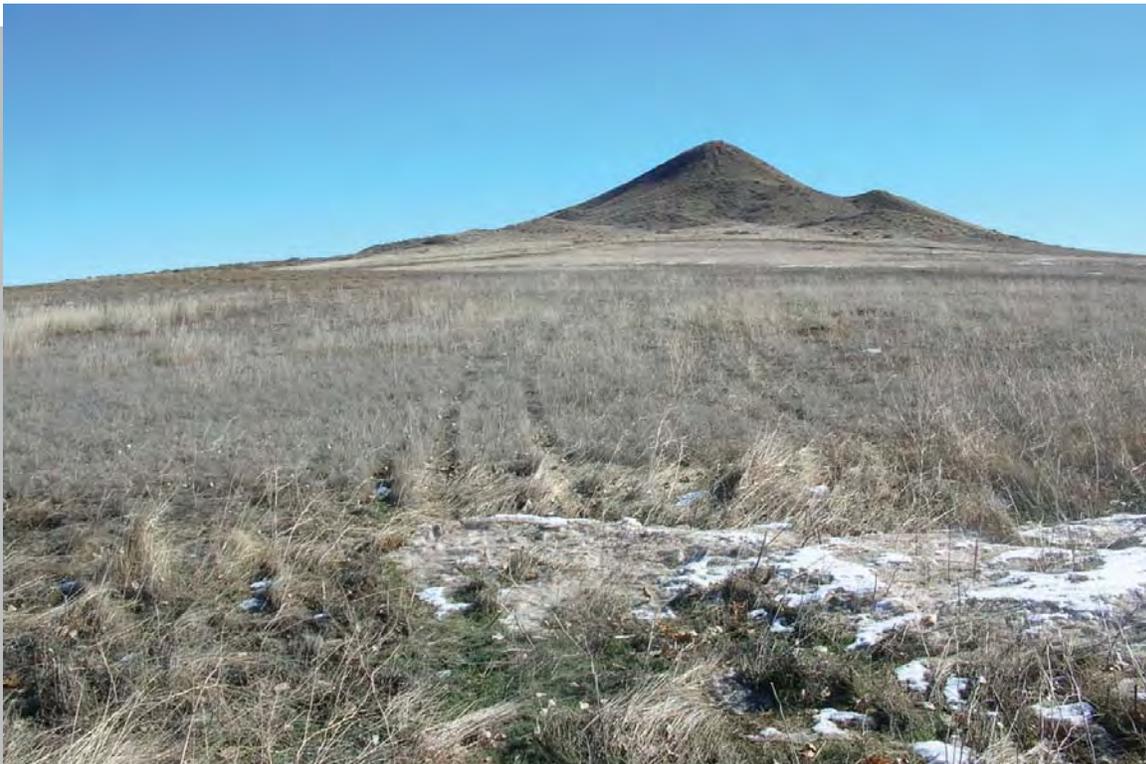
Several all-terrain vehicle (ATV) tracks were observed entering the property (through a gate) from the adjacent property to the west.

**Photo 26** - View east from west side of ATV tracks across property.

Action: Provide follow-up monitoring of use and potential resource damage.

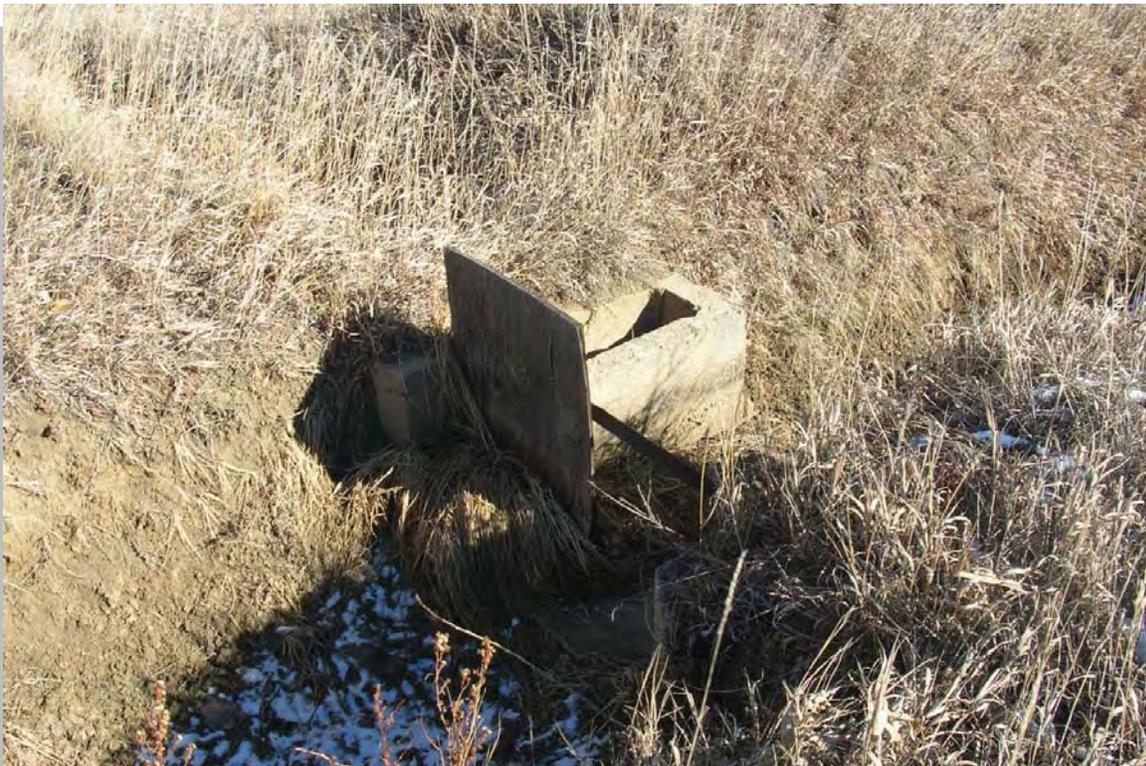
**Photo 32** - Ditch headgate on north side of property.

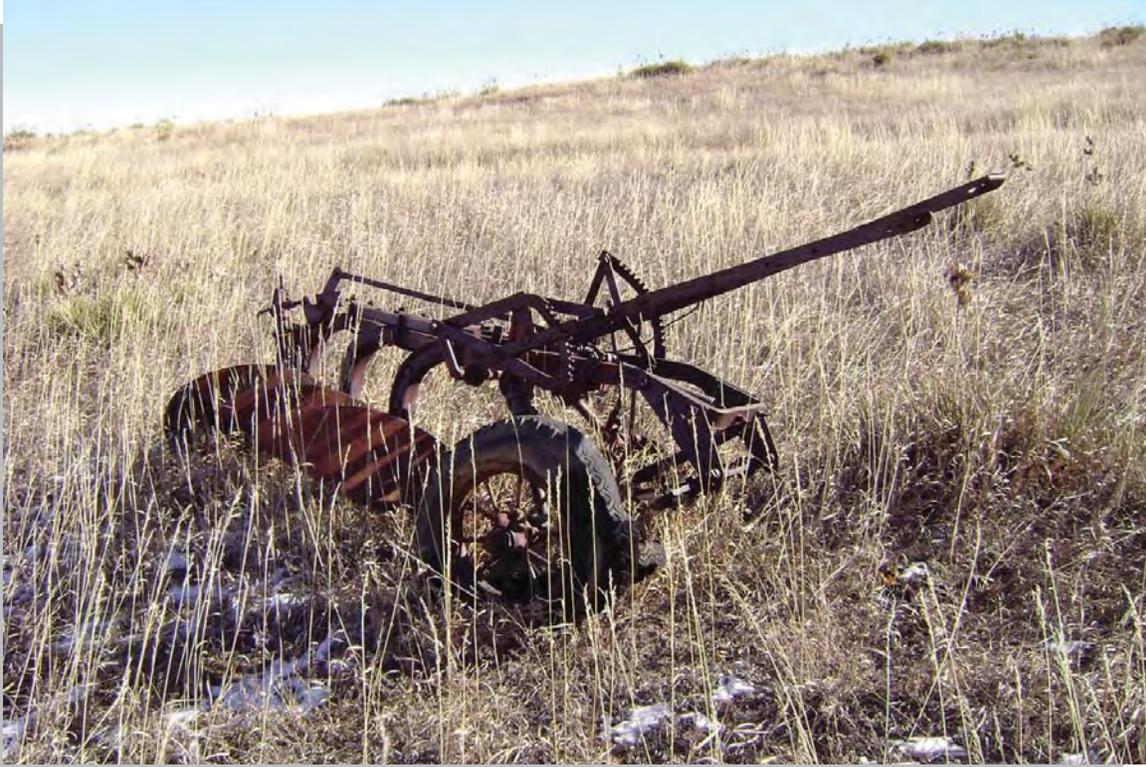
**Photo 35** - Old farming equipment in northeast corner of property.
