**RAPID RESOURCE ASSESSMENT
AND MANAGEMENT PLAN
KINEMAN OPEN SPACE
BOULDER COUNTY, COLORADO**

ERO Project #4089

August 11, 2008

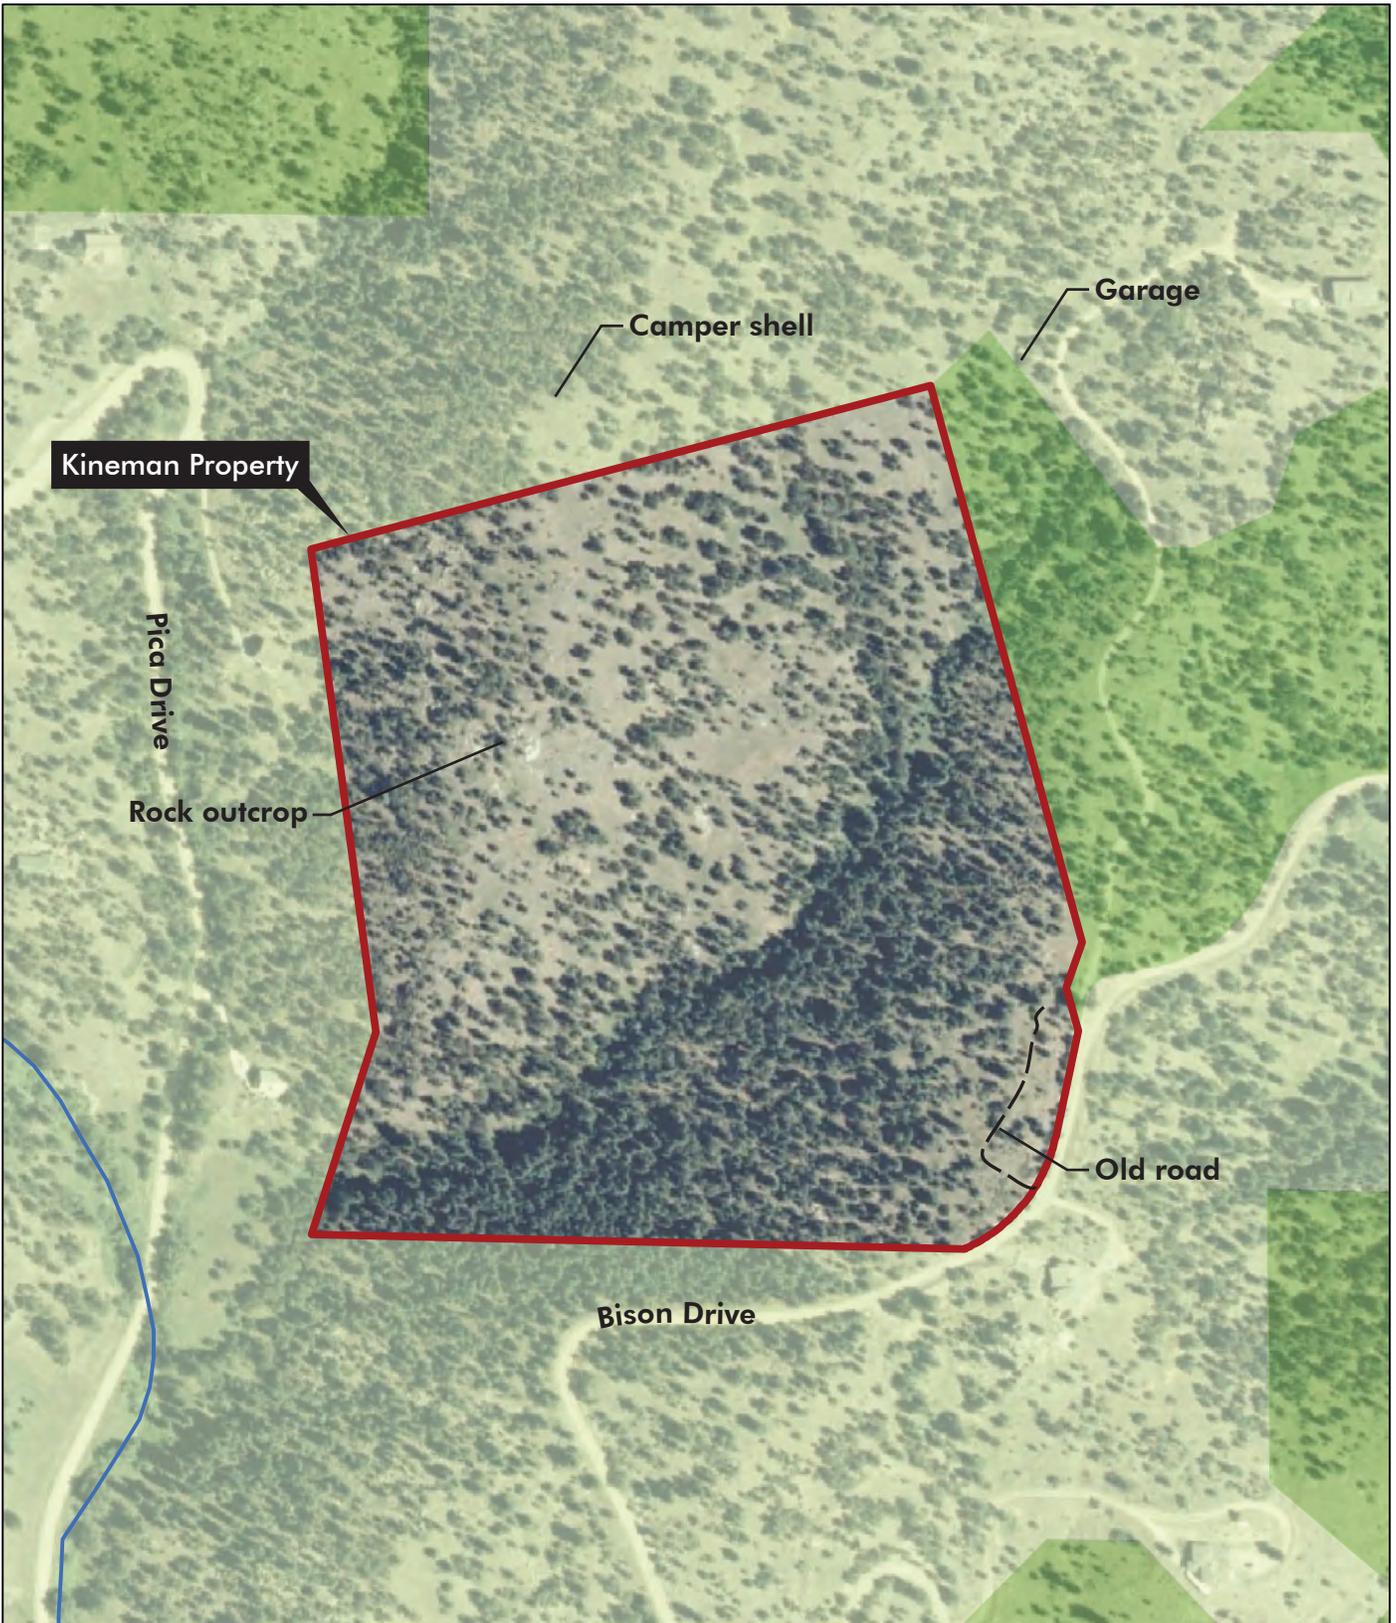
**Figure 3
 Property Features**

This section documents in more detail the basic physical and ecological characteristics and conditions that directly support the open space values of the property. Key features are shown on Figure 3.

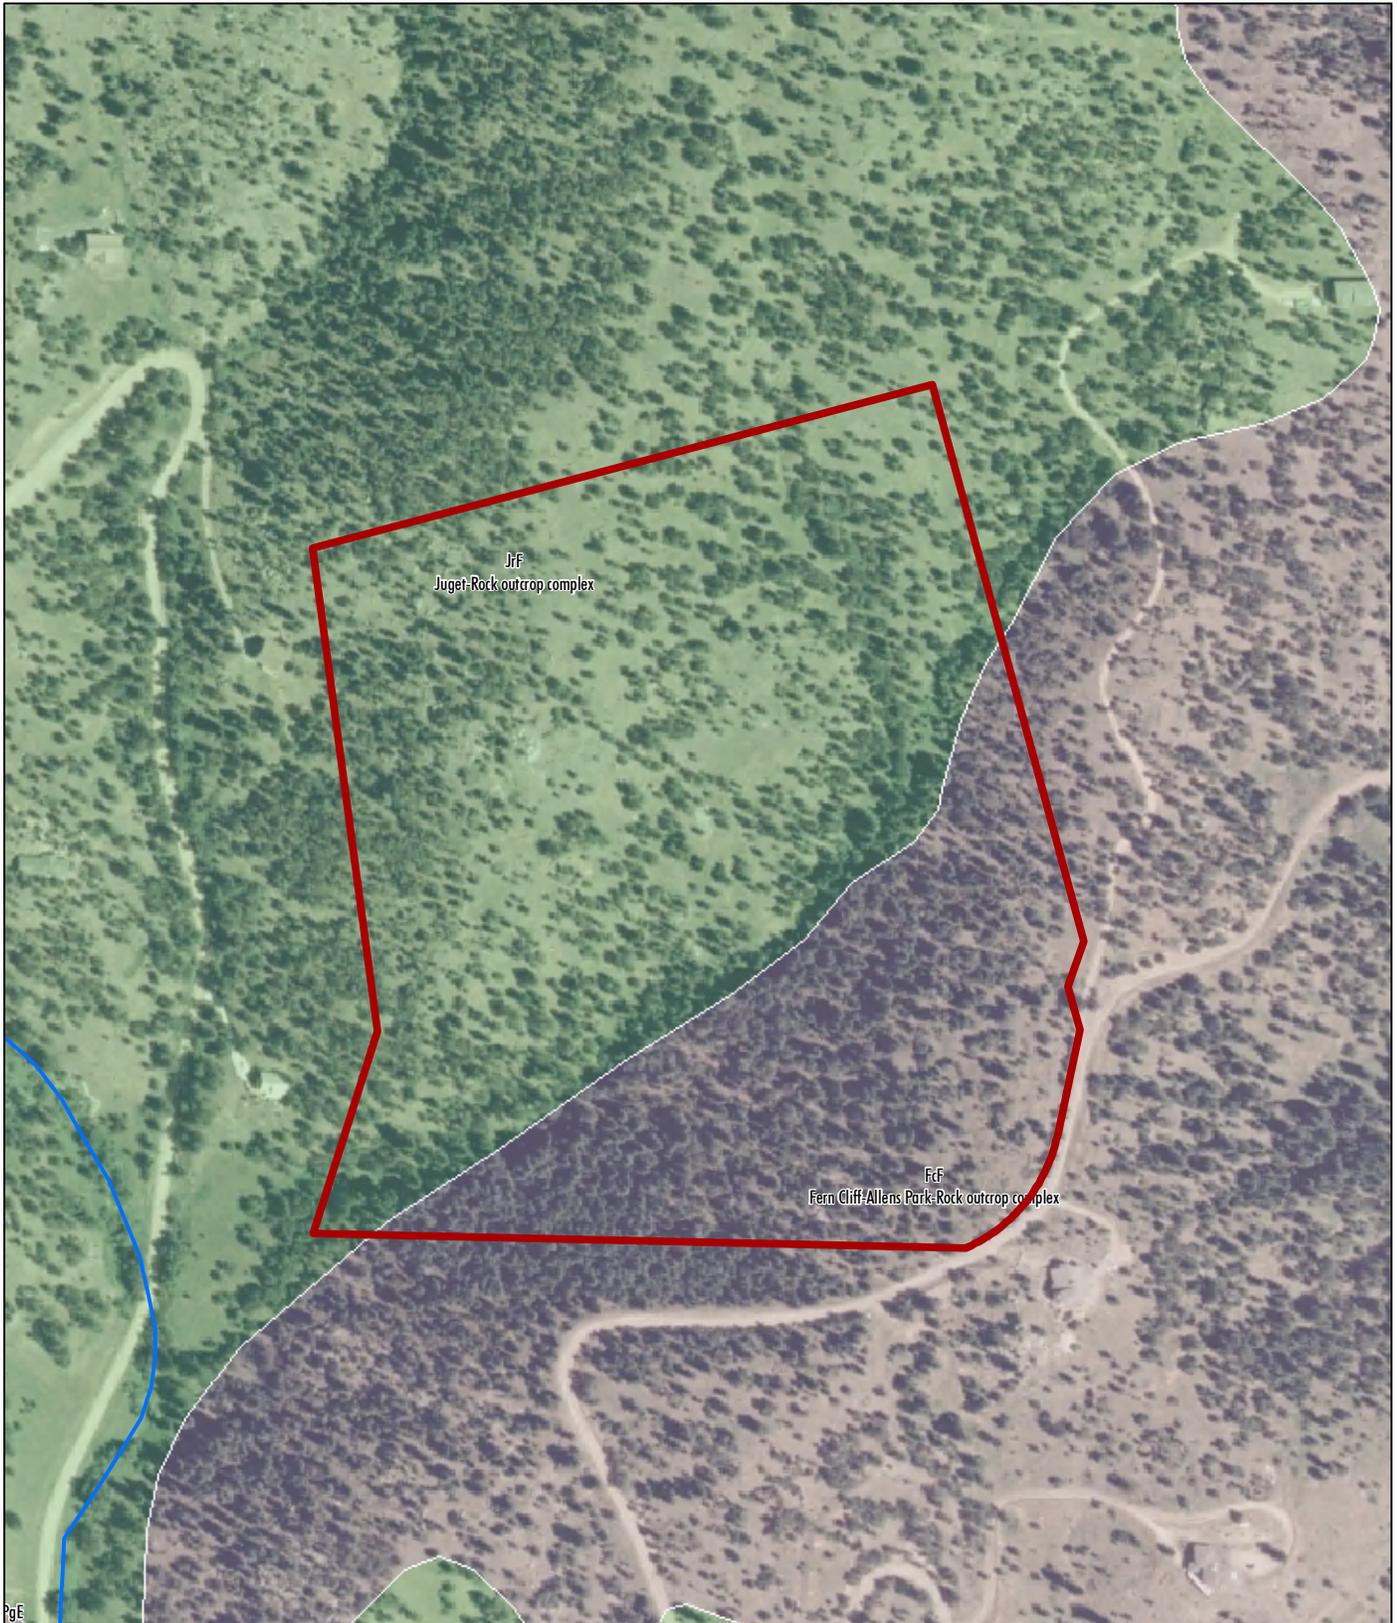
**Figure 4
 Soils**

The Natural Resources Conservation Service (NRCS) has mapped two soil types on the property. Each mapping unit is described below and Figure 4 shows the NRCS soil mapping. All soil information was gathered from the NRCS soil survey (NRCS 1975).

Mapping Unit FcF. Fern Cliff-Allens Park-Rock outcrop complex (15 to 60 percent slopes). This soil includes small areas of Fern Cliff stony loam sand, Juget soils, Peyton soils, and narrow bands of alluvial soils along drainageways. Runoff is medium to rapid and the erosion hazard is high. Native vegetation is mainly pine and fir woodland with an understory of fescue, mountain muhly, and pine dropseed.

Mapping Unit JrF. Juget-Rock outcrop (9 to 55 percent slopes). This soil includes small areas of Peyton soils near drainageways and a few small areas of Allens Park soils. Runoff is high and the erosion hazard is high. Native vegetation consists of spruce and fir at higher elevations and ponderosa pine, Gambel oak, mountain mahogany, and grasses at lower elevations.

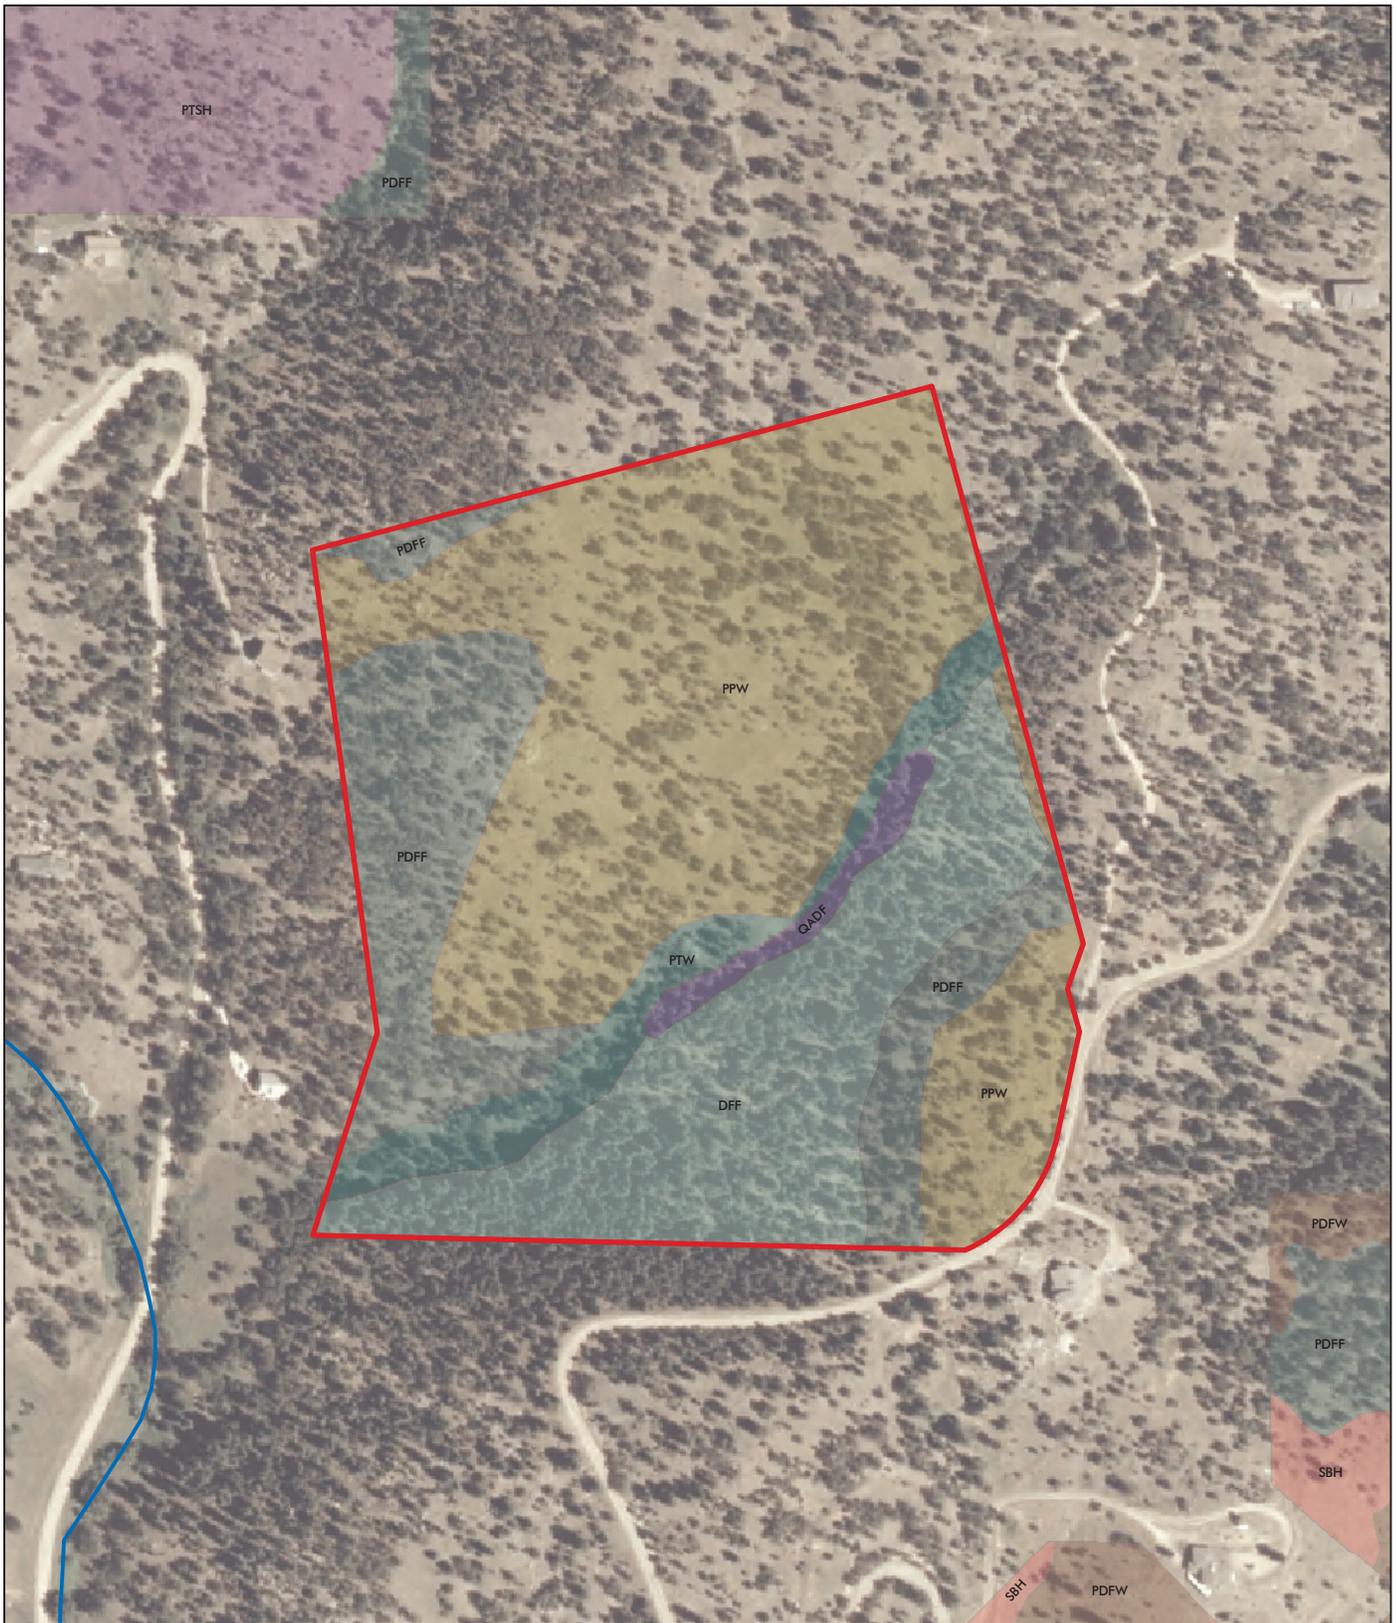
The property has steep slopes and valleys and is dominated by a ponderosa pine woodland alliance, a quaking aspen – Douglas fir woodland alliance, Douglas fir forest alliance, ponderosa pine – Douglas fir forest alliance and a ponderosa pine temporarily flooded woodland alliance. Vegetation communities are described below and shown in Figure 5. A list of plant species identified during the field visit appears in Appendix B.

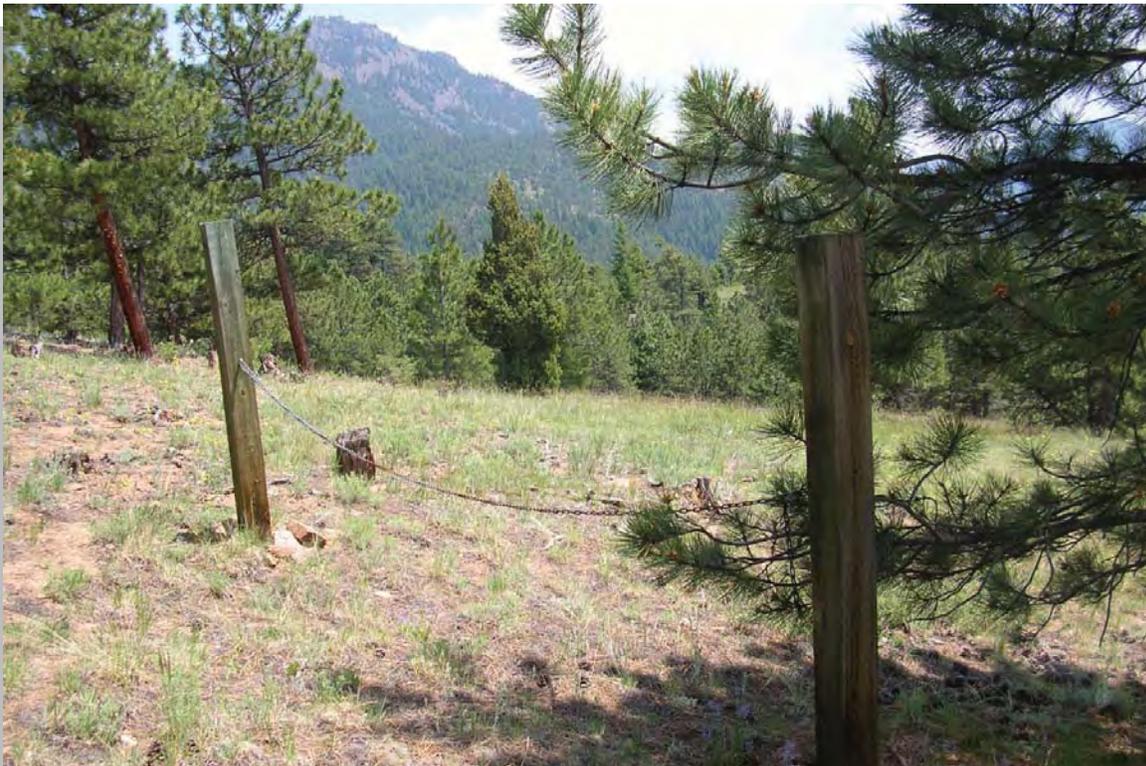
No fencing or utilities were observed on the property. A few “entryways” occur on the north side of the property. These were likely installed to promote real estate sales.

Photo 10 - View northeast along north side of property, including old lot entrance.
