Trail Condition Monitoring

Boulder Open Space and Mountain Parks

West Trail Study Area

October 2008

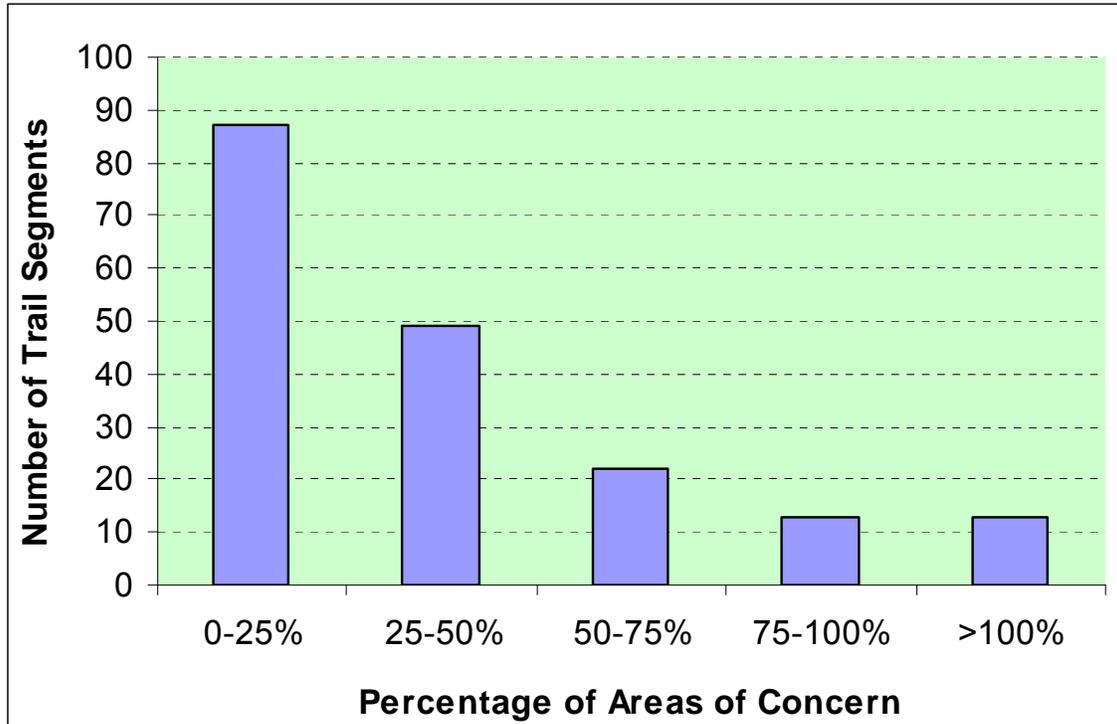
Figure 2: Number of trail segments within percentage ranges of areas of concern.

There are approximately 180 trail segments in the West TSA. Figure 2 shows the number of trail segments exhibiting areas of concern within certain percentage ranges.

OSMP staff developed a ranking system based upon the percentage of the trail that is designated as an area of concern. In this system “Good” refers to trail segments which exhibit areas of concerns along less than 25% of their total segment; “Fair” means approximately 25% to 75% of the segment length exhibits an area of concern; “Poor” means 75% to 100% of the segment length exhibits an area of concern; “Very Poor” means there are overlapping areas of concern and summing to a coverage of greater than 100% of the trail segment. Attachment B contains a map showing the condition by color for the trail segments in the West TSA.).

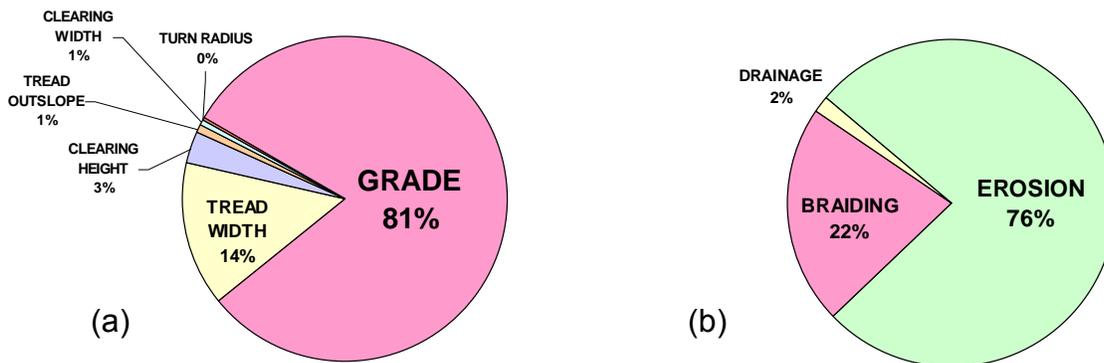
Trail grade was responsible for over 80% of the non-compliance (Figure 3a). The total length of all non-compliant trail grade portions was fifteen miles. This is twenty-one percent of the trail system in the West TSA. These issues occurred mostly in the mountain backdrop and canyons where the terrain is steep and confined. However, many grade issues also occur on gentler terrain as well.

Figure 3 shows the factors most responsible for non-compliance with sustainability guidelines.

Maintenance issues were identified totaling 12 miles of trail in the West TSA. Erosion was the primary problem identified. Erosion was noted as a problem for about nine miles of trail or twelve percent of the West TSA trail system. Most eroded portions occur in the following areas: Kohler Mesa, mountain backdrop, Flagstaff Road area, Red Rocks and Mount Sanitas. Most eroded sections co-occur with areas that are too steep. Figure 3b shows the relative proportion of different types of maintenance issues and highlights the significance that erosion represents in the TSA.

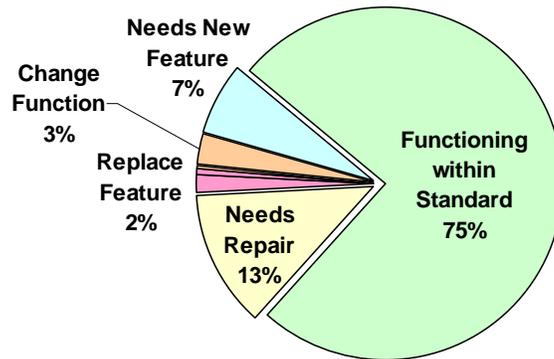
Figure 4: Condition class of constructed features in the West TSA.

A total of 4,295 constructed features are associated with trails in the West TSA. Thirty percent of these features are natural waterbars, 20% are rock steps, 15% are stacked rock retaining walls, 10% are log steps, 10% are rock waterbars and the remaining 15% are other features. Figure 4 shows the condition class distribution of the constructed features associated with trails in the West TSA. Three-fourths of the features are functioning within standard. Thirteen percent of the features are in need of repair. The bulk of the features in need of minor repair are natural and rock waterbars which need extensive rehabilitation. Also, various rock and log steps and stacked rock retaining walls are in need of repair. Many have loose logs and/or rocks and need to be secured. The major features recommended to be installed are natural waterbars and steps to assist with grade or erosion issues associated with certain trail segments.
