## MEMORANDUM

**SUBJECT:** Public hearing and consideration of an application for a Landmark Alteration Certificate to construct an addition to the building, replace non-historic windows and restore the historic façade of Whittier School at 2008 Pine Street, an individually landmarked property, per section 9-11-18 of the Boulder Revised Code 1981 (HIS2015-00243).

1. Site: 2008 Pine St.
2. Designation: Individual Landmark
3. Historic Name(s): Pine Street School, Whittier School
4. Date of Construction: 1882
5. Zoning: RMX-1 (Residential-Mixed 1)
6. Lot size: 103,693 sq. ft.
7. Proposed Addition: 1,056 sq. ft.
8. Applicant: Rodwin Architecture
9. Owner: Boulder Valley School District

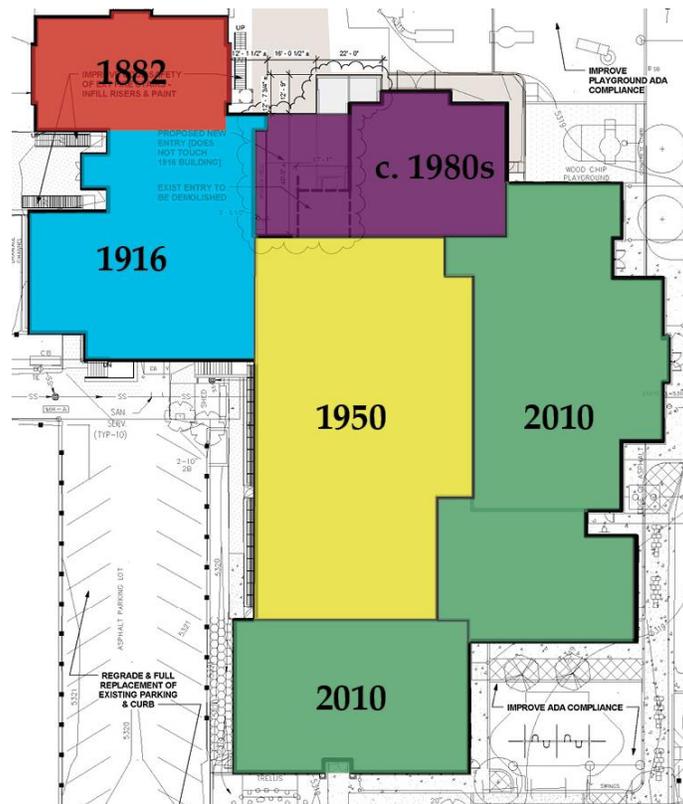
Several additions have been added to the original 1882 construction. The first was in 1916 and was constructed to the south (rear) of the old school. Around 1950, the school was further extended to the south with an addition of an auditorium and stage. In the 1980s, the neighborhood raised money to replace the bell tower (which had been removed in the early 1900s) and a brick library was also constructed to the north of the 1950 addition. In 2010, a large addition was constructed to the east and south of the 1950 addition. See Figure 4: Building Construction History of 2008 Pine St.

Figure 4. Building Construction History of 2008 Pine St.

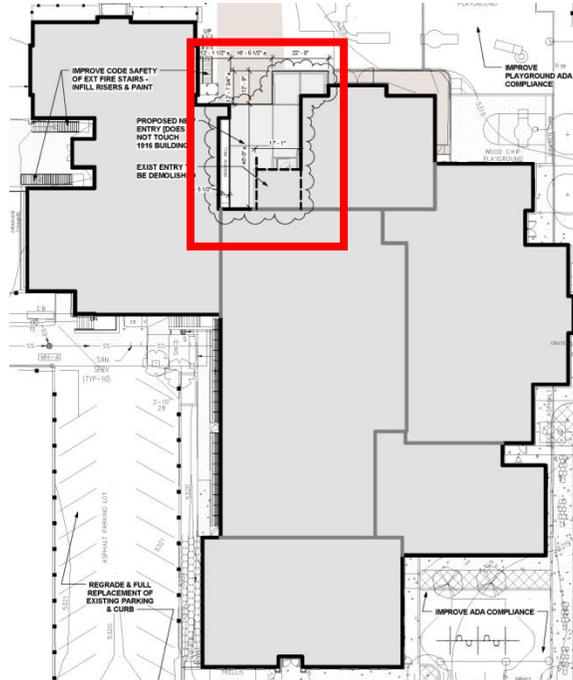
Figure 5. Site Plan. Location of north entry proposal outlined in red.

Around 1980-2000, an entry was constructed on the north side of the building to the east of the 1916 addition. In order to make room for an additional classroom, the applicant proposes the removal of this non-historic entry (measuring 746 sq. ft.) with the construction of a larger entry in its place. The new entry, measuring 1,820 sq. ft., would house the new administrative offices and provide a secure entry as required by new Boulder Valley School District standards. This

rearrangement of the north entry will allow for the construction of two new Americans with Disabilities Act compliant bathrooms on the 2<sup>nd</sup> floor, and one of the 1<sup>st</sup> floor. The new entry will add 1,056 sq ft to the building's footprint.

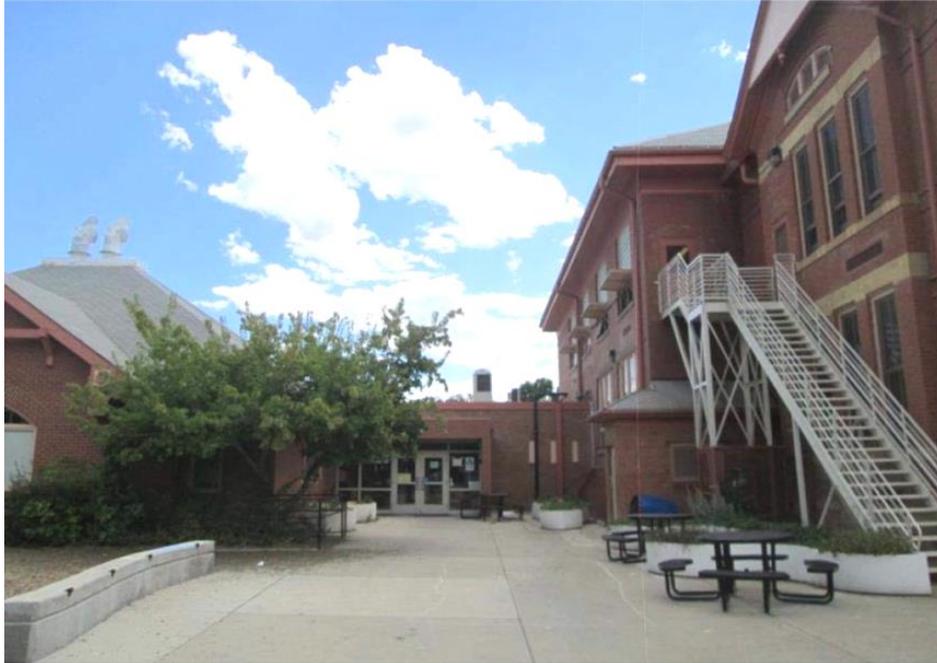
Figure 7. Existing North Elevation, 2015. North entry in center, 1882 and 1916 Schoolhouse on right. 1983 library on left.

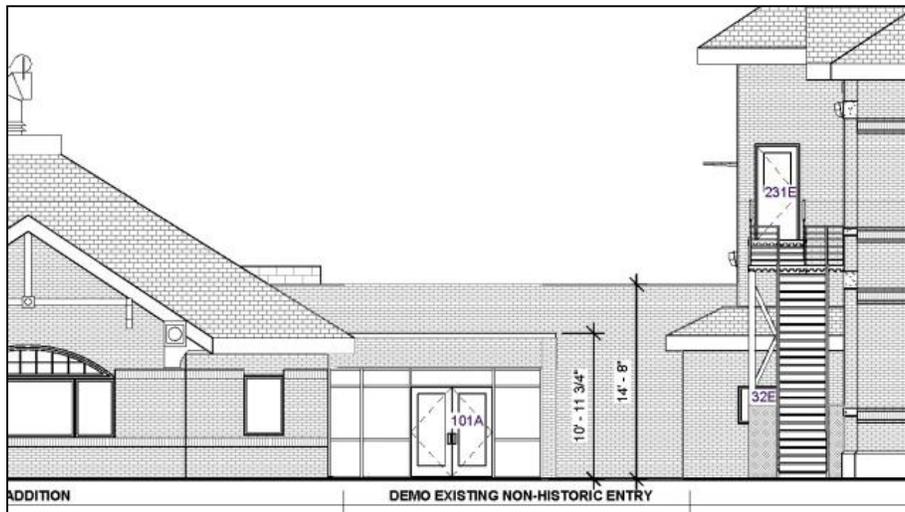
Figure 8: Existing north entry detail.

In concept, the design of the north entry is a glass cubic form intended to provide an open view to the east wall of the historic 1916 portion of the school. In plan the north wall of the new construction is shown to be set back between 18' & 32' feet from the façade of the 1882 school building. The current non-historic entry proposed for removal is located approximately 56' back from the 1882 façade.

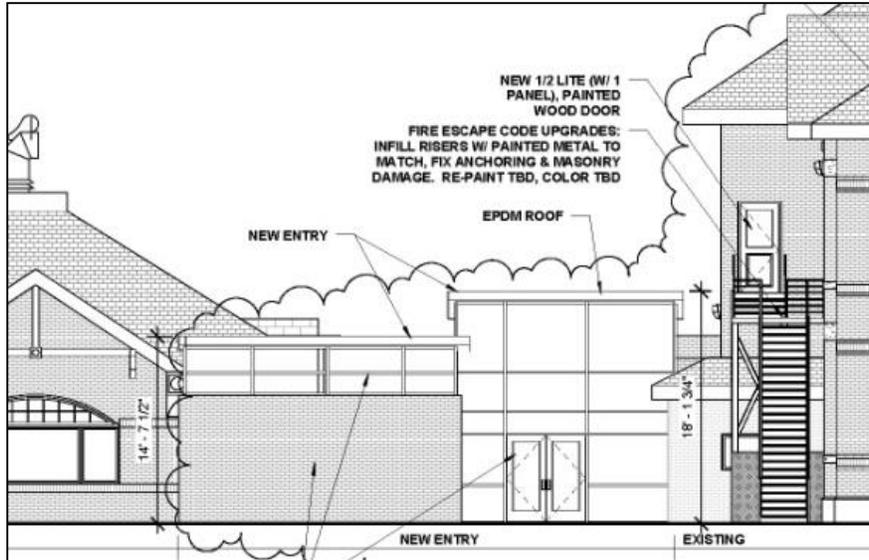
Figure 9: Proposed north entry detail.

The proposed north entry will not be attached to the 1916 portion of the building with the exception of a wall of a small mechanical stair bump-out. A window well will separate the rest of the 1916 building from the proposed entry. This is intended to minimize impact on the historic portion of the school.

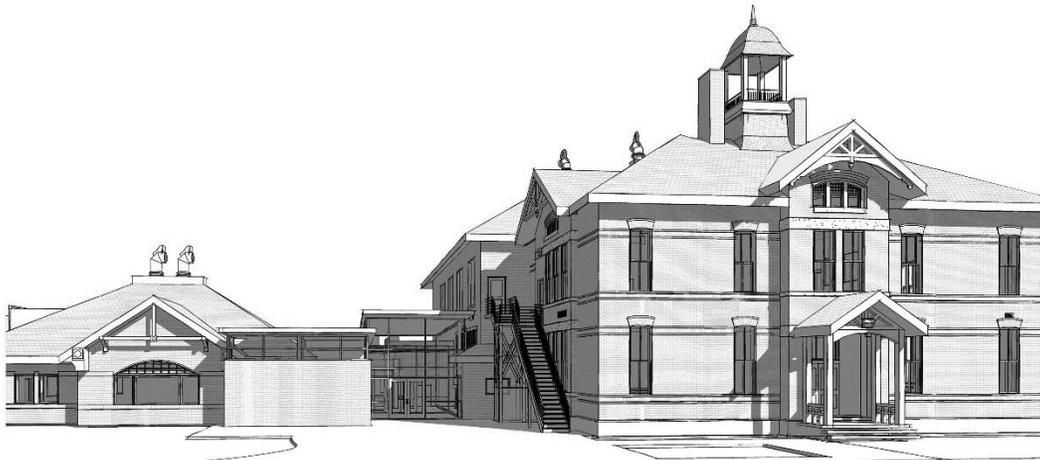
Figure 10: Rendering of proposed north entry.

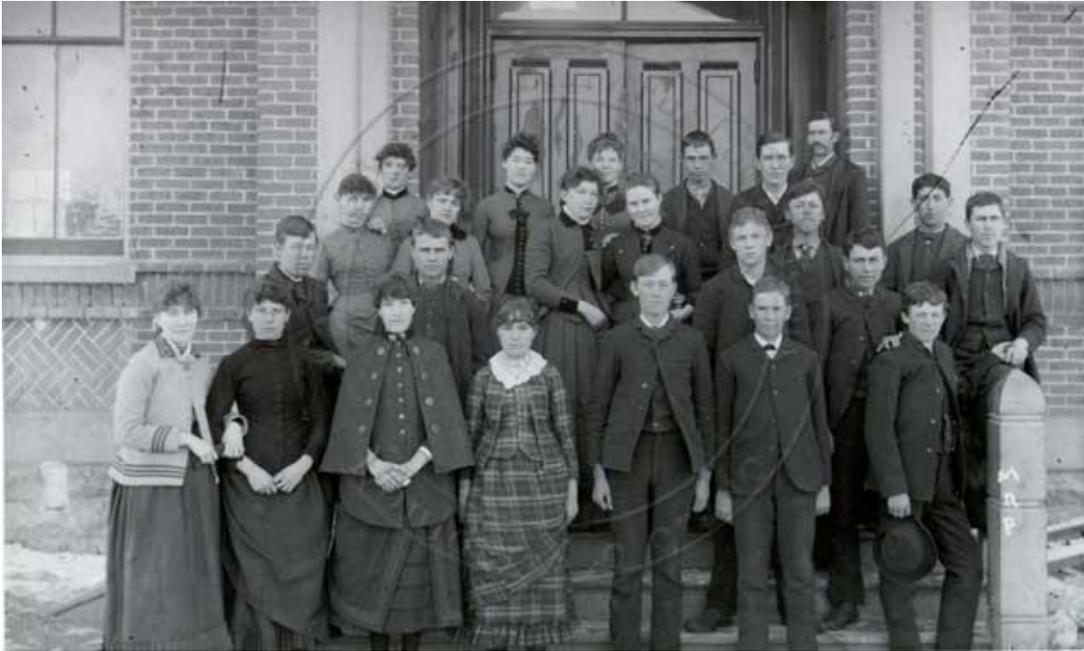
Figure 11: c.1910 graduation photograph with historic doors in background.

The non-historic doors of the original 1882 building and the 1916 addition are shown to be replaced with energy efficient doors that closely replicate the historic doors shown in historic photographs. A door and window assessment submitted with the application shows the non-historic doors having being installed in either 1997 or 1998. The other non-original openings in the 1916 building, which are currently metal, will be replaced with painted wood doors with a clear glass half-lite.

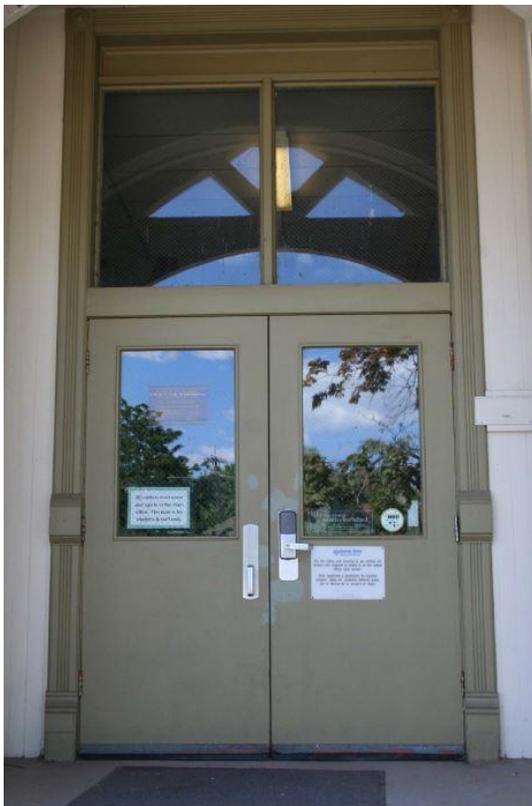
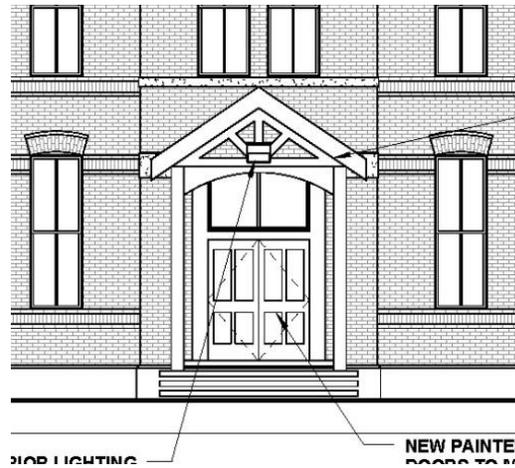
Figure 12. Detail of existing (l) and proposed (r) north entry doors on 1882 school house.

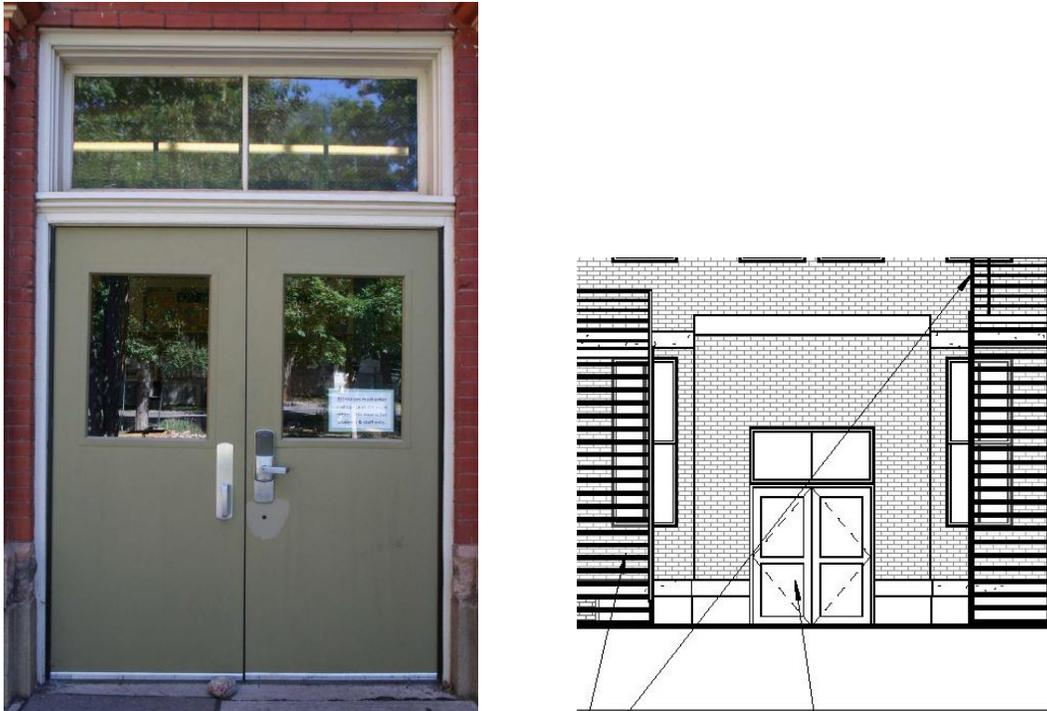
Figure 13. Detail of existing (l) and proposed (r) west entry doors on 1916 addition

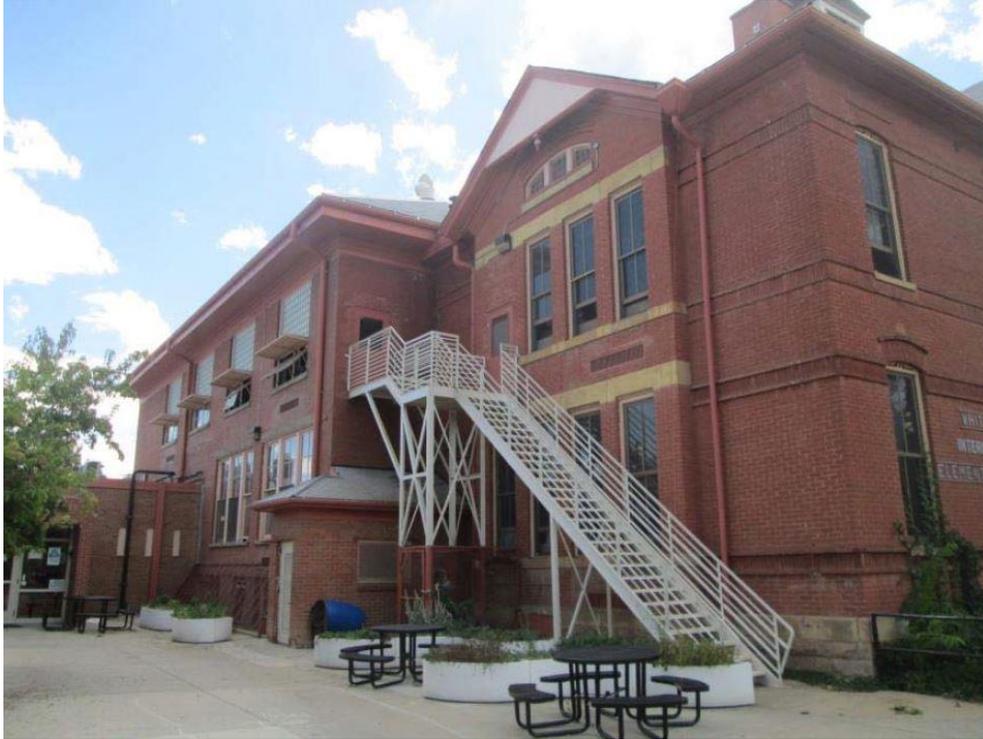
*Figure 14. East Elevations of 1882 schoolhouse and 1916 addition.*

The historic windows on the original 1882 building and the 1916 addition are proposed to be rehabilitated, keeping the original glass where possible. Weather seals and new paint are to be applied for improvements in energy-efficiency and operability. Wood frame screens are also proposed. Other improvements, such as the installation of interior or exterior storm windows, are to be determined.

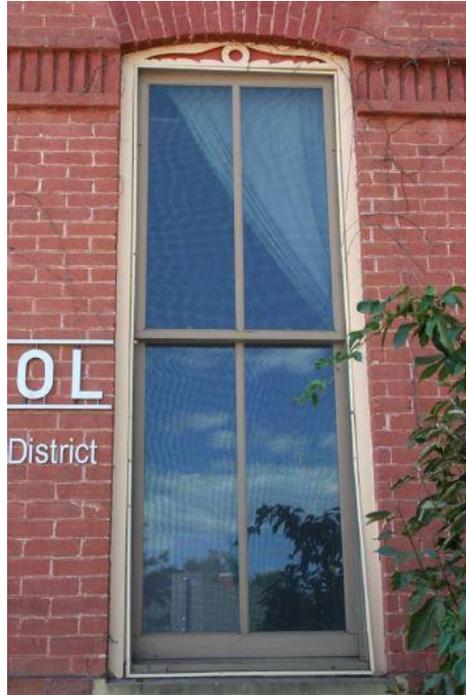
*Figure 15: Non-historic north facing window on 1882 schoolhouse.*

The non-historic windows were either installed in the 1950s or around 1997. These windows will be replaced with new solid wood double-pane low E, simulated divided light windows that will match the historic windows. Wood frame screen will also be installed on these windows. Any infilled windows will be restored, if possible, with windows to closely match the historic in material and dimension.

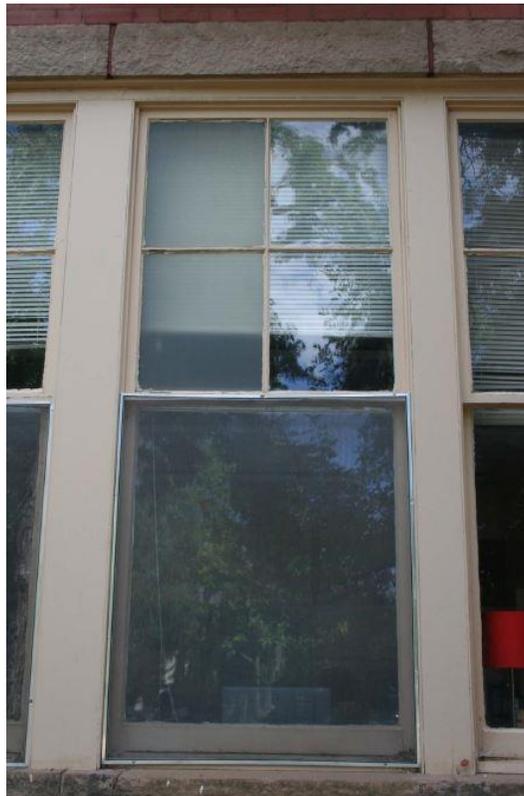
*Figure 16: Original west facing window on 1916 addition (with some glass replaced).*

11. Existing original West facing window on 1916 addition (with some replaced glass)

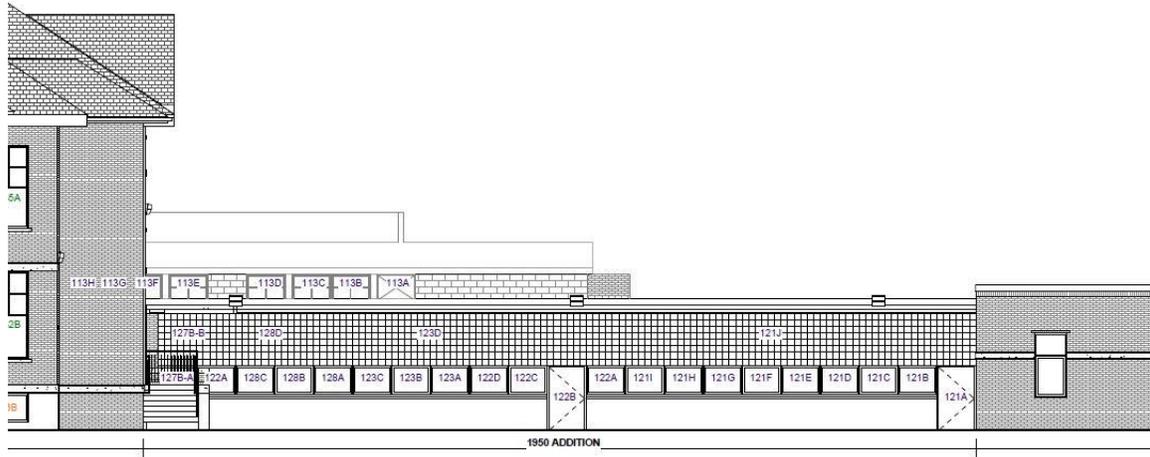
Figure 17. Existing west elevation, 2015.

Applicant proposes the replacement of doors & windows on the 1950 addition of Whittier School. This includes the Gym clerestory windows and the infill portion of glass block on the west elevation. The 1950 addition is directly south of the 1916 addition and the 2010 addition abuts the south of the 1950 addition. The request calls for replacement with energy-efficient insulated windows with a metal storefront and will have painted metal light louvers.

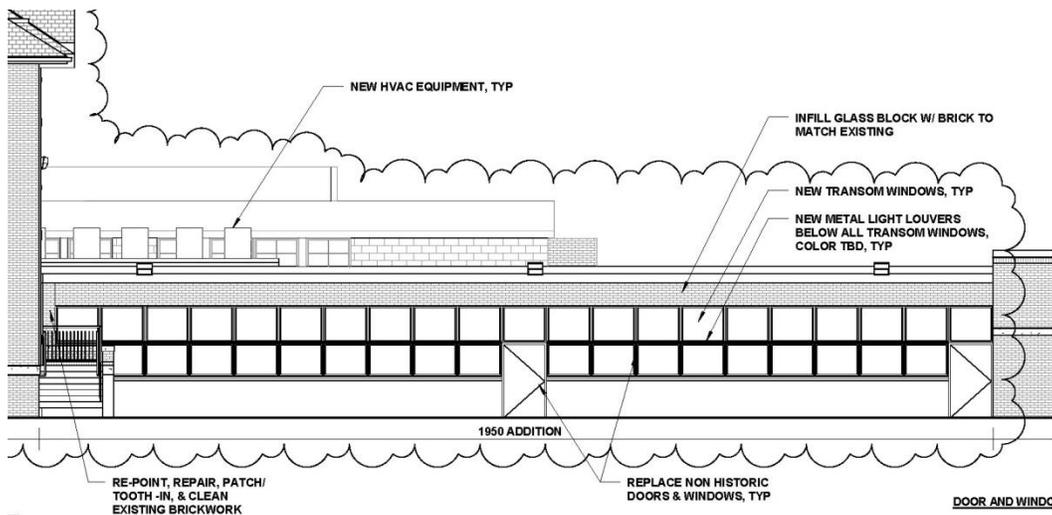
Figure 18. Proposed west elevation, 2015.

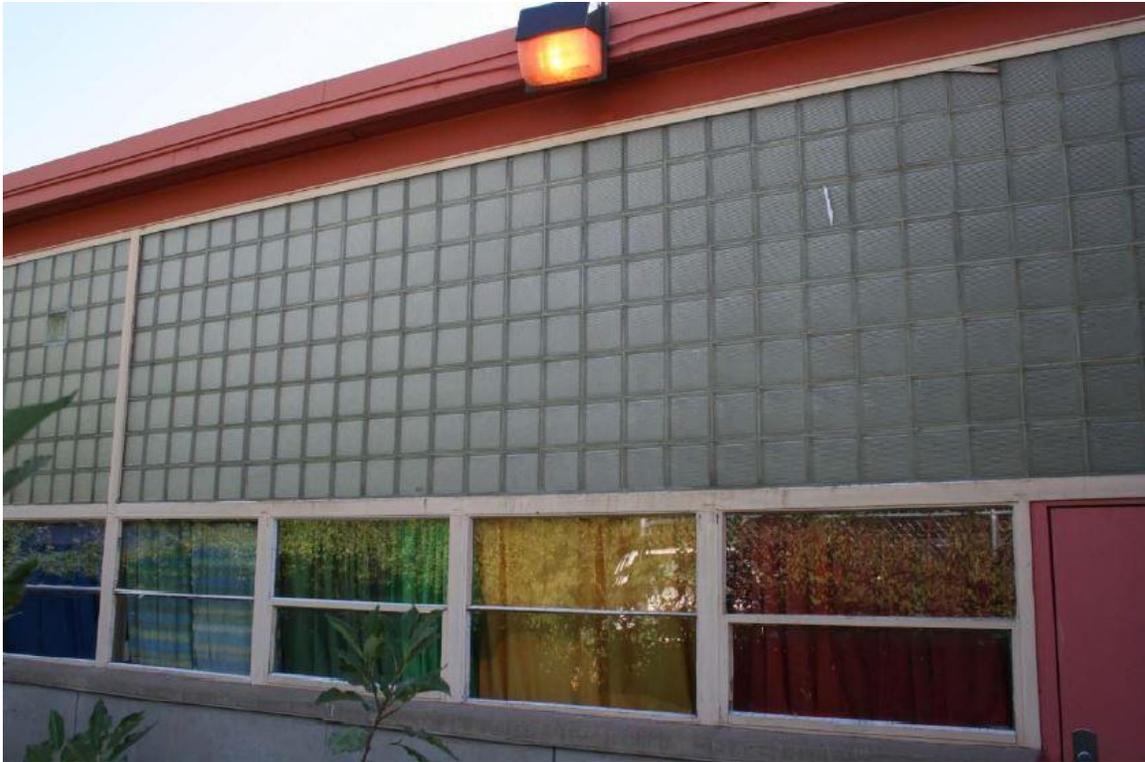
*Figure 19. Detail of glass block windows seen on west elevation, 2015.*

Likewise, staff considers the 1950s portion of the school to not have historic significance and that replacement of the glass block and windows and doors with new windows and doors consistent with the design guidelines provided the details of this work is reviewed by the Landmarks design review committee.

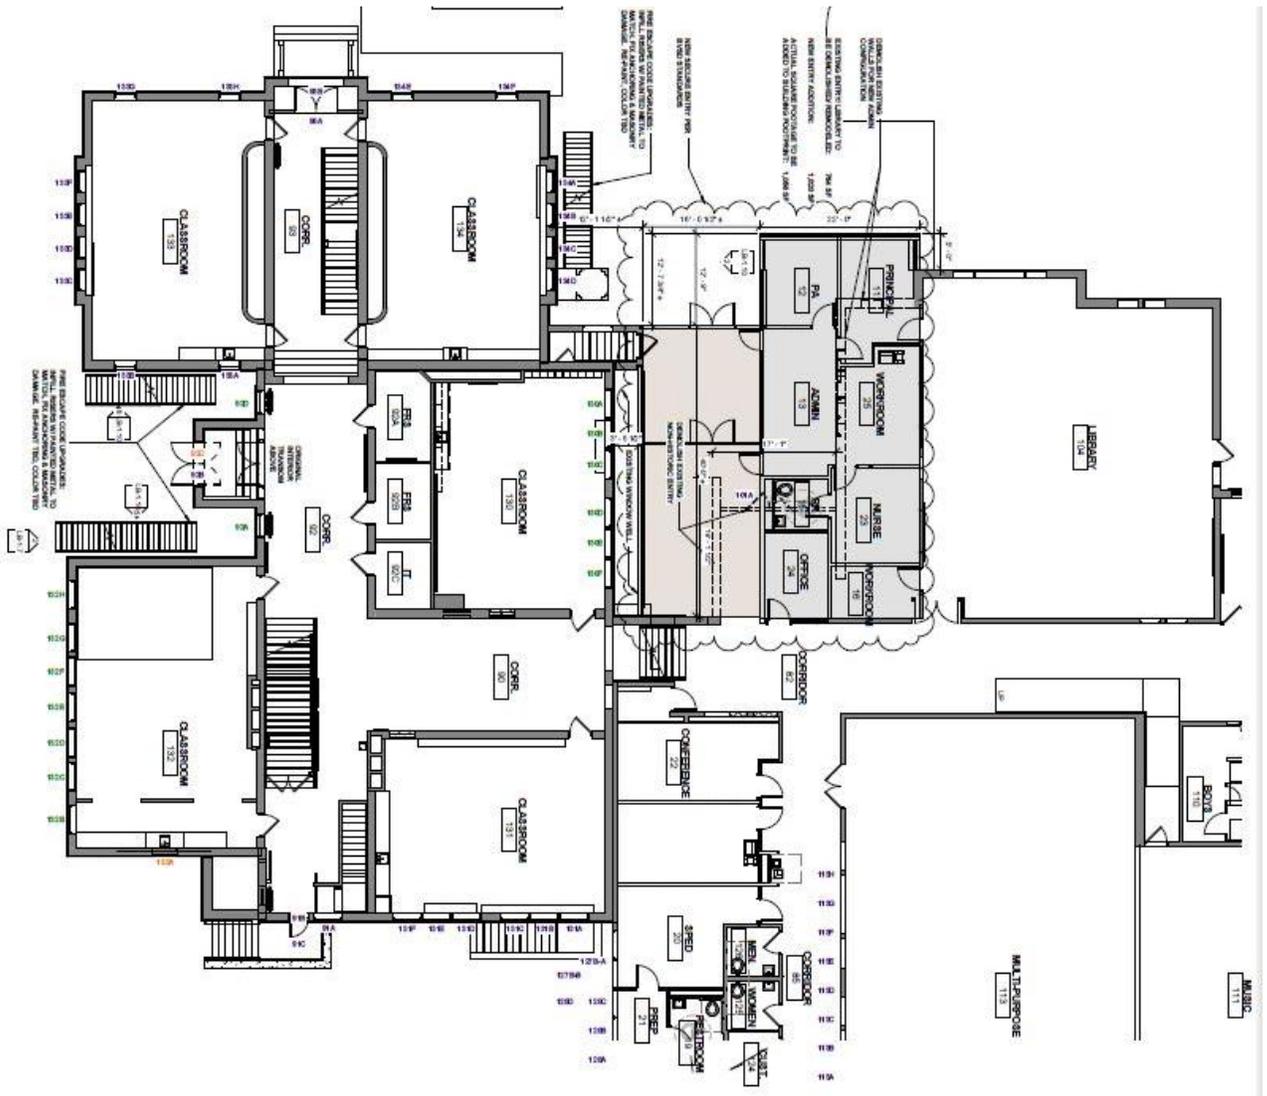
Floor plan of northwest portion of building (the 1882, 1916, and 2015 additions).

The existing 764sf non-historic north entry (built ~1980-2000) will be demolished (portions at the library to be remodeled and incorporated into the new entry/ admin), and in its place a new 1,820sf entry/ administration addition is proposed (1,056sf of building footprint is being added).

The entry was sized to only add as much square footage was needed for a new classroom in order to mitigate its visual impact (1,000sf, which a standard classroom size at Whitter but is still undersized per BVSD standards). The addition is held off from the 1916 building in order to minimize physical impact on the historic building, coming to the edge of the existing window well. The only portion of the historic building it touches is the walls of a small mechanical stair bump-out, which are not original to the 1916 design (see 1938 photo). The design of the entry is atrium-like, with glass, metal and brick, bridging between the historic portion of the building and the 1983 brick library to create a compatible yet distinct connection. It is recessed far back from the historic façade, with half of the addition projecting five feet beyond the 1983 library and the other half being even with the mechanical bump-out.

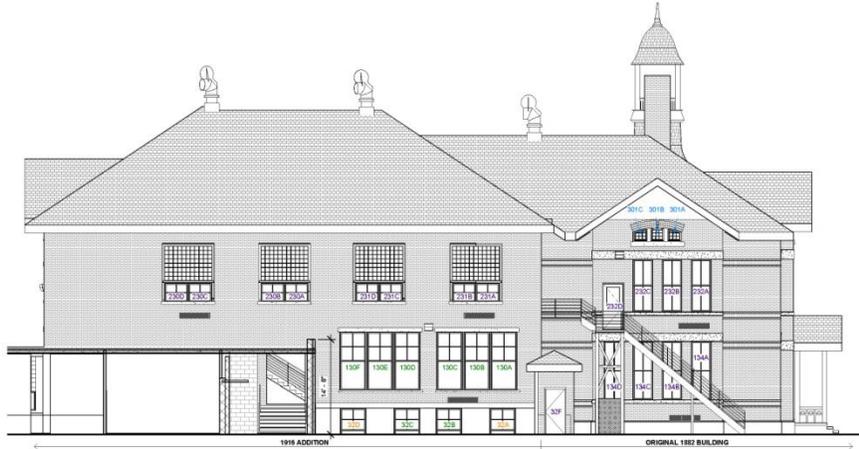
Existing (r) and proposed (l) west elevation.

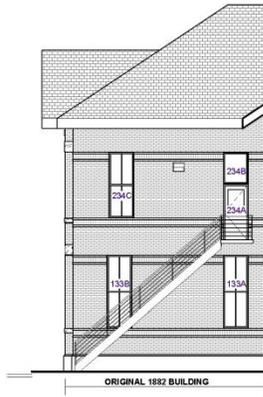
2 PROPOSED EAST ELEVATION  
1/8" = 1'-0"

Existing (r) and proposed (l) east elevation detail.

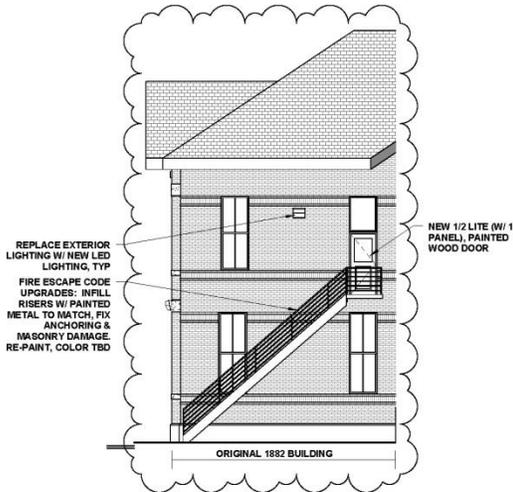
3 EXISTING SOUTH ELEVATION - WEST COURTYARD  
1/8" = 1'-0"

*Existing north and south elevations of the west courtyard.*

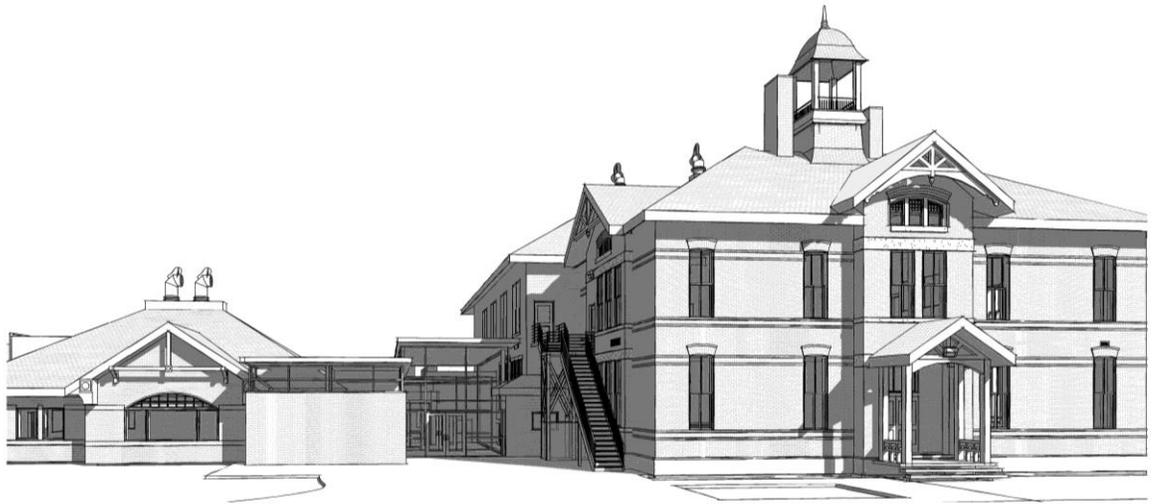
5 PROPOSED SOUTH ELEVATION - WEST COURTYARD  
1/8" = 1'-0"

*Proposed north and south elevations of the west courtyard.*

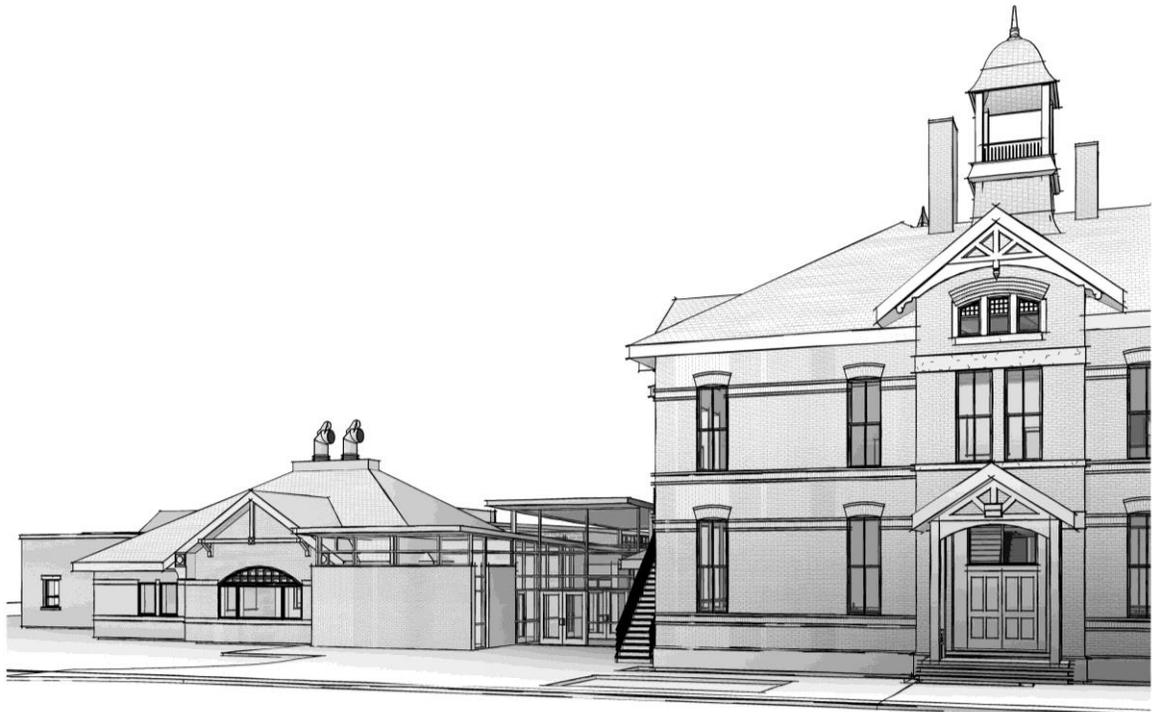
*Rendering of north elevation with proposed north entry.*

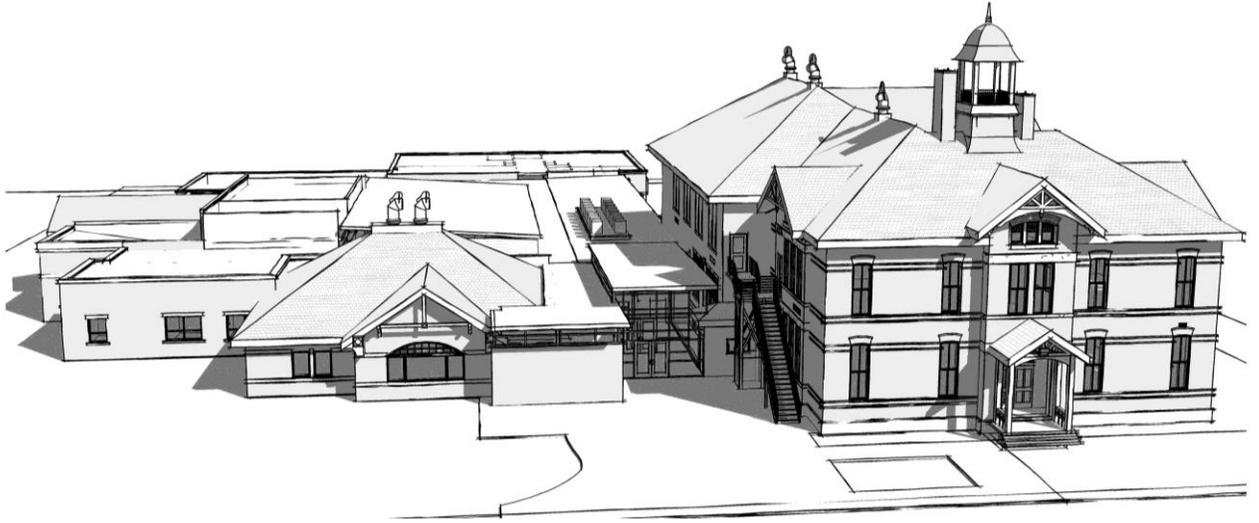
*Rendering of north elevation with proposed north entry.*

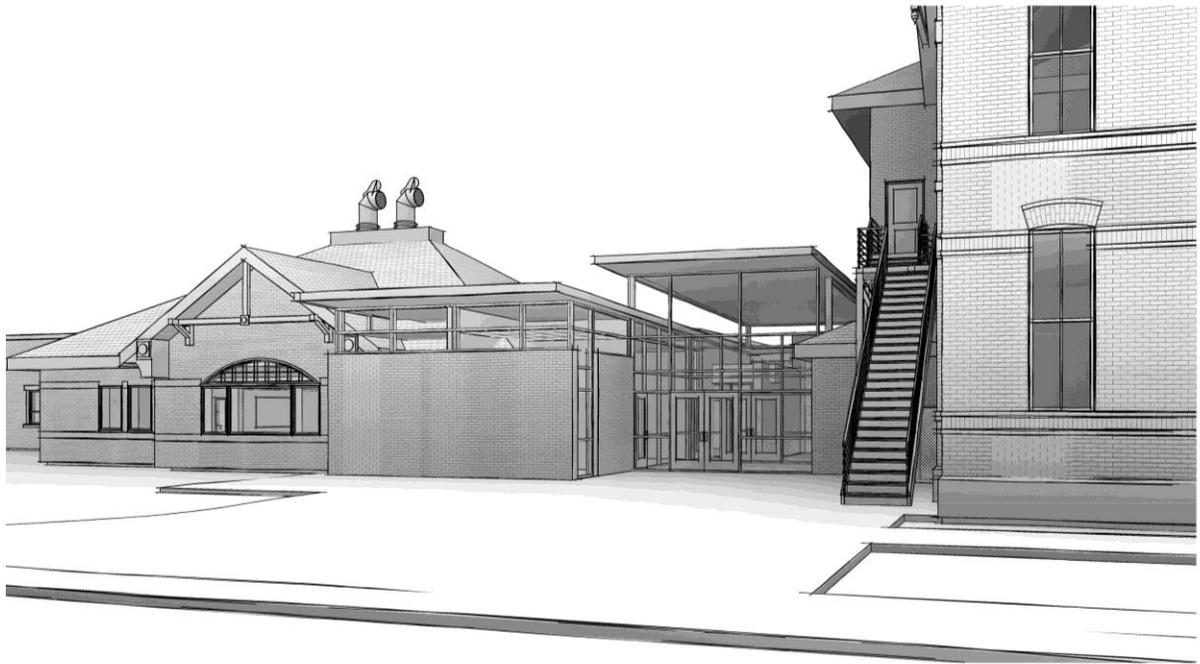
*Rendering of north elevation with proposed north entry.*

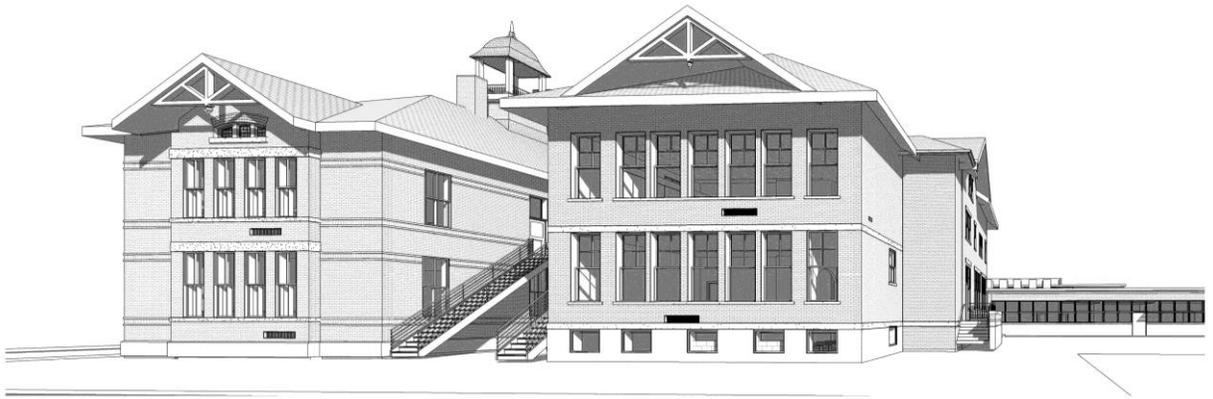
*Rendering of south elevation of 1916 addition and west elevation of 1950 addition with glass blocks replaced.*

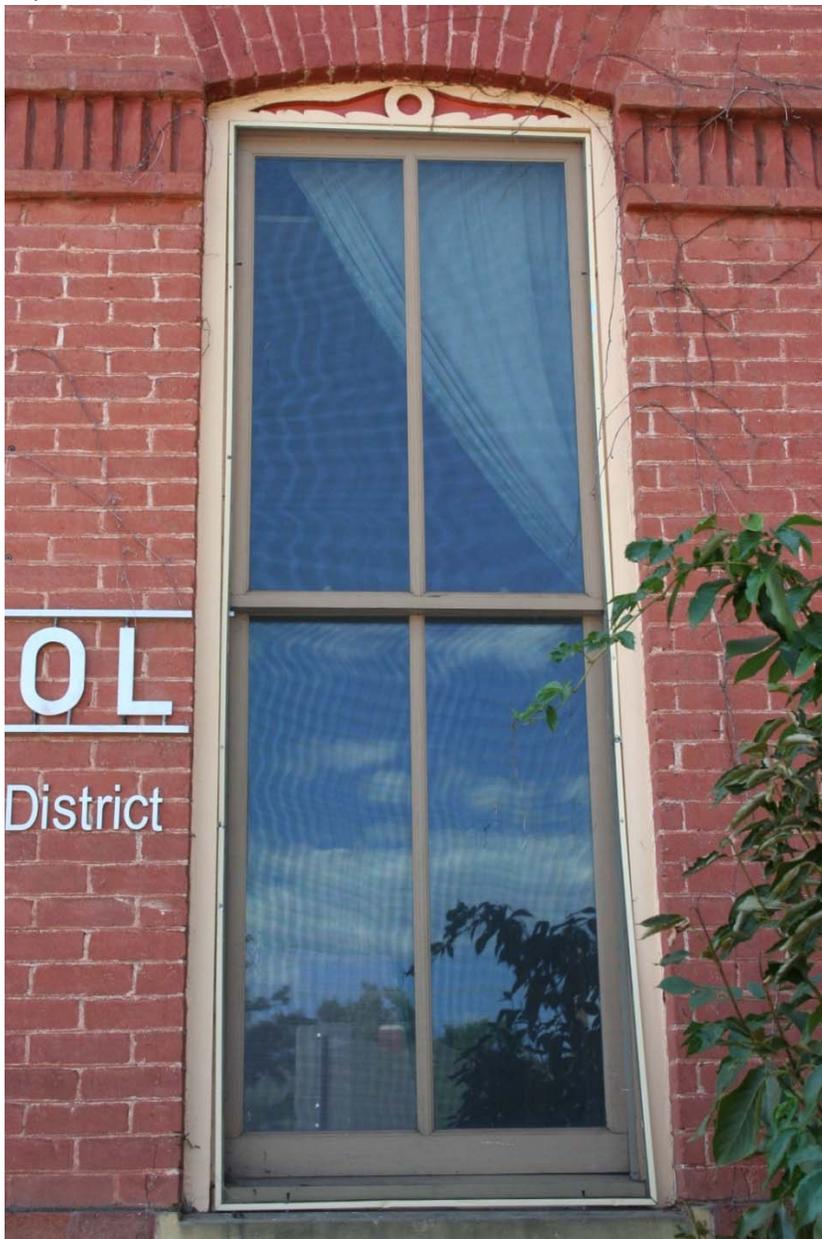
1. Typical Existing North facing window on original 1882 building. Part of 1997 window replacement. [South windows are similar]

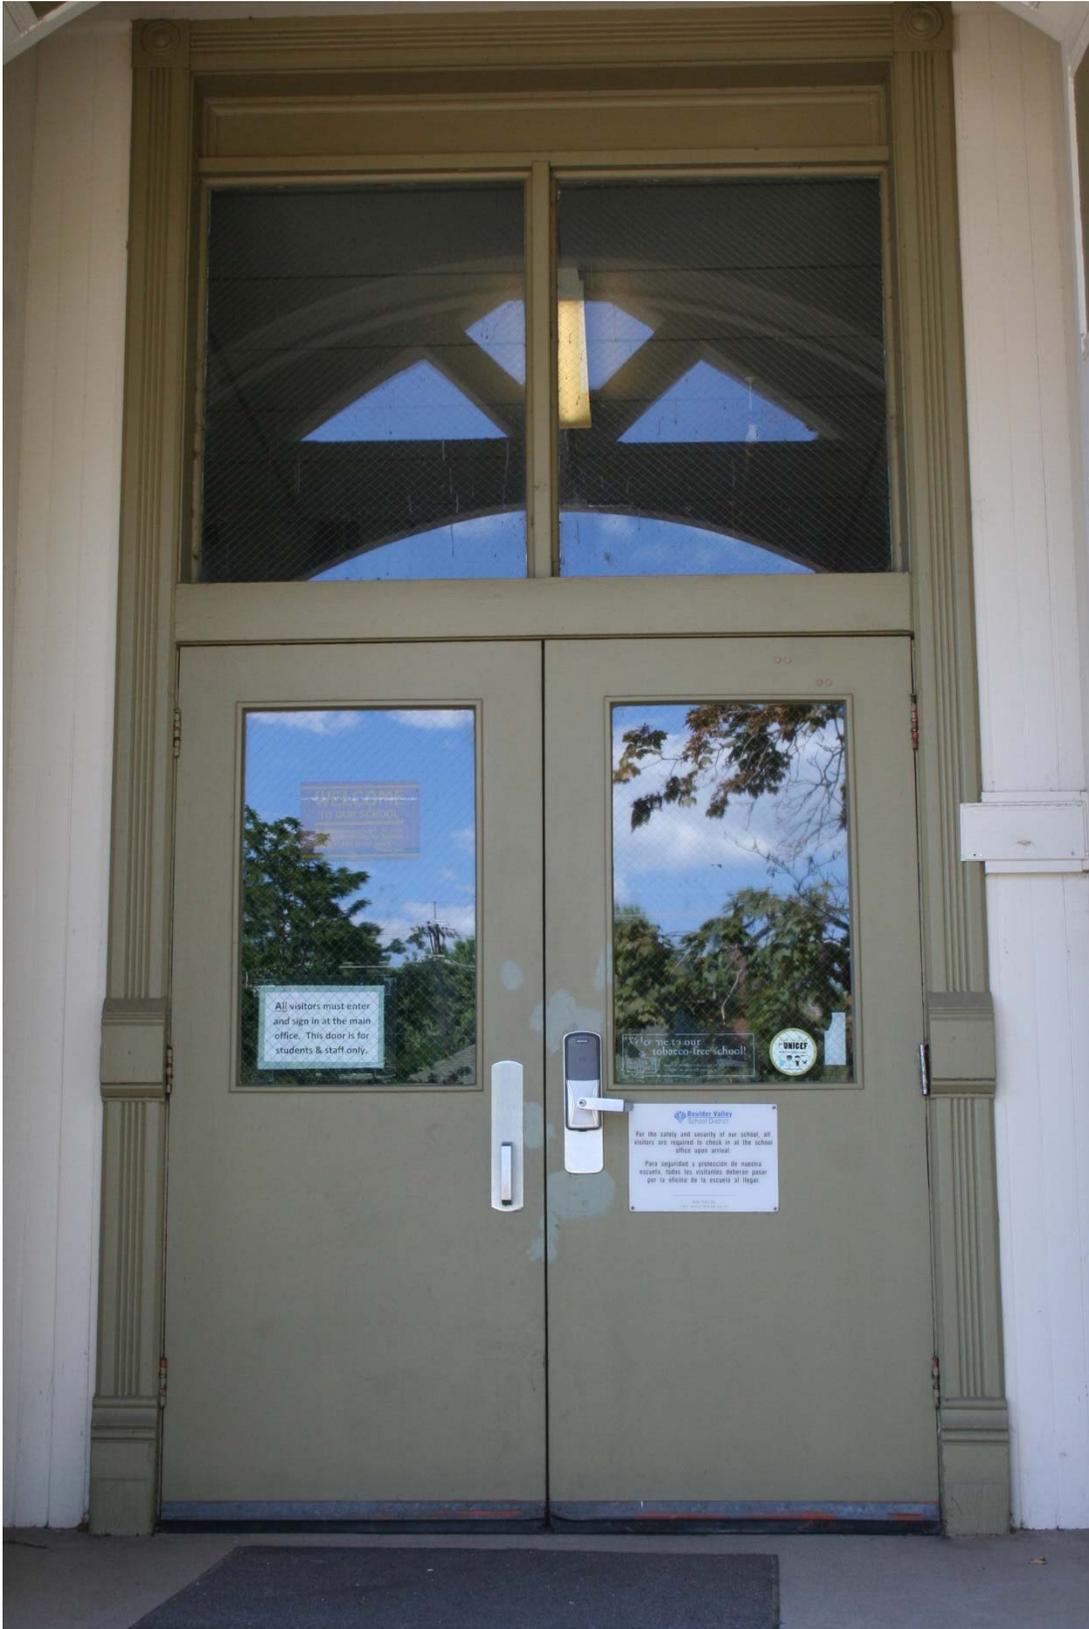
2. Existing North Entrance Door – [Main entrance to original 1882 building]

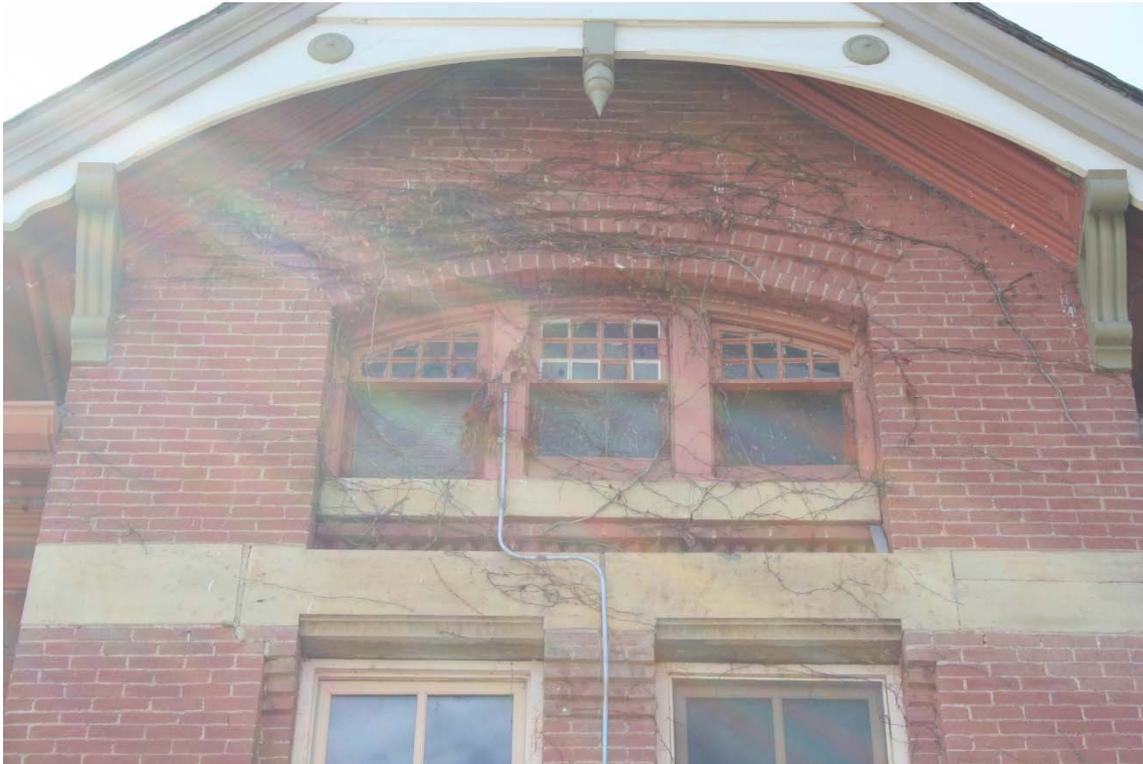
3. Existing 1882 attic windows [North]

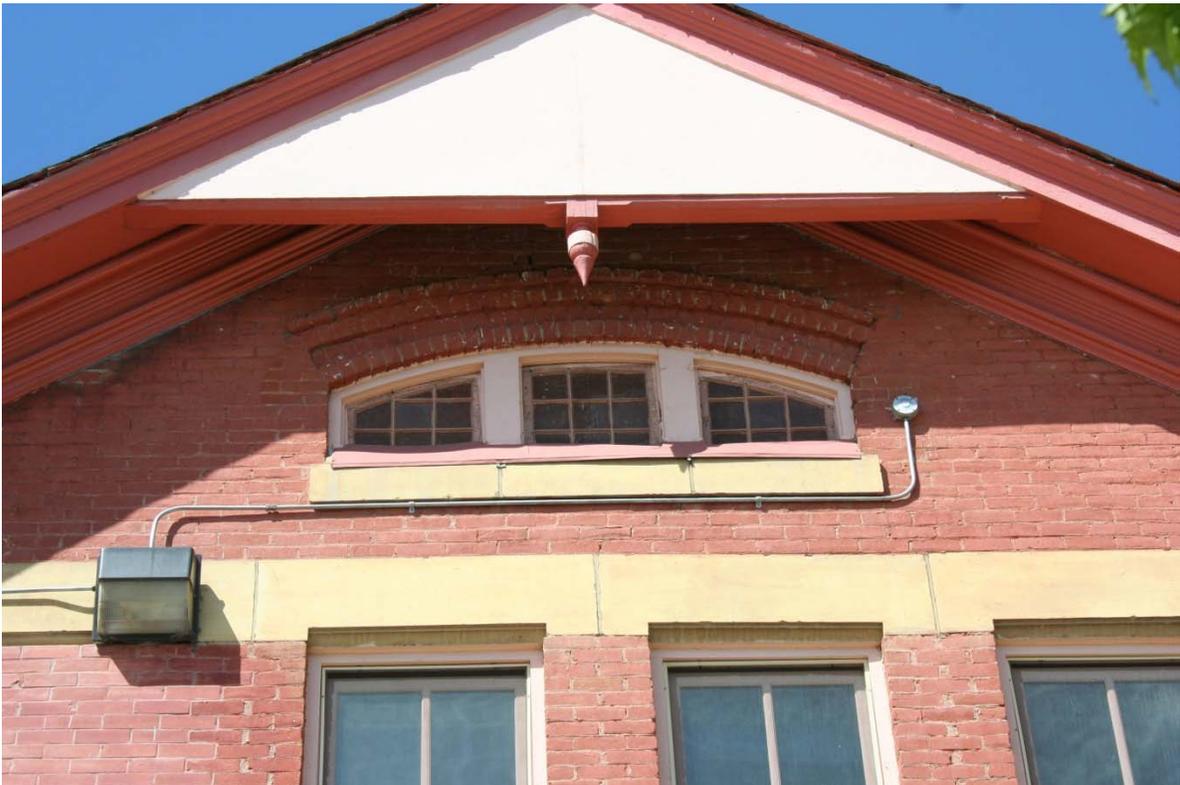
4. Existing, East facing, 1882 attic windows [West are similar]

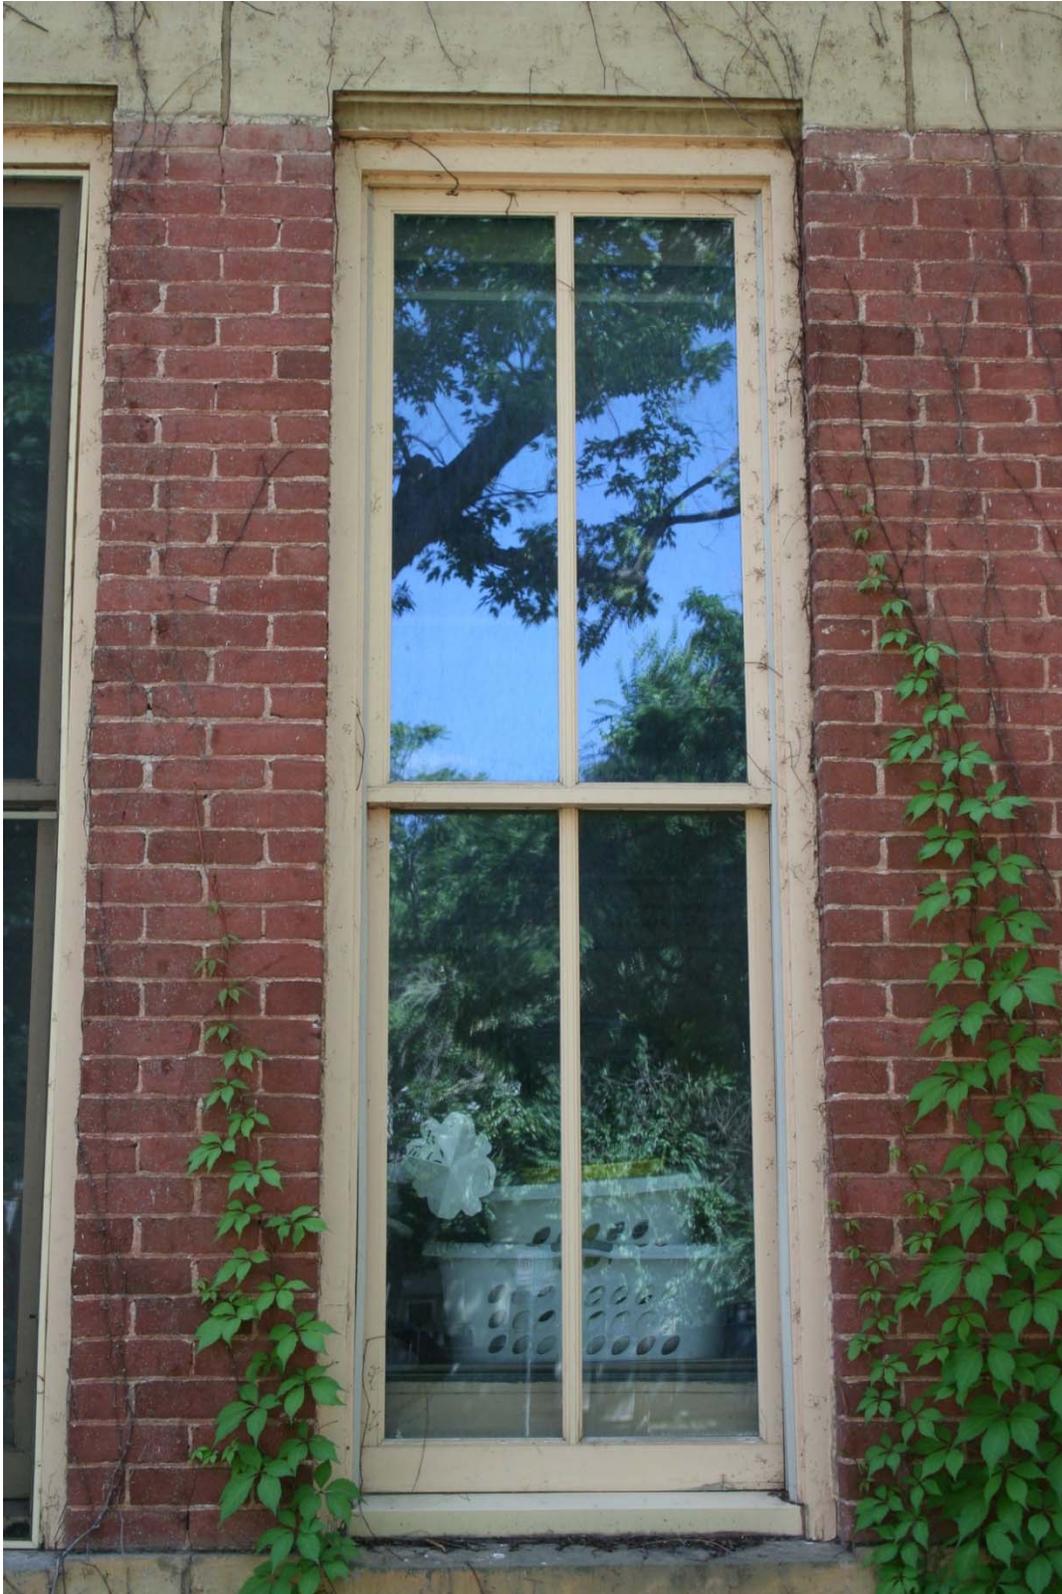
5. Typical existing West facing window on original 1882 building. Part of 1997 window replacement [East windows are similar]
