## MEMORANDUM

**SUBJECT:** Public hearing and consideration of an application for a Landmark Alteration Certificate to construct an addition to the building, replace non-historic windows and restore the historic façade of Whittier School at 2008 Pine Street, an individually landmarked property, per section 9-11-18 of the Boulder Revised Code 1981 (HIS2015-00243).

1. Site: 2008 Pine St.
2. Designation: Individual Landmark
3. Historic Name(s): Pine Street School, Whittier School
4. Date of Construction: 1882
5. Zoning: RMX-1 (Residential-Mixed 1)
6. Lot size: 103,693 sq. ft.
7. Proposed Addition: 1,056 sq. ft.
8. Applicant: Rodwin Architecture
9. Owner: Boulder Valley School District

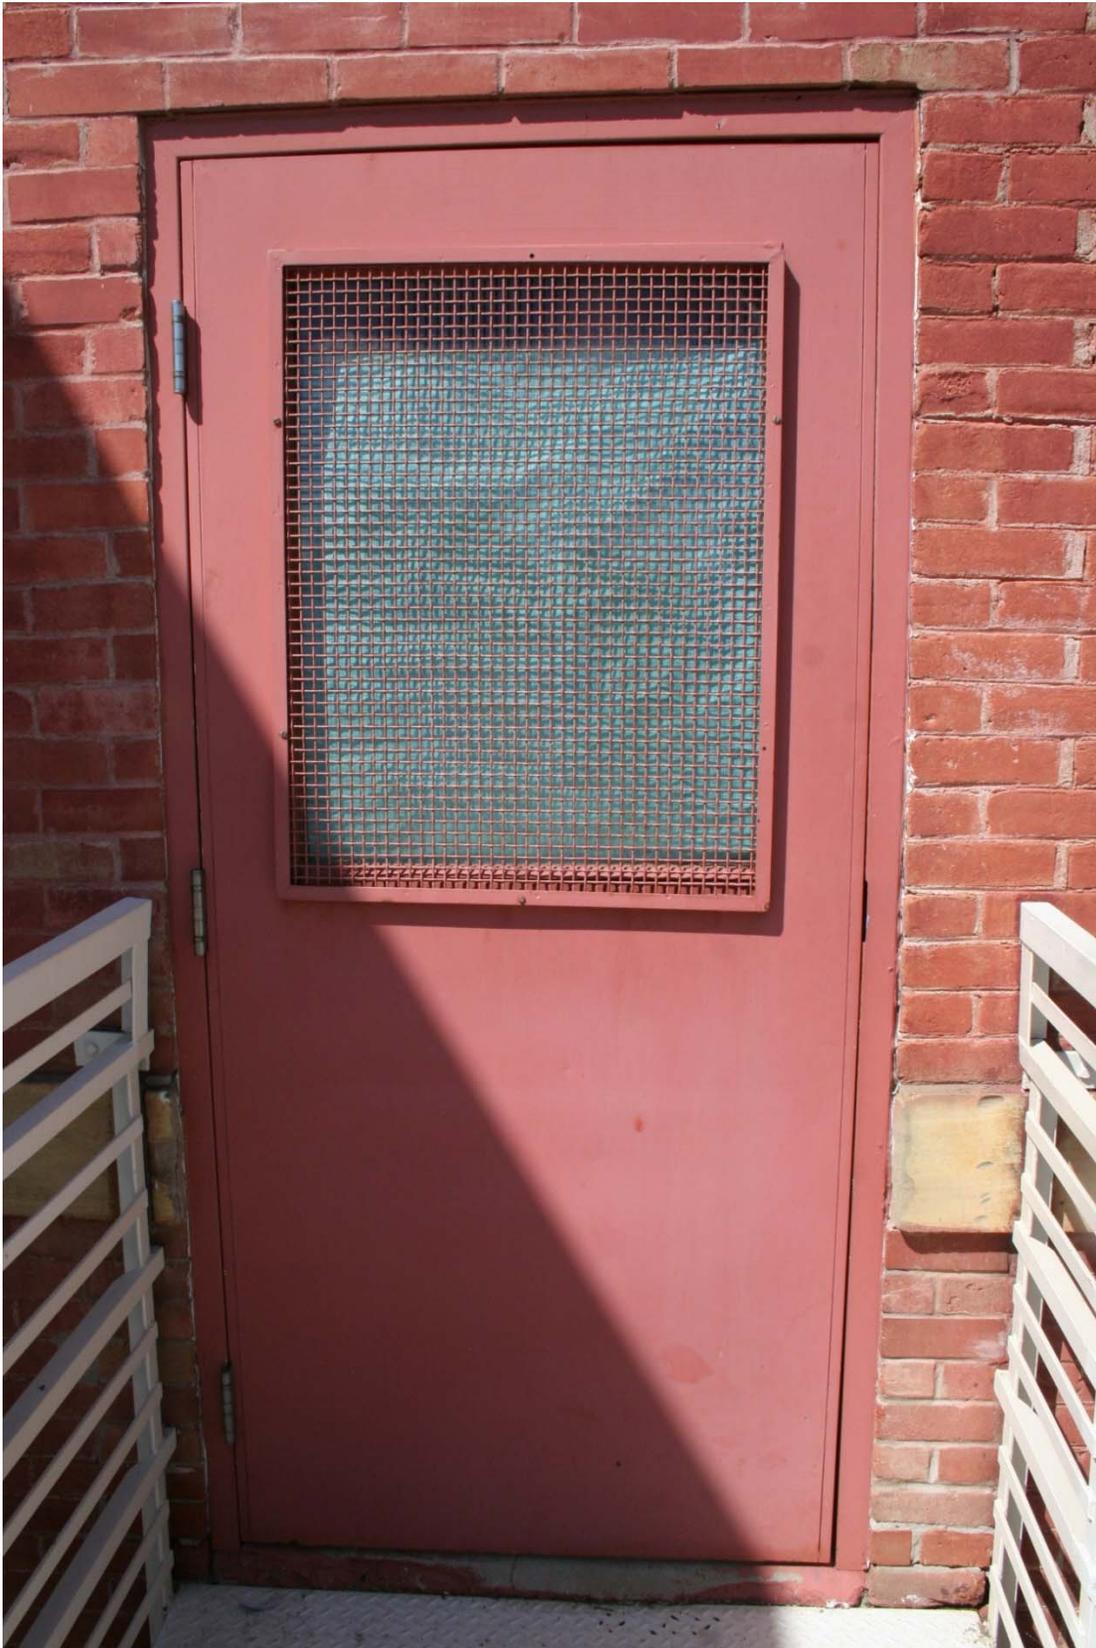
6. Existing exterior East door to fire escape. Added to original 1882 building in 1960s or 1970s?...

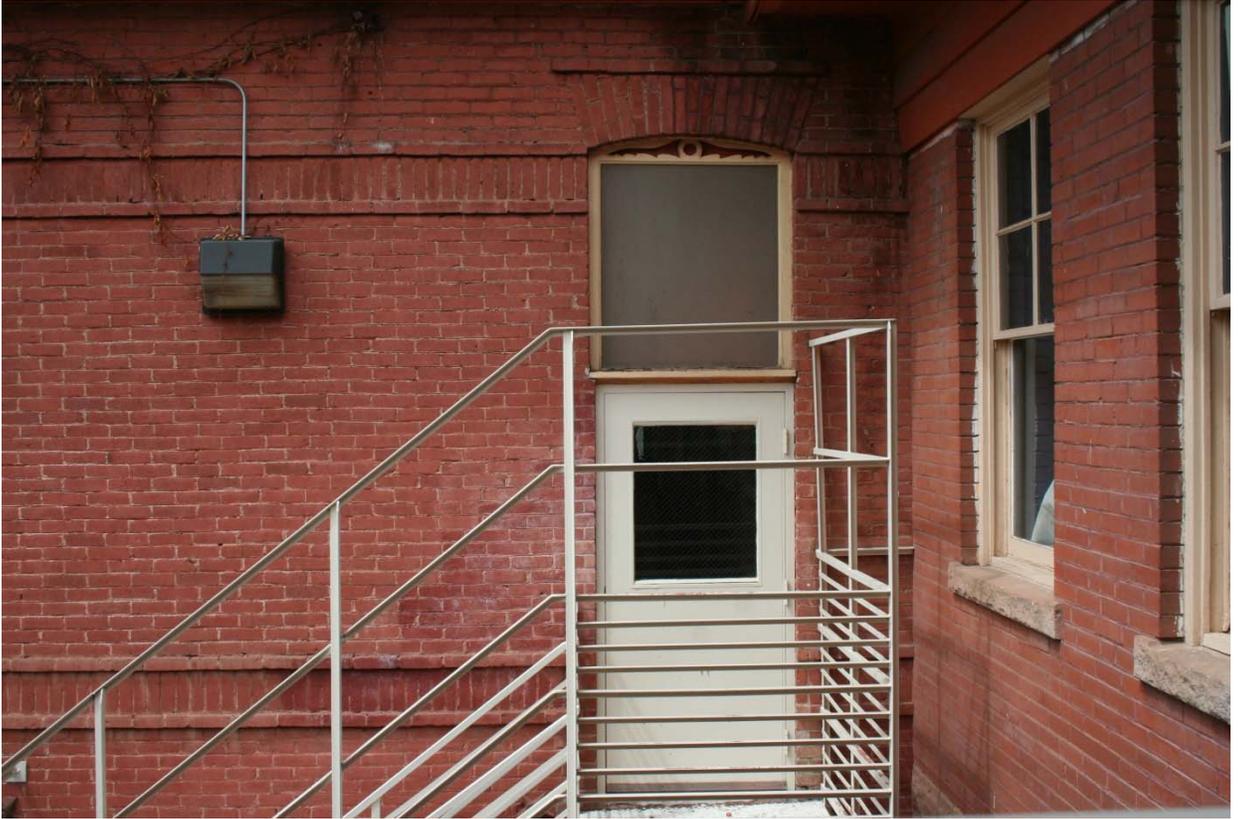
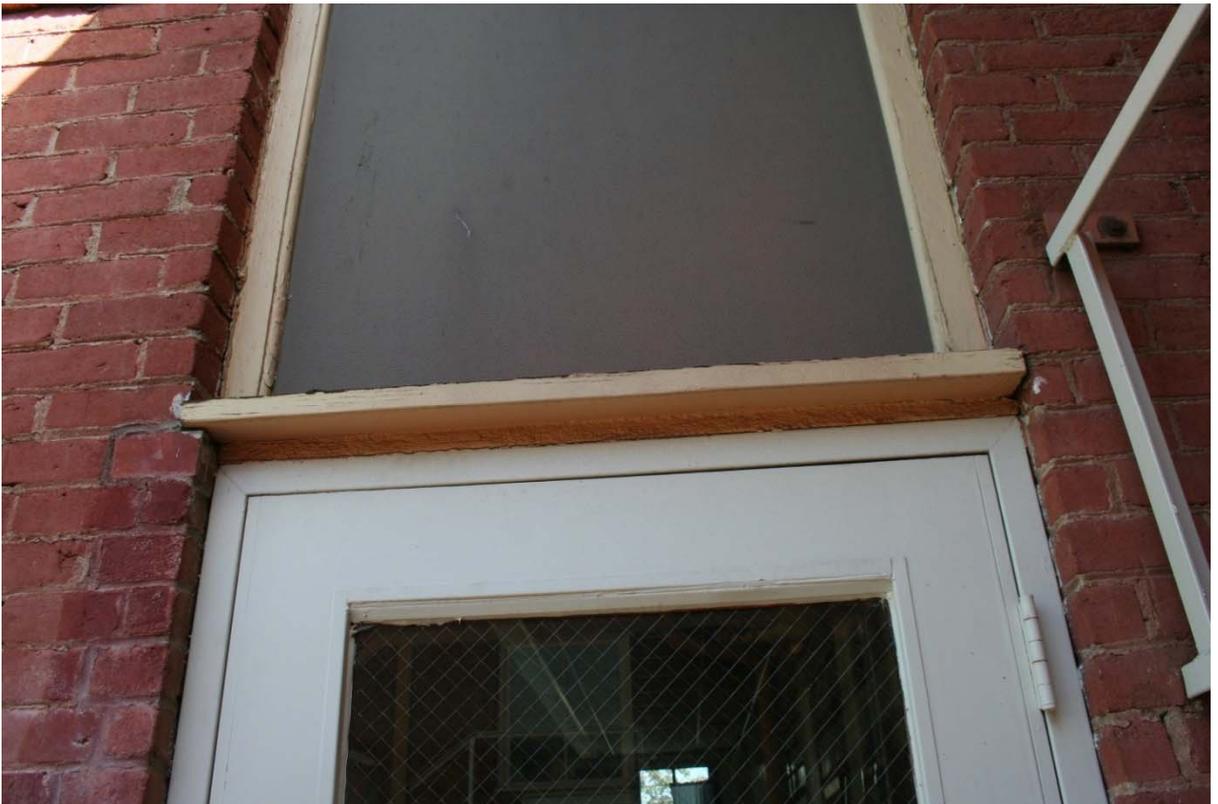
7. Existing exterior South door to fire escape. Added to original 1882 building in 1960s or 1970s?...

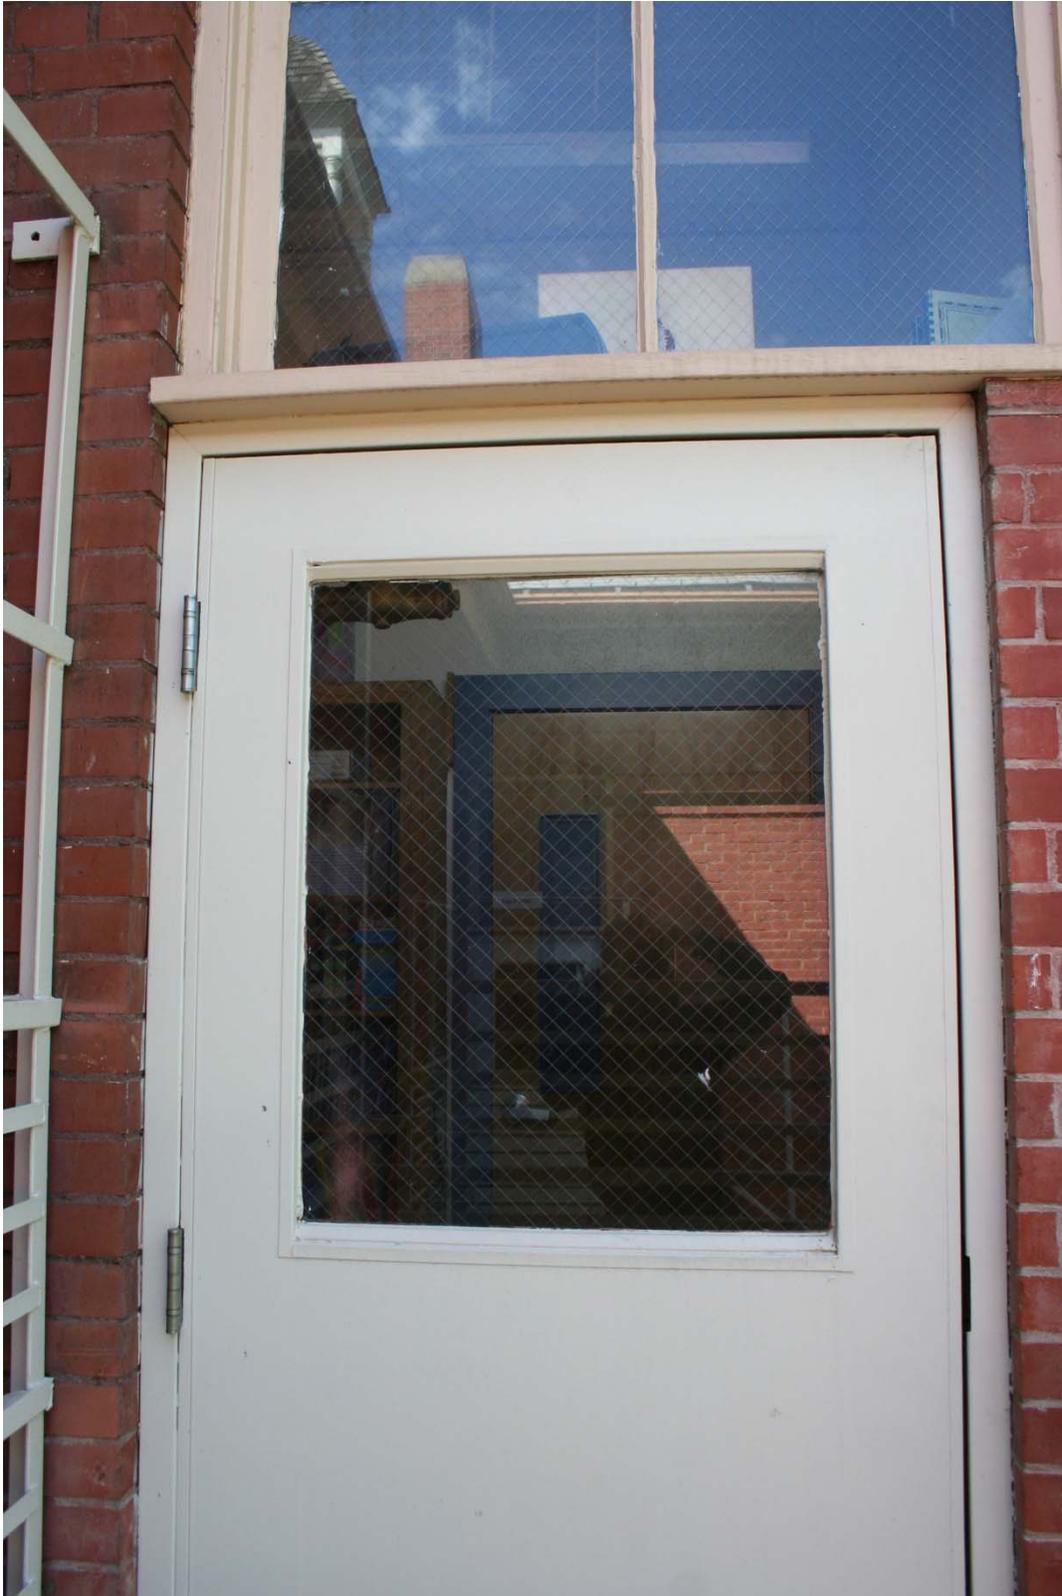
8. Existing exterior North door to fire escape from 1916 addition. Door added in 1960s or 1970s?...

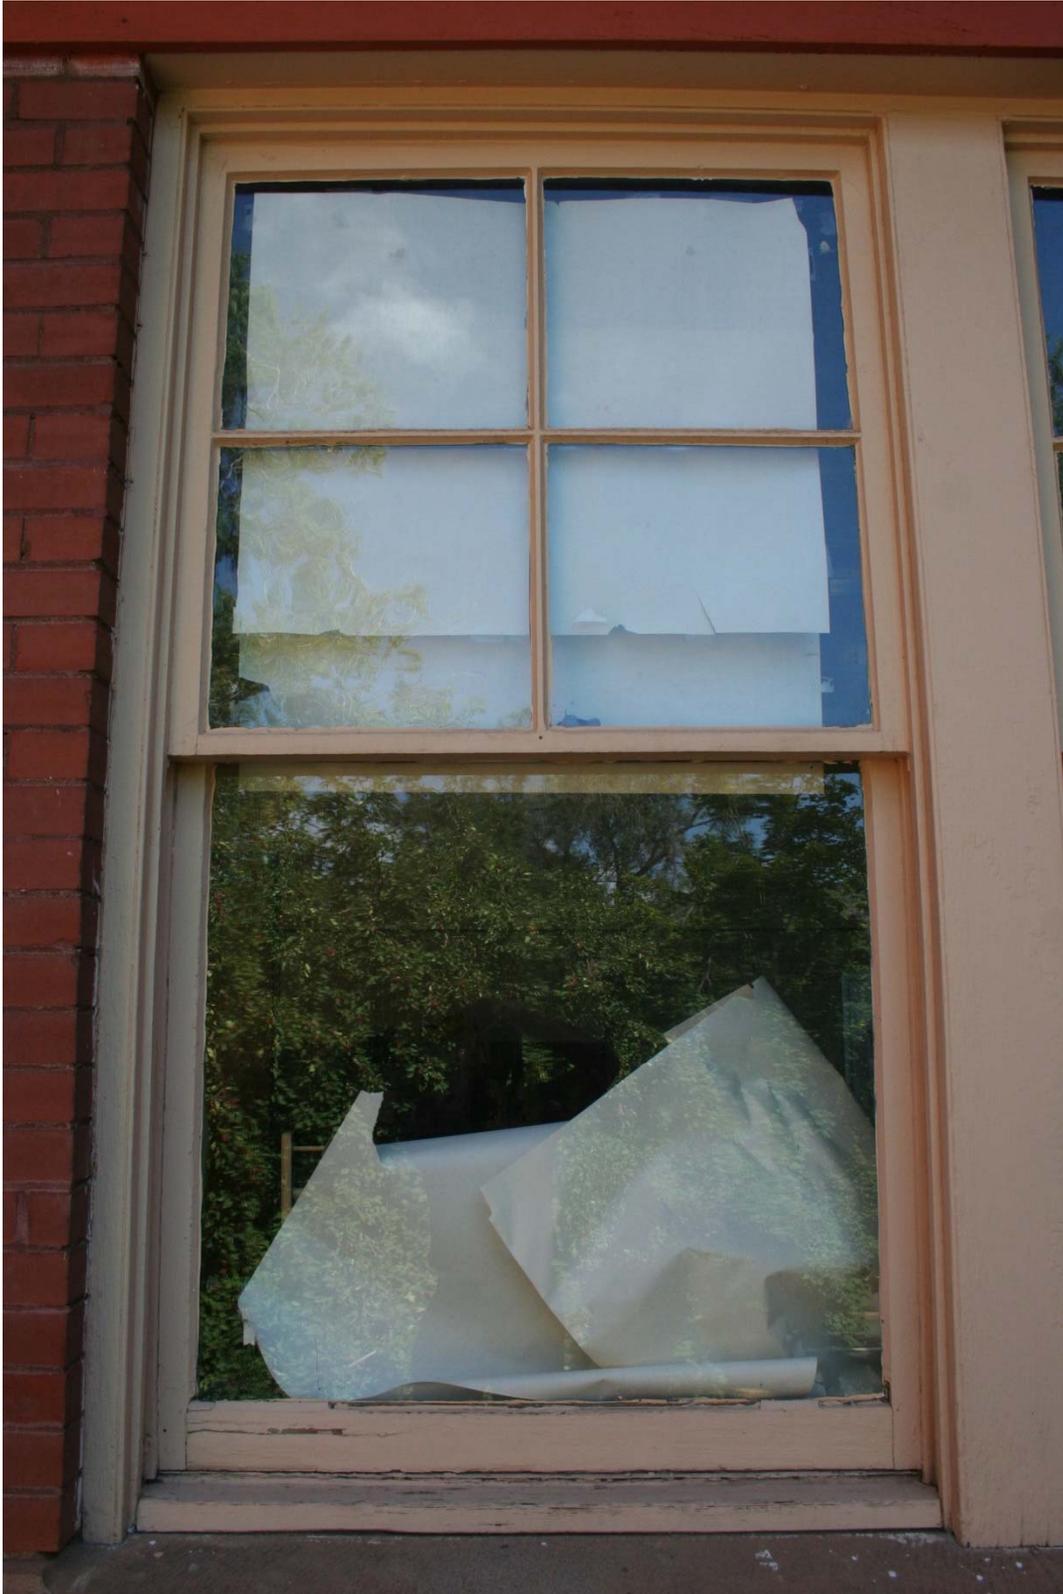
11. Existing original West facing window on 1916 addition (with some replaced glass)

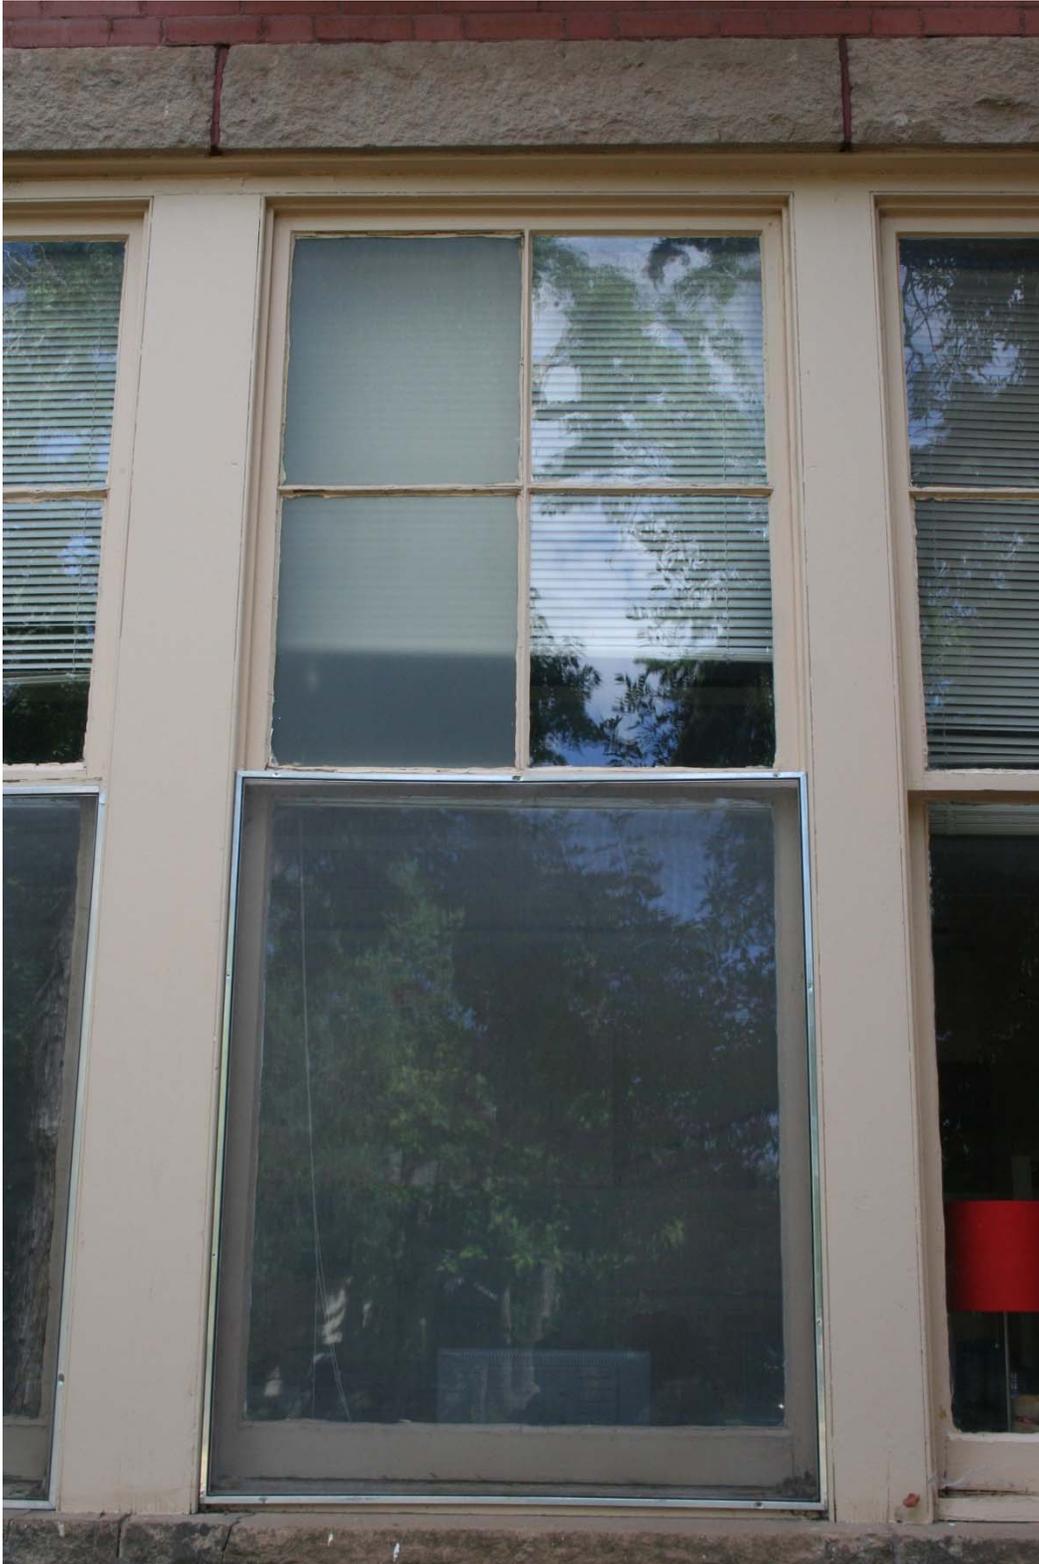
12. Existing West Facing window on basement of 1916 addition

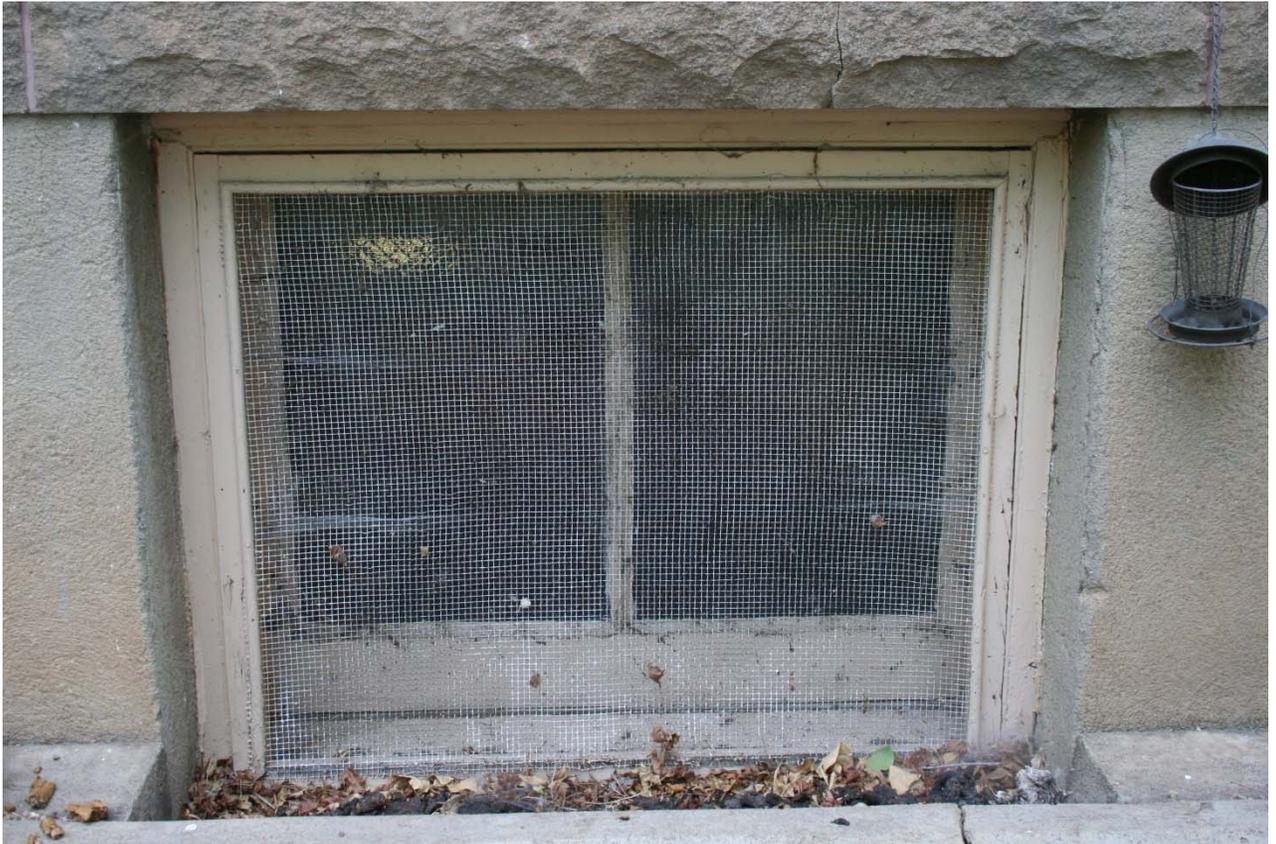
13. Partially covered West basement window on 1916 addition

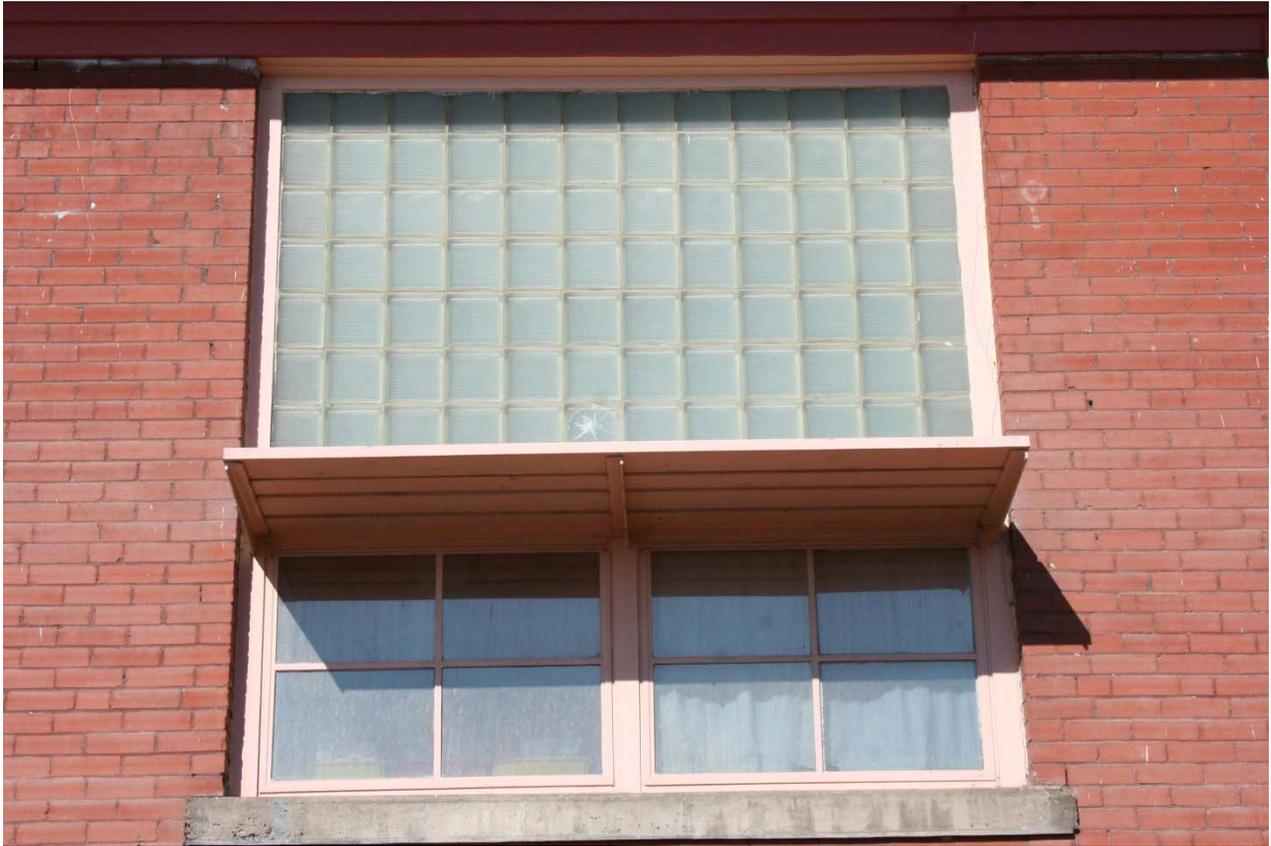
17. Existing South facing window, added to 2<sup>nd</sup> floor of 1916 addition, in 1950.

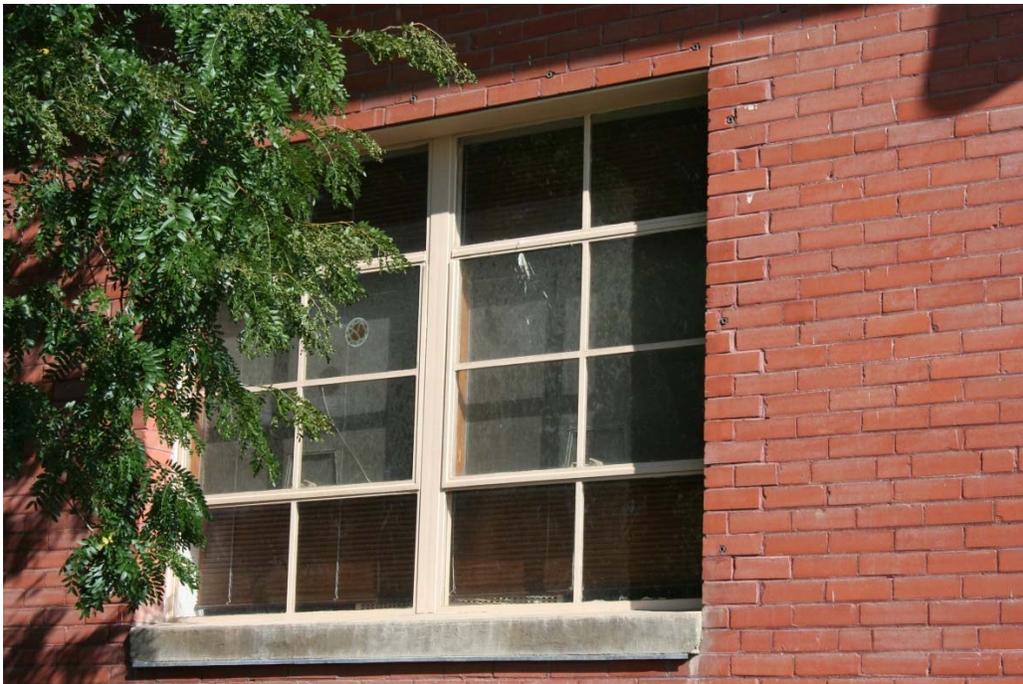
18. Existing original typical South facing double window on 2<sup>nd</sup> floor of 1916 addition.

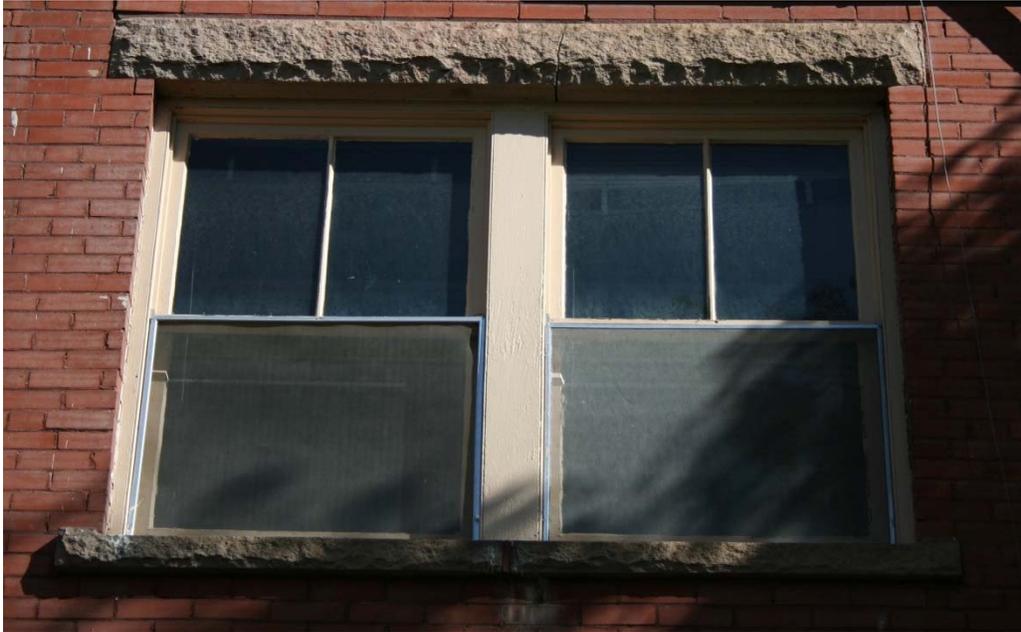
19. Typical original existing single window on 2<sup>nd</sup> floor of 1916 addition.

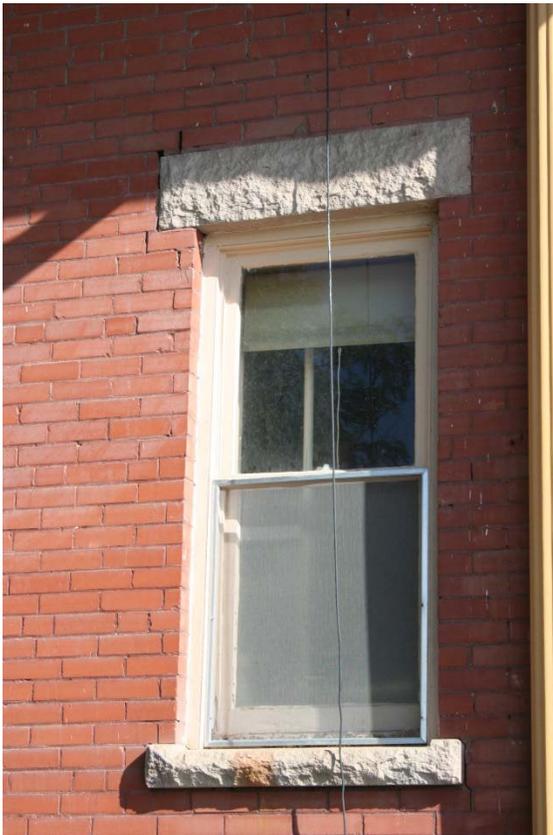
20. Existing original South facing window with Plexiglass in 1916 addition

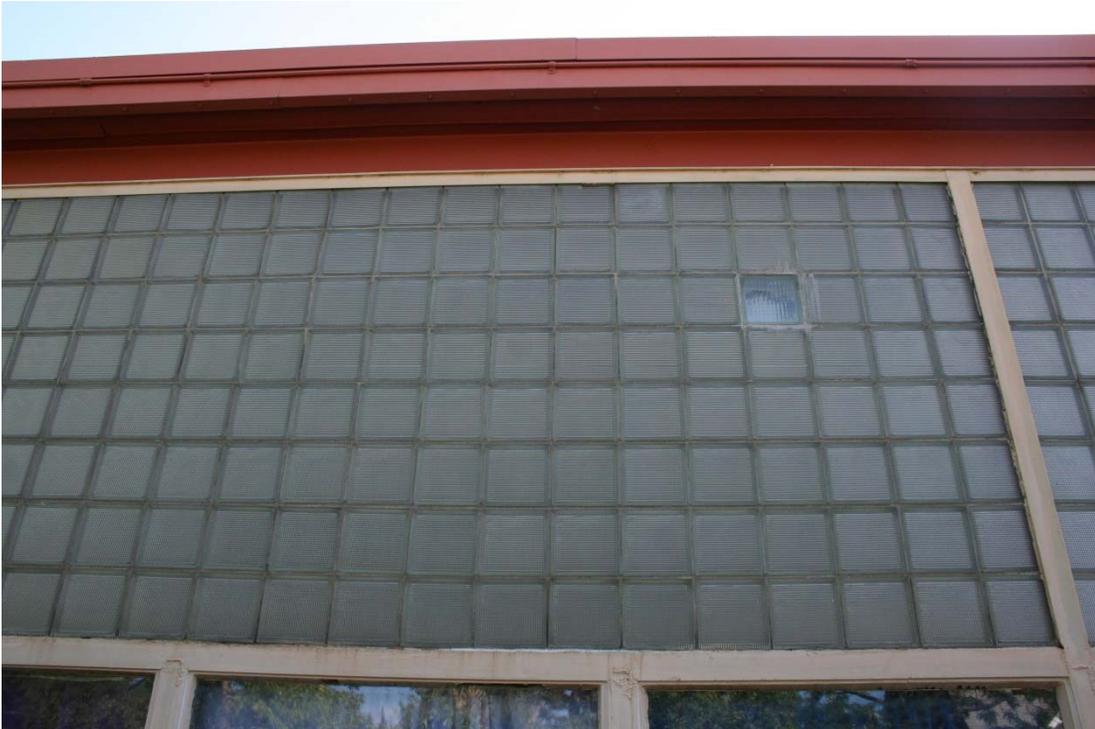
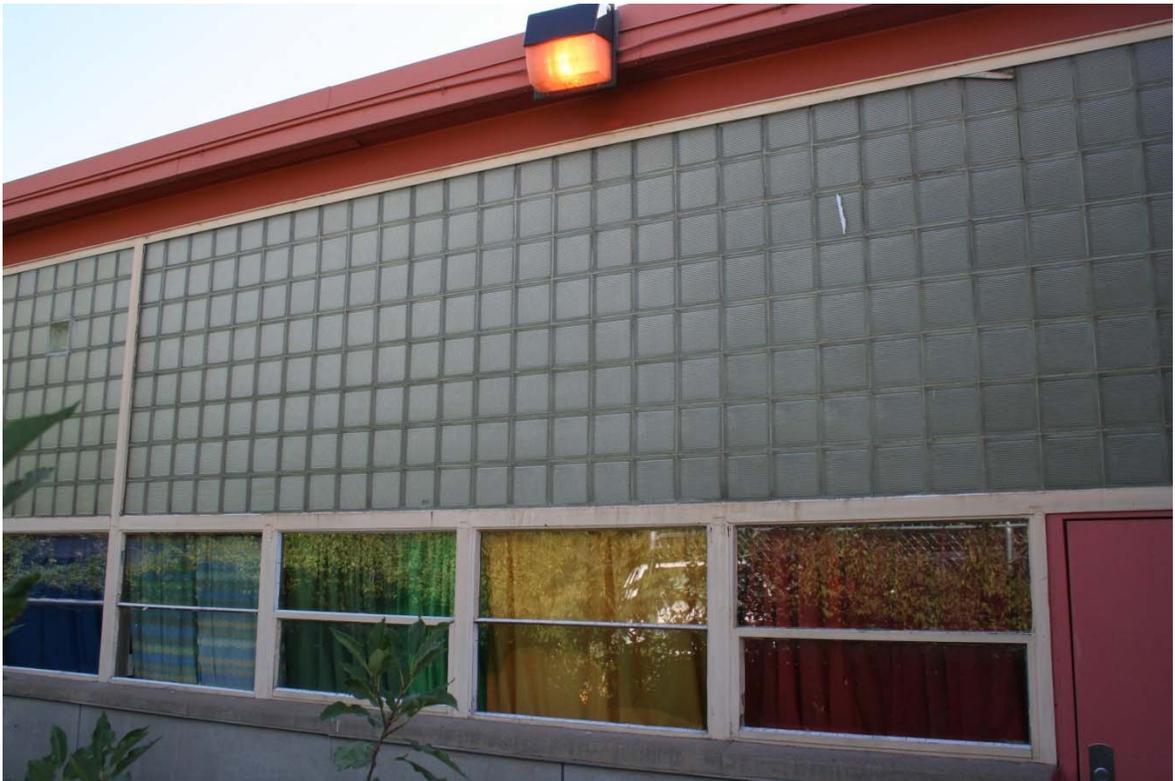
27. Typical existing painted over gym windows. 1950 addition.
