SANITAS VALLEY ROAD - FLOOD DAMAGE REPAIR AND MITIGATION OVERALL SITE PLAN			
Designer:	SJB	Structure	
Detailer:	LX	Numbers	
Sheet Subset:		Subset Sheets:

A. PROJECT SITE DESCRIPTION: REPAIRS TO THE SANITAS VALLEY TRAIL TO ADDRESS FLOOD DAMAGE AND MITIGATION MEASURES TO REDUCE THE LIKELIHOOD OF DAMAGE FROM FUTURE EVENTS.

SANITAS VALLEY ROAD - FLOOD DAMAGE REPAIR AND MITIGATION			
TYPICAL REPAIR DETAILS			
Designer:	SJB	Structure	
Detailer:	CWM	Numbers	
Sheet Subset:		Subset Sheets:

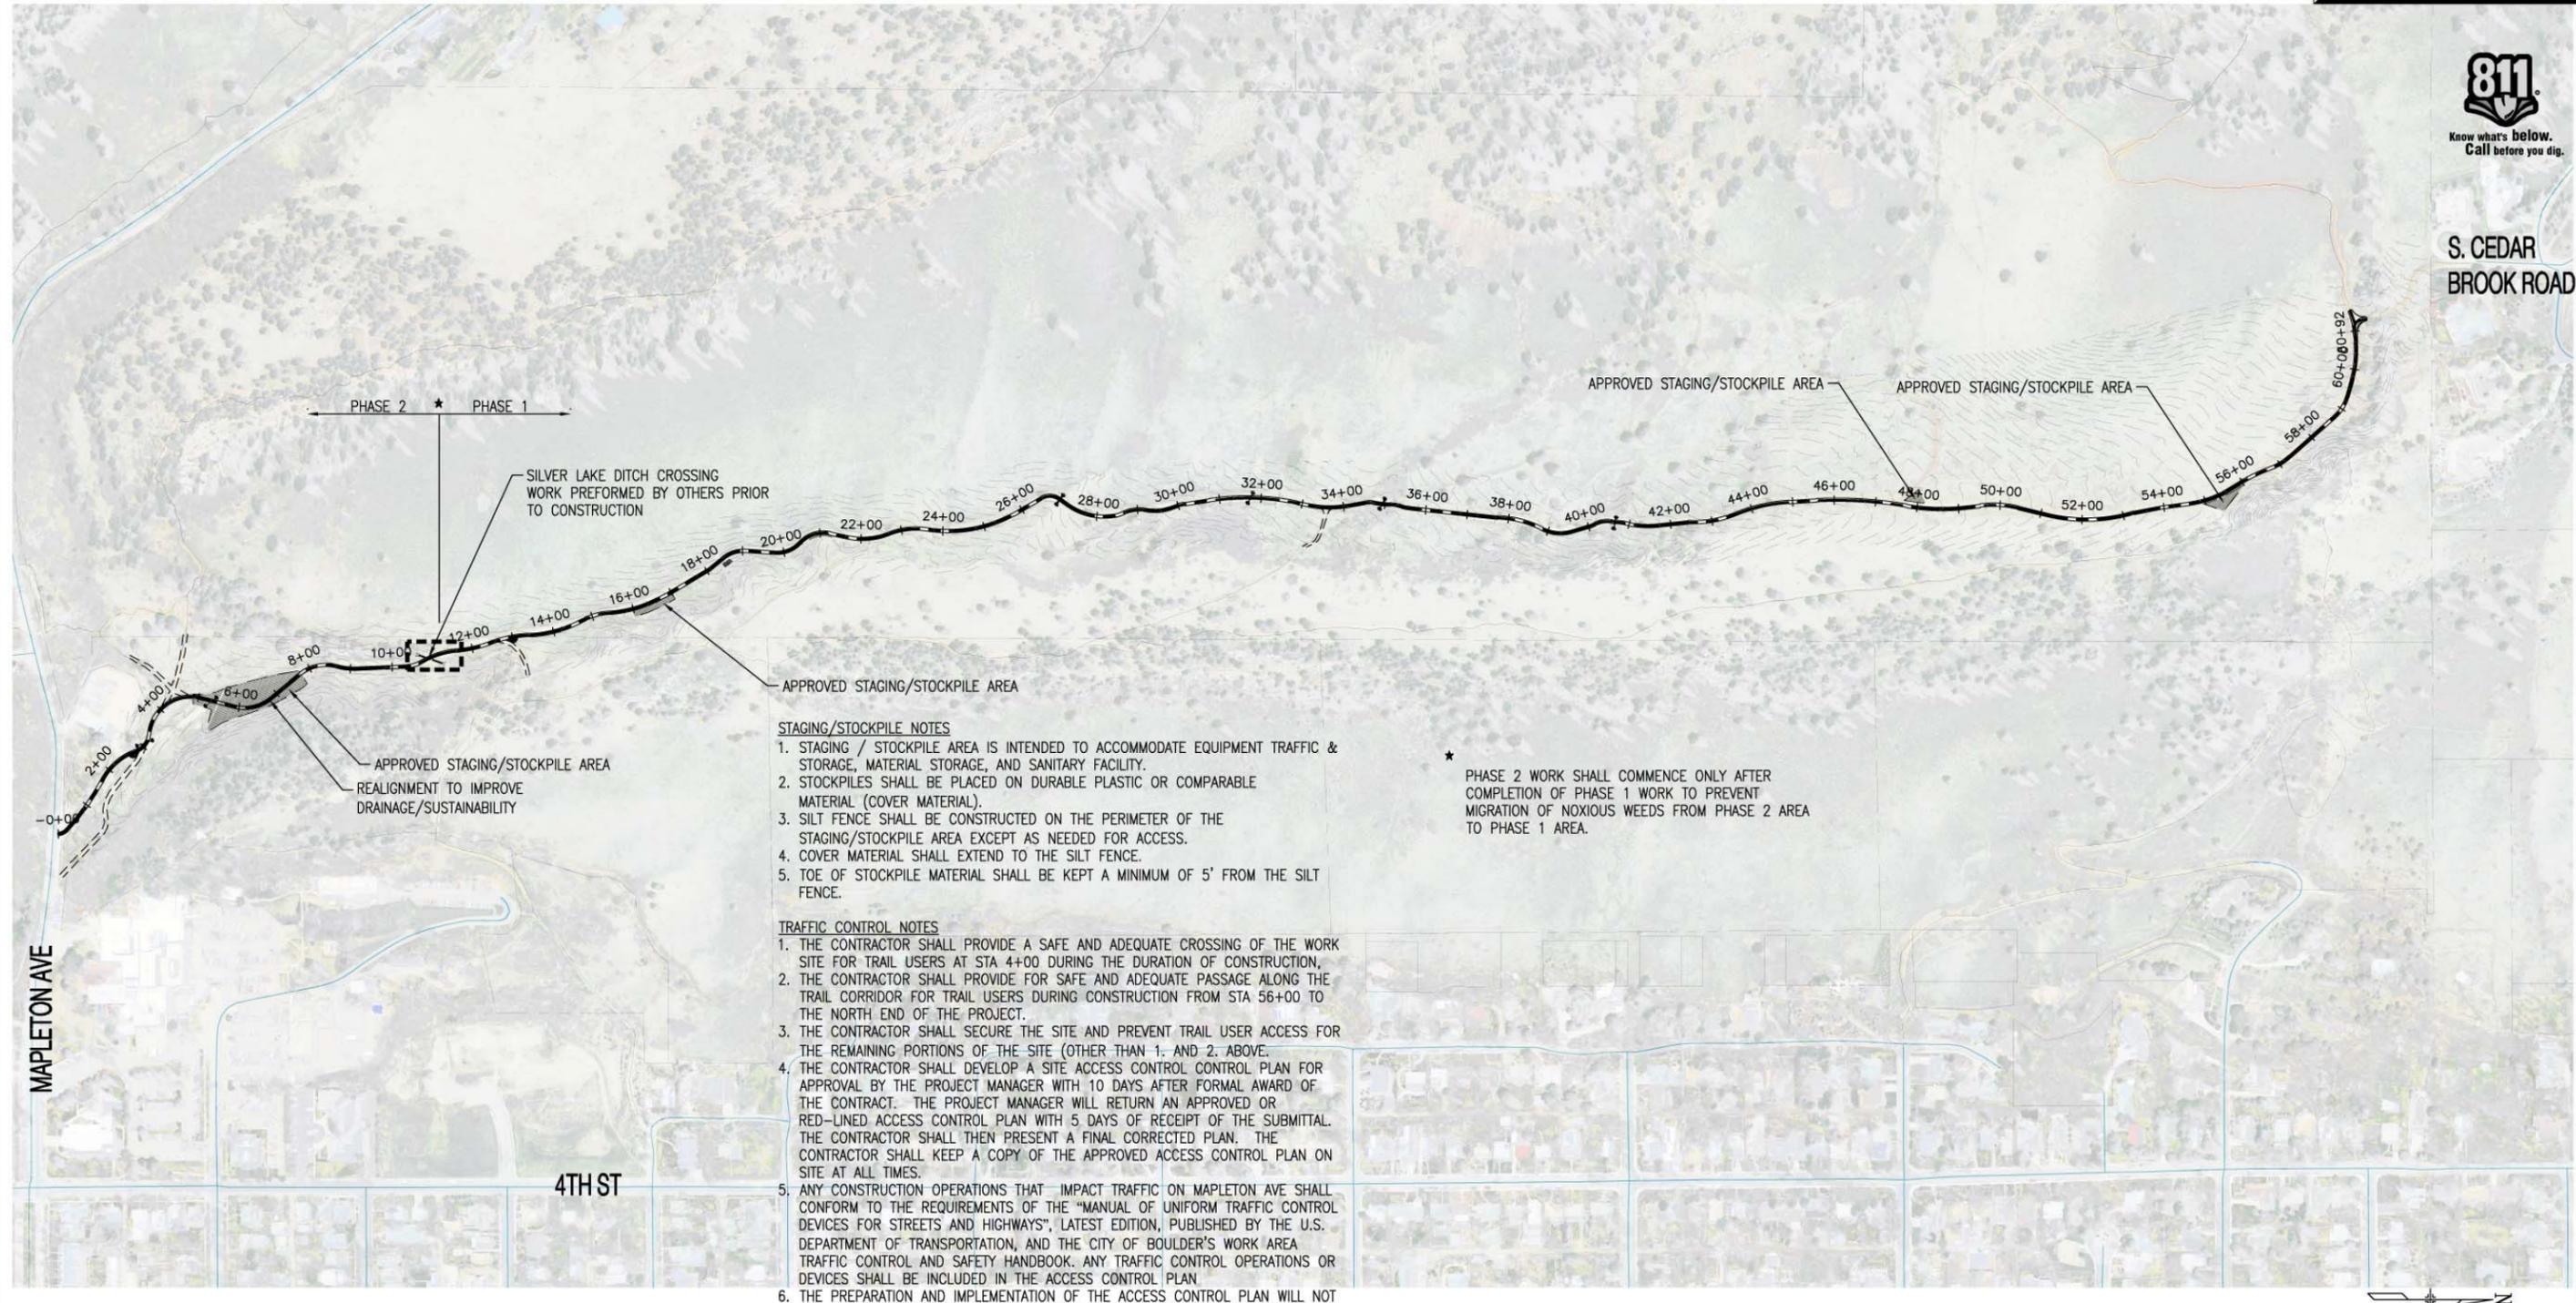
- STAGING/STOCKPILE NOTES**
1. STAGING / STOCKPILE AREA IS INTENDED TO ACCOMMODATE EQUIPMENT TRAFFIC & STORAGE, MATERIAL STORAGE, AND SANITARY FACILITY.
 2. STOCKPILES SHALL BE PLACED ON DURABLE PLASTIC OR COMPARABLE MATERIAL (COVER MATERIAL).
 3. SILT FENCE SHALL BE CONSTRUCTED ON THE PERIMETER OF THE STAGING/STOCKPILE AREA EXCEPT AS NEEDED FOR ACCESS.
 4. COVER MATERIAL SHALL EXTEND TO THE SILT FENCE.
 5. TOE OF STOCKPILE MATERIAL SHALL BE KEPT A MINIMUM OF 5' FROM THE SILT FENCE.

- TRAFFIC CONTROL NOTES**
1. THE CONTRACTOR SHALL PROVIDE A SAFE AND ADEQUATE CROSSING OF THE WORK SITE FOR TRAIL USERS AT STA 4+00 DURING THE DURATION OF CONSTRUCTION.

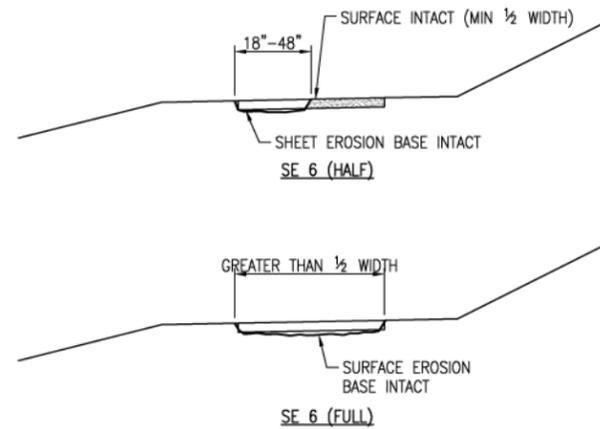
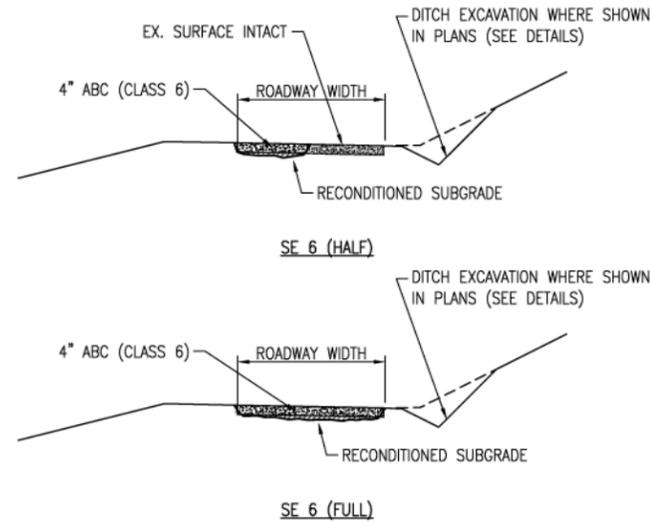
SE 6

DAMAGE TYPES: SHEET EROSION
(SEE SHEETS 14-15 FOR APPROXIMATE LOCATIONS)

STEP 1:

1. THE CONTRACTOR SHALL RIP, DOZE OR OTHERWISE REWORK TO PROVIDE A UNIFORM SUBGRADE ACROSS THE ENTIRE ROADWAY WIDTH. ROCK GREATER THAN 6 INCHES IN GREATEST DIMENSION SHALL BE REMOVED FOR USE ELSEWHERE IN THE PROJECT AS RIPRAP. PAID FOR AS RECONDITIONING (CASE 2) (LF). PLACEMENT OF SITE ROCK USED AS RIPRAP WILL BE PAID FOR SEPARATELY.

2. SURFACING REPAIRS PAID FOR AS AGGREGATE BASE COURSE (CLASS 6) BASED ON THE ACTUAL QUANTITY PLACED AND APPROVED.

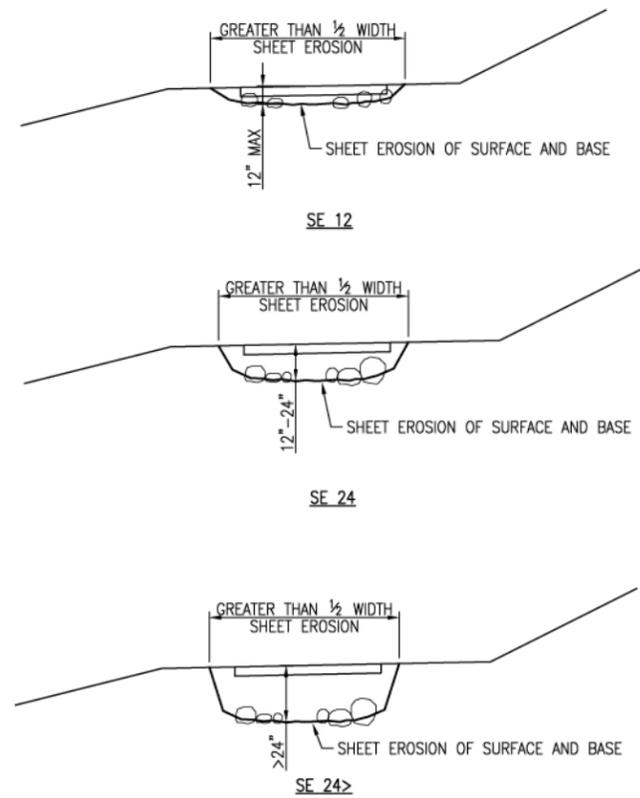
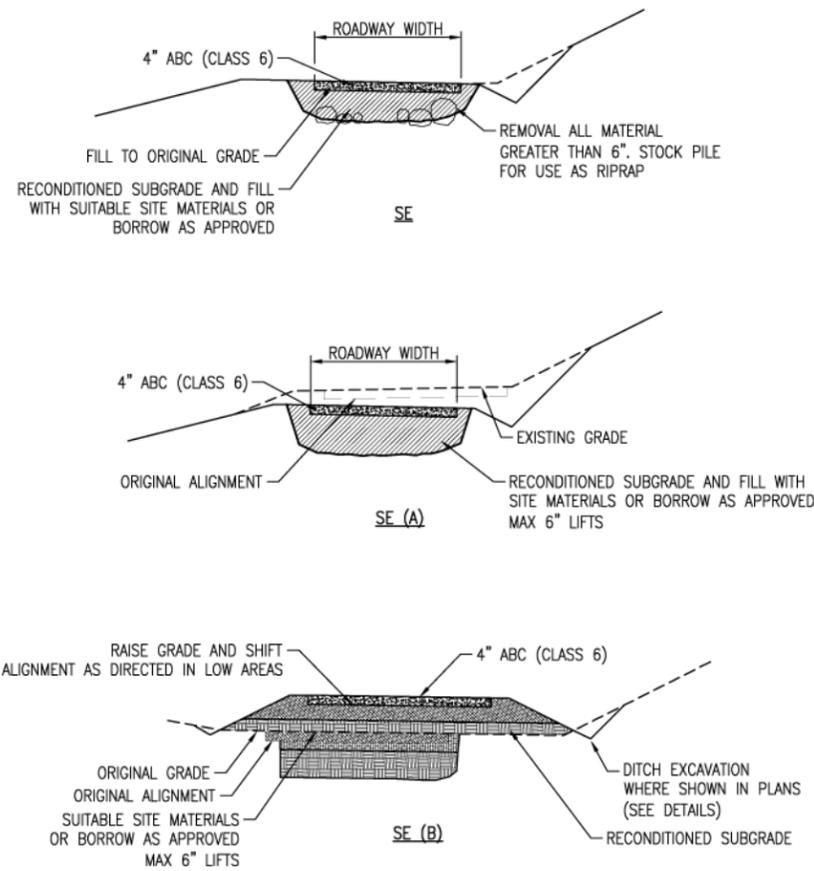
SE 12 & SE >12

STEP 1:

1. THE CONTRACTOR SHALL RIP, DOZE OR OTHERWISE REWORK TO PROVIDE A UNIFORM SUBGRADE ACROSS THE ENTIRE ROADWAY WIDTH. ROCK GREATER THAN 6 INCHES IN GREATEST DIMENSION SHALL BE REMOVED FOR USE ELSEWHERE IN THE PROJECT AS RIPRAP. PAID FOR AS RECONDITIONING (CASE 2) (LF). PLACEMENT OF RIPRAP GENERATED WILL BE PAID FOR SEPARATELY AS RIPRAP.

2. THE CONTRACTOR SHALL USE SUITABLE SITE MATERIALS FROM DITCH EXCAVATIONS, BERM EXCAVATIONS, ETC. FOR SUBGRADE REPAIR. THE COST FOR PLACEMENT AND COMPACTION OF SUITABLE SITE MATERIALS SHALL BE INCLUDED WITH THE ASSOCIATED EXCAVATION THAT GENERATED THE MATERIAL.

3. WHEN NO SUITABLE SITE MATERIALS ARE AVAILABLE FOR SUBGRADE REPAIR, IMPORTED MATERIAL, AS APPROVED BY THE PROJECT MANAGER, SHALL BE USED. MATERIAL AND PLACEMENT WILL BE PAID FOR AS BORROW.

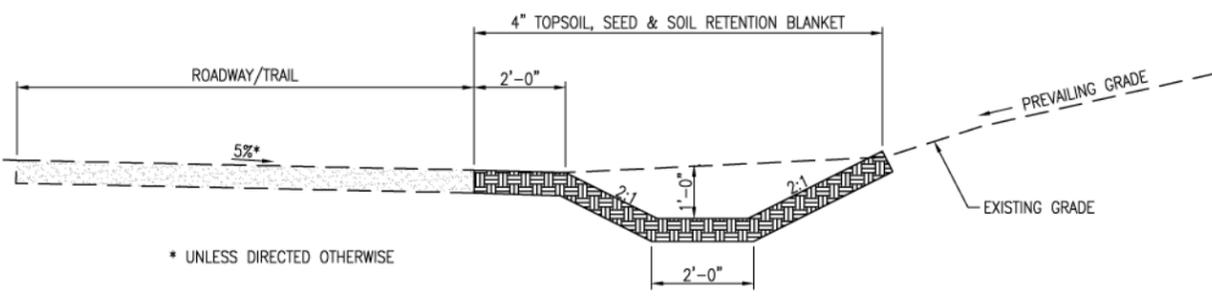
DITCH (TYPE 1) & LEADOFF DITCH

ALL SUITABLE MATERIALS EXCAVATED SHALL BE USED TO FILL EROSION DAMAGE ADJACENT TO THE DITCH LOCATION OR EROSION DAMAGE ELSEWHERE ON THE SITE. UNSUITABLE MATERIALS SHALL BE USED AS TOPSOIL OR REMOVED AND DISPOSED OF BY THE CONTRACTOR. STOCKPILING, TRANSPORT AND PLACEMENT OF SUITABLE MATERIAL AND TOPSOIL OR REMOVAL AND DISPOSAL OF UNSUITABLE MATERIAL WILL NOT BE MEASURED OR PAID FOR SEPARATELY BUT SHALL BE INCLUDED IN THE COST OF DITCH EXCAVATION (LF).

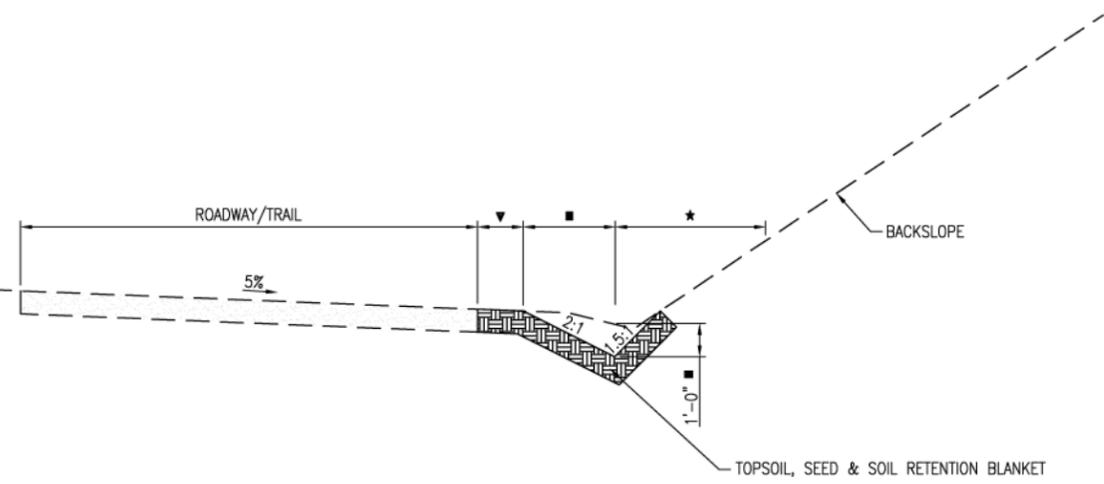
DITCH (TYPE 2)

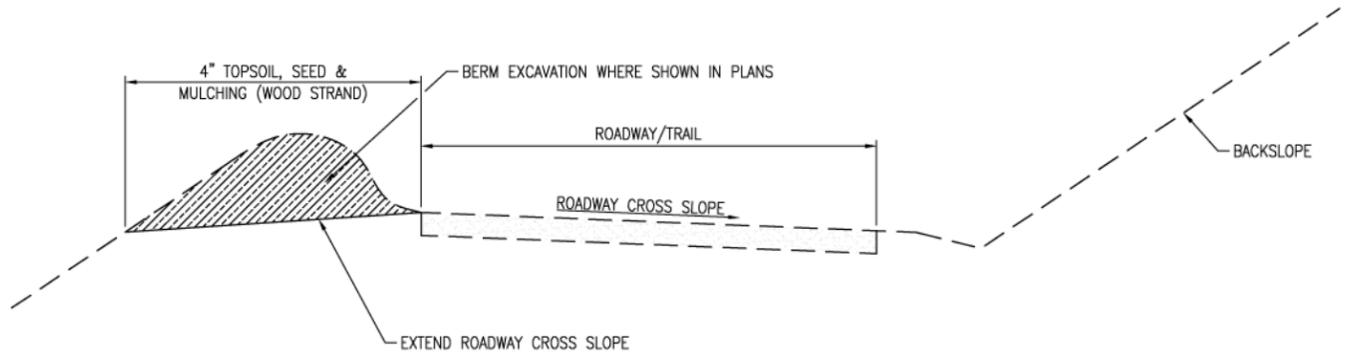
BERM EXCAVATION

ALL SUITABLE MATERIALS EXCAVATED SHALL BE USED TO FILL EROSION DAMAGE ADJACENT TO THE BERM EXCAVATION LOCATION OR EROSION DAMAGE ELSEWHERE ON THE SITE. UNSUITABLE MATERIALS SHALL BE USED AS TOPSOIL OR REMOVED AND DISPOSED OF BY THE CONTRACTOR. STOCKPILING, TRANSPORT AND PLACEMENT OF SUITABLE MATERIAL OR REMOVAL AND DISPOSAL OF UNSUITABLE MATERIAL WILL NOT BE MEASURED OR PAID FOR SEPARATELY BUT SHALL BE INCLUDED IN THE COST OF BERM EXCAVATION (LF).

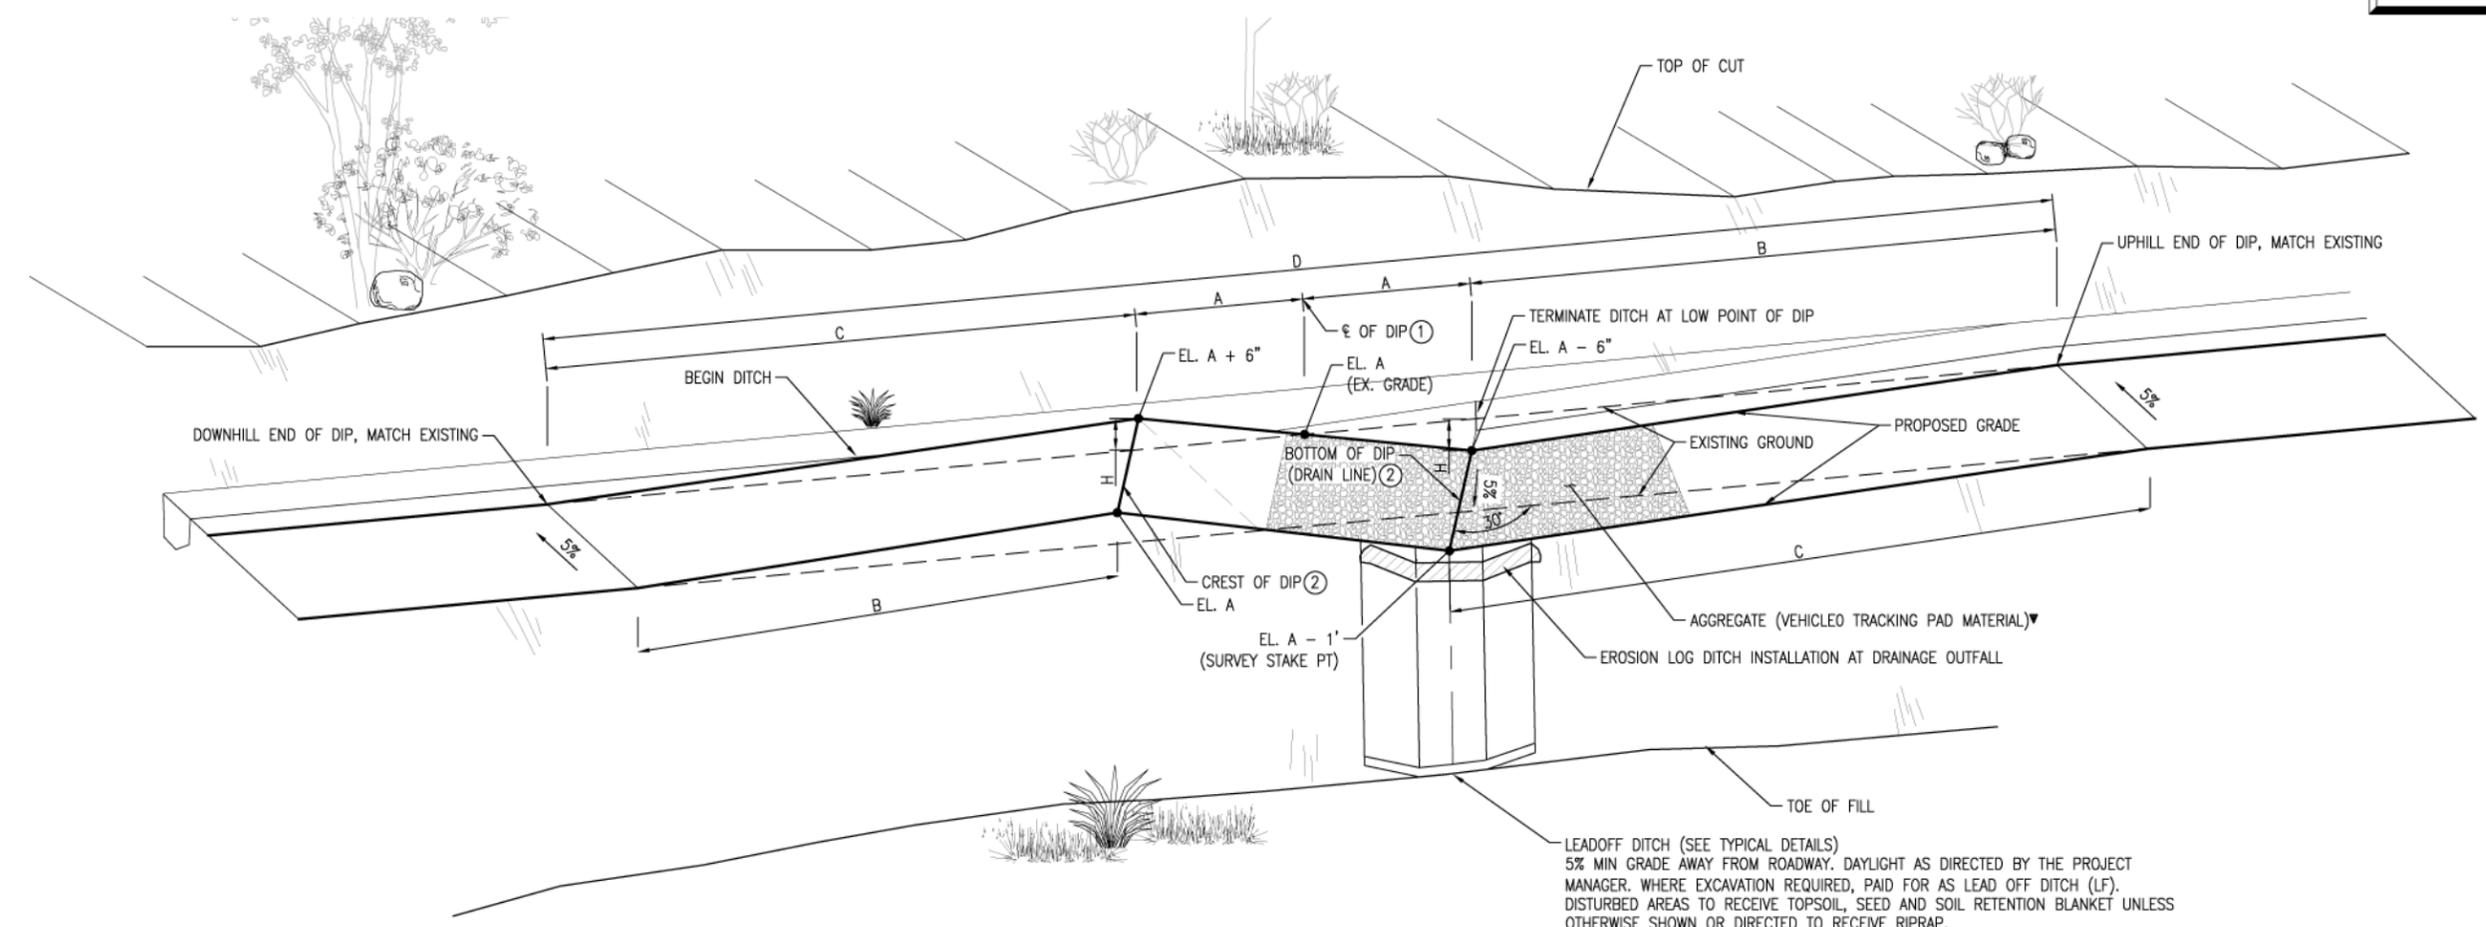
ROLLING DIP
N.T.S.

EXISTING % PROFILE GRADE	A	B	C	D
0% - 8%	6'	8'	12'	32'
9% - 12%	6'	10'	14'	36'
13% - 16%	7'	13'	17'	44'
17% & OVER	7'	18'	22'	54'

- NOTES:**
- ① ROLLING DIP STATIONS SHOWN ARE APPROXIMATE. FINAL STATION TO BE DESIGNATED BY THE PROJECT MANAGER DURING CONSTRUCTION.
 - ② ROUND GRADE
 - ▼ 6" THICK AGGREGATE (TRACKING PAD MATERIAL) PER CDOT 208.02 (K). AGGREGATE TO BE COVERED WITH SITE SOIL TO FILL VOIDS. SITE ROCK MEETING THE REQUIREMENTS OF 208.02 (K) SHALL BE USED WHEN AVAILABLE. COST OF MATERIALS AND PLACEMENT, WHETHER SITE MATERIALS OR IMPORTED SHALL BE INCLUDED IN THE COST OF ROLLING DIP (EACH)

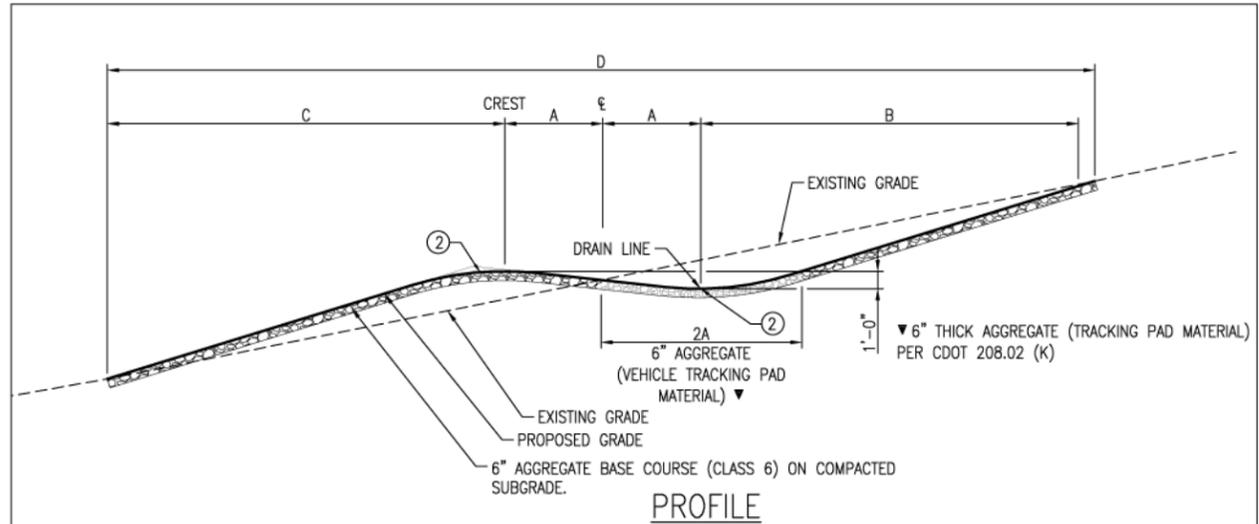
EACH LEADOFF DITCH SHALL INCLUDE EROSION LOG DITCH INSTALLATION AT THE DOWNSTREAM END AND AT 20' MAX SPACING IF APPLICABLE.

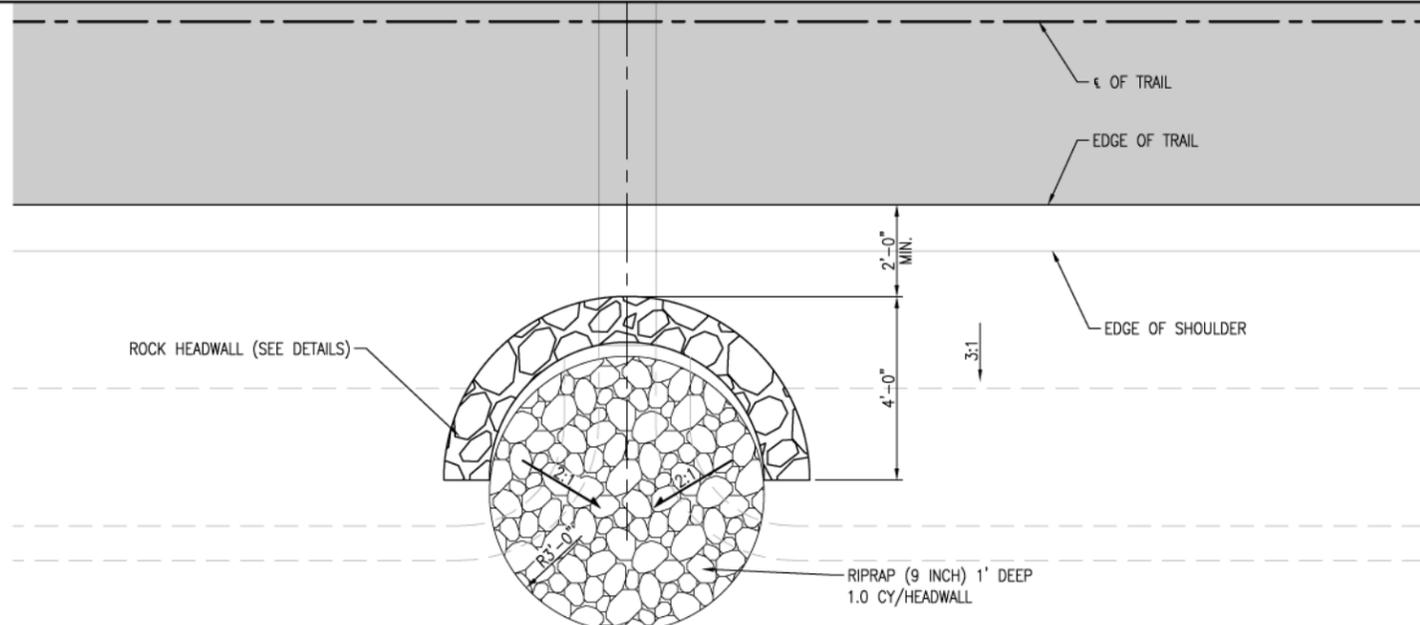
CULVERT ROCK HEADWALL PLAN
PERPENDICULAR LAYOUT
N.T.S.

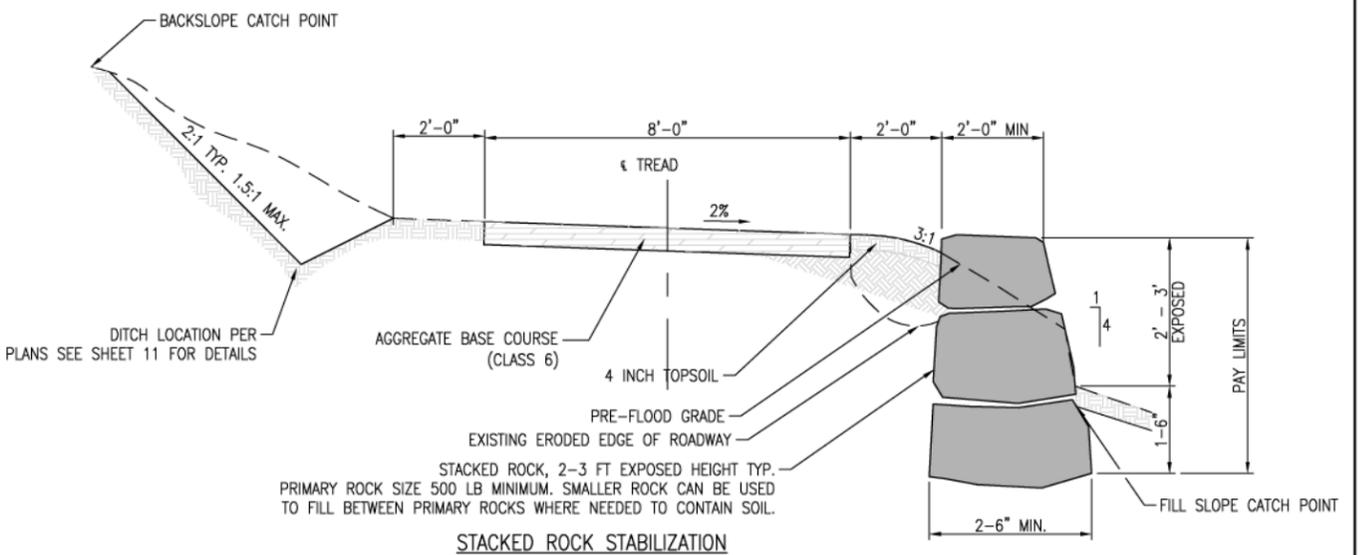
STACKED ROCK STABILIZATION

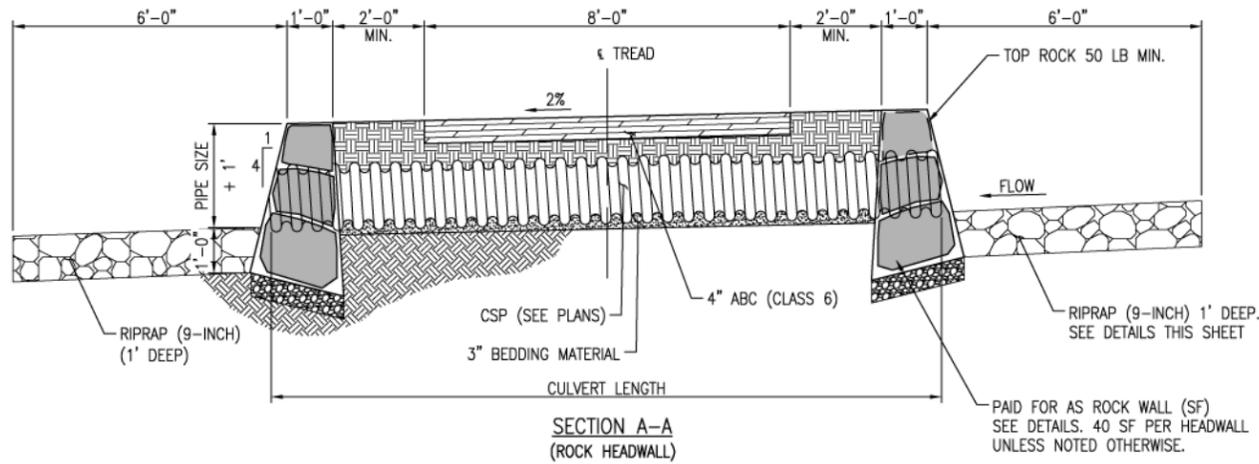
SECTION A-A
(ROCK HEADWALL)

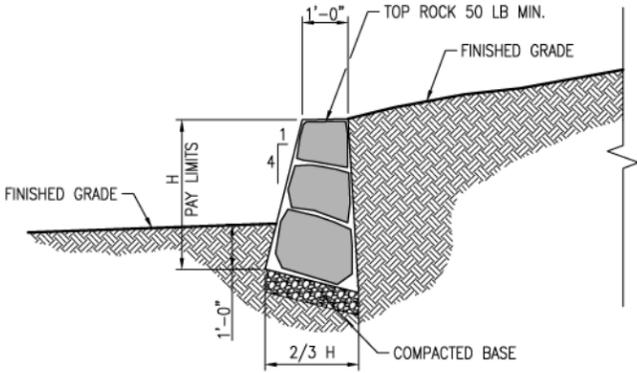
ROCK WALL DETAIL

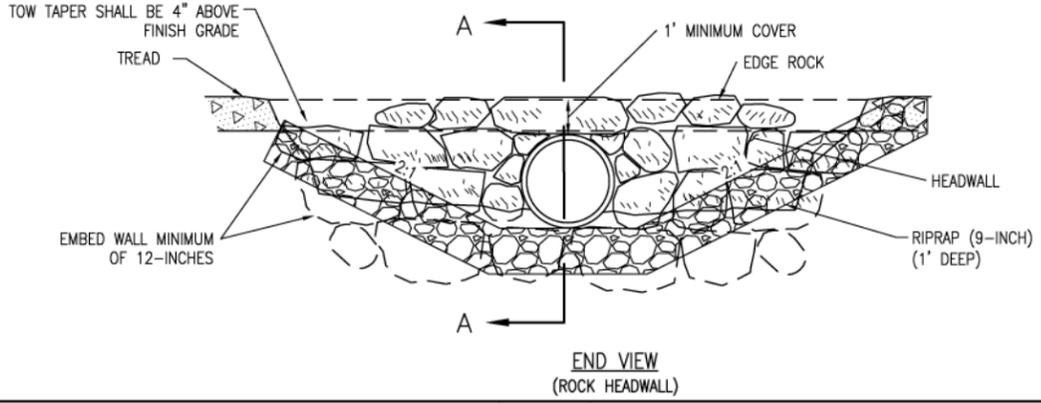
END VIEW
(ROCK HEADWALL)

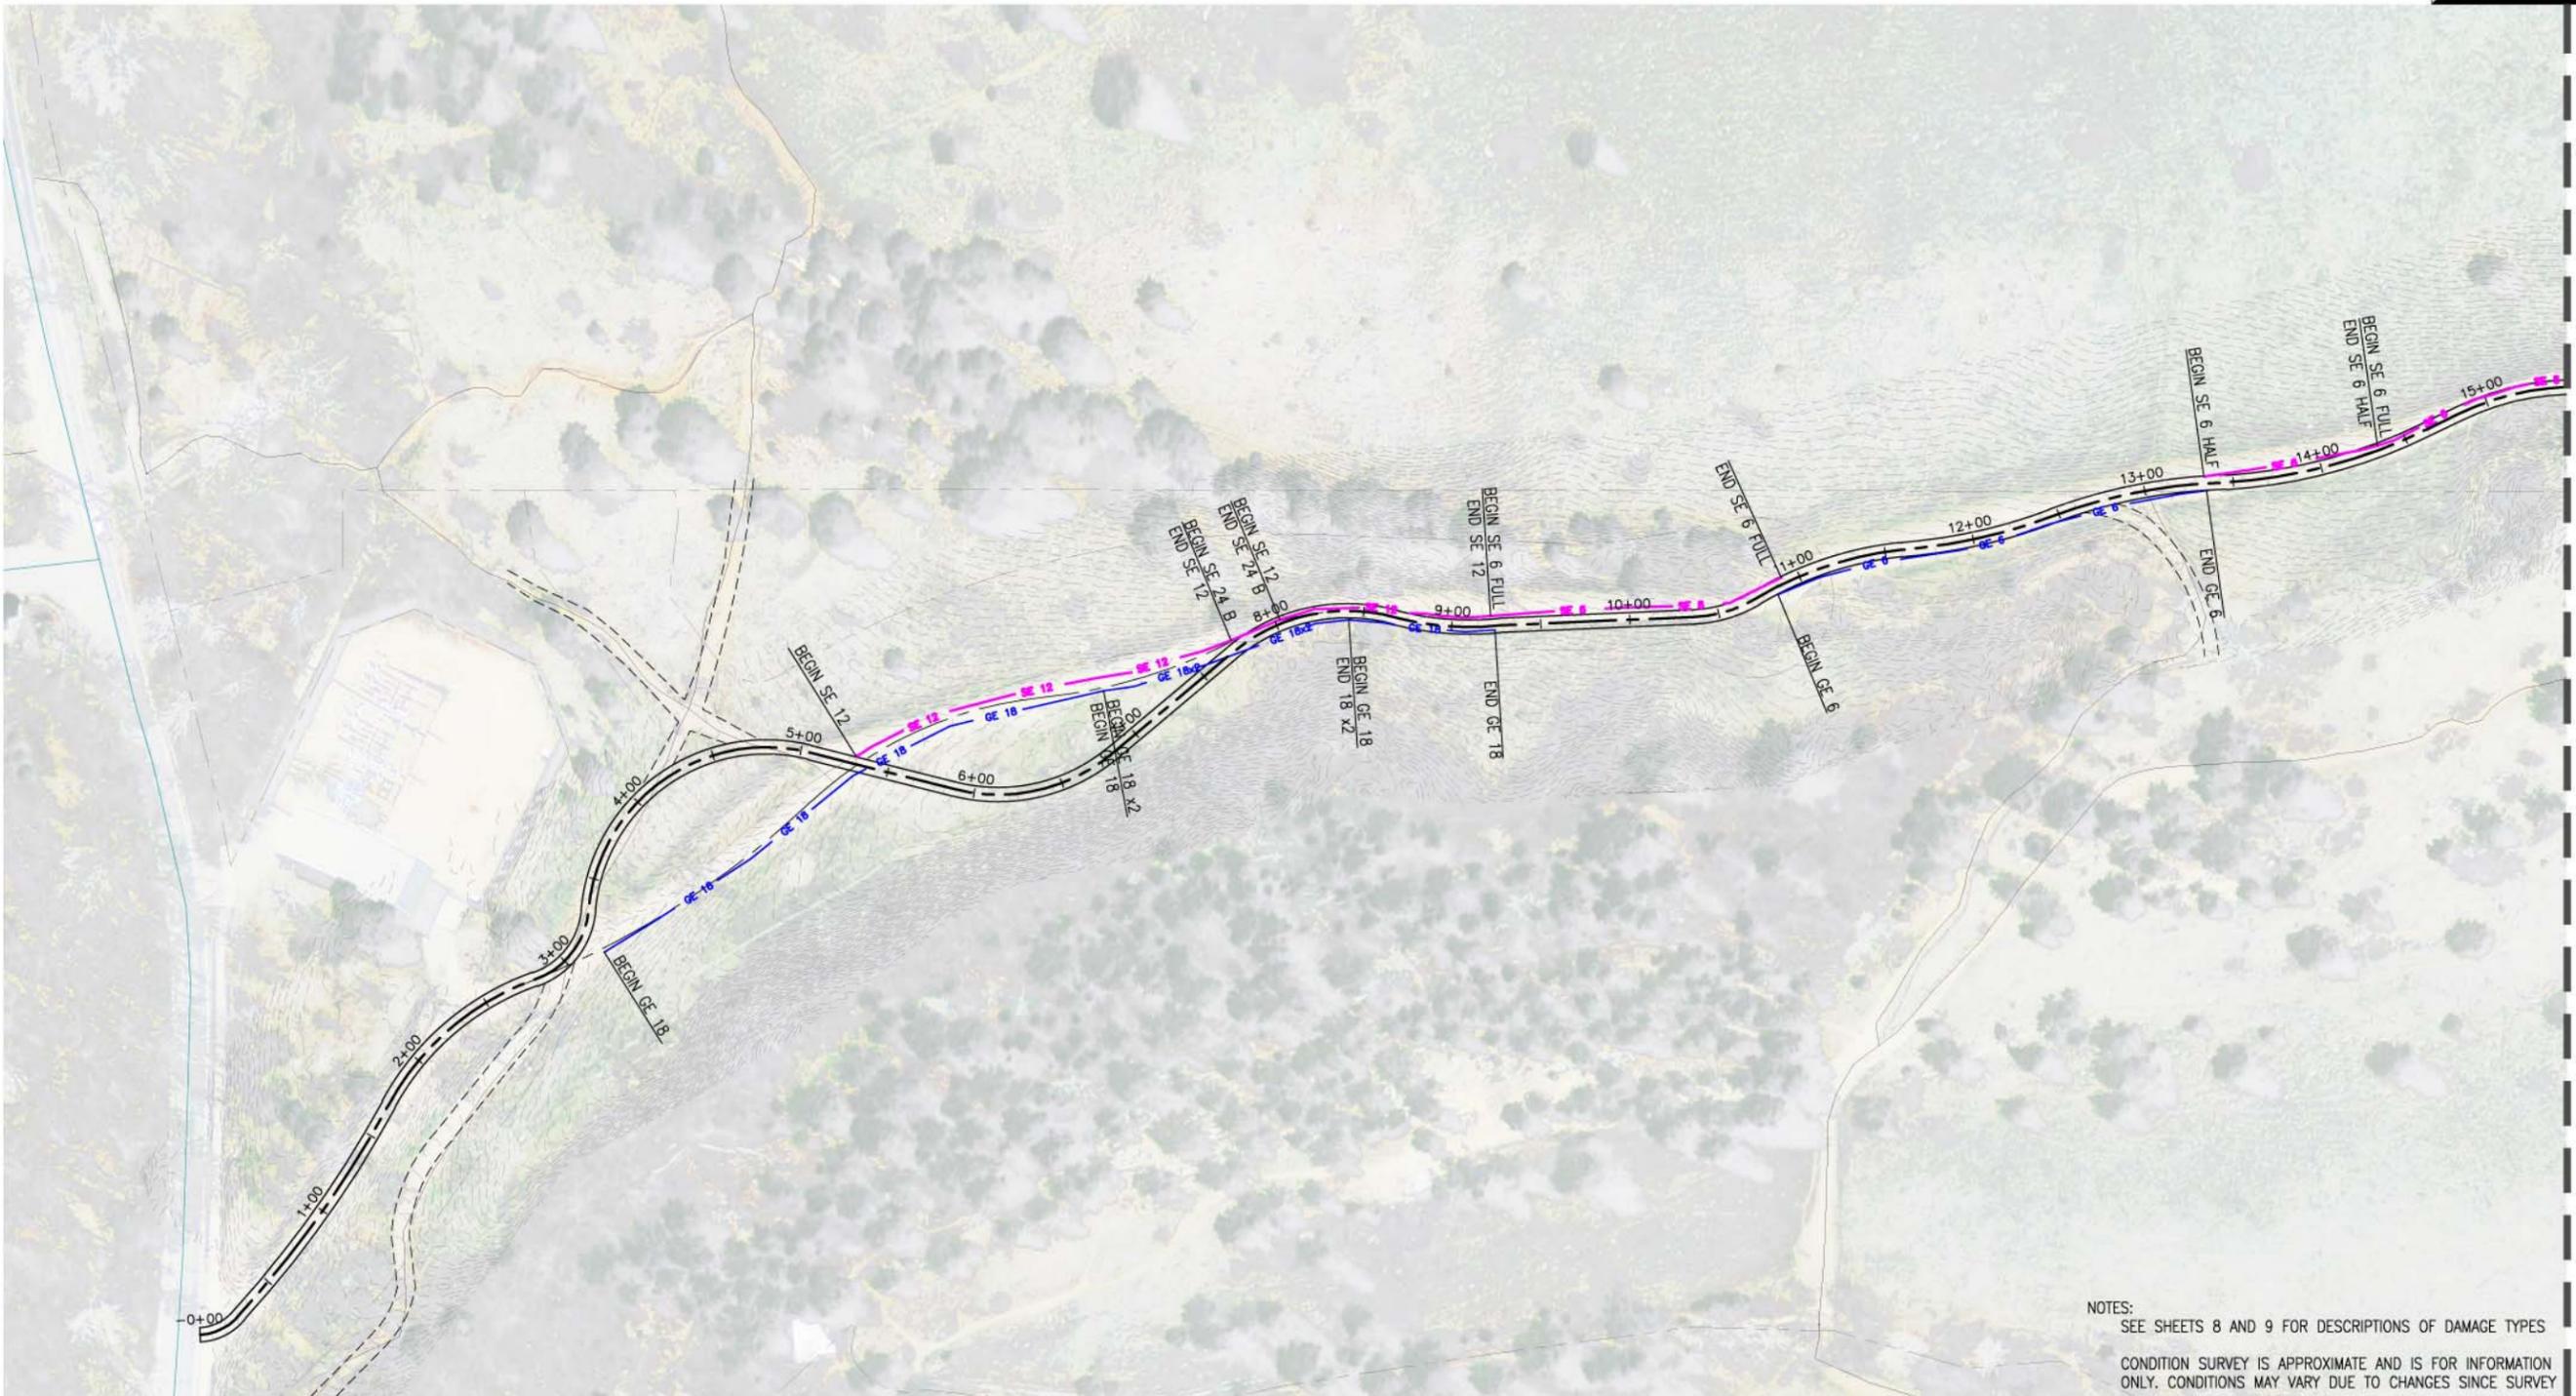
NOTES:
SEE SHEETS 8 AND 9 FOR DESCRIPTIONS OF DAMAGE TYPES
CONDITION SURVEY IS APPROXIMATE AND IS FOR INFORMATION ONLY. CONDITIONS MAY VARY DUE TO CHANGES SINCE SURVEY

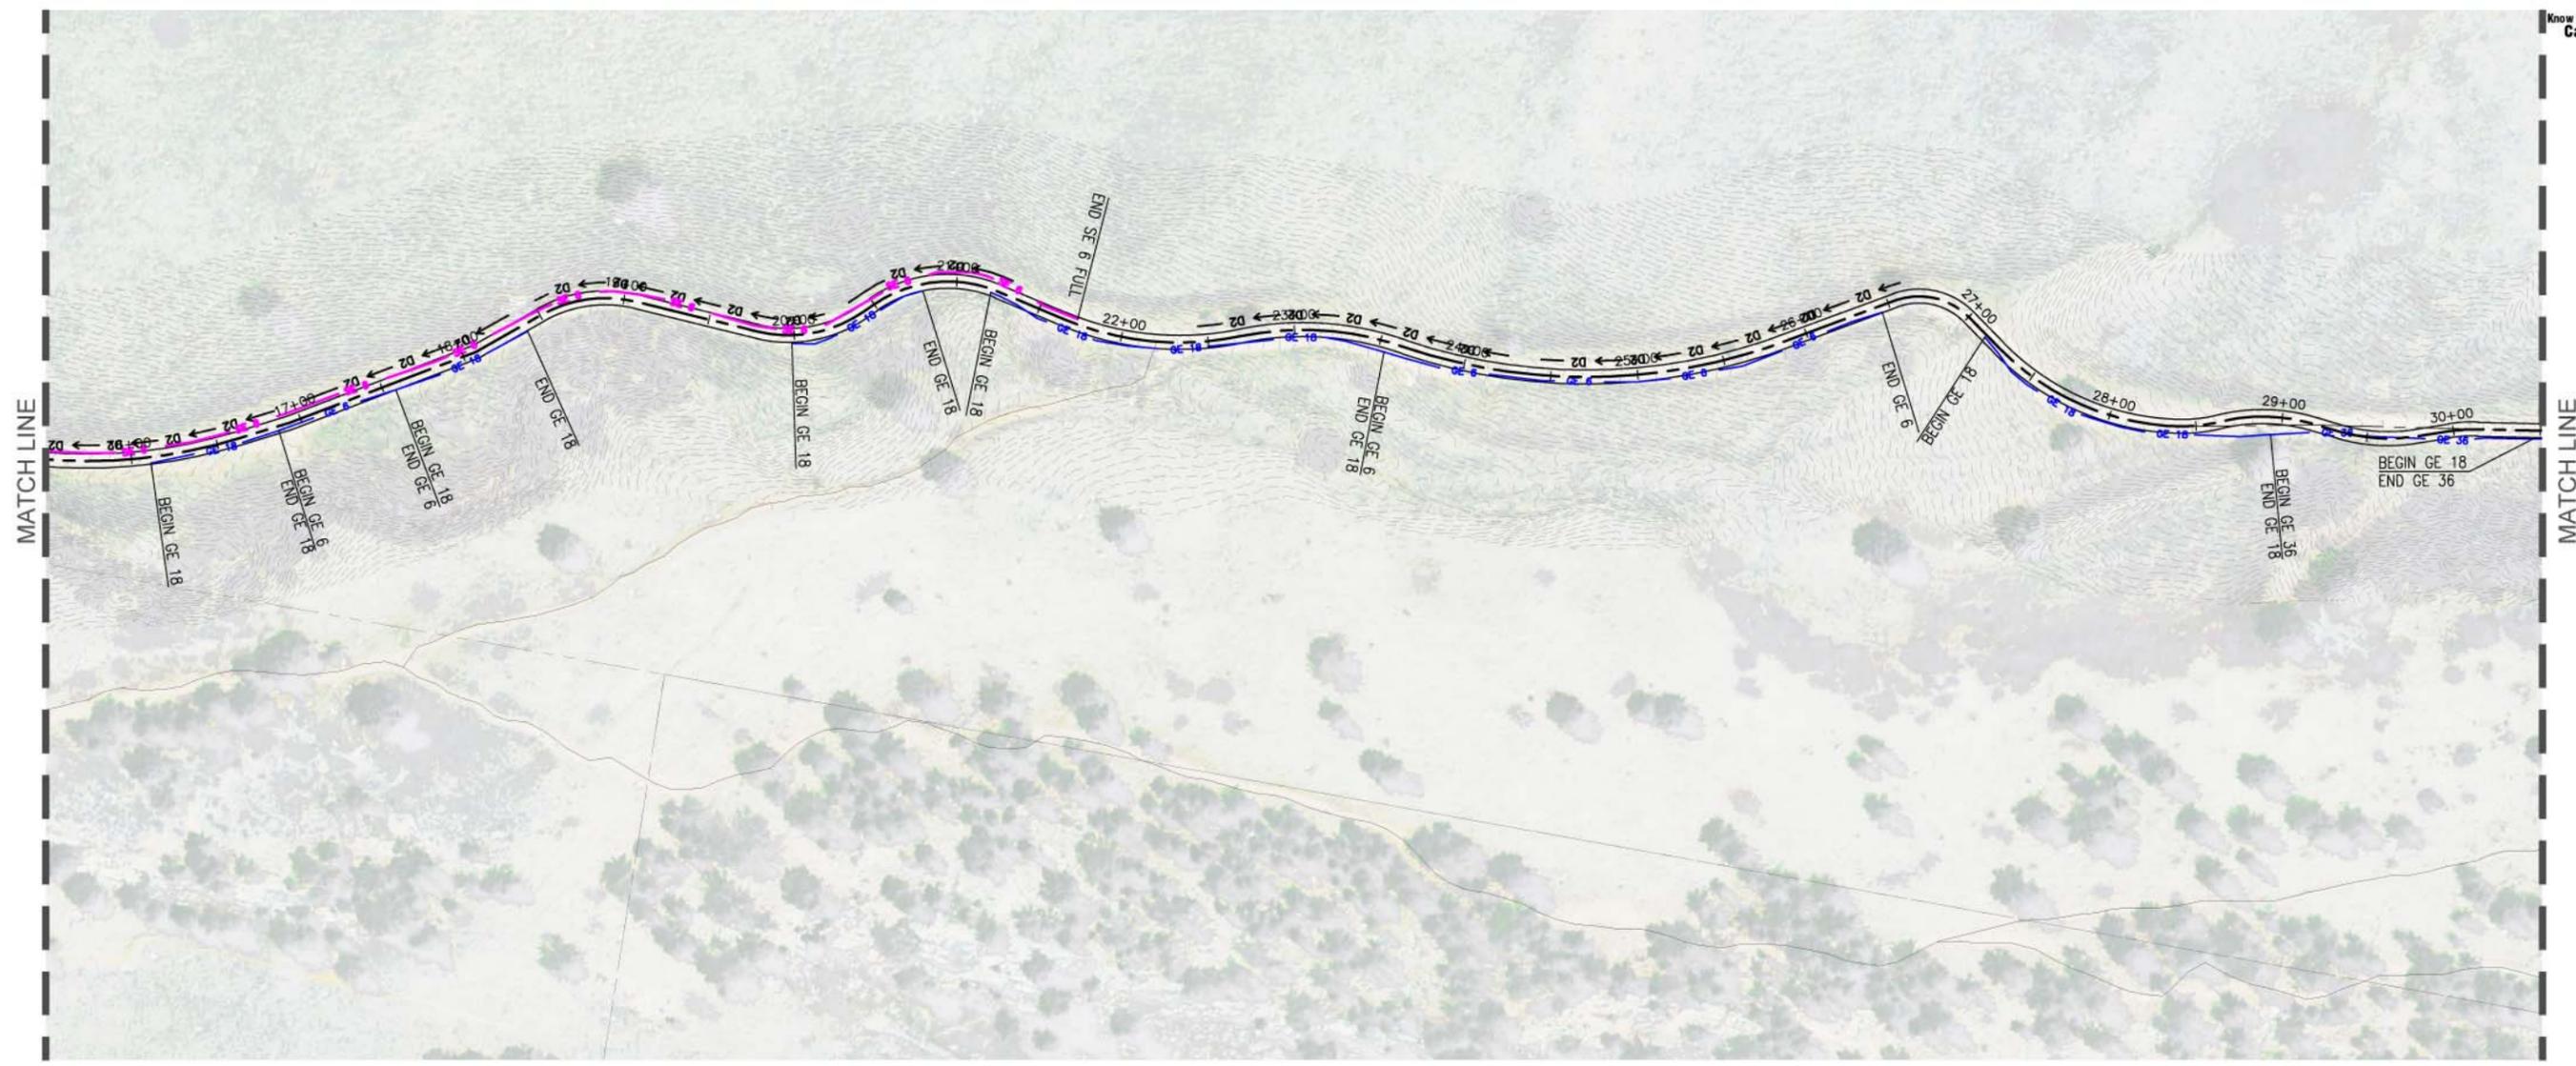
NOTES:
SEE SHEETS 8 AND 9 FOR DESCRIPTIONS OF DAMAGE TYPES
CONDITION SURVEY IS APPROXIMATE AND IS FOR INFORMATION ONLY. CONDITIONS MAY VARY DUE TO CHANGES SINCE SURVEY

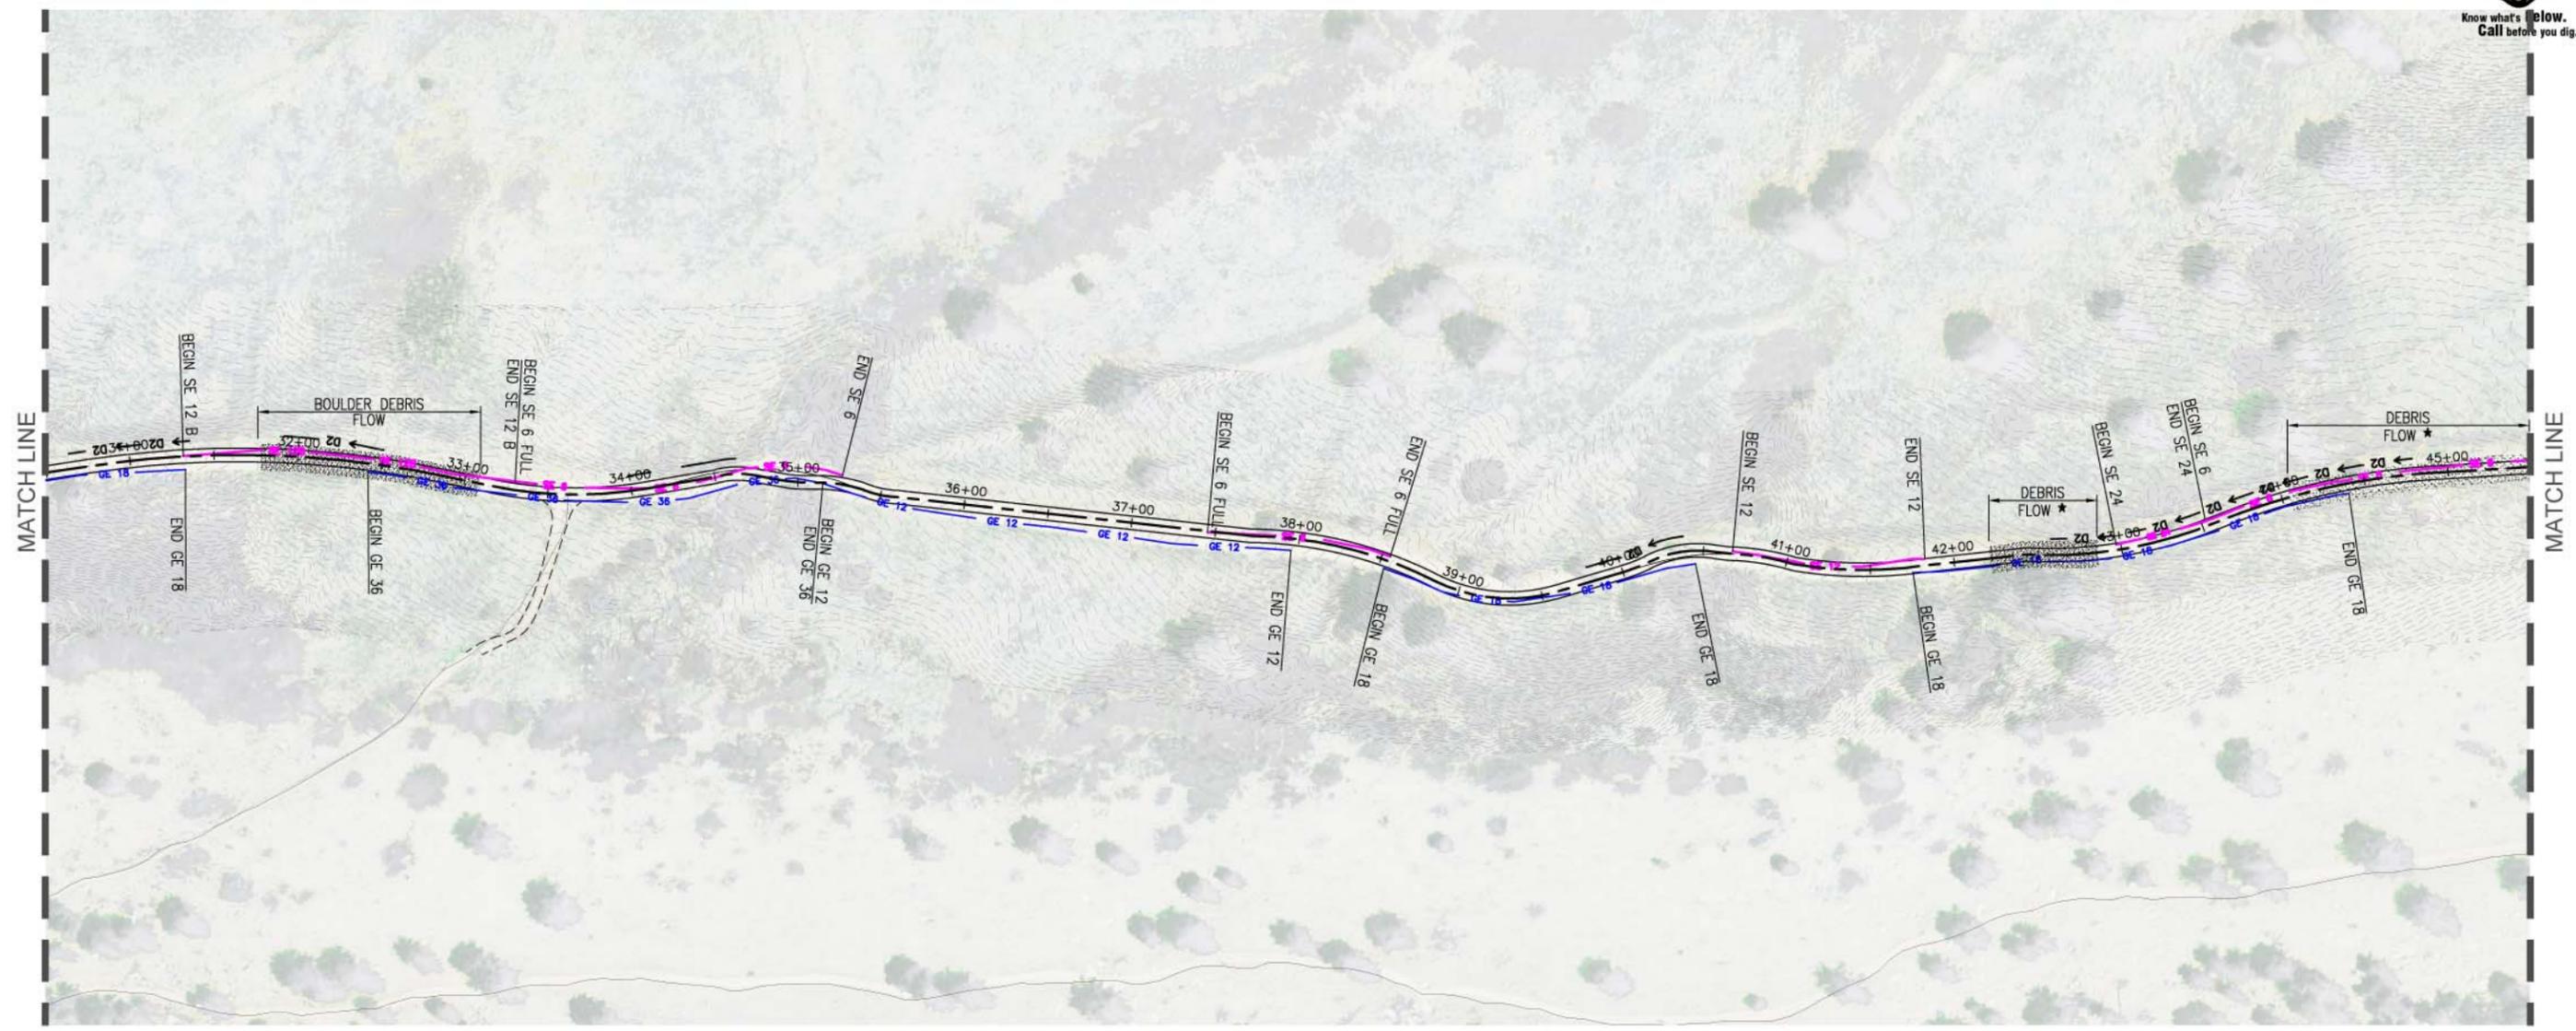
NOTES:
SEE SHEETS 8 AND 9 FOR DESCRIPTIONS OF DAMAGE TYPES
CONDITION SURVEY IS APPROXIMATE AND IS FOR INFORMATION ONLY. CONDITIONS MAY VARY DUE TO CHANGES SINCE SURVEY
*LOOSE ROCK MATERIAL SHALL BE REMOVED AND USED AS RIPRAP ELSEWHERE AS SHOWN IN PLANS.
