SANITAS VALLEY ROAD - FLOOD DAMAGE REPAIR AND MITIGATION OVERALL SITE PLAN			
Designer:	SJB	Structure	
Detailer:	LX	Numbers	
Sheet Subset:		Subset Sheets:

A. PROJECT SITE DESCRIPTION: REPAIRS TO THE SANITAS VALLEY TRAIL TO ADDRESS FLOOD DAMAGE AND MITIGATION MEASURES TO REDUCE THE LIKELIHOOD OF DAMAGE FROM FUTURE EVENTS.

SANITAS VALLEY ROAD - FLOOD DAMAGE REPAIR AND MITIGATION			
TYPICAL REPAIR DETAILS			
Designer:	SJB	Structure	
Detailer:	CWM	Numbers	
Sheet Subset:		Subset Sheets:

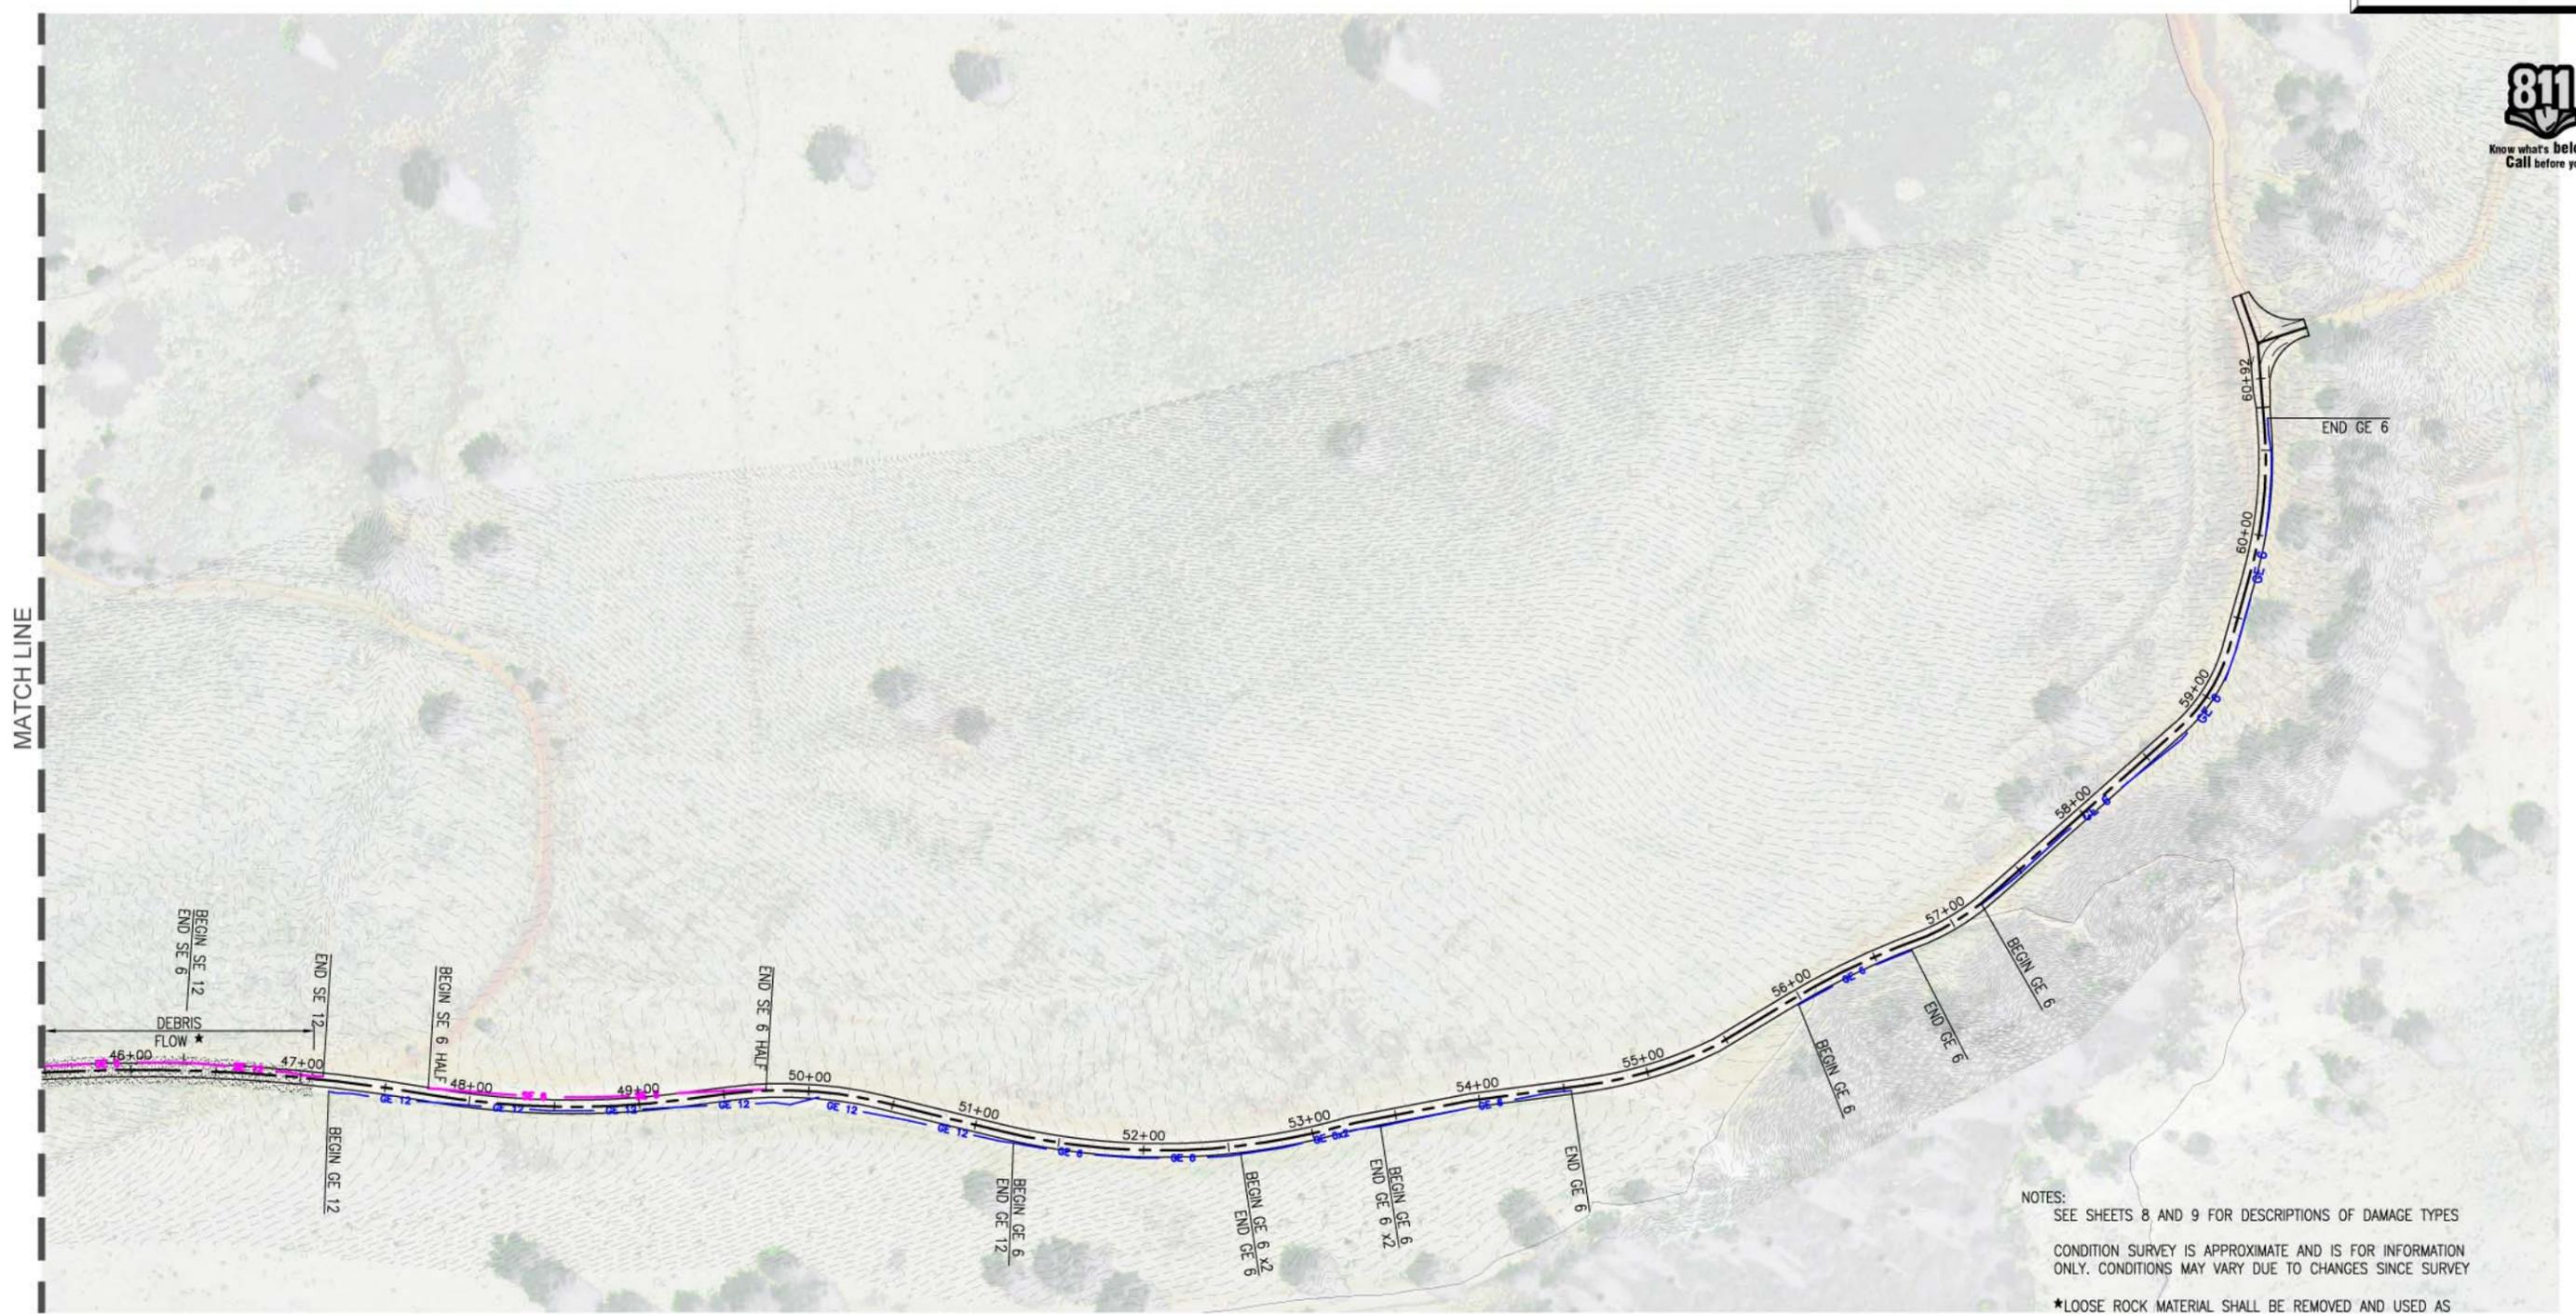
NOTES:
SEE SHEETS 8 AND 9 FOR DESCRIPTIONS OF DAMAGE TYPES
CONDITION SURVEY IS APPROXIMATE AND IS FOR INFORMATION ONLY. CONDITIONS MAY VARY DUE TO CHANGES SINCE SURVEY
*LOOSE ROCK MATERIAL SHALL BE REMOVED AND USED AS RIPRAP ELSEWHERE AS SHOWN IN PLANS.

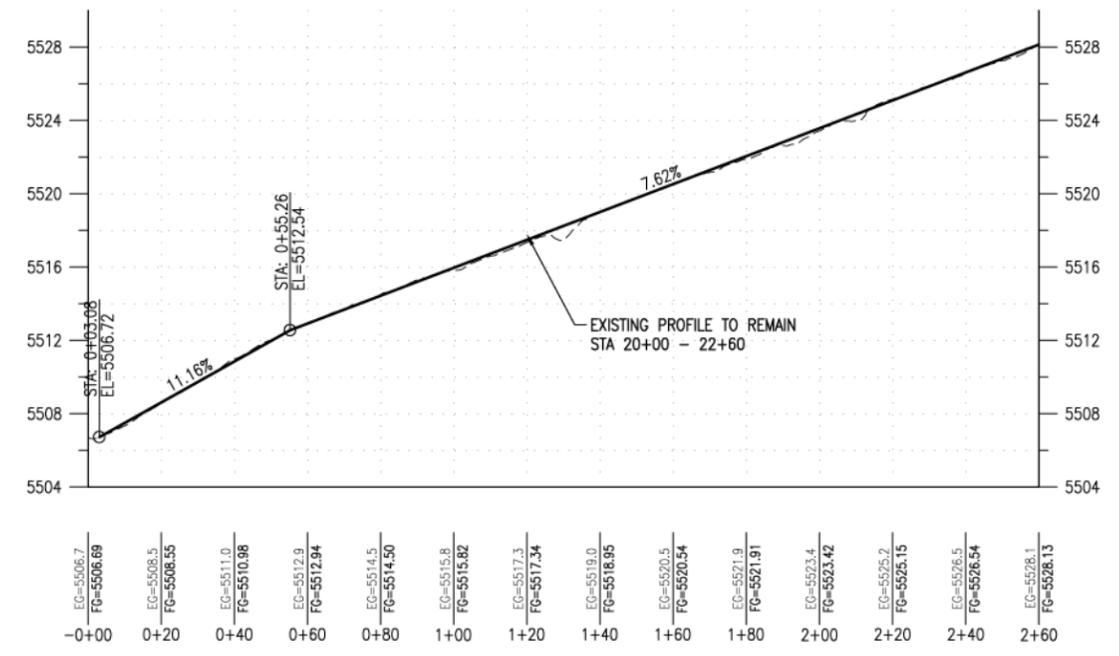
Proposed Sanitas Alignment (Beginning Segment) PROFILE
SCALE: (H) 1" = 10' (V) 1" = 2'
START STA: -0+00.00, END STA: 2+60.00

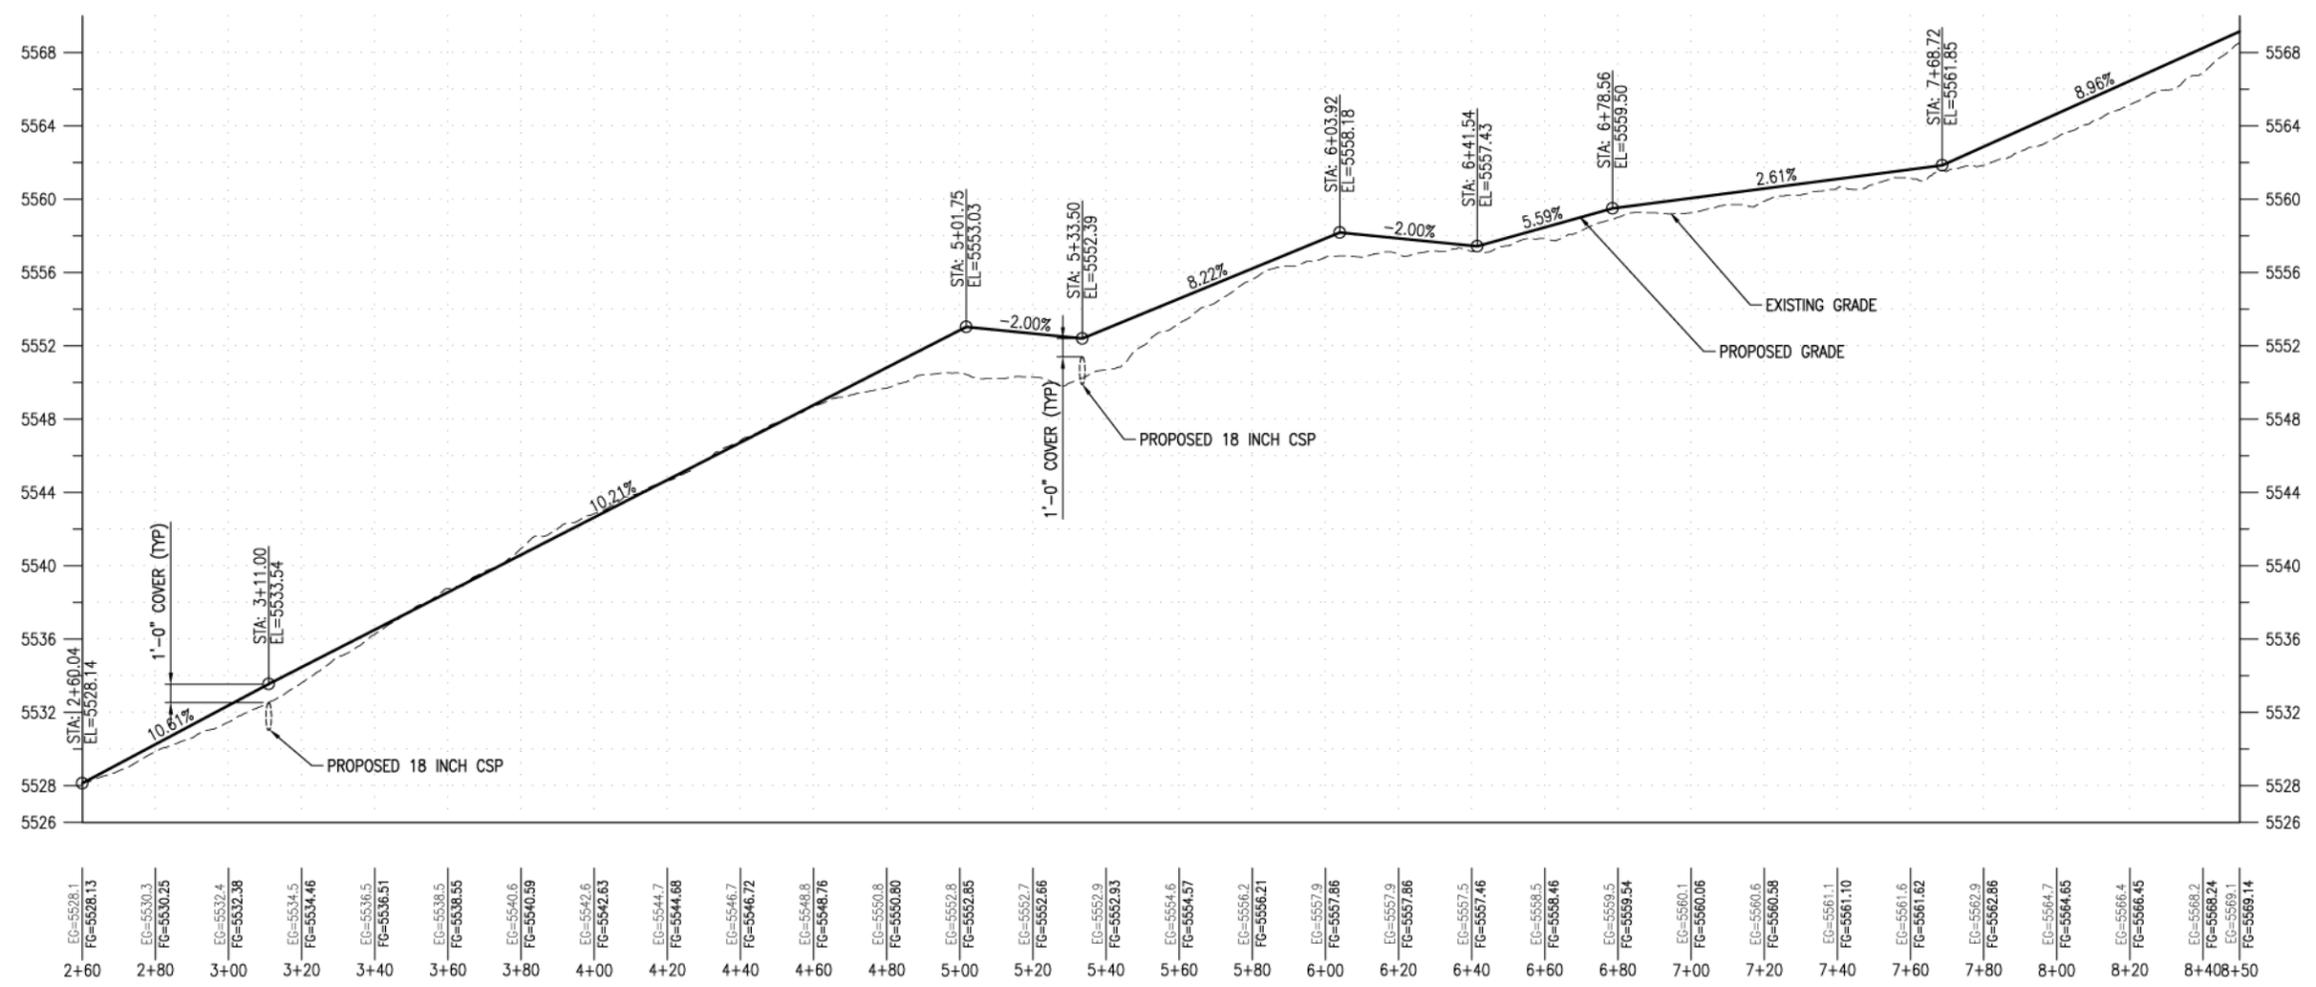
Proposed Sanitas Alignment (Beginning Segment) PROFILE
SCALE: (H) 1" = 10' (V) 1" = 2'
START STA: 2+60.00, END STA: 8+50.00

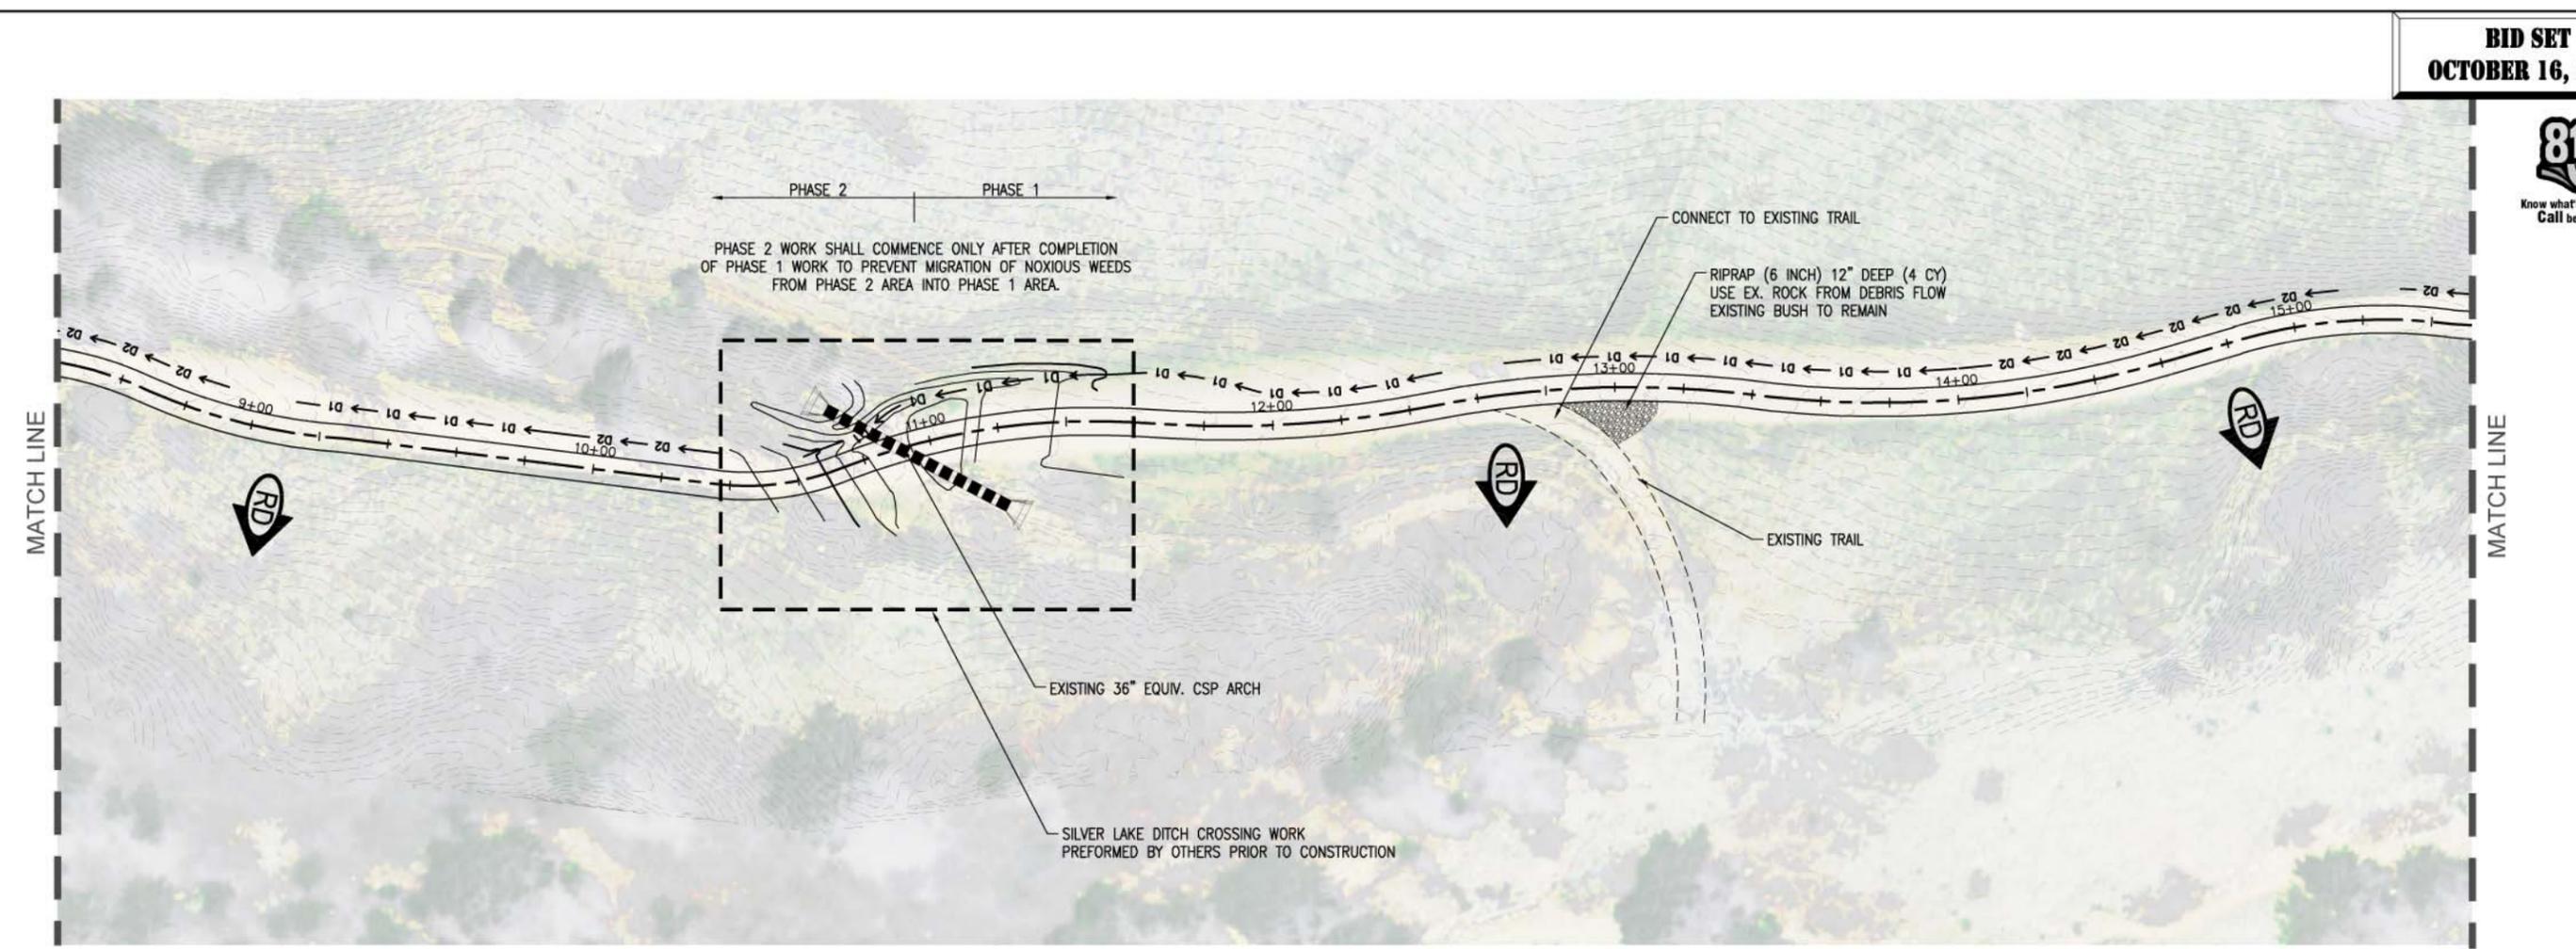
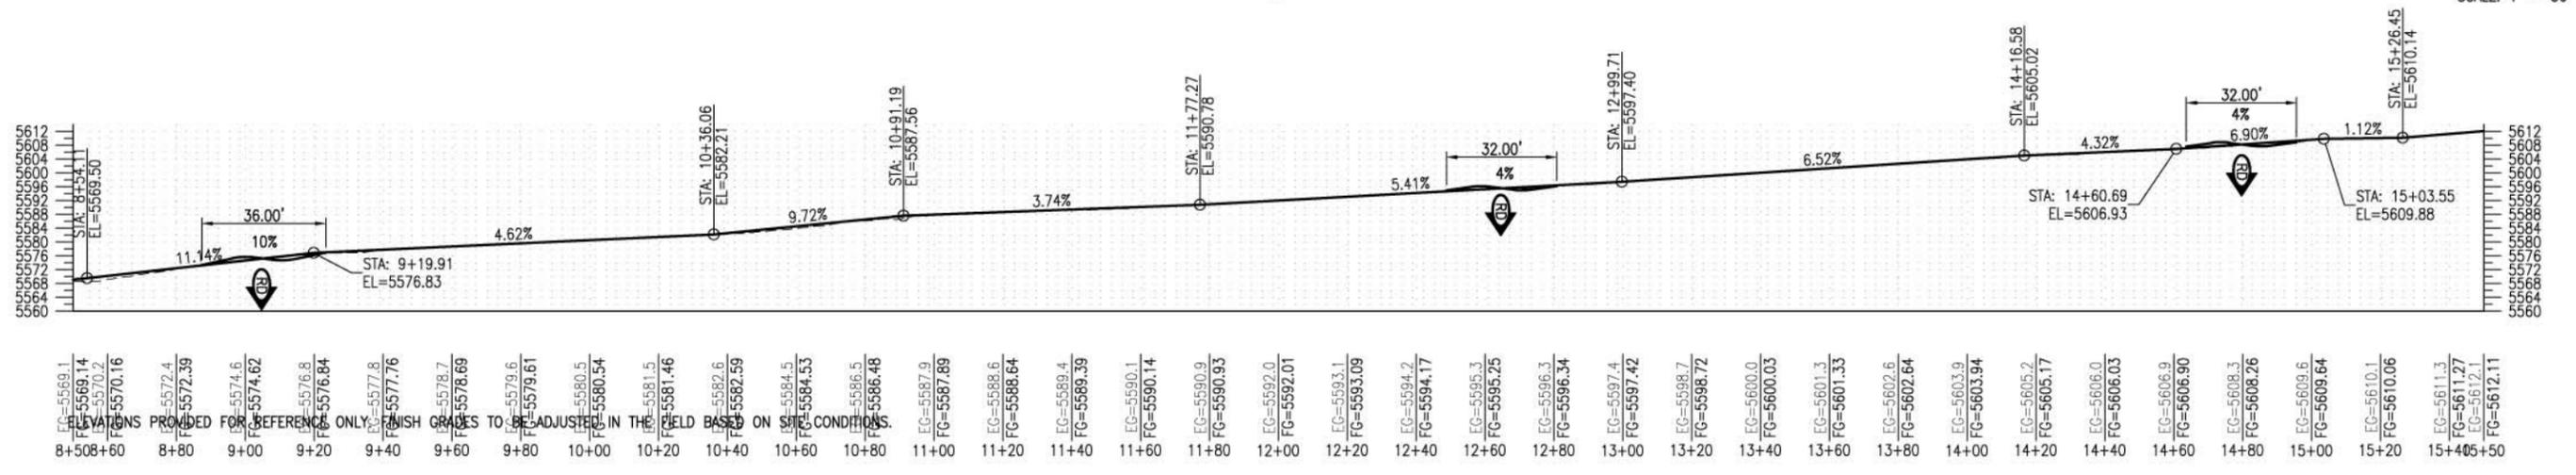
SCALE: (H) 1" = 10' (V) 1" = 10'
START STA: 8+50.00, END STA: 15+50.00

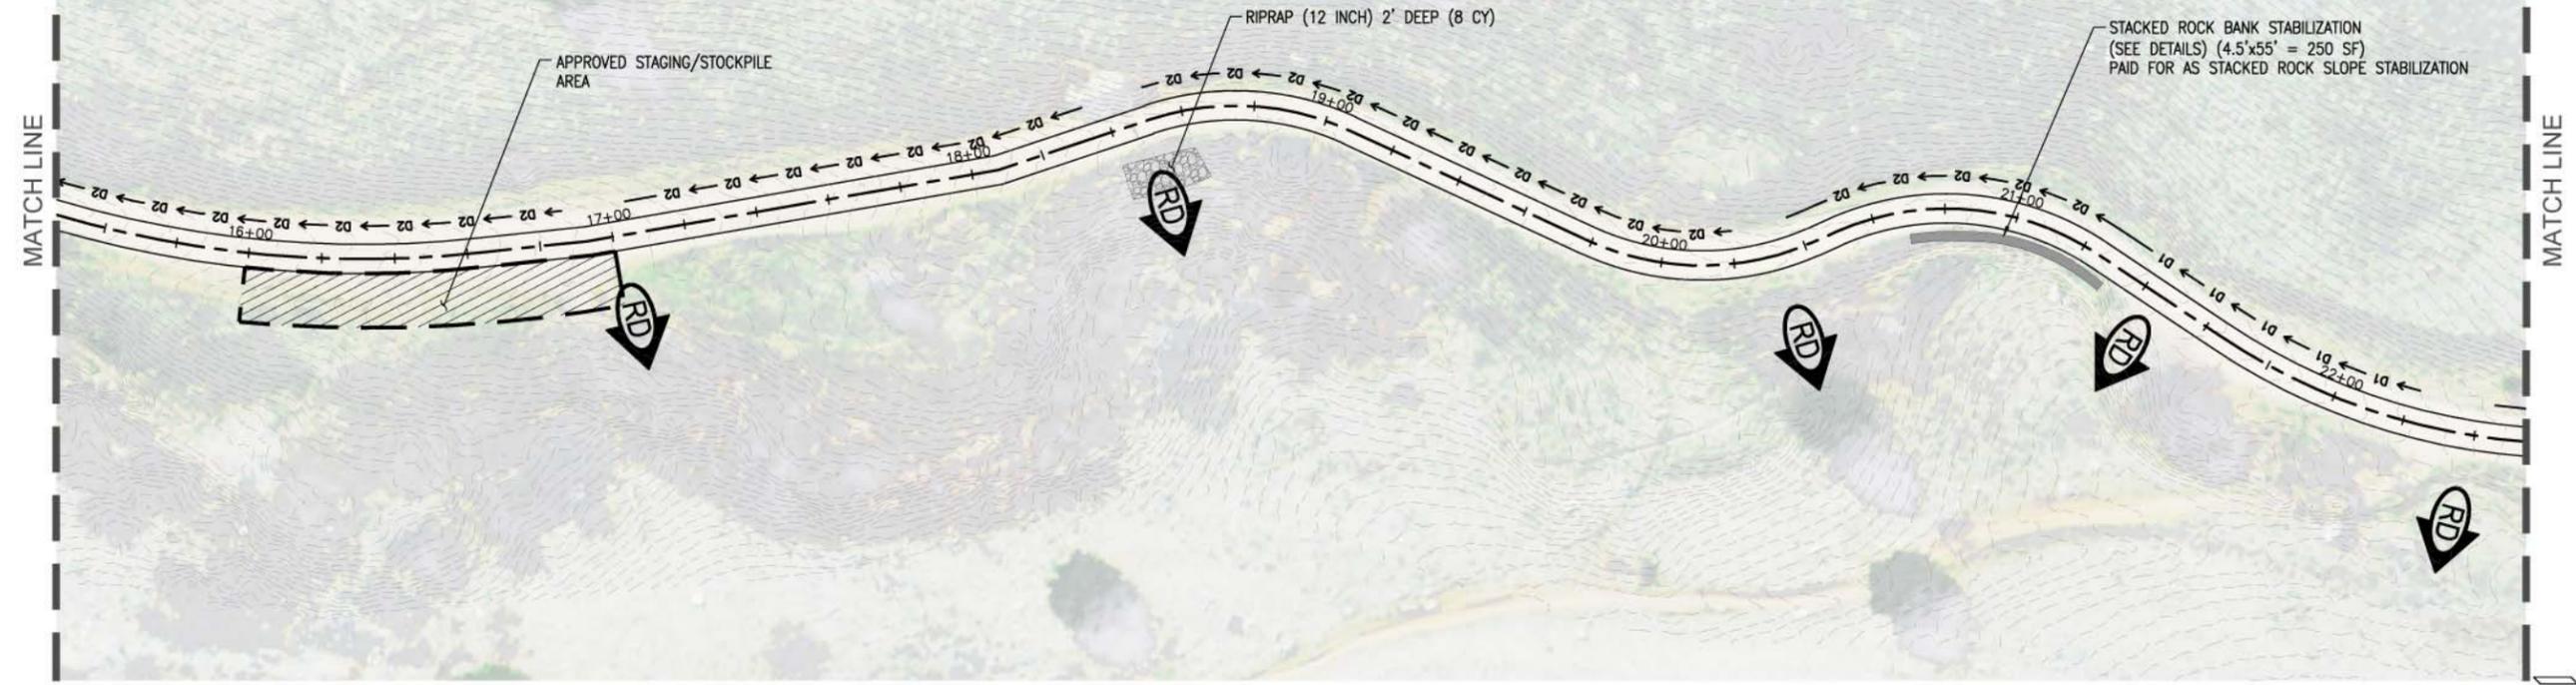
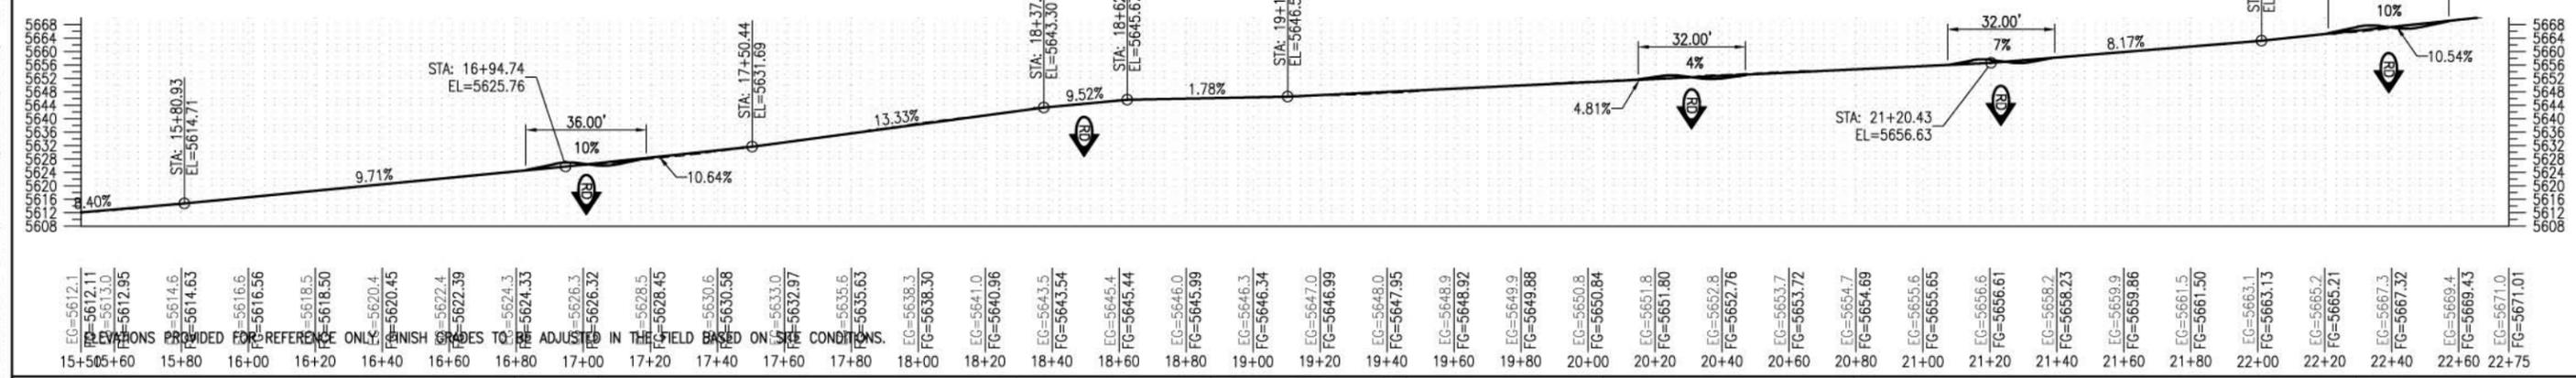
SCALE: (H) 1" = 10' (V) 1" = 10'
START STA: 15+50.00, END STA: 22+75.00

ELEVATIONS PROVIDED FOR REFERENCE ONLY. FINISH GRADES TO BE ADJUSTED IN THE FIELD BASED ON SITE CONDITIONS.

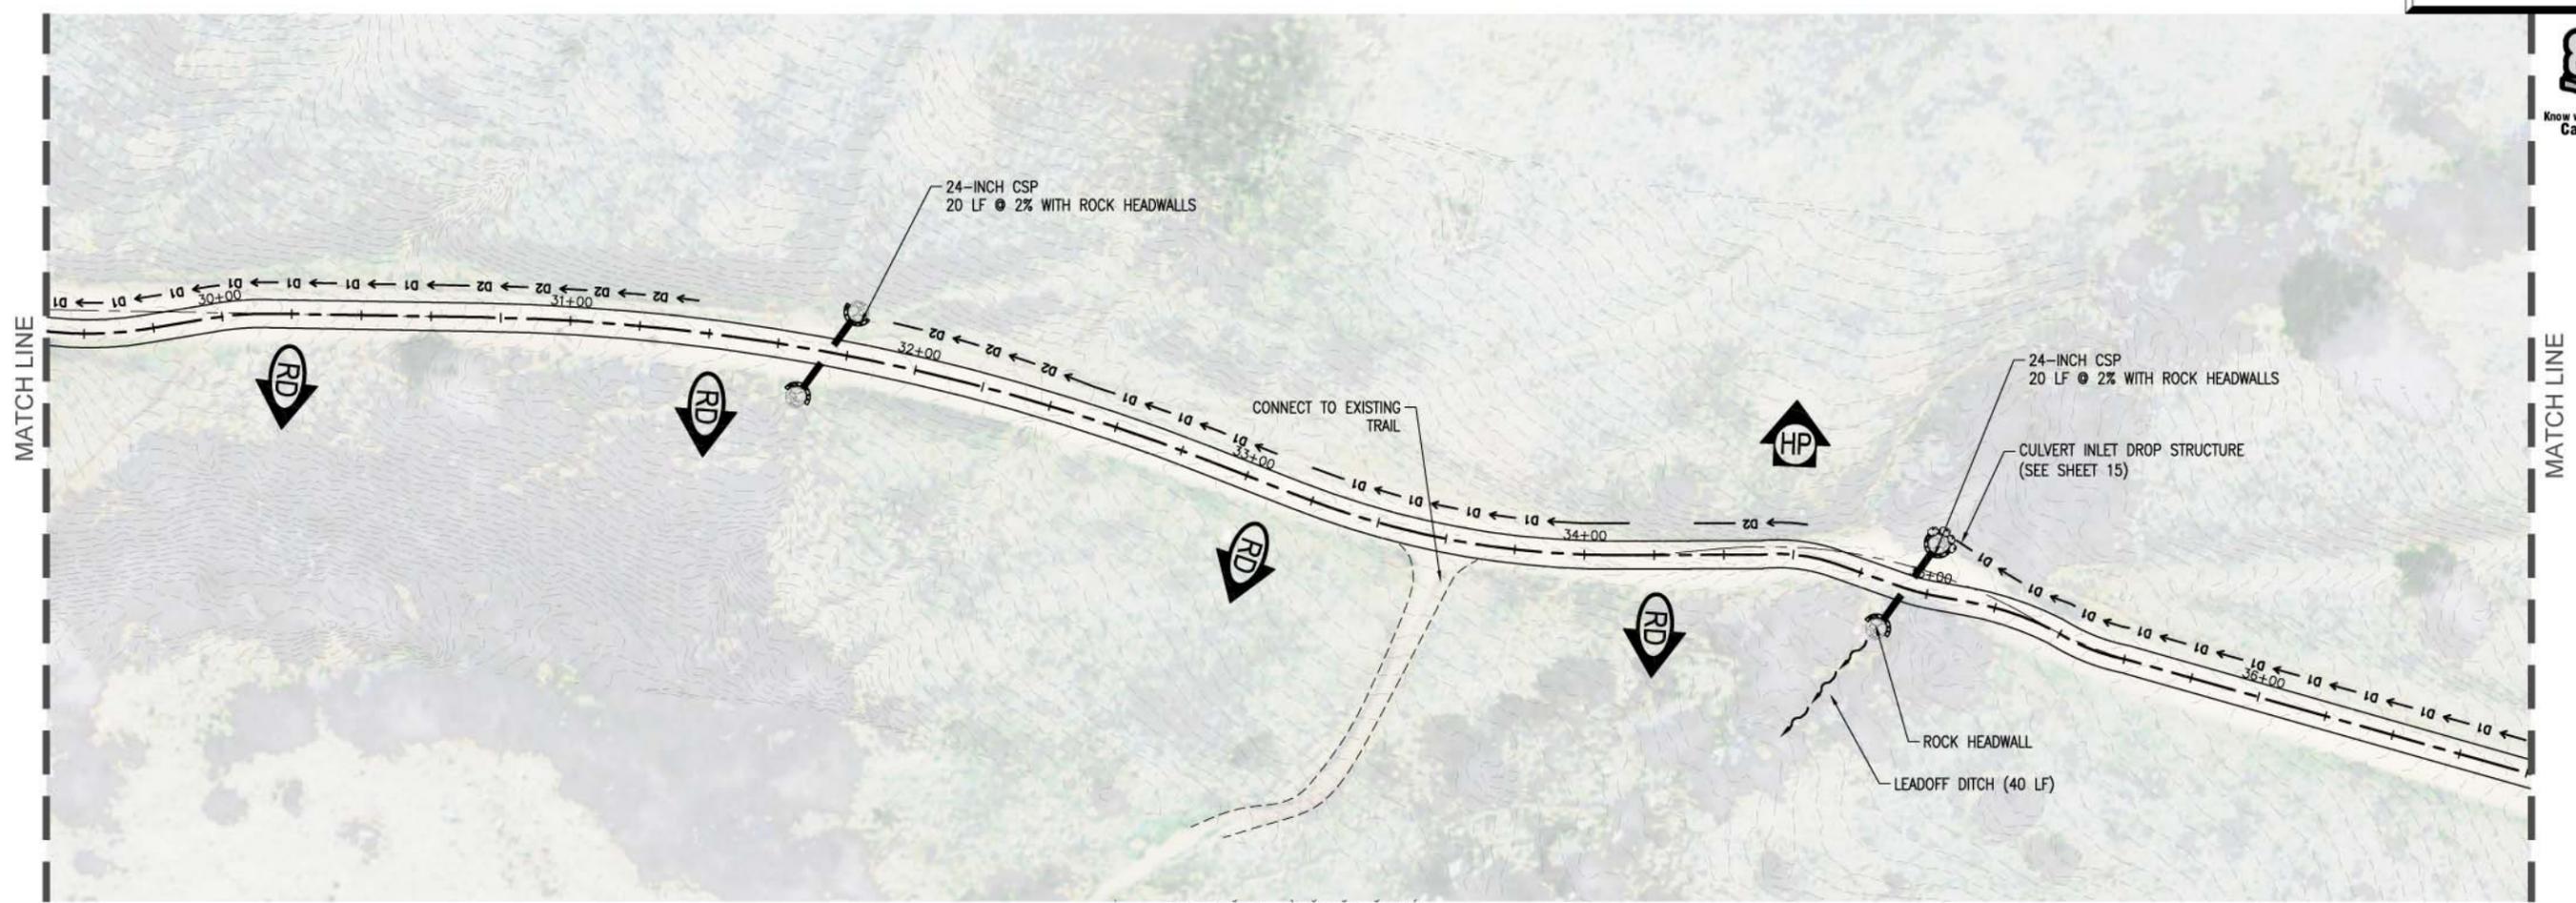
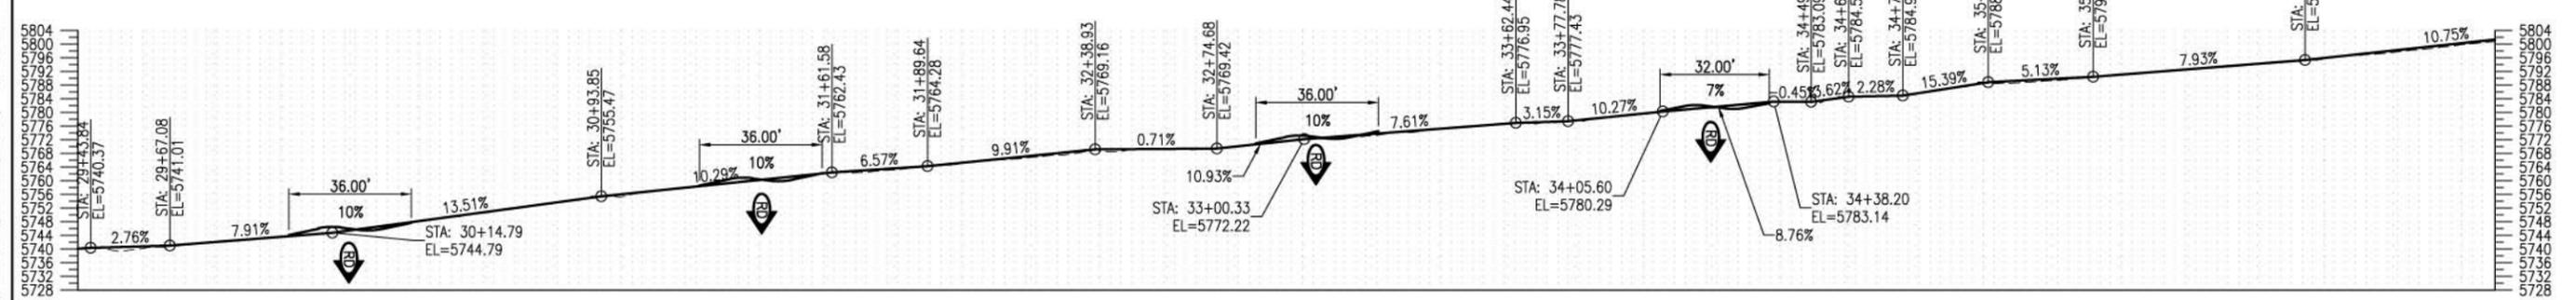
Project No./Code	SANITAS VALLEY ROAD
	279-13134
Sheet Number	23

SCALE: (H) 1" = 10' (V) 1" = 10'
START STA: 29+40.00, END STA: 36+50.00

ELEVATIONS PROVIDED FOR REFERENCE ONLY. FINISH GRADES TO BE ADJUSTED IN THE FIELD BASED ON SITE CONDITIONS.

EG=5740.1 FG=5740.13	EG=5740.8 FG=5740.82	EG=5742.0 FG=5742.03	EG=5743.6 FG=5743.62	EG=5745.5 FG=5745.49	EG=5748.2 FG=5748.19	EG=5750.9 FG=5750.89	EG=5753.6 FG=5753.59	EG=5756.1 FG=5756.10	EG=5758.2 FG=5758.16	EG=5760.2 FG=5760.21	EG=5762.3 FG=5762.27	EG=5763.6 FG=5763.64	EG=5765.3 FG=5765.30	EG=5767.3 FG=5767.29	EG=5769.2 FG=5769.17	EG=5770.0 FG=5770.00	EG=5772.2 FG=5772.19	EG=5773.7 FG=5773.72	EG=5775.2 FG=5775.24	EG=5776.8 FG=5776.76	EG=5777.7 FG=5777.66	EG=5779.7 FG=5779.71	EG=5781.5 FG=5781.55	EG=5783.1 FG=5783.13	EG=5784.6 FG=5784.56	EG=5785.5 FG=5785.55	EG=5788.6 FG=5788.63	EG=5789.8 FG=5789.78	EG=5791.0 FG=5791.03	EG=5792.6 FG=5792.62	EG=5794.2 FG=5794.20	EG=5795.9 FG=5795.95	EG=5798.1 FG=5798.10	EG=5800.3 FG=5800.25	EG=5801.3 FG=5801.33	
29+40	29+60	29+80	30+00	30+20	30+40	30+60	30+80	31+00	31+20	31+40	31+60	31+80	32+00	32+20	32+40	32+60	32+80	33+00	33+20	33+40	33+60	33+80	34+00	34+20	34+40	34+60	34+80	35+00	35+20	35+40	35+60	35+80	36+00	36+20	36+40	36+50

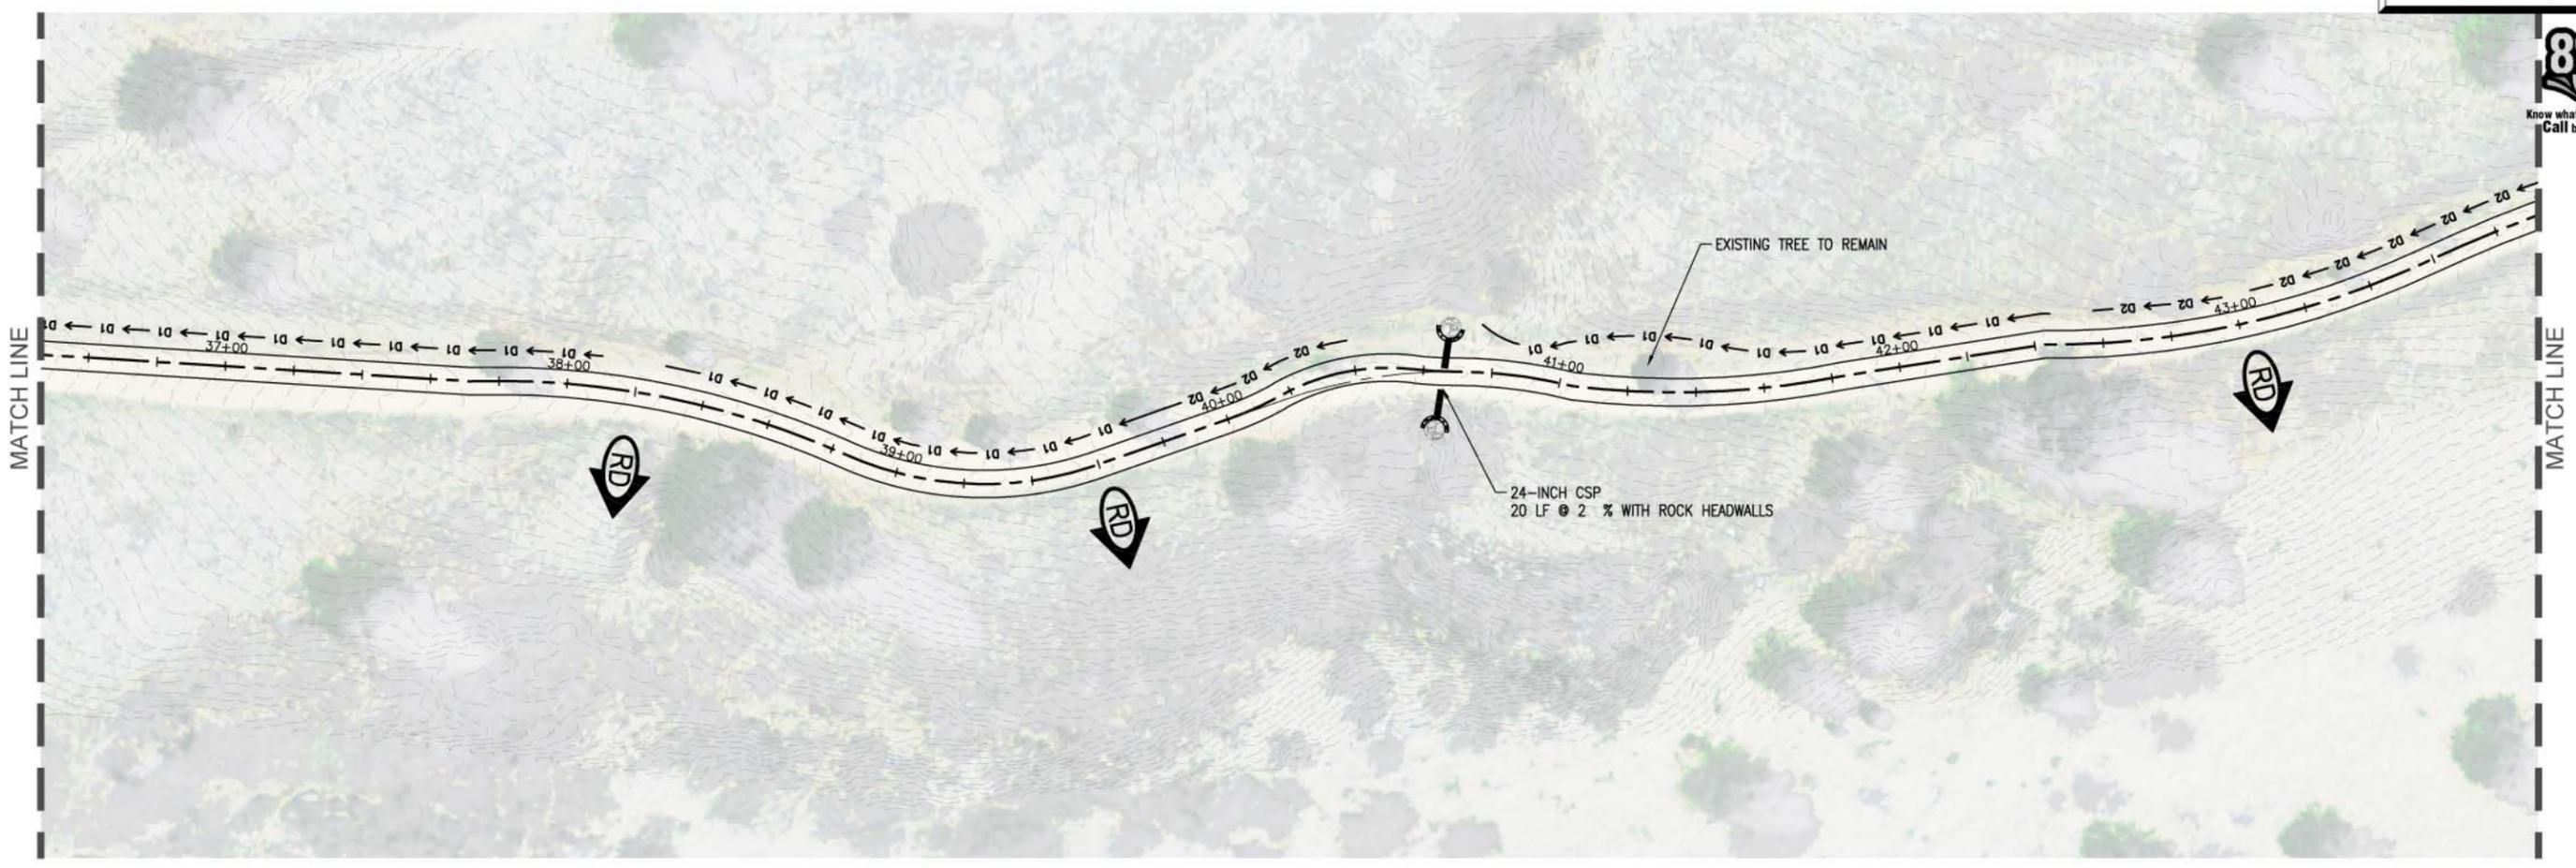
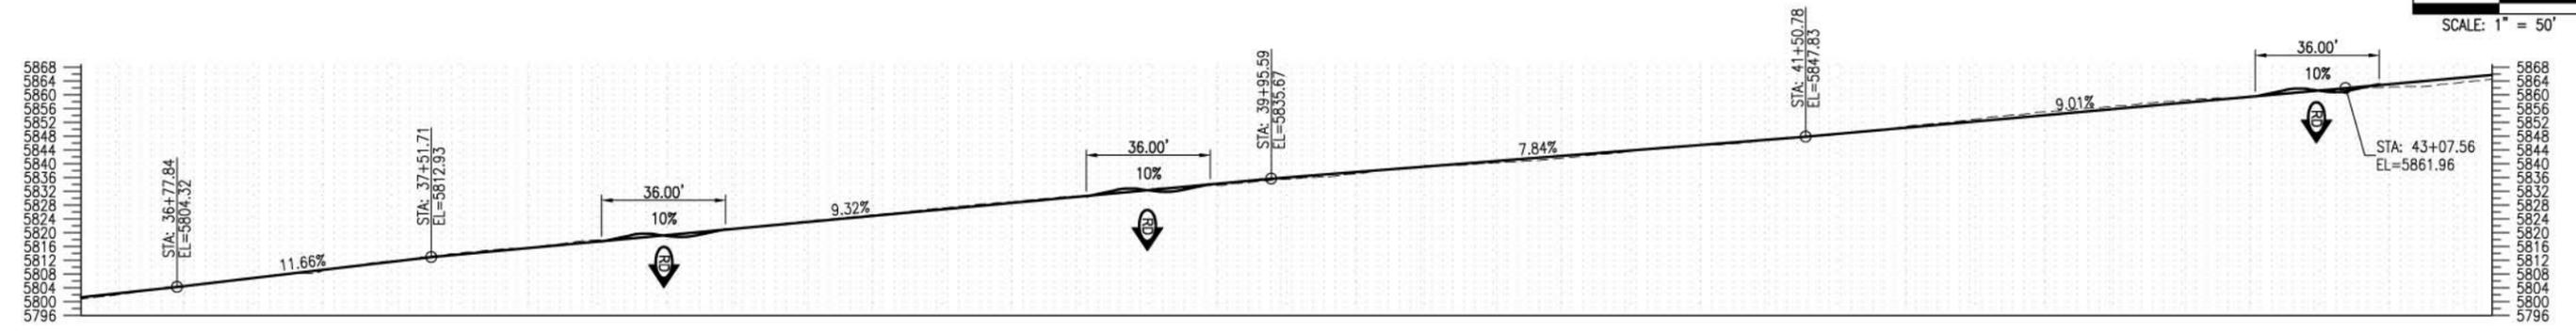
SCALE: (H) 1" = 10' (V) 1" = 10'
START STA: 36+50.00, END STA: 43+50.00

ELEVATIONS PROVIDED FOR REFERENCE ONLY. FINISH GRADES TO BE ADJUSTED IN THE FIELD BASED ON SITE CONDITIONS.

EG=5801.3 FG=5801.33	EG=5804.6 FG=5804.57	EG=5806.9 FG=5806.90	EG=5809.2 FG=5809.24	EG=5811.6 FG=5811.57	EG=5813.7 FG=5813.71	EG=5815.6 FG=5815.57	EG=5817.4 FG=5817.44	EG=5819.3 FG=5819.30	EG=5821.2 FG=5821.17	EG=5823.0 FG=5823.03	EG=5824.9 FG=5824.89	EG=5826.8 FG=5826.76	EG=5828.6 FG=5828.62	EG=5830.5 FG=5830.49	EG=5832.4 FG=5832.35	EG=5834.2 FG=5834.22	EG=5836.0 FG=5836.01	EG=5837.6 FG=5837.58	EG=5839.1 FG=5839.15	EG=5840.7 FG=5840.72	EG=5842.3 FG=5842.28	EG=5843.9 FG=5843.85	EG=5845.4 FG=5845.42	EG=5847.0 FG=5846.99	EG=5848.7 FG=5848.66	EG=5850.5 FG=5850.47	EG=5852.3 FG=5852.27	EG=5854.1 FG=5854.07	EG=5855.9 FG=5855.87	EG=5857.7 FG=5857.68	EG=5859.5 FG=5859.48	EG=5861.3 FG=5861.28	EG=5863.1 FG=5863.07	EG=5864.9 FG=5864.86	EG=5865.7 FG=5865.75
36+50+60	36+80	37+00	37+20	37+40	37+60	37+80	38+00	38+20	38+40	38+60	38+80	39+00	39+20	39+40	39+60	39+80	40+00	40+20	40+40	40+60	40+80	41+00	41+20	41+40	41+60	41+80	42+00	42+20	42+40	42+60	42+80	43+00	43+20	43+40	43+50

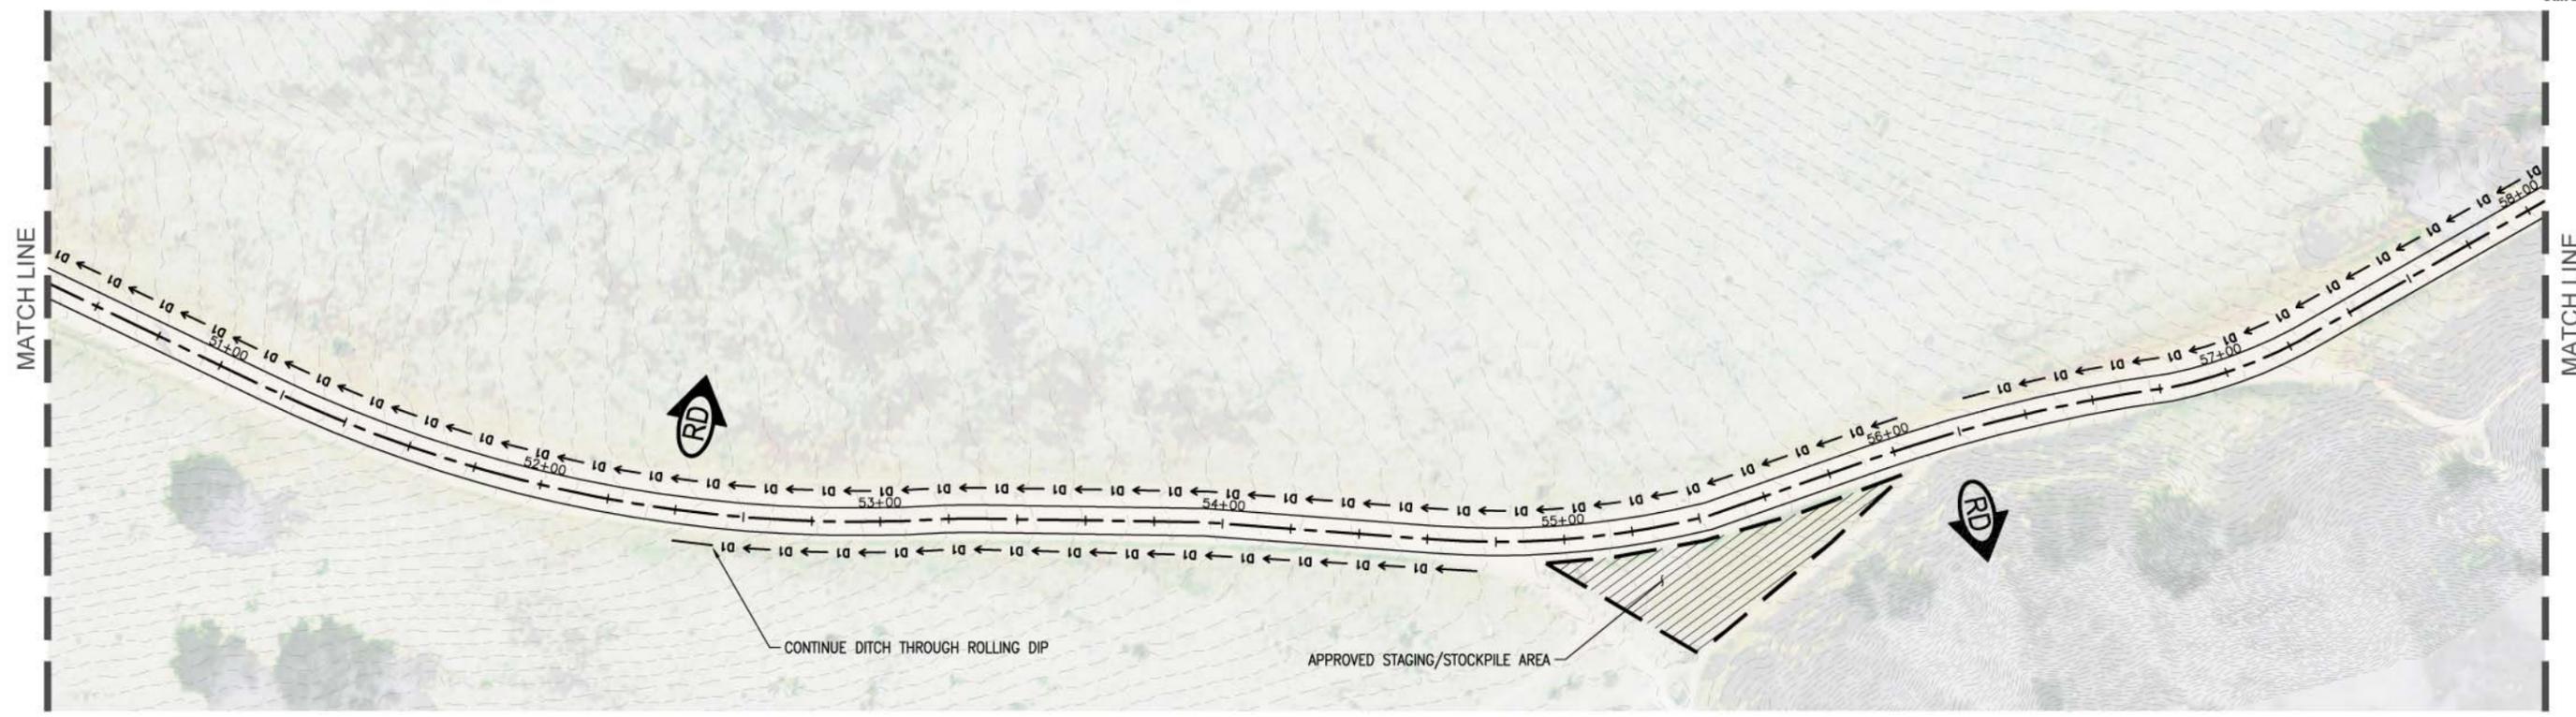
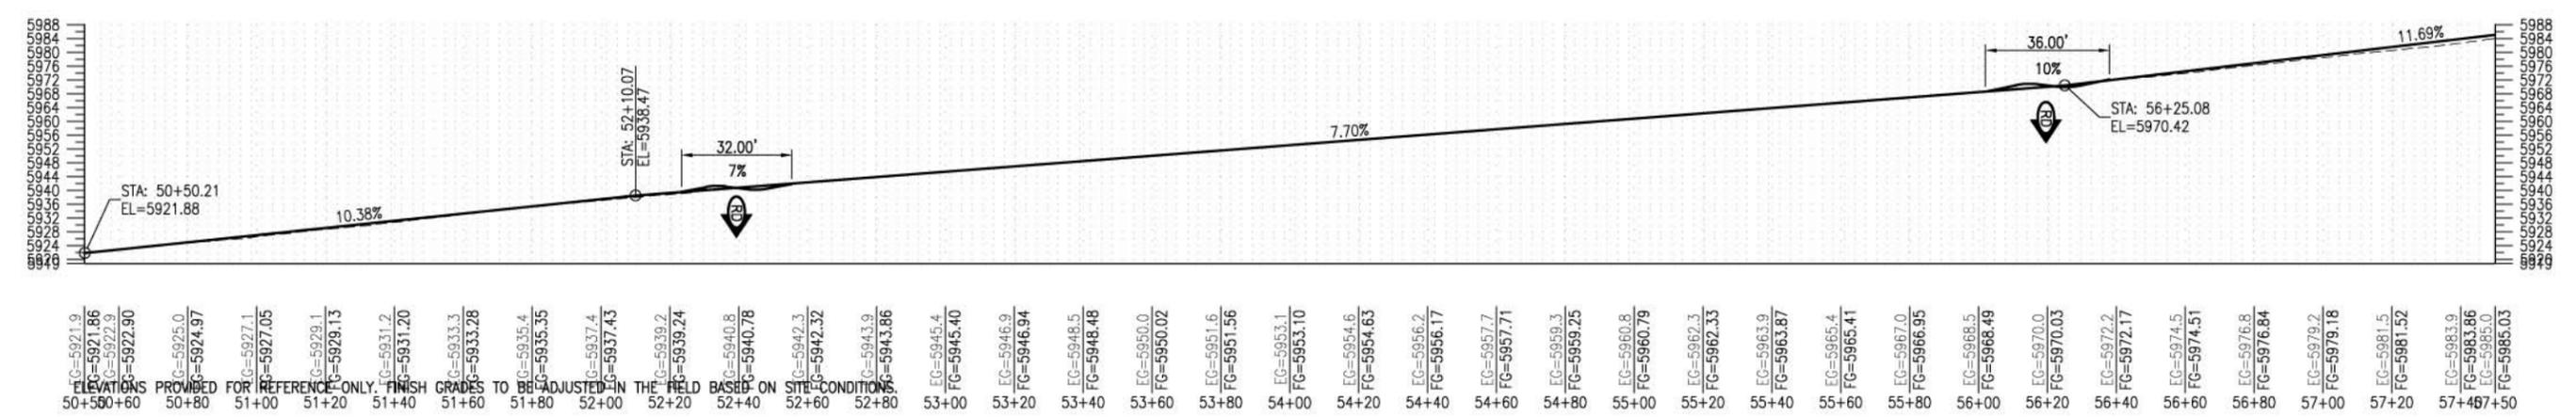
SCALE: (H) 1" = 10' (V) 1" = 10'
START STA: 50+50.00, END STA: 57+50.00

ELEVATIONS PROVIDED FOR REFERENCE ONLY. FINISH GRADES TO BE ADJUSTED IN THE FIELD BASED ON SITE CONDITIONS.

CG=5921.9	CG=5921.86	CG=5922.9	CG=5925.0	CG=5927.1	CG=5927.05	CG=5929.1	CG=5929.13	CG=5931.2	CG=5931.20	CG=5933.3	CG=5933.28	CG=5935.4	CG=5935.35	CG=5937.4	CG=5937.43	CG=5939.2	CG=5939.24	CG=5940.8	CG=5940.78	CG=5942.3	CG=5942.32	CG=5943.9	CG=5943.86	EG=5945.4	FG=5945.40	EG=5946.9	FG=5946.94	EG=5948.5	FG=5948.48	EG=5950.0	FG=5950.02	EG=5951.6	FG=5951.56	EG=5953.1	FG=5953.10	EG=5954.6	FG=5954.63	EG=5956.2	FG=5956.17	EG=5957.7	FG=5957.71	EG=5959.3	FG=5959.25	EG=5960.8	FG=5960.79	EG=5962.3	FG=5962.33	EG=5963.9	FG=5963.87	EG=5965.4	FG=5965.41	EG=5967.0	FG=5966.95	EG=5968.5	FG=5968.49	EG=5970.0	FG=5970.03	EG=5972.2	FG=5972.17	EG=5974.5	FG=5974.51	EG=5976.8	FG=5976.84	EG=5979.2	FG=5979.18	EG=5981.5	FG=5981.52	EG=5983.9	FG=5983.86	EG=5985.0	FG=5985.03
