New Britain and Park Central Buildings

Structural Flood Assessment

Revised - March 18, 2013

Structural Engineering

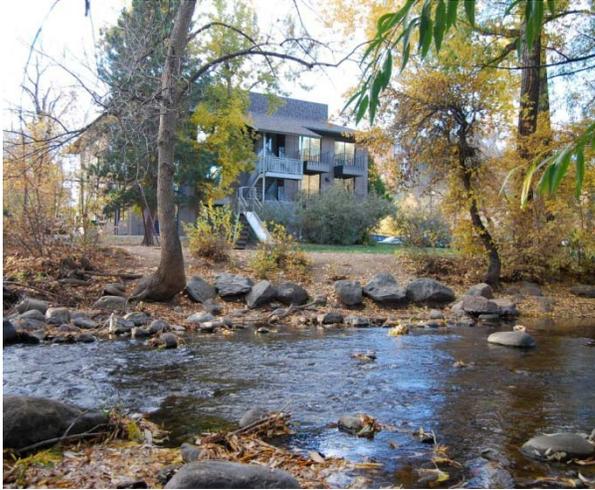
The New Britain building is a 3-story wood structure framed with wood joists spanning approximately 30'-0" bearing on a central steel beam spanning approximately 20'-0" to 8" diameter steel columns bearing on 12'-0" x 12'-0" x 16" concrete spread footings, and exterior bearing walls supported on 8" thick concrete stem walls, over a 72" x 12" continuous concrete spread footing. The bearing elevation of

the footings is approximately 4'-6" below first floor elevation. These components were visible in the crawl space. The following components were not observable without destructive testing, but are consistent with wood framed structures:

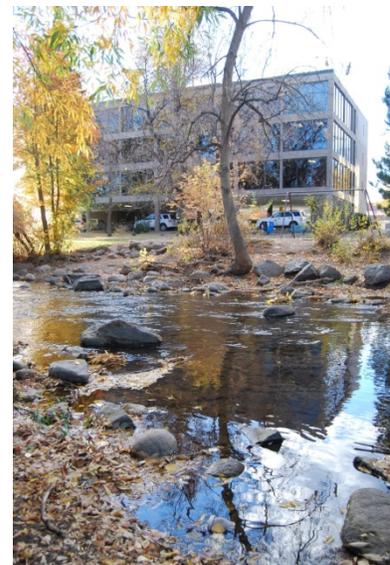
Drawings for the Park Central building were provided by the City of Boulder. The structure is a four-story concrete structure consisting of a 4" concrete slab-on-grade, 8" thick, post-tensioned concrete floor slabs and an 8" thick, post-tensioned concrete roof slab spanning 30'-0" supported by 24" deep by 16" wide exterior post-tensioned concrete spandrel beams, and an interior central concrete beam strip integral within the thickness of the slab. The spandrel beams and central beam strip are supported by concrete columns –

16” x 16”, 16” x 14”, 14” x 20” and 14” x 24”. The concrete columns are founded on concrete spread footings. Based on the drawings, the footings bearing elevation is 5’-0” below the top of first floor elevation; however, during the Broadway Bridge over Boulder Creek replacement project, these footings were observed by city personnel to be much shallower - more on the order of 2’-6” below top of first floor elevation. There is a concrete-enclosed stair tower at the west end of the structure and a concrete and storefront enclosed combined stair tower and elevator shaft at the east end of the structure. Additionally, there is a brick-faced, one story structure at the southeast corner of the structure. Analysis of the existing restaurant at the southeast corner of the Park Central Building is not included in this report.

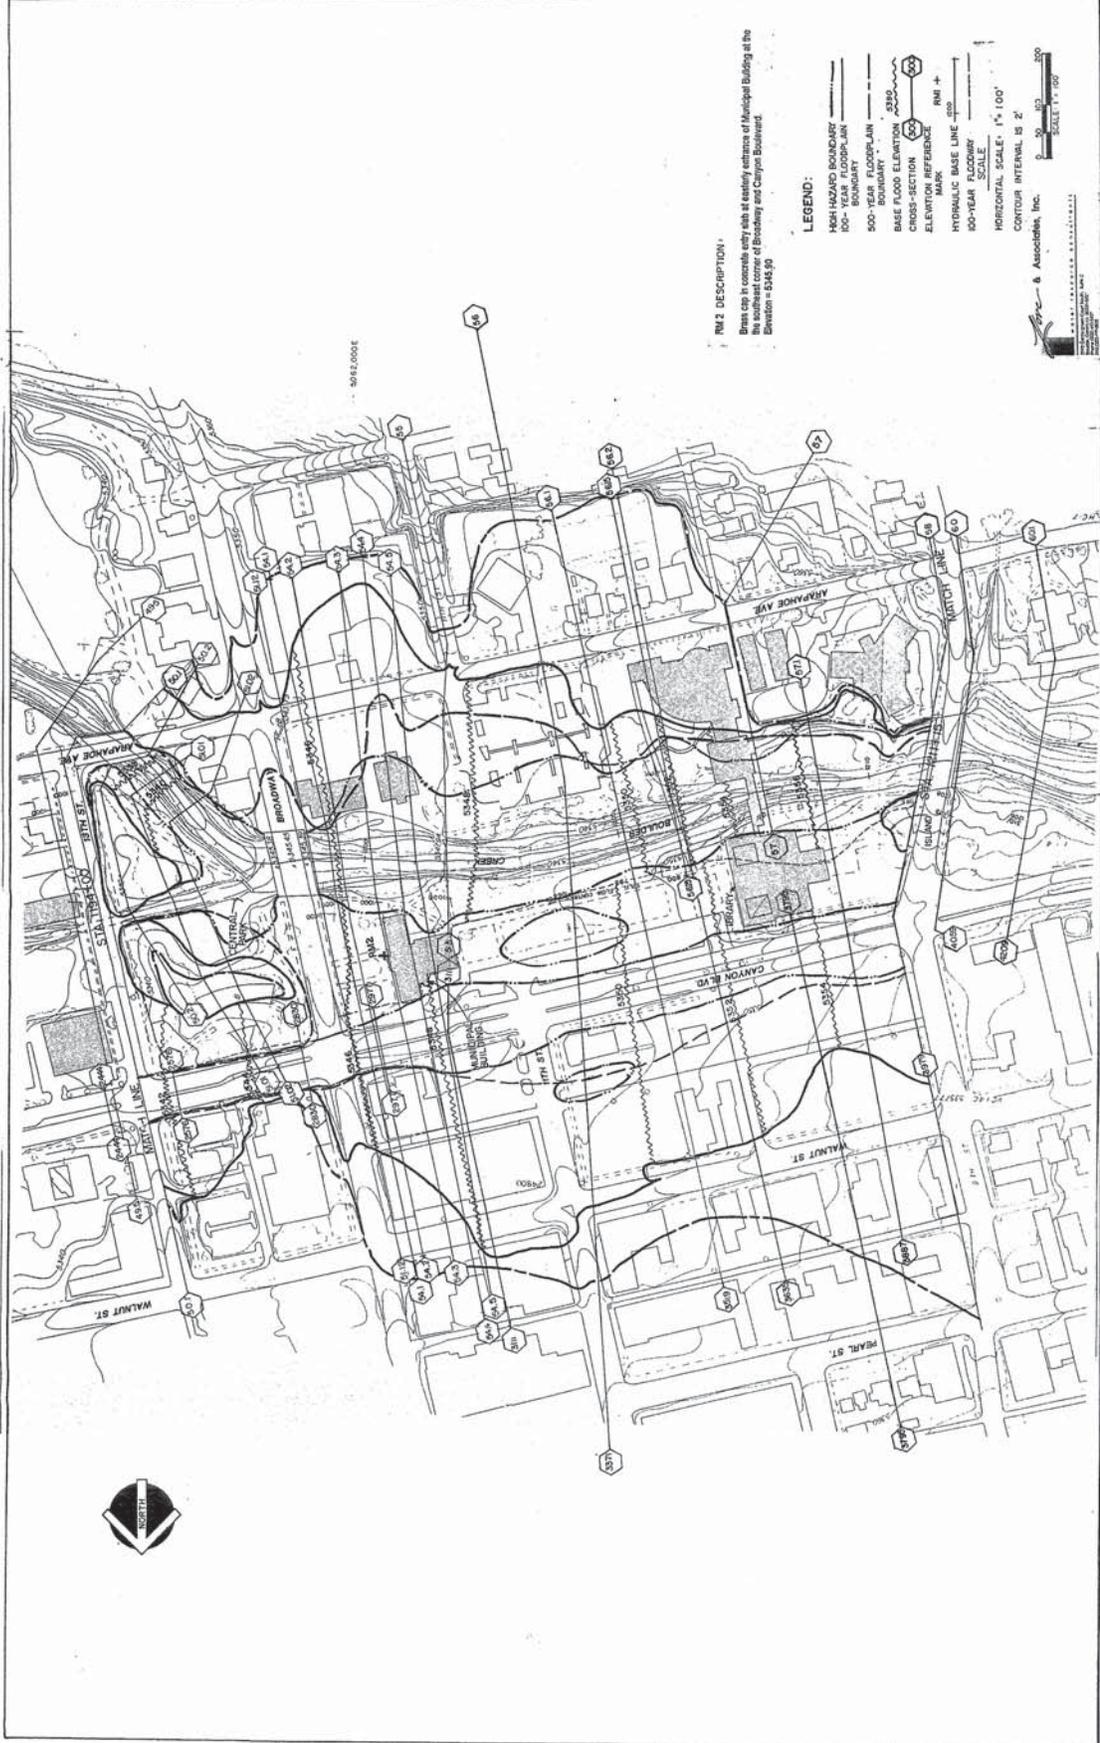
City 100 Year Flood Plain

PM2 DESCRIPTION
 Brass caps in concrete utility vaults at nearby addresses of Municipal Building at the southwest corner of Broadway and Canyon Boulevard.
 Elevation = 5245.50

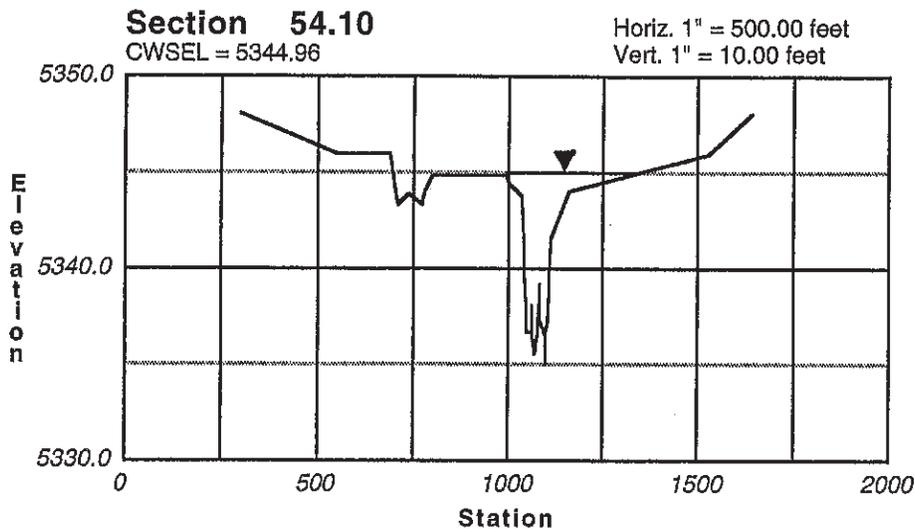
*SECNO 54.100

FLOW DISTRIBUTION FOR SECNO= 54.10 CWSEL= 5344.96

STA=	996.	1000.	1036.	1106.	1114.	1160.	1338.
PER Q=	.1	1.7	89.6	3.2	4.2	1.3	
AREA=	1.6	31.1	520.2	44.7	101.9	86.0	
VEL=	2.1	3.7	11.6	4.8	2.8	1.0	
DEPTH=	.4	.9	7.4	5.6	2.2	.5

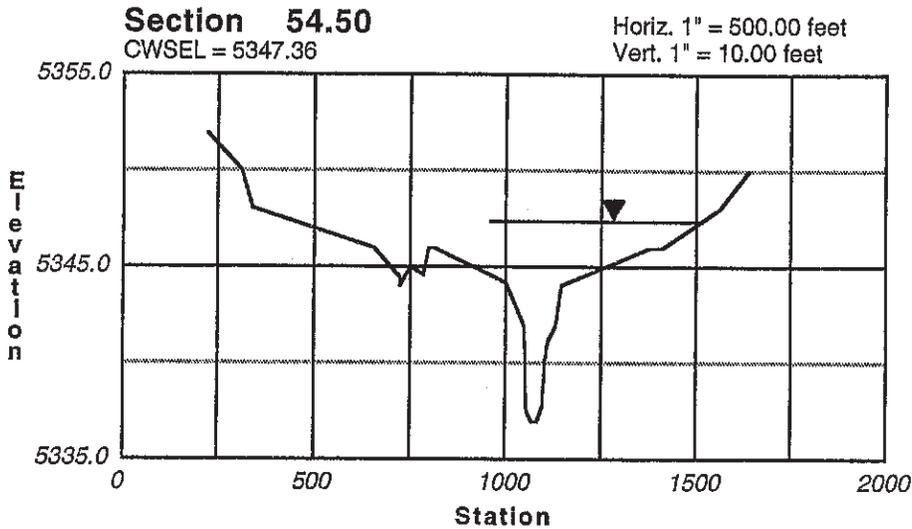
*SECNO 54.500

3470 ENCROACHMENT STATIONS=	955.0	1640.0	TYPE=	1	TARGET=	-955.000			
54.500	10.46	5347.36	5346.62	.00	5348.38	1.02	.19	.01	5341.90
9600.0	2249.8	5281.5	2068.7	338.3	532.8	902.8	98.8	30.4	5340.20
.09	6.65	9.91	2.29	.040	.050	.100	.000	5336.90	955.00
.005637	35.	35.	35.	2	21	0	.00	557.28	1512.28

FLOW DISTRIBUTION FOR SECNO= 54.50 CWSEL= 5347.36

STA=	955.	1000.	1048.	1103.	1113.	1135.	1146.	1376.	1410.	1512.
PER Q=	7.6	15.8	55.0	2.8	4.8	1.5	11.2	.7	.6	
AREA=	132.5	205.8	532.8	67.1	127.9	48.0	543.7	46.4	69.7	
VEL=	5.5	7.4	9.9	4.0	3.6	2.9	2.0	1.4	.9	
DEPTH=	2.9	4.3	9.6	6.7	5.8	4.4	2.4	1.4	.7

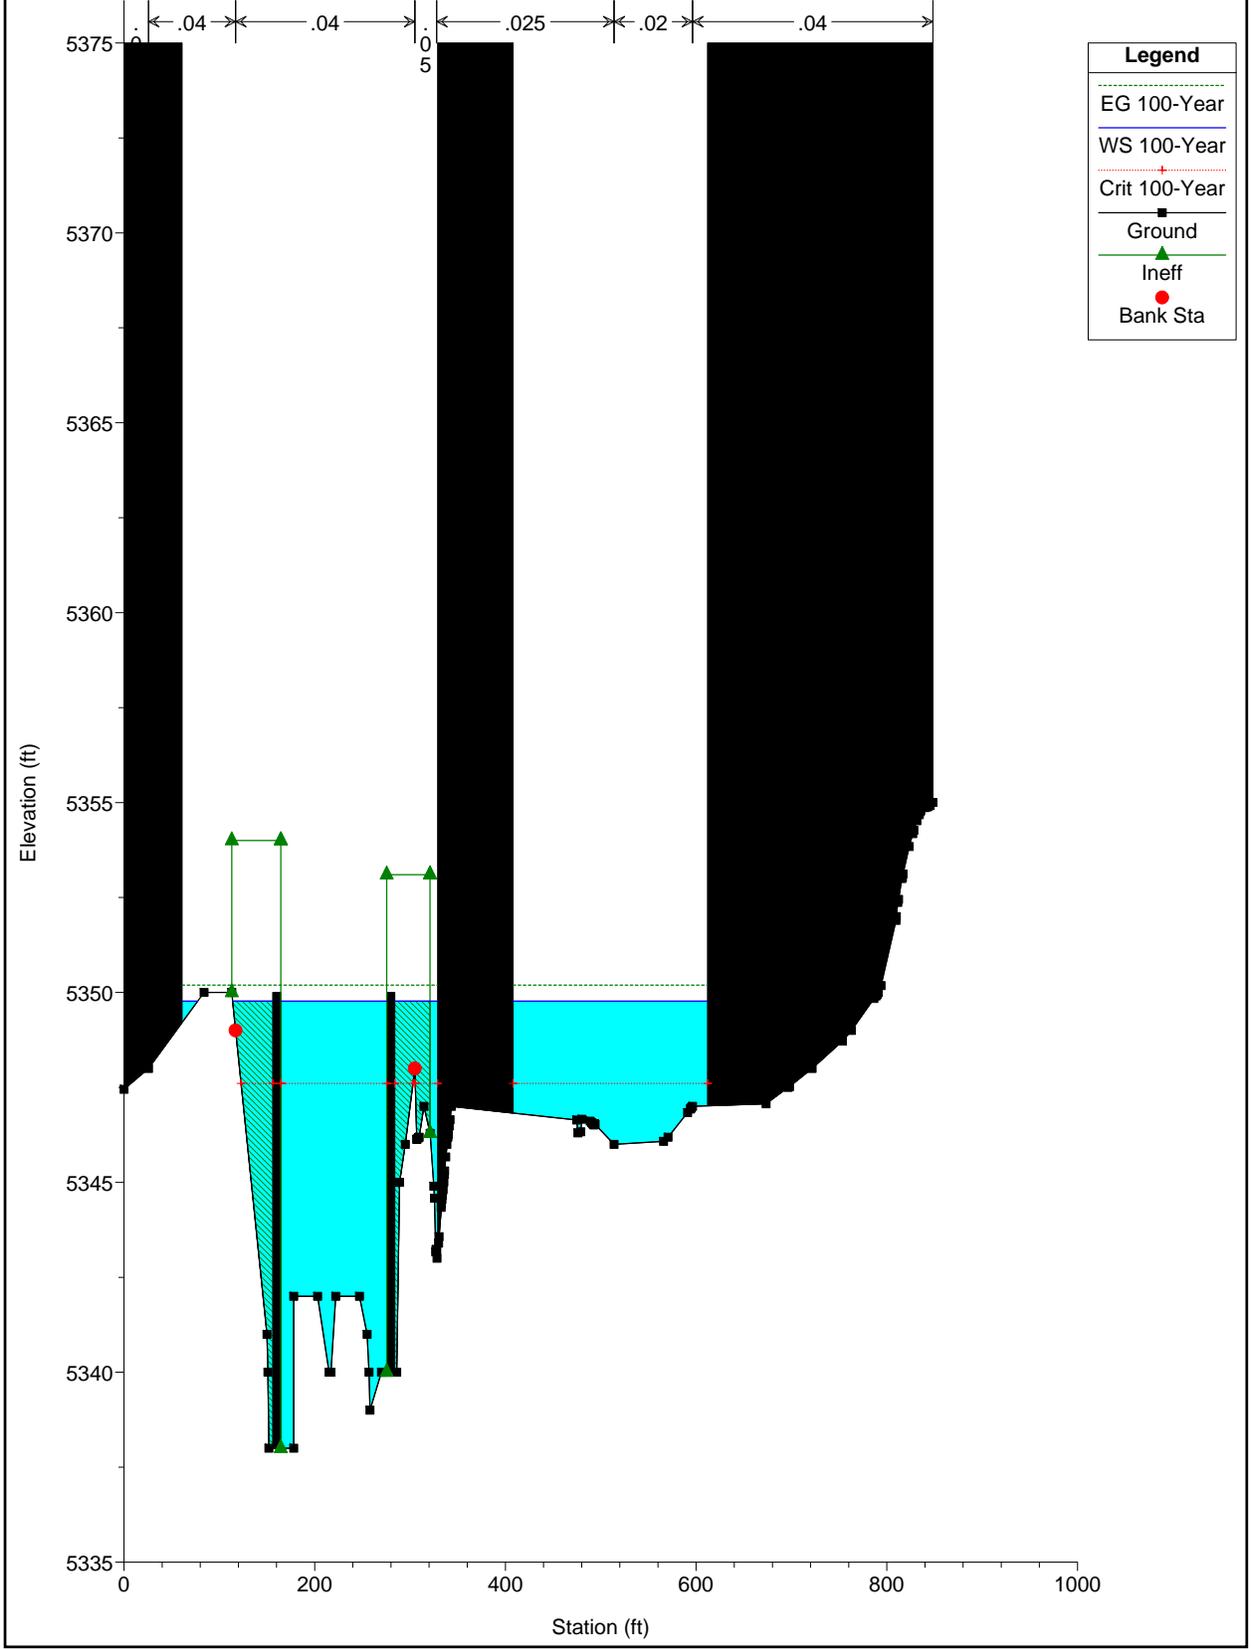
Plan: 100yr Taft Boulder Creek 6th-Broadway RS: 30635 Profile: 100-Year

E.G. Elev (ft)	5351.38	Element	Left OB	Channel	Right OB
Vel Head (ft)	1.14	Wt. n-Val.	0.027	0.040	0.025
W.S. Elev (ft)	5350.24	Reach Len. (ft)			
Crit W.S. (ft)	5350.24	Flow Area (sq ft)	249.22	793.08	381.91
E.G. Slope (ft/ft)	0.008116	Area (sq ft)	256.68	793.08	381.91
Q Total (cfs)	12000.00	Flow (cfs)	1700.51	7272.42	3027.07
Top Width (ft)	590.81	Top Width (ft)	194.08	173.85	222.88
Vel Total (ft/s)	8.43	Avg. Vel. (ft/s)	6.82	9.17	7.93
Max Chl Dpth (ft)	7.24	Hydr. Depth (ft)	1.44	4.56	1.71
Conv. Total (cfs)	133199.6	Conv. (cfs)	18875.6	80723.6	33600.4
Length Wtd. (ft)		Wetted Per. (ft)	176.35	174.86	228.47
Min Ch El (ft)	5343.00	Shear (lb/sq ft)	0.72	2.30	0.85
Alpha	1.03	Stream Power (lb/ft s)	4.89	21.07	6.71
Frctn Loss (ft)	0.70	Cum Volume (acre-ft)	0.61	3.92	1.85
C & E Loss (ft)	0.36	Cum SA (acres)

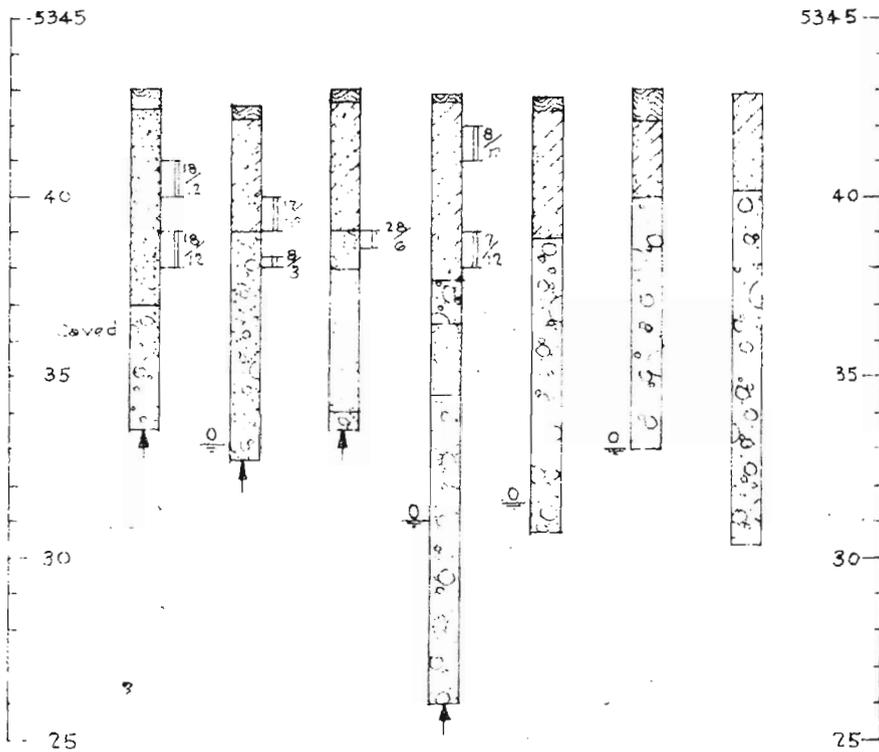
- TH BORING #1 elev. 5343.0'
- TH BORING #2 elev. 5342.6'
- TH BORING #3 elev. 5343.0'
- TH BORING #4 elev. 5342.19'
- TP TEST PIT #1 elev. 5342.8'
- TP TEST PIT #2 elev. 5345.0'
- TP TEST PIT #3 elev. 5342.9'

- Topsoil, sand, silty, contains roots & decomposing vegetation, dark brown.
- Sand, silty, gravelly, occasionally clayey, contains occasional cobble & debris, probable fill, medium brown to dark brown loose to medium dense.
- Sand, gravelly with occasional cobble, relatively clean, medium brown.
- Random mixture of gravel & cobbles in a matrix of sand, medium brown, medium dense.
- Free water level & the number of days after drilling that measurement was taken.
- Indicates drilling refusal.
- Indicates that a blow of a 140 lb. hammer falling 30" were required to drive a 2" outside diameter sampler 12".

1. Borings were performed December 13, 1972 with a 4" continuous flight power auger. Test pits were excavated December 7, 1972 with a tractor-mounted backhoe.
2. Elevations are approximate & were referred to a bench mark (elevation 5345.2') being a cross in the top of the sidewalk @ the southwest corner of the bridge on Broadway north of the proposed building.
3. Boring logs & test pits shown in this report are subject to the limitations, explanations & conclusions of the report.
