# Trail Condition Monitoring

Boulder Open Space and Mountain Parks  
**East Trail Study Area**

February 2008

## East Trail Study Area Trail Condition Monitoring Report

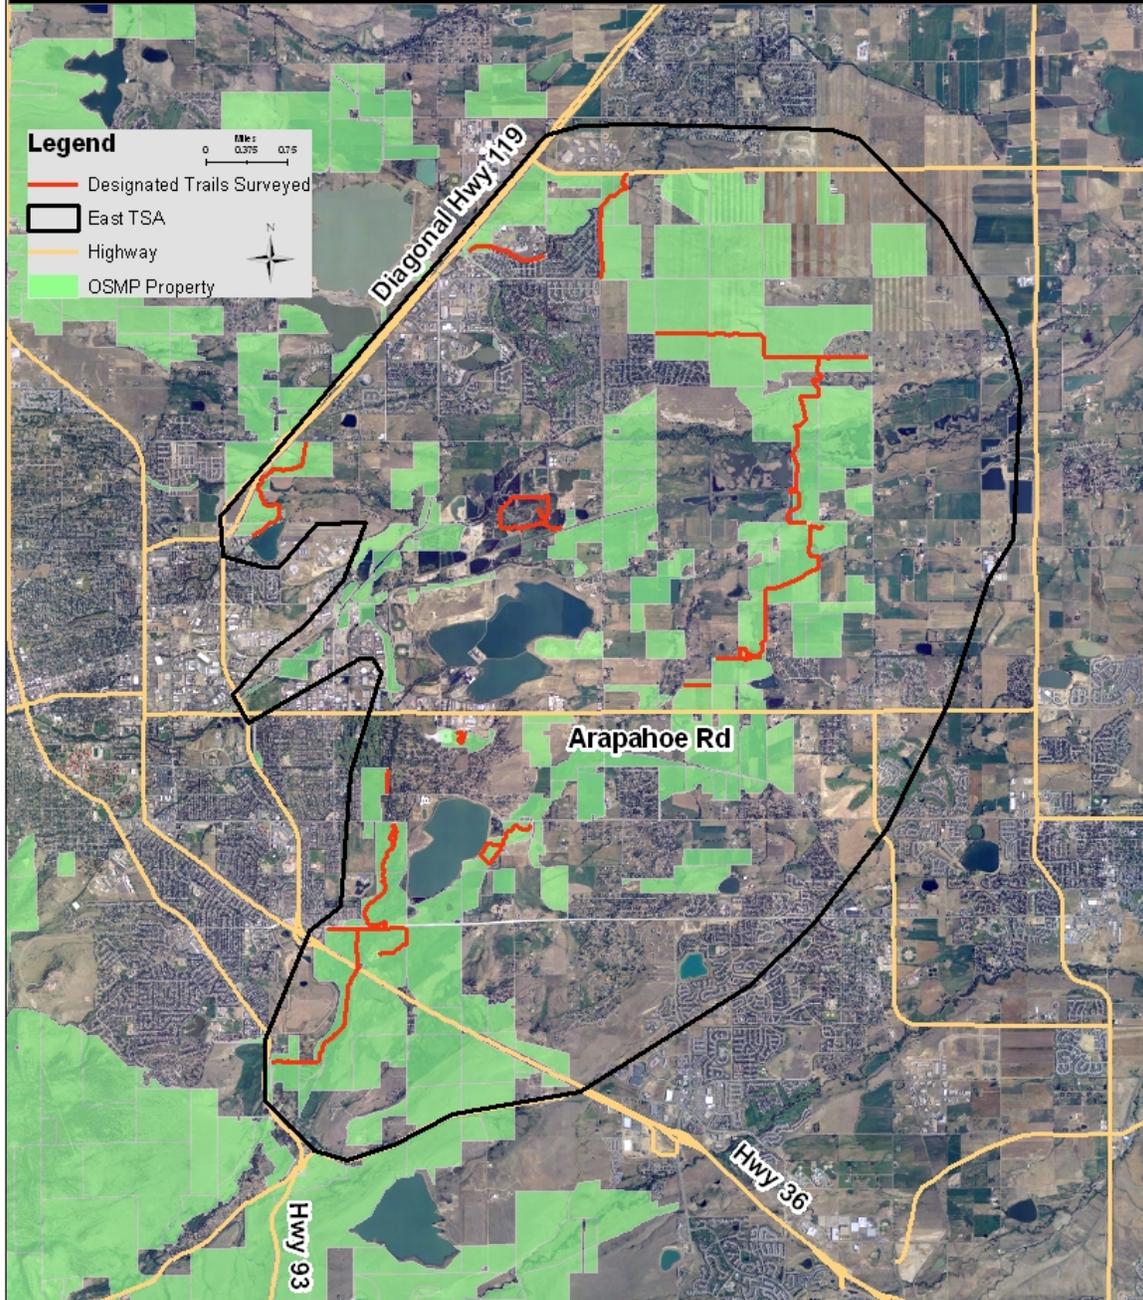
**Figure 1:** Designated trails surveyed for trail condition monitoring in East TSA.

Trail condition monitoring was conducted in the **East Trail Study Area (TSA)** (see Figure 1) during September and October of 2007. Extensive database development time for this project was a one-time cost shared across all TSAs. Estimates of time to complete monitoring are given below.

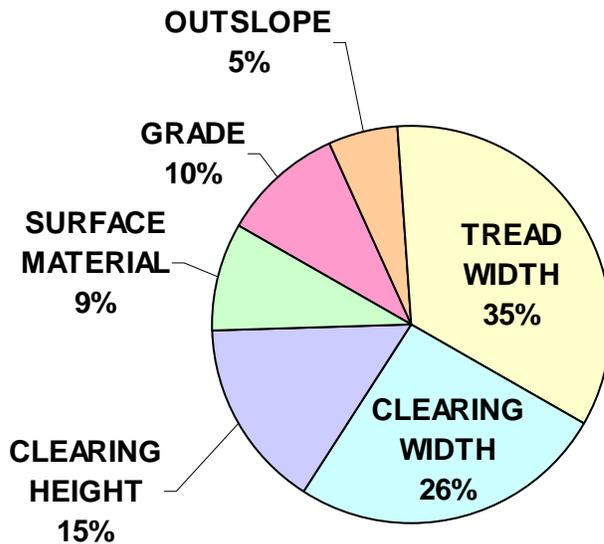
**Figure 2:** Contribution of various trail sustainability factors to **non-compliance** in the East TSA. (total distance of trail out of compliance = 4,190ft or 1,277m)

Figure 2 shows the factors most responsible for non-compliance with standards. Figure 3 shows the relative proportion of different types of maintenance issues.

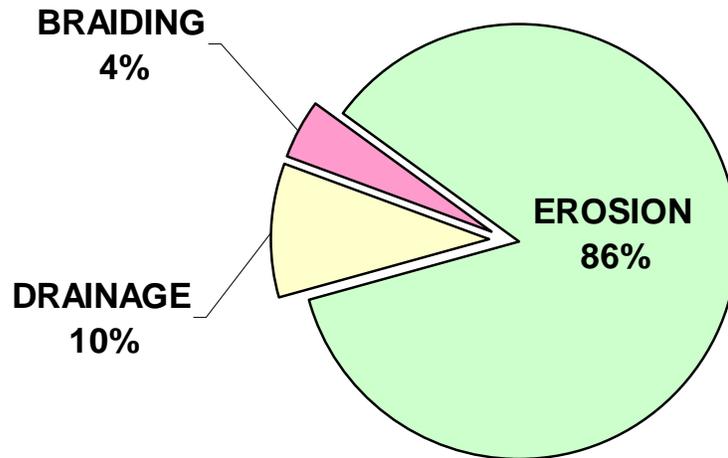
**Figure 3:** Contribution of various **maintenance issue** categories in the East TSA. (total distance of trail with maintenance issues = 4,914ft or 1,498m)

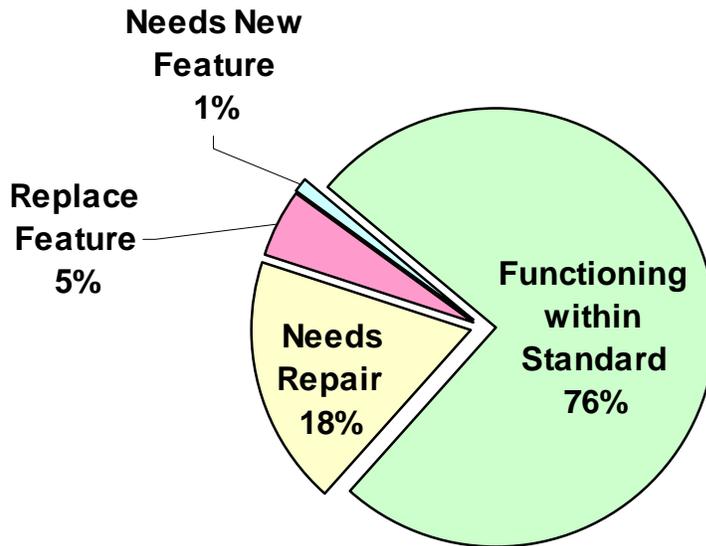
**Figure 4:** Condition class of constructed features in the East TSA.

Figure 4 shows the condition class distribution of the 98 constructed features associated with trails in the East TSA. Three fourths of the features are functioning within standard. Maps showing the location and condition of constructed features in the East TSA are included as Attachment D. Details about the constructed features are included in Attachment C.

Three fourths of the 98 constructed features associated with trails in the East TSA are functioning within standard. The most common features in need of repair are culverts. These require extensive cleaning to regain proper function. A few wooden fences need minor repairs as well, such as securing posts and/or fallen logs. Two bridges are in need of repair: one on East Boulder-Teller Lake Trail segment 503.01 and one on South Boulder Creek Trail segment 511.04. Five erosion control structures need to be replaced on the East Boulder – White Rocks Trail due to deterioration. One drain dip is recommended for the Cherryvale Trail segment 513.02.
