OPEN SPACE BOARD OF TRUSTEES

Wednesday, May 14, 2014 at 6:00 p.m.

MEETING AGENDA

Ecological Best Management Practices

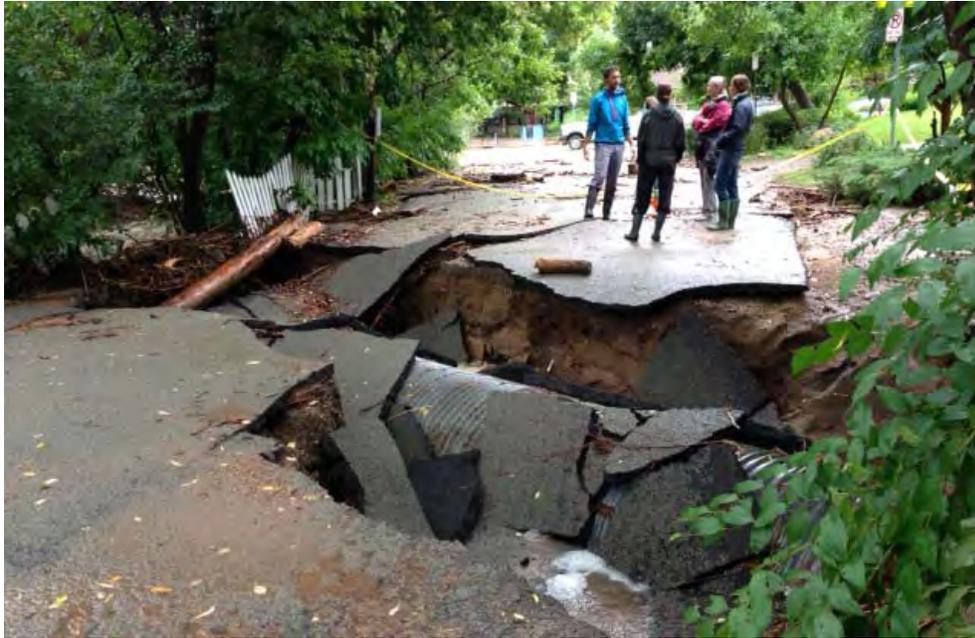
During the flood events of September 2013, Gregory Canyon Creek overtopped and severely damaged the Pennsylvania Avenue roadway. The roadway was not immediately repaired because it looked like there was an opportunity to increase the flood conveyance capacity and improve the riparian habitat for what was initially considered to be a similar cost to replace the culvert pipe and repair the roadway.

When the damaged asphalt pavement was removed, the existing culvert pipe was assessed. The pipe was determined to be in poor condition and therefore could not be reused.

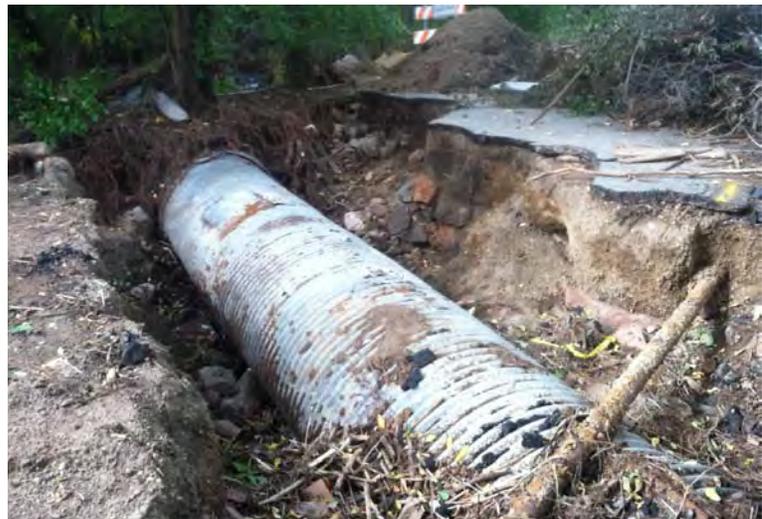
Remnants of old bridge abutments were also revealed. The city's Historic Preservation Planners visited the site and determined that the old bridge abutments were not significantly intact and did not require preservation. It was recommended that salvaged stones from the abutments be used in the repair project, if possible.

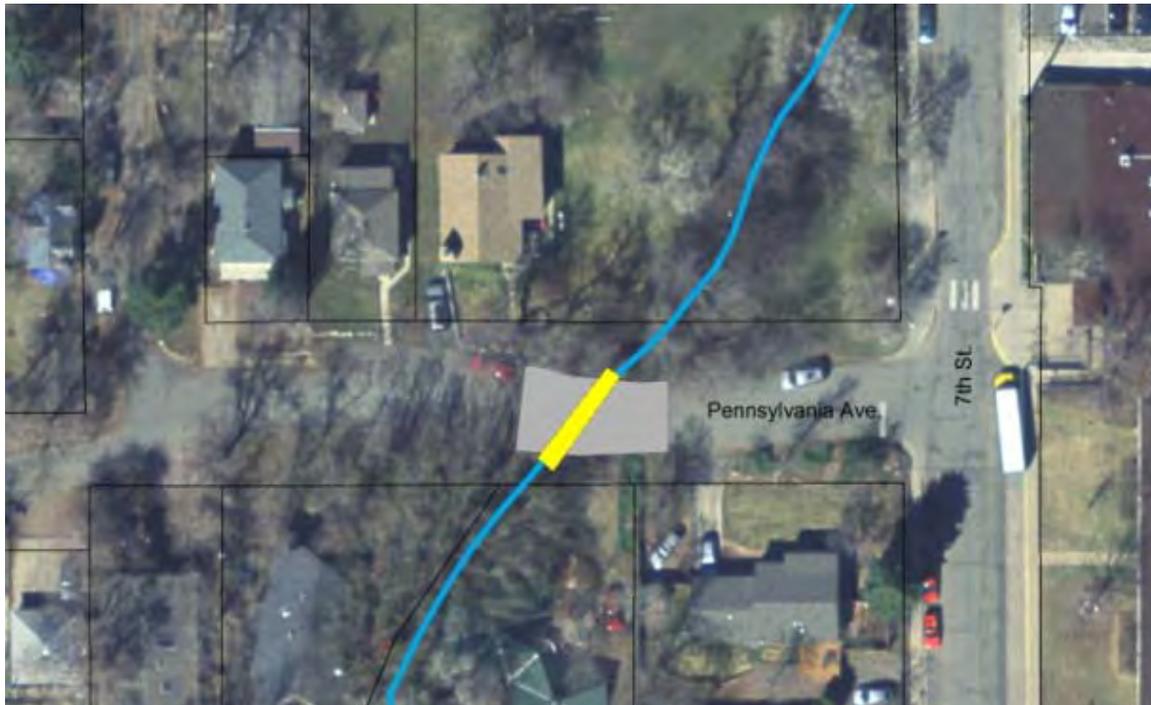
Alternative 1

The first alternative would involve replacing the existing culvert pipe and repairing the roadway back to pre-flood conditions. This is the most economical solution and could be completed for approximately \$4,000. It would also be the quickest to implement because it would not require a floodplain analysis or any flood or wetland permits. If selected, this alternative could be implemented in early June, once the school is out for summer break.

This alternative would not increase the flood conveyance or include flood mitigation improvements, but it would allow the area to be stabilized the fastest. Future flood mitigation options for the area would be assessed as part of the Gregory Canyon Creek Flood Mitigation Study, a separate project currently underway to identify flood mitigation opportunities along Gregory Canyon Creek between Flagstaff Road and Boulder Creek.

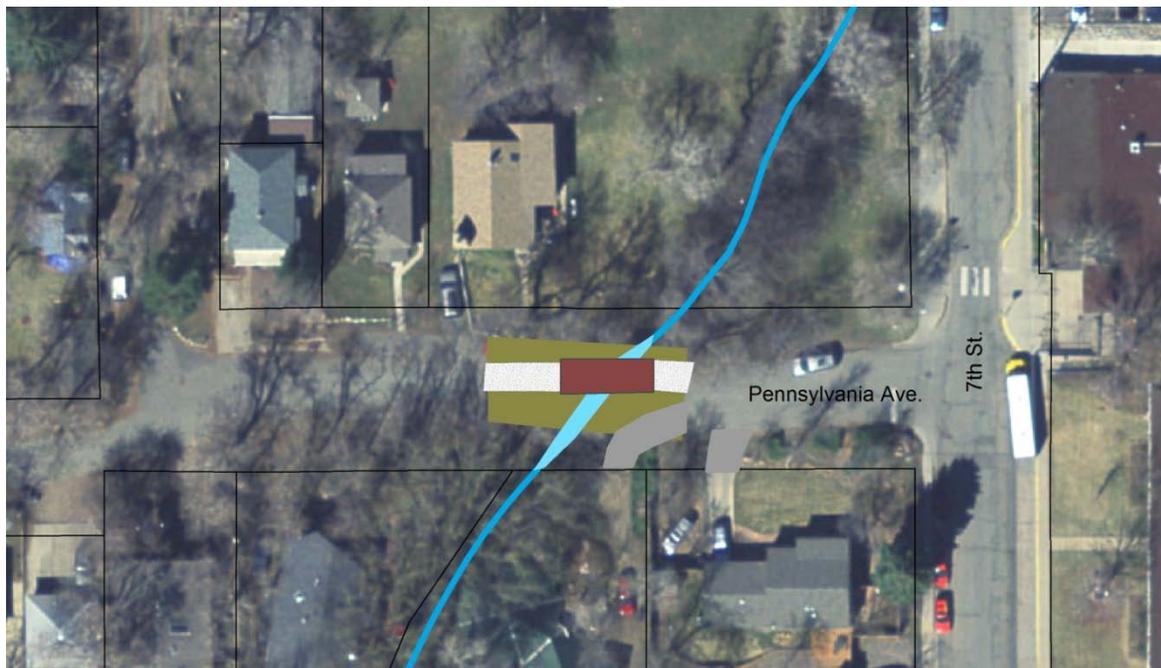
Alternative 2

The second alternative would involve removing the existing culvert pipe and adjacent asphalt roadway, and building a multi-use trail with a bridge across the creek. This alternative would cost approximately \$95,000. This alternative would change the geometry and the flow characteristics of the creek and would therefore require a floodplain analysis and flood and wetland permits. Permanent closure of the roadway would also require Planning Board approval in accordance with the City Street Closure/Traffic Restrain Policy (**Appendix A**). The floodplain analysis, design work, approval process and permitting would take approximately four to six months before construction could begin.

Installing a pedestrian bridge would provide additional flood capacity at this location which could decrease the flooding risks for properties in the area. This option provides the greatest wildlife and wetland habitat benefits by minimizing the impervious area above and adjacent to the creek and increasing the length of open channel and riparian area.

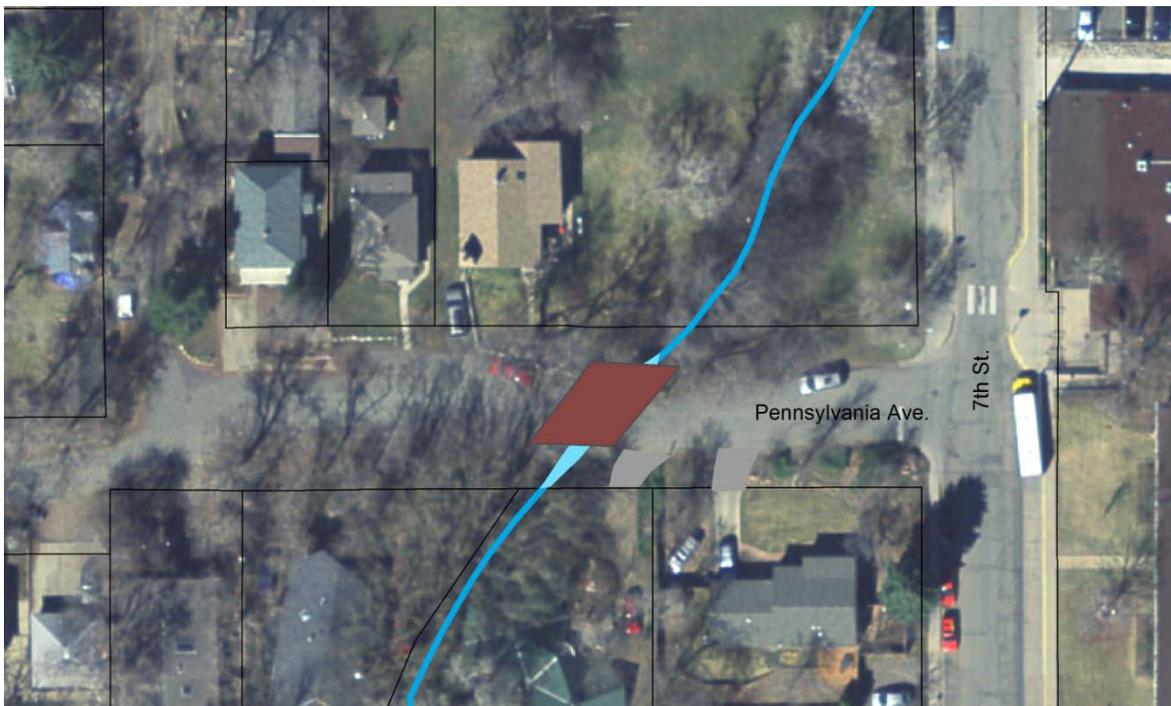
Alternative 3

The third alternative would involve removing the existing culvert pipe and rebuilding the roadway with a vehicular bridge or a larger box-style culvert across the creek. This alternative would cost approximately \$225,000. This alternative would change the geometry and the flow characteristics of the creek and would therefore require a floodplain analysis and flood and wetland permits. The floodplain analysis, design work and permitting would take approximately four to six months before construction could begin.

Installing a vehicular bridge or larger culvert would provide additional flood capacity at this location which could decrease the flooding risks for properties in the area. Historic traffic patterns would also be restored.

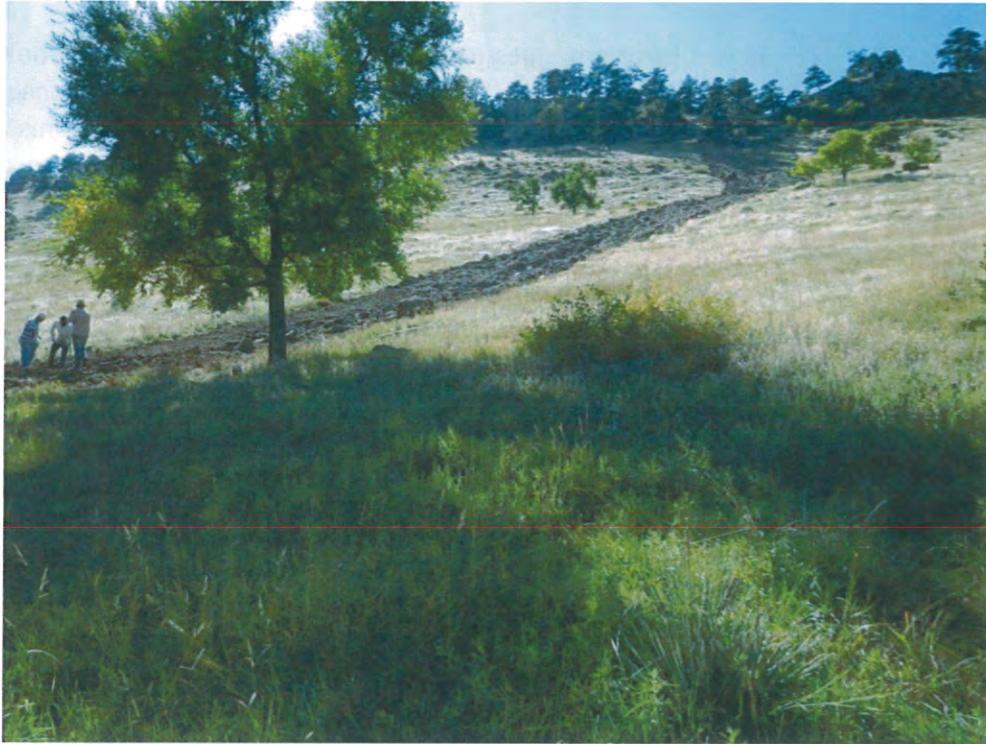
Photo 1: Debris flow channel and source zone near top of ridge (looking west).

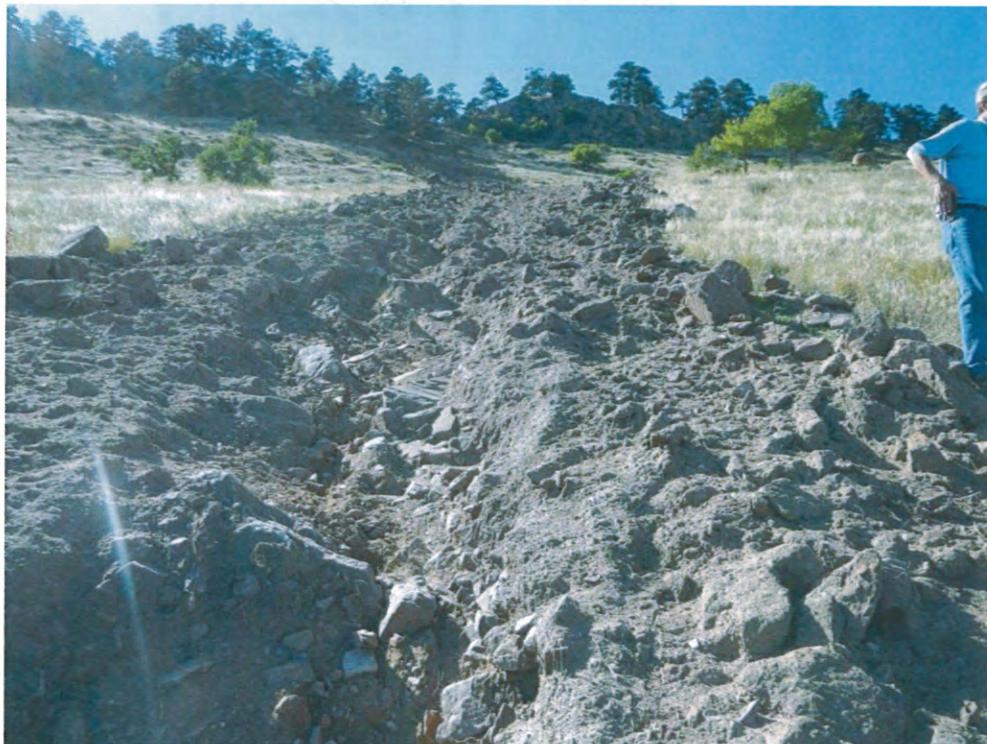
Photo 2: Debris flow channel; note the 1-2 feet deep zone of scour.

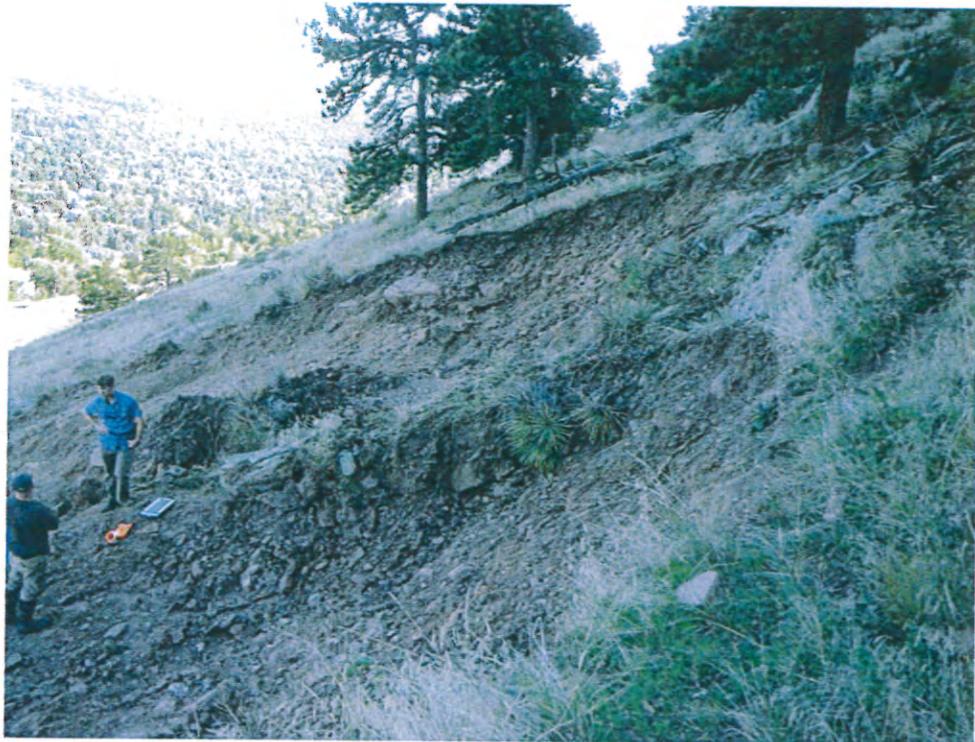
Photo 4: Two scarps observed at the source zone (looking south).

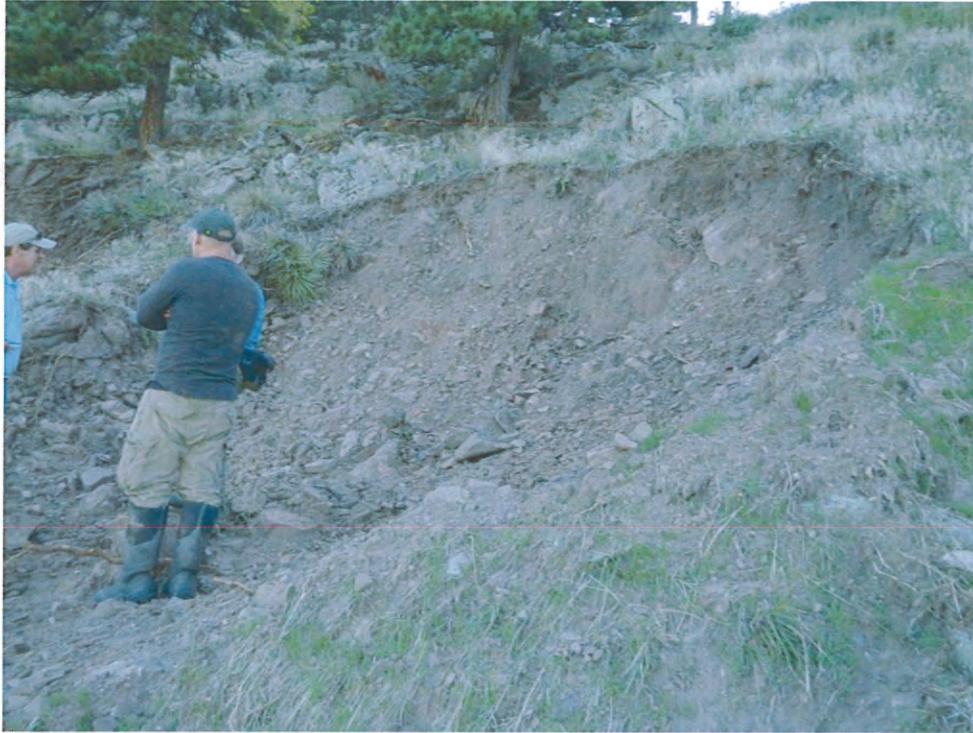
Photo 5: North scarp at the source zone.

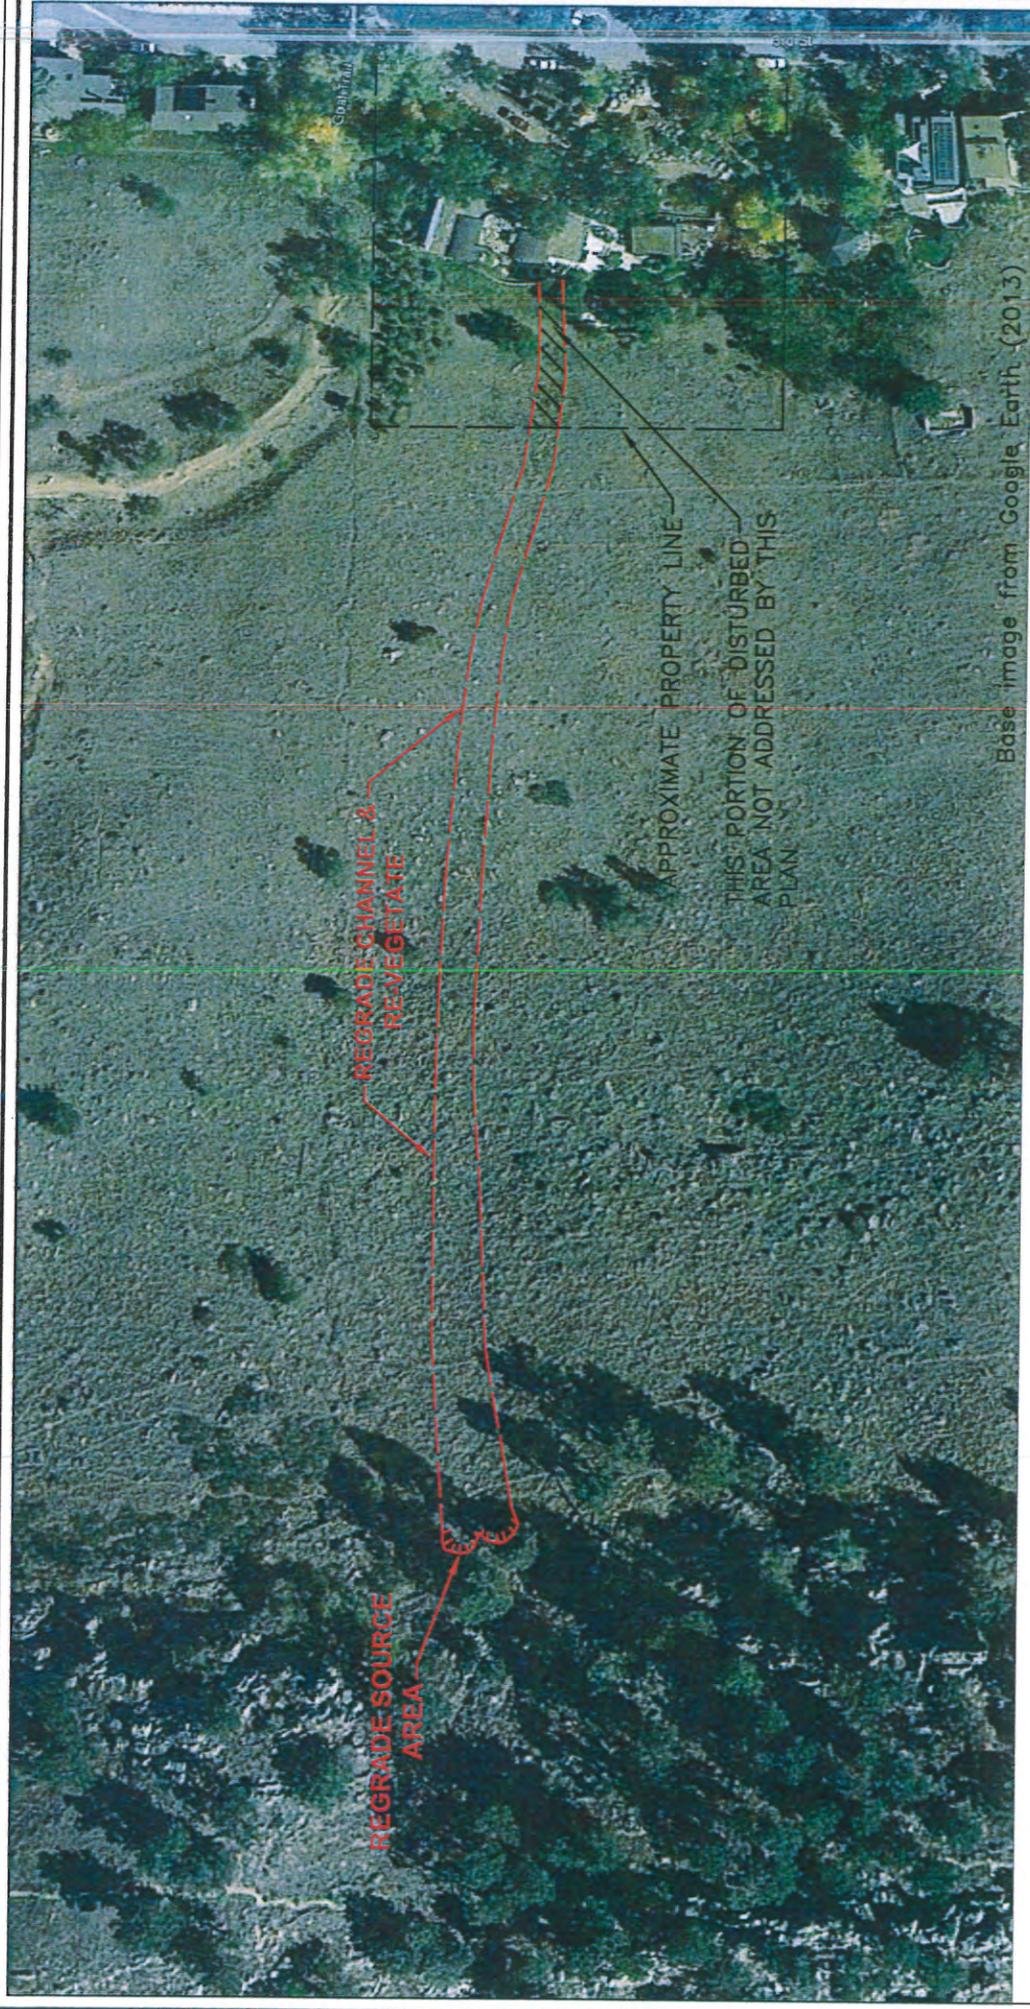
FIGURE: 1

--- EXTENT OF DEBRIS FLOW CHANNEL

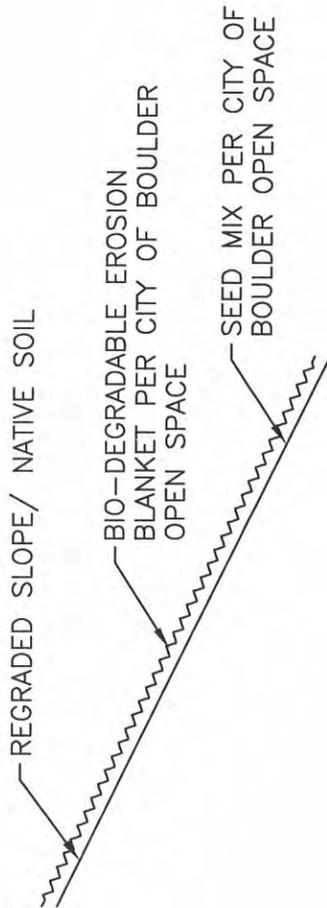
1 RE-VEGETATION DETAILS
N.T.S.

FOR SLOPES 4:1 (H:V) OR STEEPER

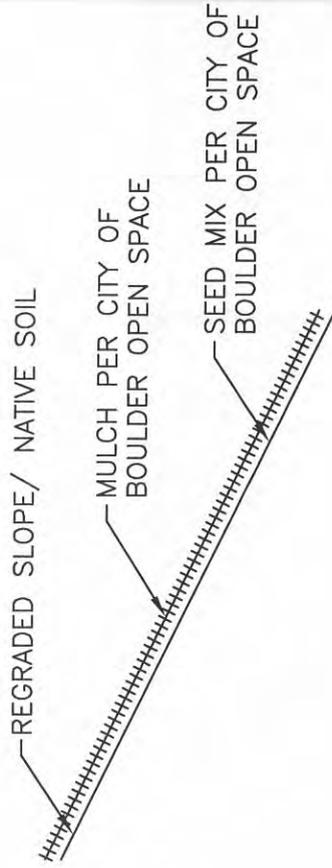
FOR SLOPES FLATTER THAN 4:1 (H:V)
