Evert Pierson Kids' Fishing Pond

SITE RESTORATION AND ENHANCMENT - DESIGN INTENT

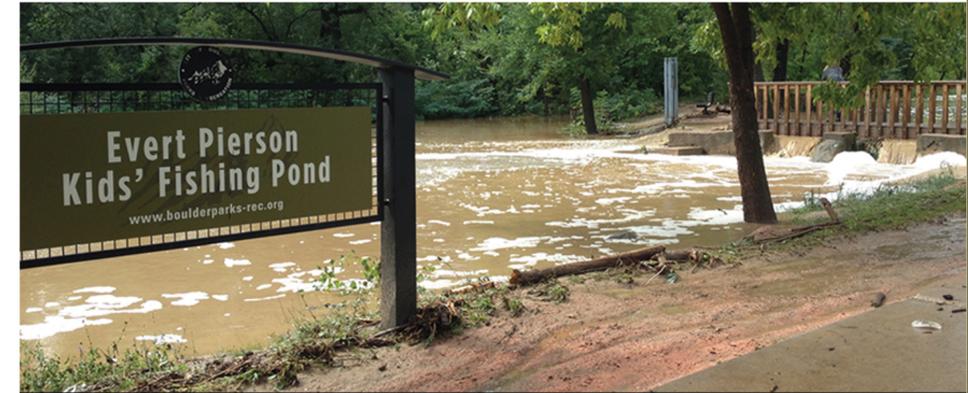
2013 FLOOD

The rehabilitation and enhancement of the Evert Pierson Kids' Fishing Pond is in response to damage due to flooding that occurred in the fall of 2013. This project aims to repair the functionality of the ponds and enhance the utility and quality of the ponds with respect to fishing access, water quality, water control, and habitat value. The flood damage is primarily characterized by sediment deposits and damaged structures including the fishing piers, bridges and water control structures.
