# BOULDER CREEK COMMONS

Groundwater Summer Information  
Existing Conditions

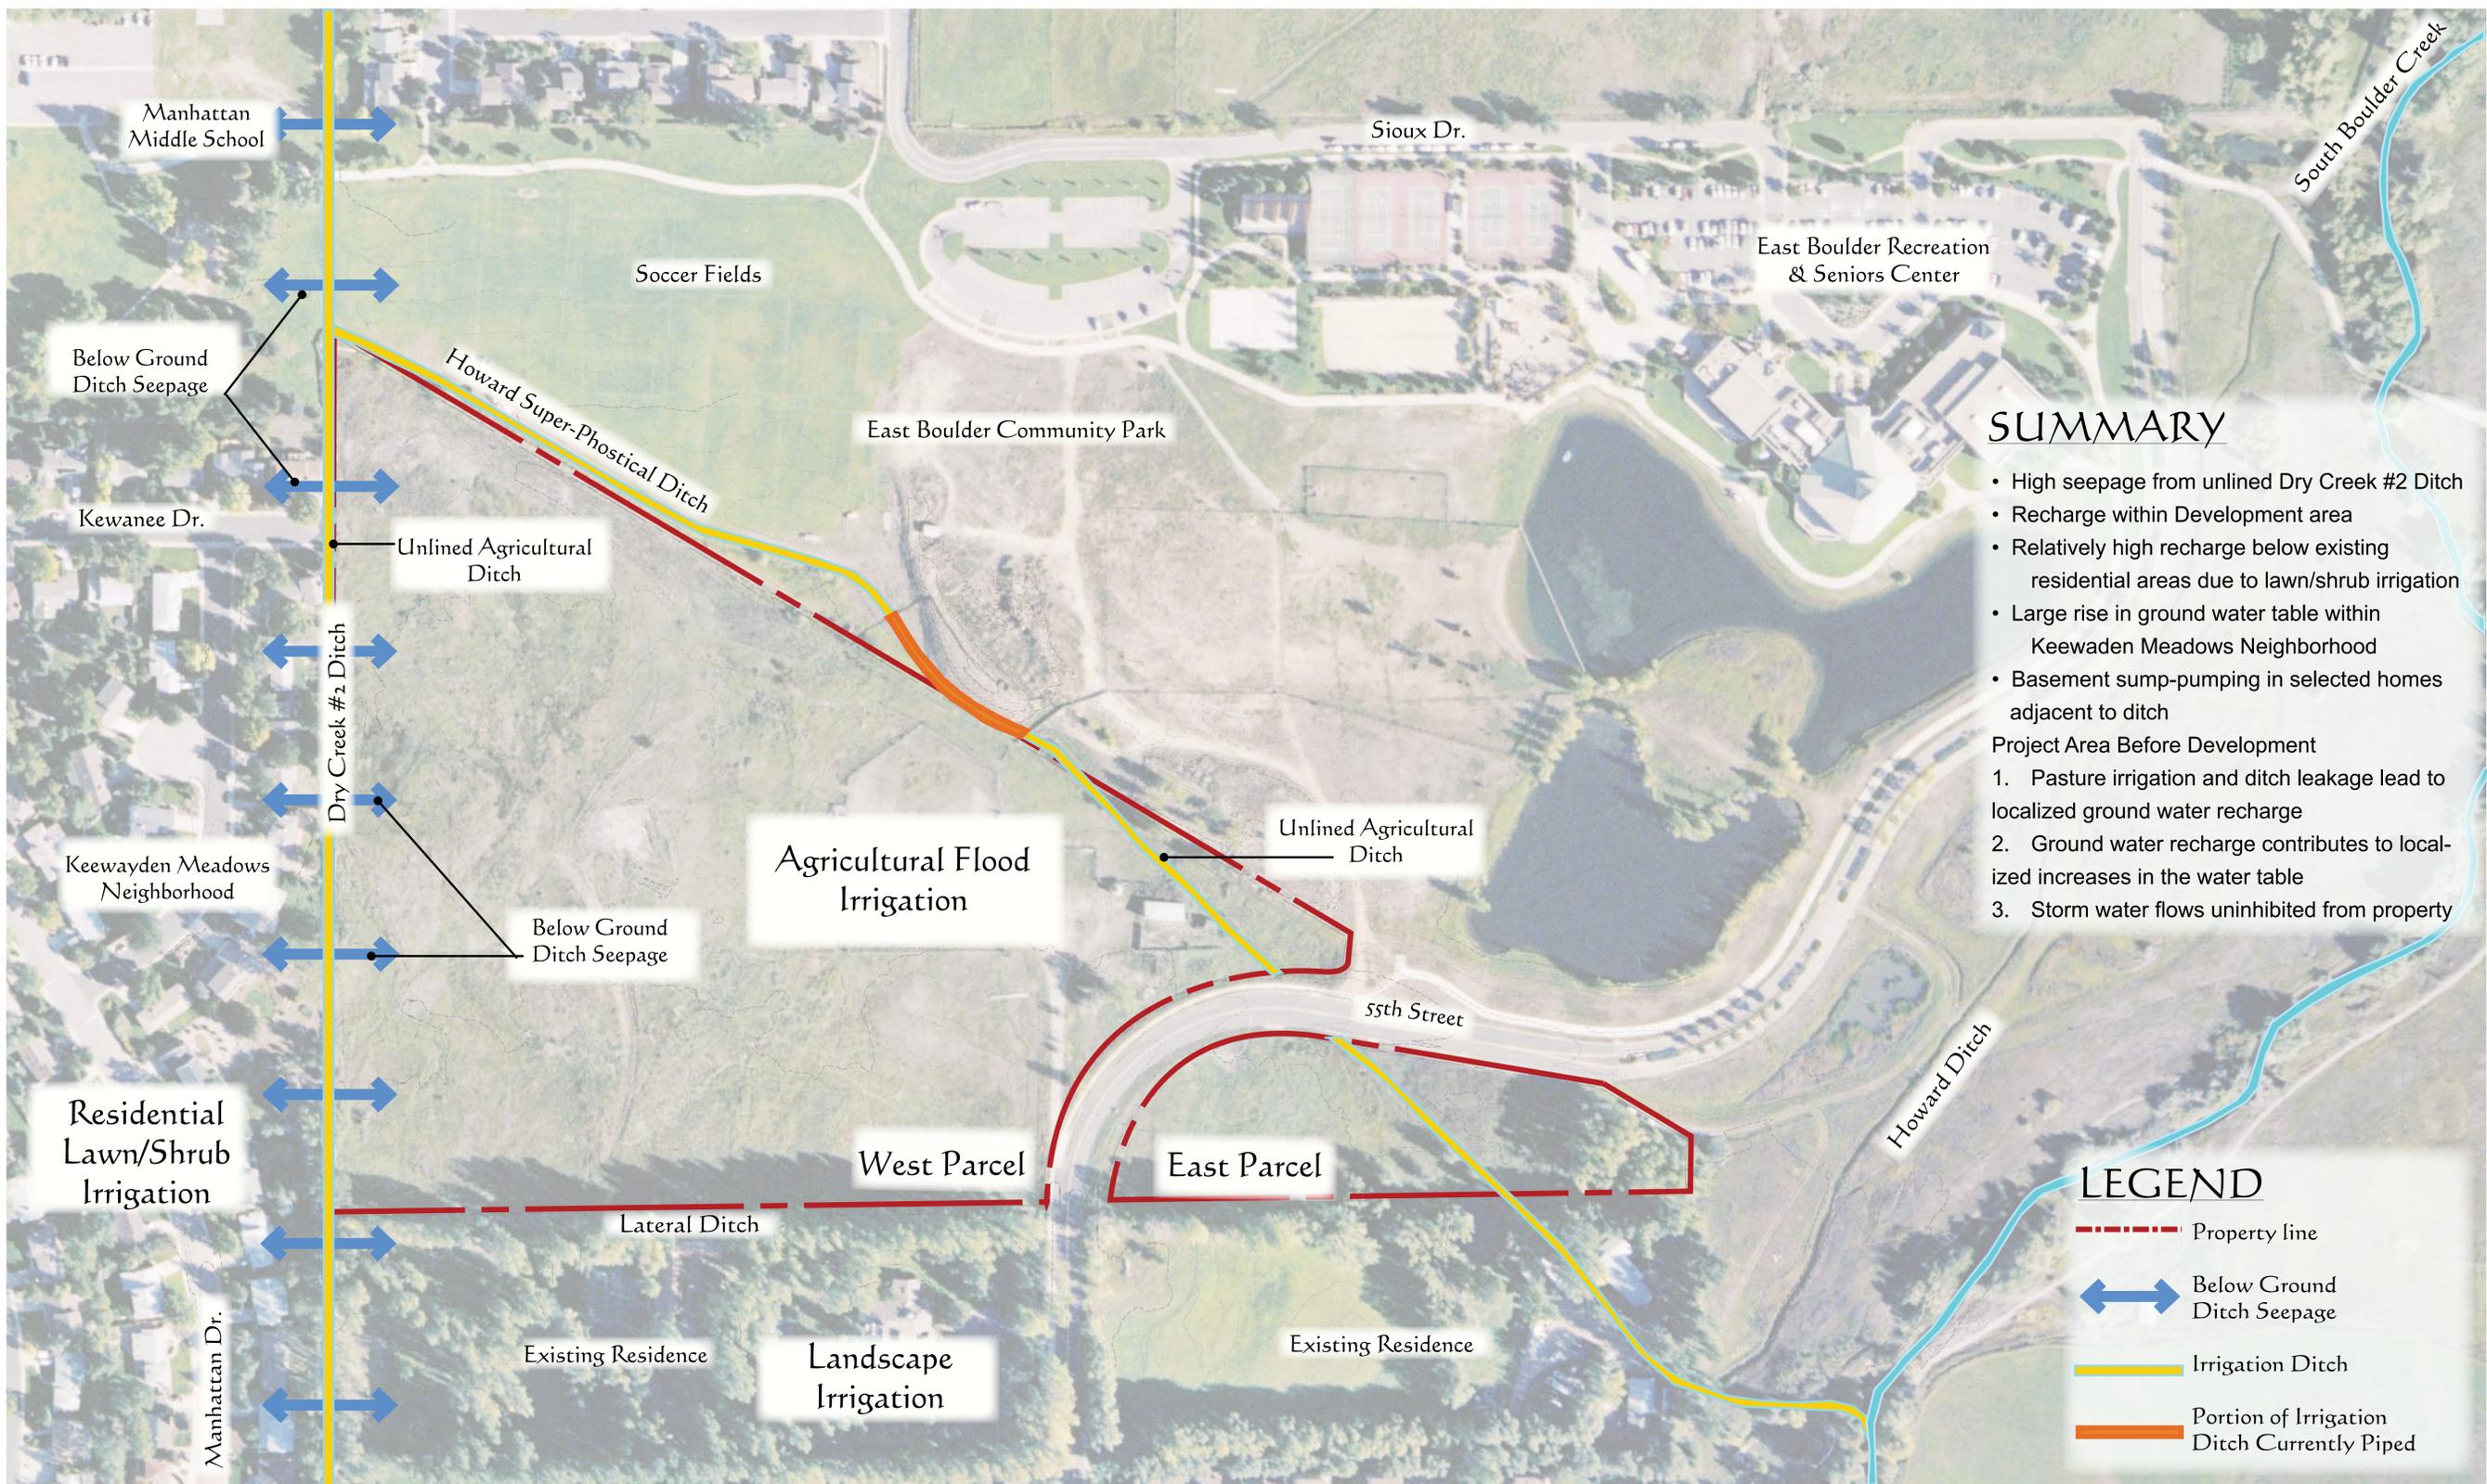
- High seepage from unlined Dry Creek #2 Ditch
  - Recharge within Development area
  - Relatively high recharge below existing residential areas due to lawn/shrub irrigation
  - Large rise in ground water table within Keewaden Meadows Neighborhood
  - Basement sump-pumping in selected homes adjacent to ditch
- Project Area Before Development
1. Pasture irrigation and ditch leakage lead to localized ground water recharge
  2. Ground water recharge contributes to localized increases in the water table
  3. Storm water flows uninhibited from property
