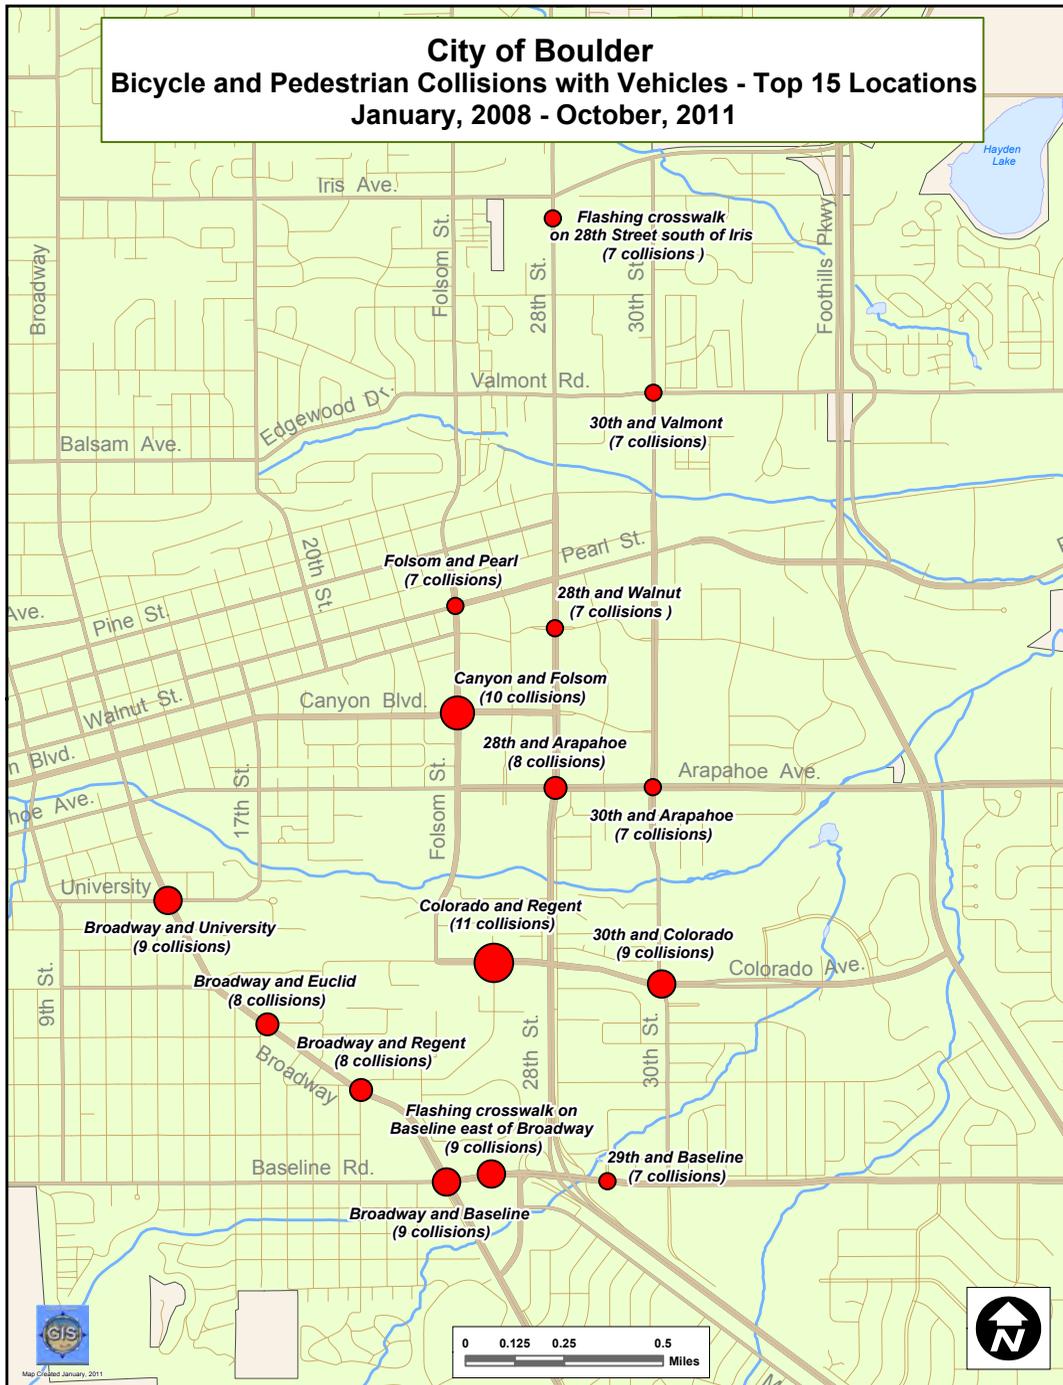
**Figure 15: Most common locations for collisions**

Signalized intersections were the most common location for collisions. As a standard practice, the Transportation Division examines the collision trends at high collision locations to identify possible changes to the geometry or operations of the intersections. Countermeasures have been implemented at Baseline east of Broadway (a pedestrian signal has replaced the flashing crosswalk and an underpass is planned) and countermeasures have been implemented or are being considered for all of the other locations as well.
